**STATE OF HAWAII**  
**DEPARTMENT OF LAND AND NATURAL RESOURCES**  
**COMMISSION ON WATER RESOURCE MANAGEMENT**  
 Stream Protection and Management Branch

**FIELD INVESTIGATION REPORT**  
**FI2008102802 (East Maui, Honopou IIFS Site B)**

<b>Date of Field Investigation:</b>	October 28, 2008	<b>Time (24-hour):</b>	0930 - 1100
<b>CWRM Staff:</b>	Ed Sakoda, Dean Uyeno, and Chui Ling Cheng		
<b>Individuals Present:</b>	EMI - Garret Hew (EMI Water Resources Manager) and Henry Robello (Field Superintendent) Honopou community - Beatrice Kekahuna, and Wanda Vierra		
<b>Hydrologic Unit:</b>	Honopou (6034)		
<b>Stream Name:</b>	Honopou Stream

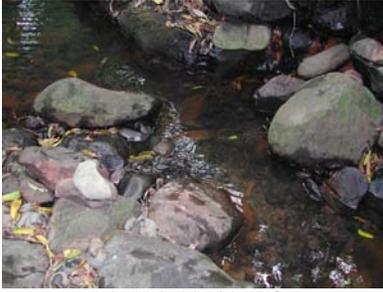
20081028011.JPG

<u>File Name:</u>	<u>Brief Description:</u>
20081028011	IIFS Site B on Honopou Stream.
20081028012	CRM wall of the gage pool on Honopou Stream at IIFS Site B.
20081028013	Capped PVC pipe at the CRM wall of the gage pool on Honopou Stream at IIFS Site B.

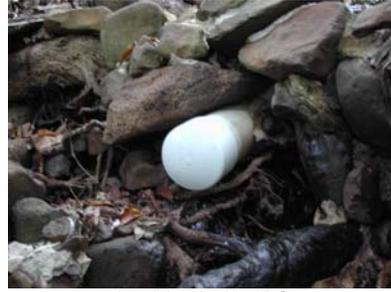
20081028013.JPG

On the previous day, Garret Hew offered to bring the cap for the pipe (see Field Investigation Report FI2008102705 (East Maui, Huelo IIFS Site A). CWRM staff and Garret Hew capped the PVC pipe that is part of the concrete-reinforced masonry (CRM) wall of the gage pool on Honopou Stream. They used PVC cement to prevent any leakage from the pipe.
