STATE OF HAWAII  
DEPARTMENT OF LAND AND NATURAL RESOURCES  
COMMISSION ON WATER RESOURCE MANAGEMENT  
Stream Protection and Management Branch

**FIELD INVESTIGATION REPORT**  
FI2008120903 (East Maui, Waiokamilo Koolau Ditch)

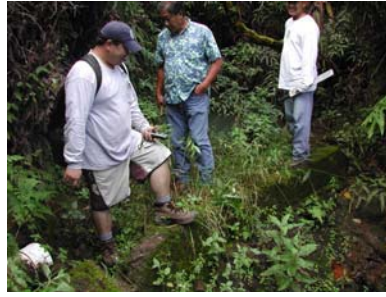
**20081209035.JPG**

<b>File Name:</b>	<b>Brief Description:</b>
20081209031	View of Keanae Valley from the service road.
20081209035	Minor diversion on a tributary of Waiokamilo Stream (K-22a). A 6-inch aluminum PVC pipe diverts water to a tributary of East Waiokamilo Stream, formerly known as Kualani Stream.
20081209037	Tributary of Waiokamilo Stream downstream of the minor diversion K-22a.
20081209038	Minor diversion on a tributary of Waiokamilo Stream (K-22a). A 6-inch aluminum PVC pipe diverts water to a tributary of East Waiokamilo Stream, formerly known as Kualani Stream.
20081209039	Concrete wall of the minor diversion on a tributary of Waiokamilo Stream (K-22a). This section of the concrete wall is broken sever diversion of water and allow continuous flow of water in the stream.
20081209040	Minor diversion on a tributary of Waiokamilo Stream (K-22a). This section of the 6-inch aluminum PVC pipe is broken sever diversion of water from the stream.

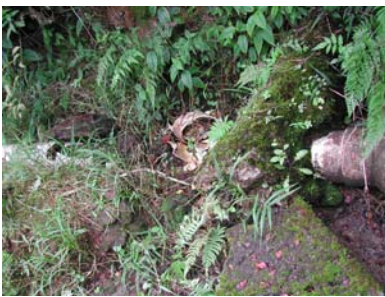
**20081209041.JPG**

20081209041	Minor diversion on a tributary of Waiokamilo Stream (K-22a). This section of the 6-inch aluminum PVC pipe is broken sever diversion of water from the stream.
20081209042	Minor diversion on a tributary of Waiokamilo Stream (K-22a). A 6-inch aluminum PVC pipe diverts water to a tributary of East Waiokamilo Stream, formerly known as Kualani Stream.
20081209043	Tributary of East Waiokamilo Stream upstream of the Koolau Ditch major diversion #10 intake (K-22).
20081209045	Koolau Ditch major diversion (K-22, #10 intake) on a tributary of East Waiokamilo Stream. Metal grate on the left streambank has been sealed with concrete.
20081209046	Koolau Ditch major diversion (K-22, #10 intake) on a tributary of East Waiokamilo Stream.
20081209047	Koolau Ditch major diversion (K-22, #10 intake) on a tributary of East Waiokamilo Stream.
20081209049	Koolau Ditch major diversion (K-22, #10 intake) on a tributary of East Waiokamilo Stream.

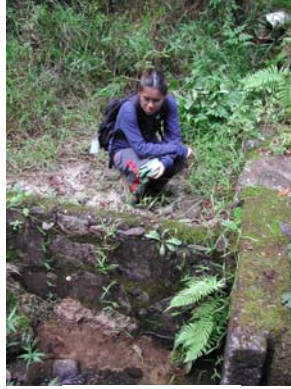
**20081209050.JPG**

20081209050	Koolau Ditch major diversion (K-22, #10 intake) on a tributary of East Waiokamilo Stream.
20081209051	Tributary of East Waiokamilo Stream downstream of the Koolau Ditch major diversion (K-22, #10 intake).
20081209052	Koolau Ditch major diversion (K-22, #10 intake) on a tributary of East Waiokamilo Stream. A 6-inch PVC pipe outfall is located on the left bank. This pipe transported water from a tributary of Waiokamilo Stream at minor diversion K-22a to this stream.
20081209054	Tributary of East Waiokamilo Stream downstream of the Koolau Ditch major diversion (K-22, #10 intake). With the diversion structure sealed shut, water was seen flowing through the sluice gate and out the side of

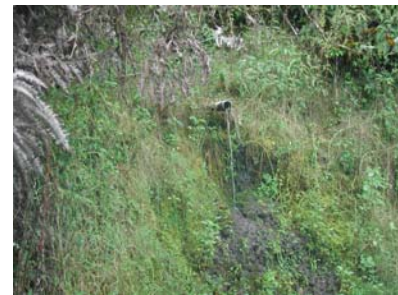
**20081209055.JPG**

the mountain.
20081209055	Minor diversion on a tributary of Waiokamilo Stream. A #10 crosscut intake pipe that used to divert water from Waiokamilo Stream.
20081209056	Koolau Ditch major diversion on Waiokamilo Stream (K-23, #11 intake).
20081209059	Koolau Ditch major diversion on Waiokamilo Stream (K-23, #11 intake).
20081209060	Waiokamilo Stream downstream from Koolau Ditch major diversion #11 intake (K-23).
20081209061	Board gates of the Koolau Ditch access tunnel at #11 intake (K-23) to prevent water from flowing into the ditch.
20081209062	Waiokamilo Stream above the Koolau Ditch major diversion #11 intake (K-23).
20081209063	Waiokamilo Stream above the Koolau Ditch major diversion #11 intake (K-23). Water from the stream was falling outside of the access tunnel and flowing downstream.
20081209064	Waiokamilo Stream downstream from Koolau Ditch major diversion #11 intake (K-23) and the access tunnel.

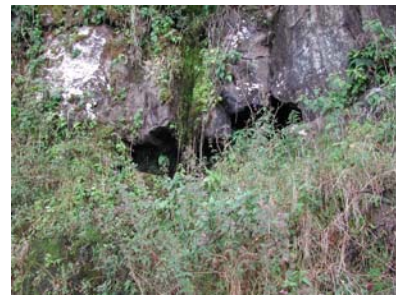
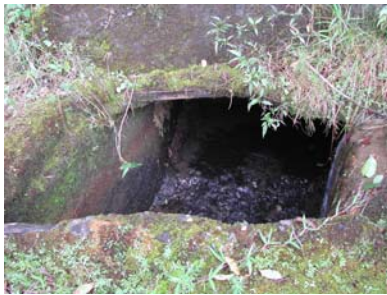
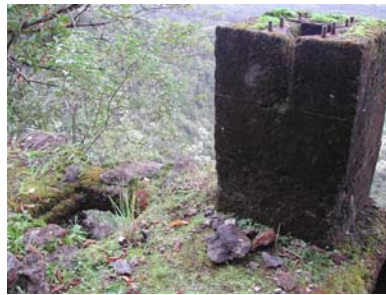
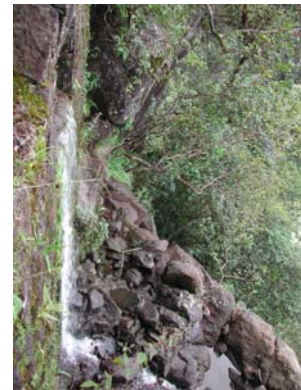
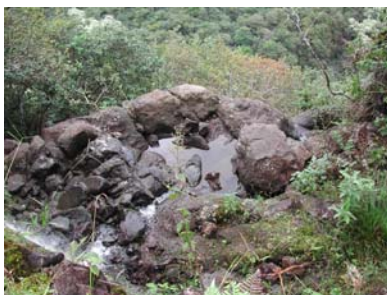
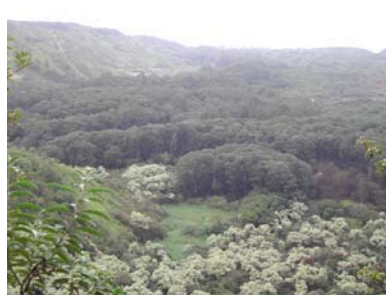
intake sealed with cement, water continued to flow downstream. Based on staff's observation, major diversion #12 intake (K-24) is no longer functional and not diverting water from Waiokamilo Stream. See photos 20081209077 - 20081209084.

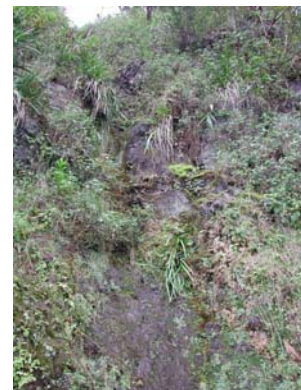
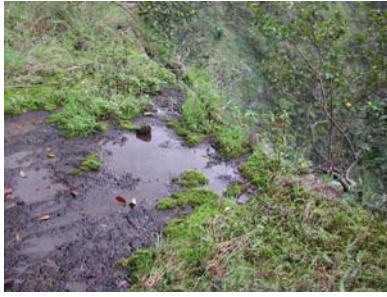
7. Time: 1435 hours. Minor diversion on Waiokamilo Stream. This is a crosscut #12 intake diversion structure with a small PVC pipe that captured seepage and transported water into Koolau Ditch. Very little water was observed. Based on staff's observation, this crosscut intake is no longer in operation. See photos 20081209085 and 20081209086.

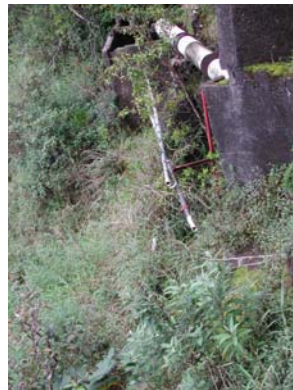
**20081209094.JPG**

20081209094	Koolau Ditch Kikokiko minor intake structure on Waiokamilo Stream. PVC pipe and catchment basin below the service road that used to capture seepage from upstream. The pipe from minor diversion K-25c can be seen in this photo.
20081209096	Koolau Ditch Kikokiko minor intake structure K-25a on Waiokamilo Stream. PVC pipe and catchment basin below the service road bridge that used to capture seepage from upstream.
20081209098	Koolau Ditch Kikokiko minor intake structure K-25d on Waiokamilo Stream. PVC pipe and catchment basin further West along the service road that used to capture seepage and transport to Koolau Ditch.
20081209099	Koolau Ditch Kikokiko minor intake structure K-25e on Waiokamilo Stream. PVC pipe and catchment basin 20 feet West of minor diversion K-25d along the service road that used to capture seepage and transport to Koolau Ditch.
20081209101	Main Kikokiko 6-inch intake pipe that used to divert water from Waiokamilo Stream to Koolau Ditch.

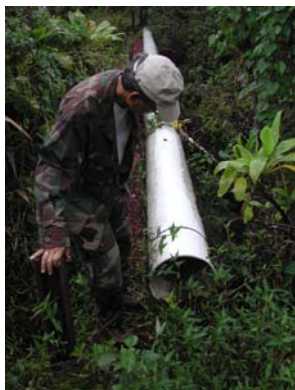
**20081209102.JPG**

8. Time: 1440 hours. Koolau Ditch major diversion (K-25, Kikokiko intake) on Waiokamilo Stream and the minor diversions. Water from Waiokamilo Stream would flow down a small waterfall and into the main intake structure on the left bank below the falls. A minor diversion (K-25a) is located on the left bank of the stream under the service road bridge. The diversion structure is a concrete catchment basin with a 2-inch pipe intake that would capture seepage and transported that water via a PVC pipe into another catchment basin below the service road. A second minor diversion (K-25c) begins mauka of the service road bridge on the left bank and then crossed over to the right bank. The diversion structure is a concrete catchment basin with a 6-inch pipe intake that would capture seepage and transported that water to Koolau Ditch. A third minor diversion (K-25d) is located further West along the service road. This diversion structure is a concrete catchment basin with a 4-inch PVC pipe that would capture seepage and transported that water to Koolau Ditch. A fourth minor diversion (K-25e) is located 20 feet West of minor diversion K-25d. This diversion structure is a concrete catchment basin with a 3-inch PVC pipe that would capture seepage and transported that water to Koolau Ditch. Based on staff's observation, the Kikokiko intake and the minor diversions are no longer functional because either the intakes were cemented and / or the pipes were severed. See photos 20081209088 and 20081209102.

20081209102	Main Kikokiko 6-inch intake pipe that used to divert water from Waiokamilo Stream to Koolau Ditch.
20081209104	Koolau Ditch minor diversion on Waiokamilo Stream (K-23a). The diversion structure is a 4-inch PVC pipe intake located East of #11 intake.
20081209105	Koolau Ditch #10 crosscut minor intake on Waiokamilo Stream (K-22d).

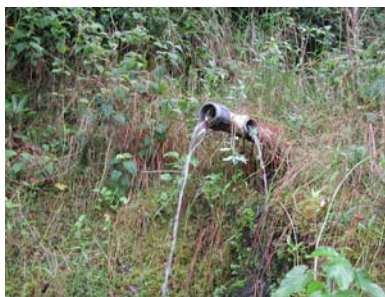
**20081209104.JPG**

9. Time: 1543 hours. Koolau Ditch minor diversion (K-23a) on Waiokamilo Stream. The diversion structure is a 4-inch PVC pipe intake located east of #11 intake (K-23). The outfall of the minor diversion was not capped and very little water was flowing out of the pipe. Based on staff's observation, this minor intake is no longer in operation. See photo 20081209104.

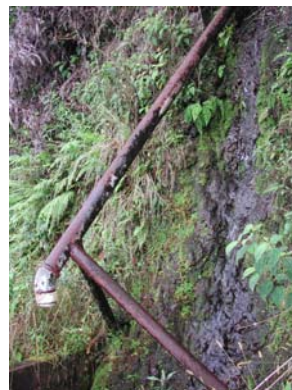
**20081209105.JPG**

10. Time: 1548 hours. Koolau Ditch #10 crosscut minor intake (K-22d) on Waiokamilo Stream. The outfall of the minor diversion was not capped and no water was flowing out of the pipe. Based on staff's observation, this minor intake is no longer in operation. See photo 20081209105.
