STATE OF HAWAII
DEPARTMENT OF LAND AND NATURAL RESOURCES
COMMISSION ON WATER RESOURCE MANAGEMENT
 Stream Protection and Management Branch

FIELD INVESTIGATION REPORT

FI2008121002 (East Maui, East Wailuanui Koolau Ditch)

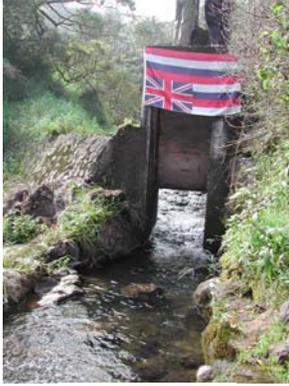
20081210001.JPG

| <u>File Name:</u> | <u>Brief Description:</u> |
|---|---|
| 20081210001 | Downstream side of the Koolau Ditch bypass sluice gate on East Wailuanui Stream. |

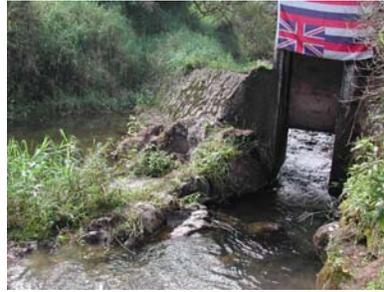
20081210002.JPG

| <u>File Name:</u> | <u>Brief Description:</u> |
|---|---|
| 20081210002 | Downstream side of the Koolau Ditch bypass sluice gate on East Wailuanui Stream. |

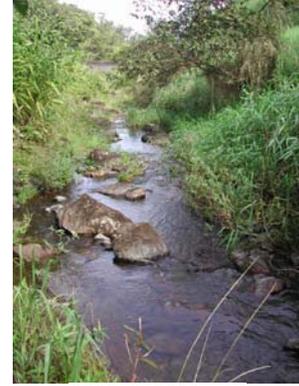
20081210003.JPG

| <u>File Name:</u> | <u>Brief Description:</u> |
|---|---|
| 20081210003 | East Wailuanui Stream downstream of the Koolau Ditch bypass sluice gate. |

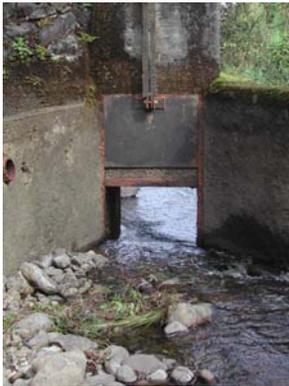
20081210005.JPG

| <u>File Name:</u> | <u>Brief Description:</u> |
|---|---|
| 20081210005 | Upstream side of the Koolau Ditch bypass sluice gate on East Wailuanui Stream. |

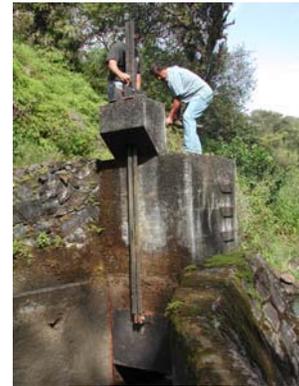
20081210008.JPG

| <u>File Name:</u> | <u>Brief Description:</u> |
|---|---|
| 20081210008 | EMI staff adjusting the Koolau Ditch bypass sluice gate on East Wailuanui Stream. |

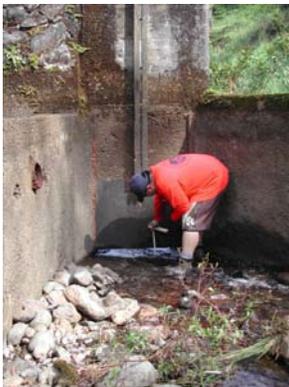
20081210011.JPG

The final height of the sluice gate opening after adjustment was 0.35 feet. CWRM staff fluorescent yellow flagging tape to mark the height of the sluice gate opening.

| <u>File Name:</u> | <u>Brief Description:</u> |
|---|---|
| 20081210011 | CWRM staff measuring the height of the Koolau Ditch bypass sluice gate opening on East Wailuanui Stream. |

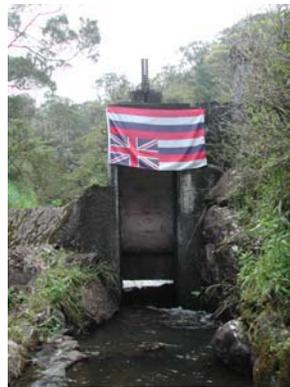
20081210012.JPG

| <u>File Name:</u> | <u>Brief Description:</u> |
|---|---|
| 20081210012 | Upstream side of the Koolau Ditch bypass sluice gate on East Wailuanui Stream after gate adjustment. |

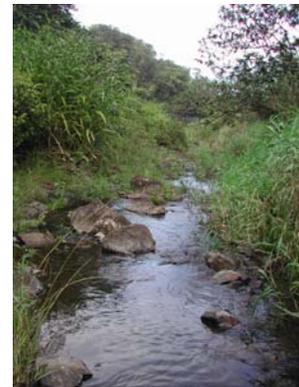
20081210013.JPG

| <u>File Name:</u> | <u>Brief Description:</u> |
|---|---|
| 20081210013 | East Wailuanui Stream downstream of the Koolau Ditch bypass sluice gate after adjustment. |

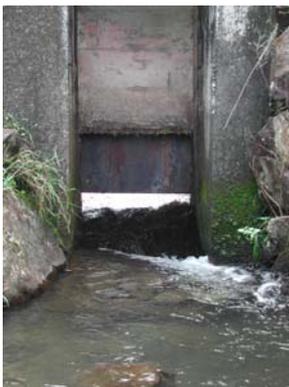
20081210014.JPG

| <u>File Name:</u> | <u>Brief Description:</u> |
|---|---|
| 20081210014 | Upstream side of the Koolau Ditch bypass sluice gate on East Wailuanui Stream after gate adjustment. |

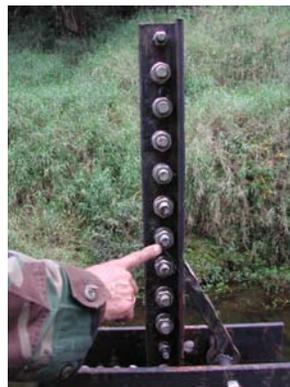
20081210016.JPG

CWRM staff measured the dimensions of the sluice gate opening to be 3.0 x 2.0 feet (W x H). The depth of water at the sluice gate was 0.11 feet, which was 0.015 feet lower than the water depth recorded on Monday, Dec. 8, 2008 (refer to FI2008120801). Staff also measured the gap between each notch on the sluice gate adjustment structure to be 0.18 feet.

| <u>File Name:</u> | <u>Brief Description:</u> |
|---|---|
| 20081210016 | Notches of the Koolau Ditch bypass sluice gate on East Wailuanui Stream. |

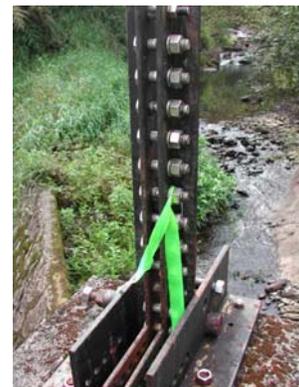
20081210020.JPG

| <u>File Name:</u> | <u>Brief Description:</u> |
|---|---|
| 20081210020 | Notches of the Koolau Ditch bypass sluice gate on East Wailuanui Stream. |
