STATE OF HAWAII
DEPARTMENT OF LAND AND NATURAL RESOURCES
COMMISSION ON WATER RESOURCE MANAGEMENT
 Stream Protection and Management Branch

FIELD INVESTIGATION REPORT
FI2008121005 (East Maui, Piinaau Koolau Ditch)

Date of Field Investigation:	December 10, 2008	Time (24-hour):	1630 - 1700
CWRM Staff:	Ken Kawahara, Ed Sakoda, Dean Uyeno, and Chui Ling Cheng		
Individuals Present:	EMI - Garret Hew (Water Resources Manager), Mark Vaught (Operations Manager), Henry Robello (Field Superintendent); DOCARE - 3 officers		
Hydrologic Unit:	Piinaau (6053)		
Stream Name:	Piinaau Stream

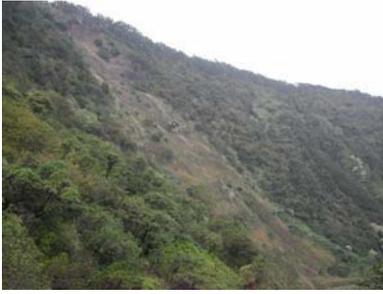
20081210079.JPG

File Name:	Brief Description:
20081210079	The 2003 landslide that covered the service road (Piinaau Road) and a section of Piinaau Stream in the valley.
20081210080	Keanae valley below Koolau Ditch.
20081210081	Section of Piinaau Stream covered by the 2003 landslide.
20081210082	Piinaau Stream upstream from Koolau Ditch.
20081210084	Outfall of minor diversion (K-31a) that transports water around the losing reach, from upstream reaches to Piinaau Stream immediately upstream of the ditch.
20081210085	Piinaau Stream upstream of minor diversion (K-31a).
20081210086	Minor diversion (K-31a) on Piinaau Stream. Six inch steel and PVC pipe diversion to main Piinaau Stream intake.
20081210088	Piinaau Stream (losing reach) downstream of minor diversion (K-31a).
20081210090	Piinaau Stream (losing reach) downstream of minor diversion (K-31a).
20081210091	Possibly a sink hole on Piinaau Stream, downstream of minor diversion (K-31a).

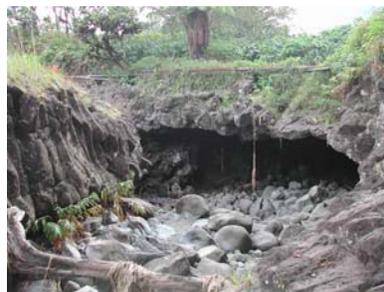
20081210092.JPG

20081210092	Minor diversion (K-31a) on Piinaau Stream. Six inch steel and PVC pipe diversion to main Piinaau Stream intake.
20081210093	Koolau Ditch intake structure on the right bank of Piinaau Stream.
20081210095	Section of Piinaau Stream covered by the 2003 landslide.

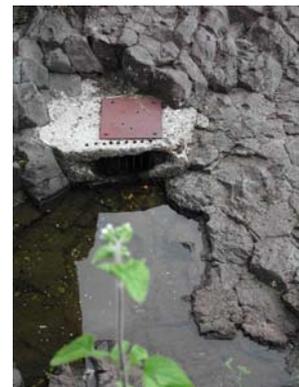
20081210093.JPG

The major diversion intake (K-31) is directly below the bridge where Piinaau Stream crosses the service road. The intake is concrete with a metal grate. When the stream is full, water is ponded in front of the grate. When the level of the water reaches a specific height, the water will spill into the ditch through the metal grate.
