STATE OF HAWAII
DEPARTMENT OF LAND AND NATURAL RESOURCES
COMMISSION ON WATER RESOURCE MANAGEMENT
Stream Protection and Management Branch

FIELD INVESTIGATION REPORT
FI2009032301 (East Maui, Low Flow Channel)

Date of Field Investigation:	March 23, 2009	Time (24-hour):	0900 - 1530
CWRM Staff:	Ed Sakoda, Dean Uyeno, and Chui Ling Cheng		
Individuals Present:	Honopou community - Lynn Scott, Beatrice Kekahuna, Sanford Kekahuna, and Boni Kekahuna EMI Staff - Garret Hew and staff from the HC&S Pump and Power section		
Hydrologic Unit:	Honopou (6034)		
Stream Name:	Honopou Stream		
Findings:	<p>CWRM staff departed Oahu for Maui at 0600 hours.</p> <p>The purpose of this field visit was to document the installation of the low-flow bypass channel on Haiku Ditch in Honopou Stream. In November of 2008, CWRM staff met with EMI staff to discuss the design of the low-flow bypass channel. It was in agreement between the two parties and the Honopou community that the bypass channel would be installed on the Haiku Ditch intake structure in Honopou Stream as a pilot project. Since then, EMI staff has been working to construct the bypass channel in their shop. Because the openings of the Haiku Ditch i

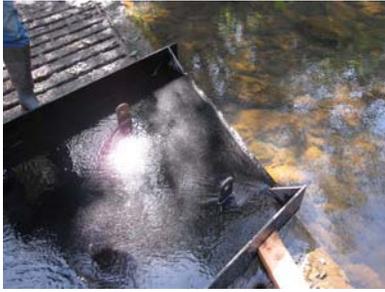
20090323004.jpg

File Name:	Brief Description:
20090323004	Low-flow bypass channel, upstream side
20090323005	Low-flow bypass channel, downstream side
20090323006	EMI staff welding an anchor bracket onto the main low-flow bypass channel
20090323008	Low-flow bypass channel (downstream side) with one of the anchor brackets in place
20090323009	EMI staff installing 2in x 4in wood onto the upstream side of the intake structure
20090323010	EMI staff welding an anchor bracket onto the main low-flow bypass channel
20090323015	EMI staff installing 2in x 4in wood onto the upstream side of the intake structure
20090323018	Left streambank where EMI staff transported the low-flow bypass channel onto the ditch intake structure
20090323020	EMI staff placing the pump line downstream of the ditch
20090323025	EMI staff operating the pump
20090323026	EMI staff operating the pump
20090323029	The pump used to pump water from the above the ditch downstream

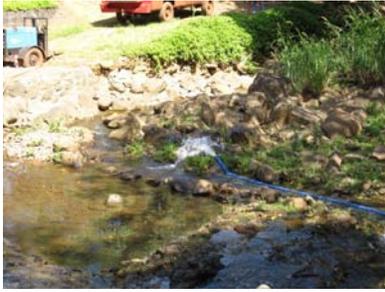
20090323030.jpg

20090323030	Pump water line upstream of the ditch
20090323031	Pump water line downstream of the ditch
20090323036	EMI staff installing the low-flow bypass channel
20090323038	EMI staff installing the low-flow bypass channel
20090323039	EMI staff welding an anchor bracket onto the main low-flow bypass channel
20090323040	A piece of metal welded on the upstream side of the bypass channel and over the side of the intake structure to prevent high water from flowing underneath the bypass channel and lifting it up
20090323042	Low-flow bypass channel, upstream side
20090323043	USGS temperature probe in Kekahuna's auwai
20090323046	USGS stream gage at the beginning of Kekahuna's auwai
20090323047	USGS stream gage at the beginning of Kekahuna's auwai
20090323053	Kekahuna's taro loi
20090323058	EMI staff sanding the low-flow bypass channel
20090323061	EMI staff completing the installation of the low-flow bypass channel

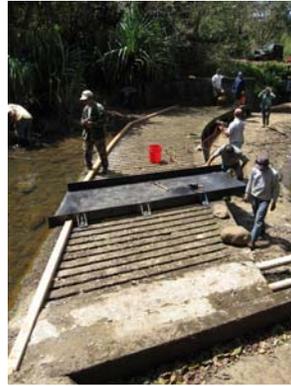
20090323065.jpg

20090323065	EMI staff completing the installation of the low-flow bypass channel
20090323067	Metal that was welded on the upstream side of the bypass channel and over the side of the intake structure to prevent high water from flowing underneath the bypass channel and lifting it up
20090323070	One of the anchor brackets of the low-flow bypass channel
20090323074	Downstream view of the low-flow bypass channel. Rocks were placed beneath the intake structure to minimize the amount of water back-flowing into the ditch.
20090323080	Completed low-flow bypass channel
20090323087	First water entering the low-flow bypass channel
20090323090	First water entering the low-flow bypass channel
20090323092	First water entering the low-flow bypass channel
20090323094	First water entering the low-flow bypass channel and flowing downstream
20090323102	First water entering the low-flow bypass channel and flowing downstream

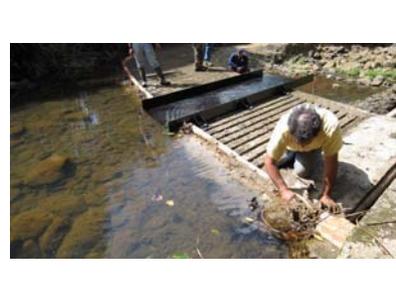
20090323106.jpg

20090323106	EMI staff using mud and other debris to fill holes and gaps between the wood and the intake structure to prevent stream water from entering the ditch
20090323109	Water flowing through the bypass channel while the 3 pipes were plugged
