STATE OF HAWAII
DEPARTMENT OF LAND AND NATURAL RESOURCES
COMMISSION ON WATER RESOURCE MANAGEMENT
 Stream Protection and Management Branch

FIELD INVESTIGATION REPORT
FI2009111601 (East Maui, Makapipi)

Date of Field Investigation:	November 16, 2009	Time (24-hour):	0730 - 1600
CWRM Staff:	Ken Kawahara, Ed Sakoda, Dean Uyeno, and Chui Ling Cheng		
Individuals Present:	EMI Staff - Garret Hew, Henry Robello		
Hydrologic Unit:	Makapipi, Hanawi		
Stream Name:	Makapipi Stream, Hanawi Stream

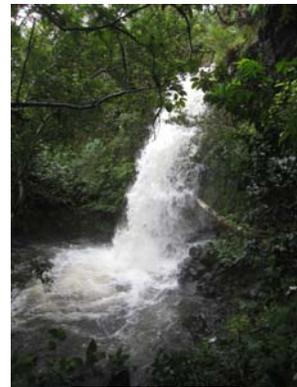
20091116012.jpg

Staff then visited the start of EMI’s Koolau Ditch on the left bank of east Makapipi Stream. A development tunnel (Makapipi tunnel 2) is located on the right bank of the stream. Water from this development tunnel is conveyed to the Koolau Ditch via a pipe crossing under a waterfall on east Makapipi Stream (see photo 20091116011). The Koolau Ditch also receives water from Kuhiwa Well (via a pipe) located further east in the hydrologic unit (see photo 20091116032). Addition water input is seepage captured in a concrete collection box and conveyed to the ditch via a pipe. As the Koolau Ditch daylights, the County of Maui Department of Water Supply diverts water from the ditch to serve the Lower Nahiku Community. This water is chlorine treated.

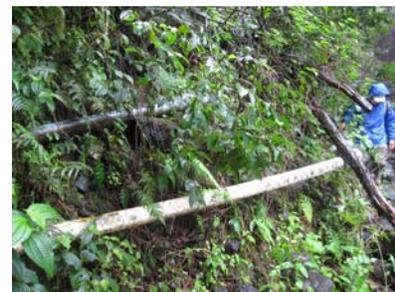
20091116016.jpg

20091116016	Pipe located below the waterfall (see photo 20091116012) conveying water from a development tunnel to the Koolau Ditch (tunnel).
20091116018	Pipe conveying water from Kuhiwa Well to the start of the Koolau Ditch (tunnel).
20091116021	Start of the Koolau Ditch (tunnel) near East Makapipi Stream.
20091116023	Development tunnel – Makapipi tunnel 2.
20091116027	East Makapipi Stream.
20091116032	Right bank of East Makapipi Stream. Kuhiwa Well is located further east.
20091116033	East Makapipi Stream.

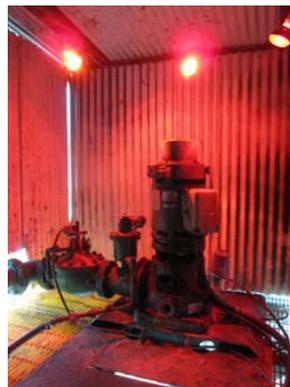
20091116061.jpg

Next, staff visited the Hanawi Pump Station on Hanawi Stream (see photo 20091116061). Maui Land & Pineapple Company used to divert water for irrigating their pineapple fields. Further upstream, staff visited EMI’s major diversion on Hanawi Stream. The diversion intake grate is located on the right bank of the stream. Staff took a short hike from the right bank of the stream to a small tributary stream where there was a minor diversion (see photo 20091116083).

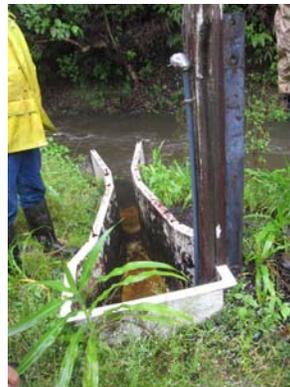
20091116088.jpg

20091116059	Makapipi coast.
20091116061	Hanawi Pump.
20091116063	Hanawi Stream (at high flow) upstream from Hana Highway.
20091116064	Hanawi Stream (at high flow) at Hana Highway.
20091116066	EMI major diversion on Hanawi Stream.
20091116067	EMI major diversion on Hanawi Stream.
20091116072	EMI major diversion intake grate on Hanawi Stream.
20091116075	EMI major diversion on Hanawi Stream.
20091116082	EMI minor diversion on a tributary of Hanawi Stream.
20091116083	Tributary of Hanawi Stream.
20091116088	This flume was used to measure the amount of water diverted by the Nahiku Pump.
