PREPARED BY
ERSKINE ARCHITECTS, INC.
540 Lagoon Drive, Suite 4
Honolulu, HI 96819
808-833-8891

Preliminary Findings & Recommendations Report for
MALAEKAHANA STATE RECREATION AREA
KAHUKU SECTION
Laie, HI
15 January 2014

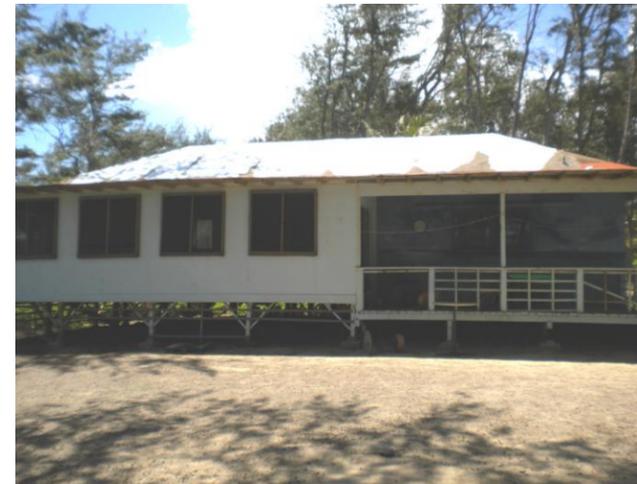
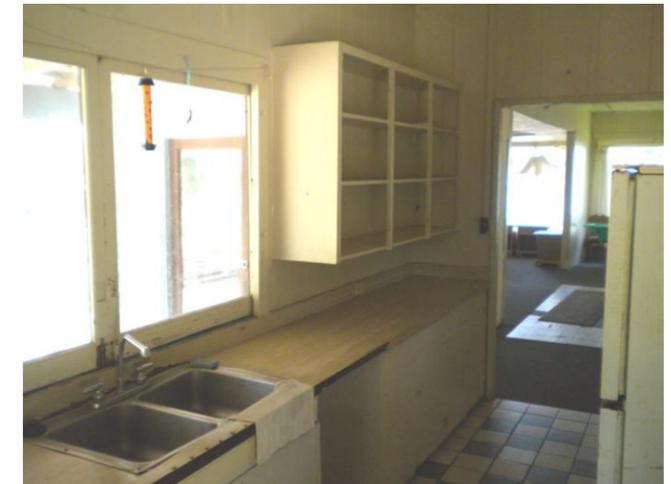
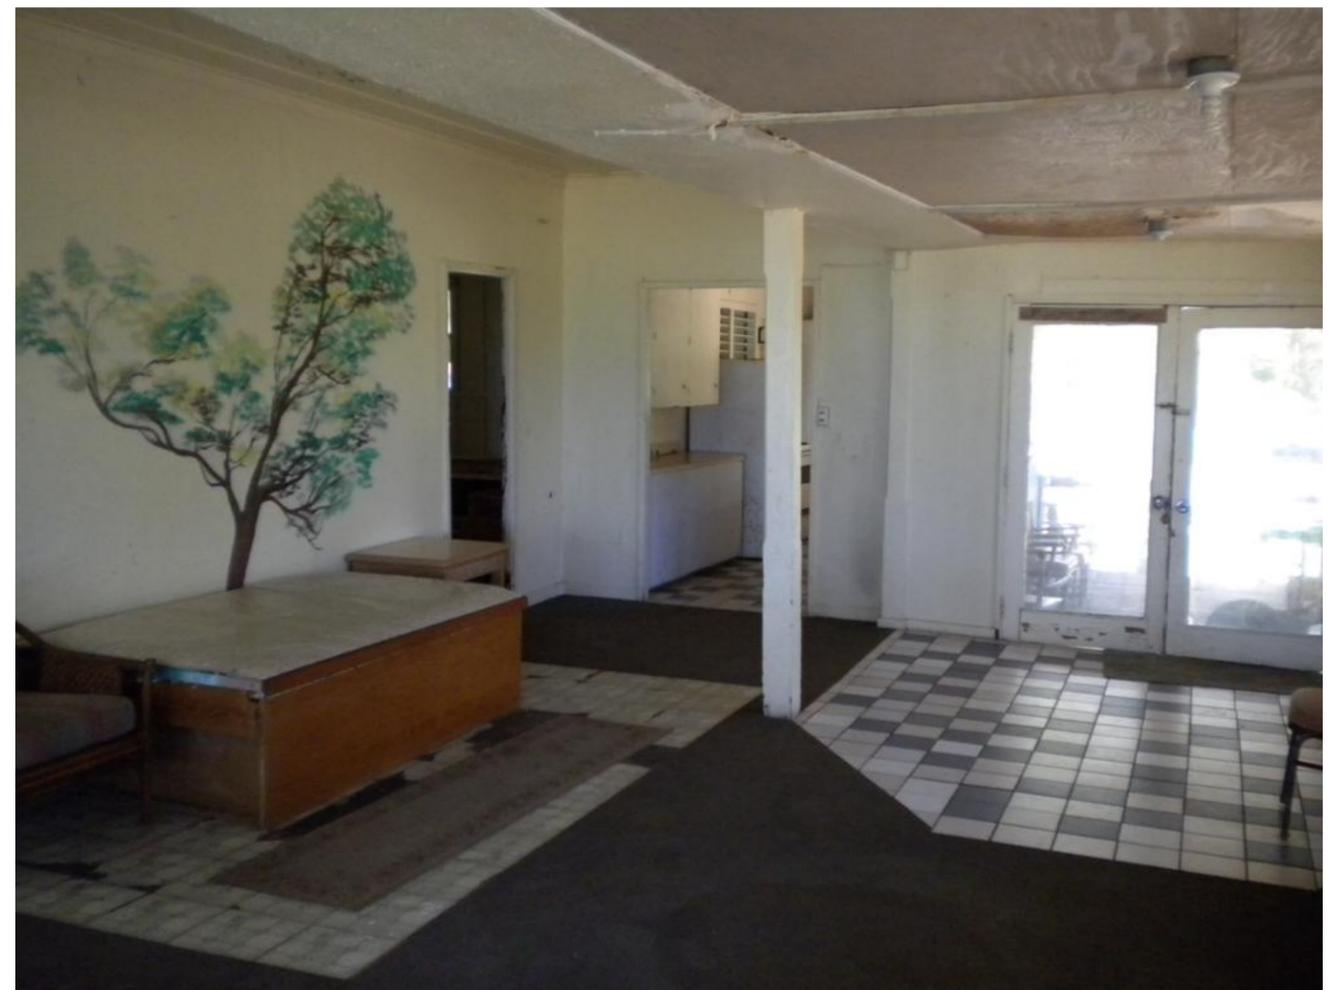
CABIN 2 - PHOTOGRAPH A

Per the Hazardous Materials Survey Report, the Cabin contains ACM's. The vinyl composition tile (VCT), bathroom sink counter caulking and black asphaltic roofing material tested positive for Category I non-friable ACM. Friable asbestos was found in the drywall partitions. Lead was detected in the interior and exterior beige paint. In addition, the exterior red paint at the stairs, doors, and beams and the aqua paint at the exterior contain lead. Arsenic was found in the brown fibrous ceiling material.

Due to the overall damaged condition of the cabin, the presence of hazardous materials, and non-compliance with ADA requirements, Cabin 2 should be boarded up to prevent public entry. Cabin 2 should not be available for rent and should not be occupied.

The DLNR should contract to have the hazardous materials properly removed and disposed of by a licensed contractor(s) approved to perform such work in the State of Hawaii.

Because Cabin 2 is considered historic, prior to demolition the structure shall be measured, drawn and photographed for the purposes of documenting it in accordance with §13-275-8 Hawaii Administrative Rules (HAR). This has largely been completed as part of this Report. A report shall be submitted to the State of Hawaii, the DLNR, and the State Historic Preservation Division (SHPD) for review and approval prior to demolition.

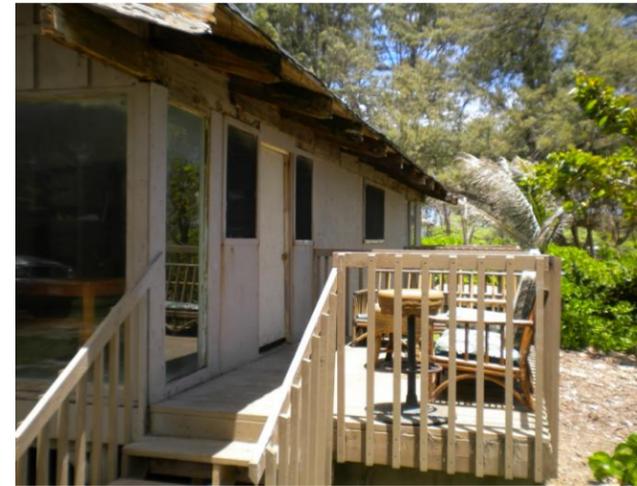
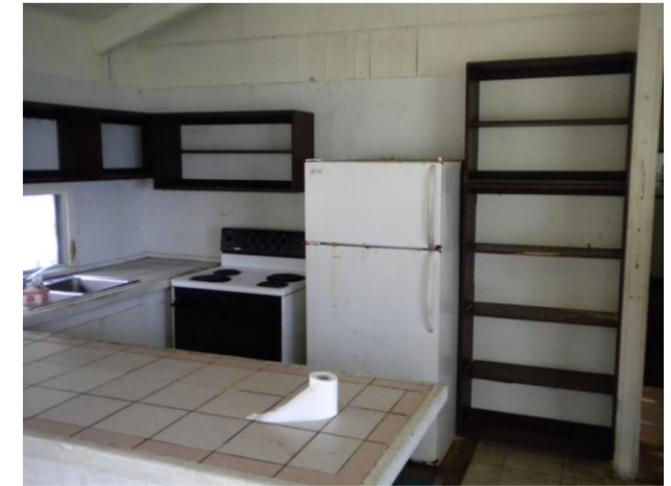
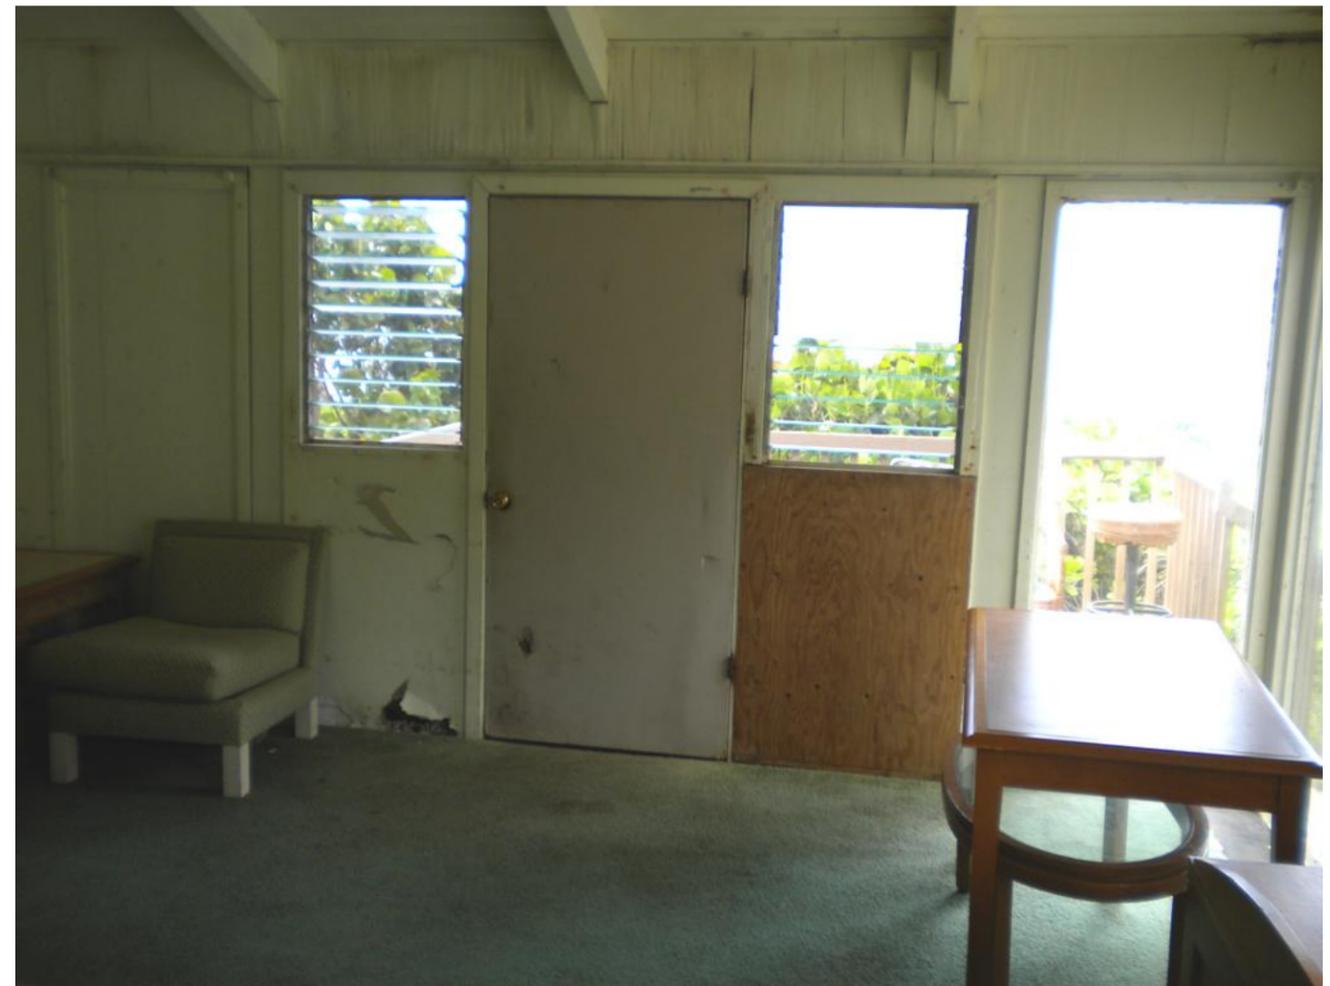
CABIN 3 - PHOTOGRAPH A

As indicated in the Hazardous Materials Survey Report, the Cabin contains ACM's. Category I non-friable ACM was detected in the Cabin in the black asphaltic roofing material. Lead containing paint was found in the off white paint throughout the interior of the Cabin. Arsenic was not detected.

Due to the overall damaged condition of the Cabin, presence of hazardous materials, and non-compliance with the ADA requirements, it is recommended that Cabin 3 is boarded up to prevent public entry. Cabin 3 should not be available for rent and should not be occupied.

The DLNR should proceed with the proper removal of the hazardous material, which is required to be by a licensed contractor(s) approved to perform such work in the State of Hawaii. Following the cleaning of hazardous materials, the Cabin should be demolished.

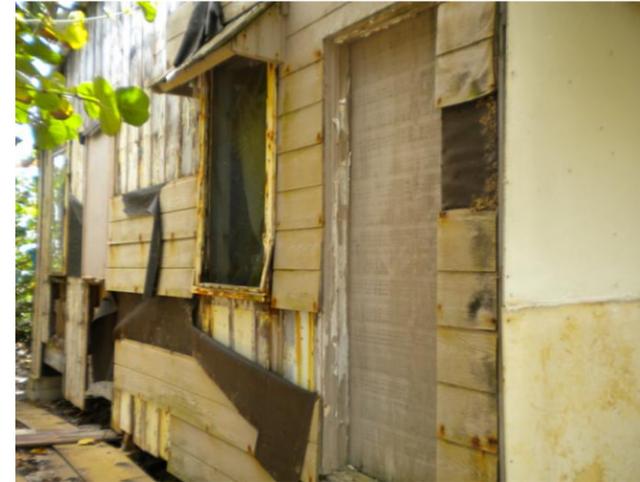
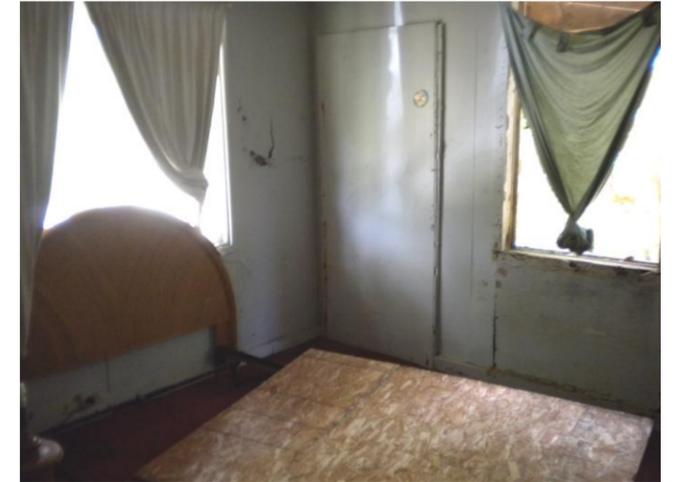
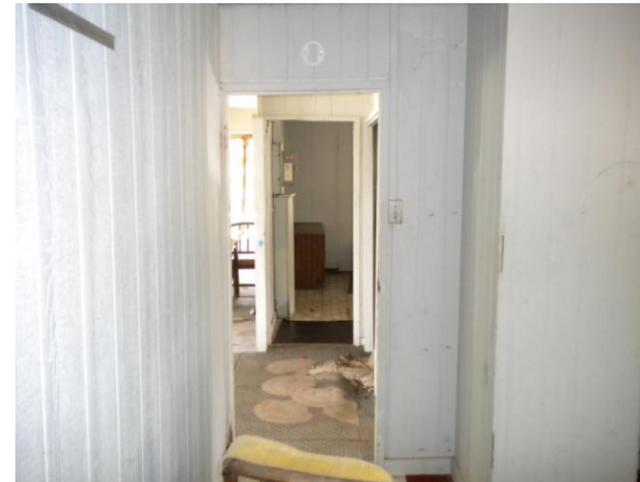
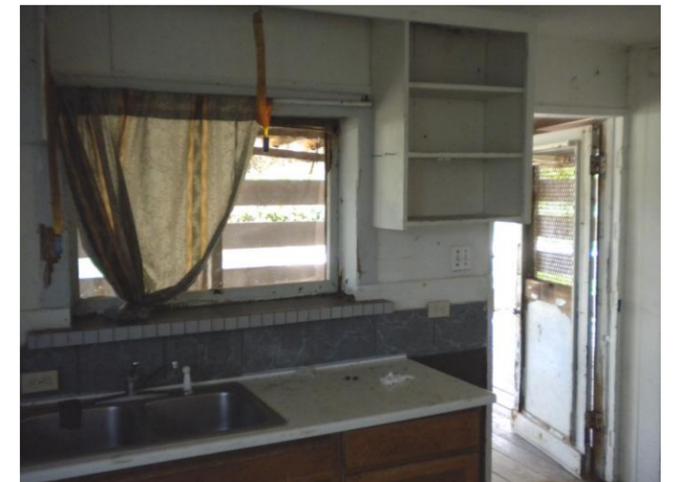
CABIN 4 - PHOTOGRAPH A

The Cabin is located within the FEMA Flood Zone VE, which is a coastal flood zone with velocity hazard, for which the Base Flood Elevation (BFE) has been determined to be 12'. The Cabin's finish floor elevation is slightly above the BFE and is 12.49'.

A licensed contractor(s) approved to properly remove and dispose of hazardous materials should be contracted by the DLNR to address the hazardous materials issue. Because Cabin 4 is considered historic, prior to demolition the structure shall be measured, drawn and photographed for the purposes of documenting it in accordance with §13-275-8 HAR. This has largely been completed as part of this Report. A report shall be submitted to the State of Hawaii, the DLNR, and the SHPD for review and approval prior to demolition.

Should the DLNR construct a new cabin at the same location, special consideration should be taken to avoid constructing within the shoreline setback.

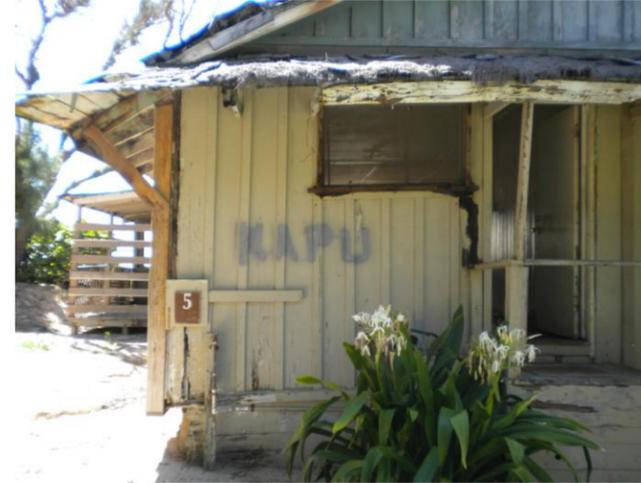
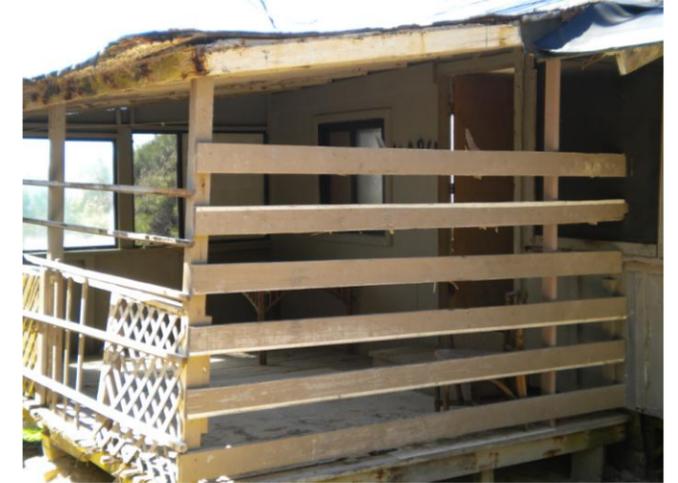
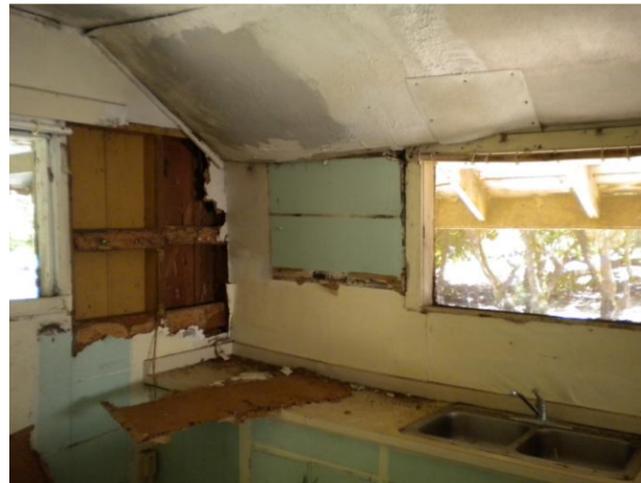
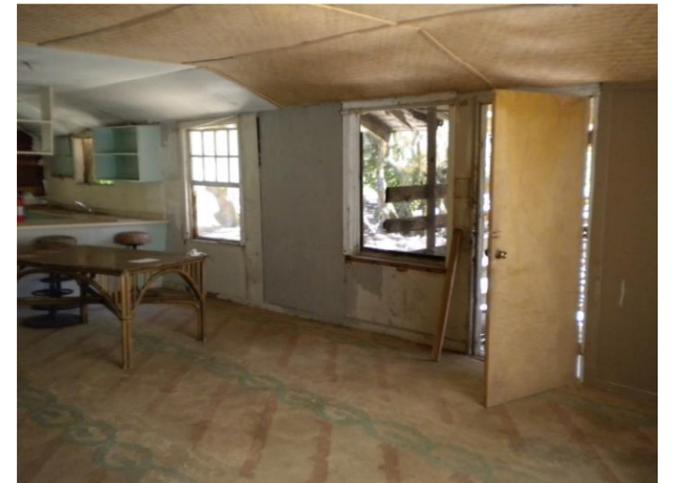
CABIN 5 - PHOTOGRAPH A

Per the Hazardous Materials Survey Report, Category I non-friable ACM was detected in the interior VCT, black with mastic located under the carpet. Lead containing paint was found within the Cabin at several locations including the beige interior paint throughout, light blue kitchen paint, white bedroom and restroom paint, in addition to the brown, beige, and aqua paint at the exterior. Arsenic was detected in the brown fibrous ceiling material, although it was a low level and therefore does not require action.

A licensed contractor(s) approved to properly remove and dispose of hazardous materials should be contracted by the DLNR to address the hazardous materials issue. Due to the overall damaged condition and non-compliance with ADA requirements, Cabin 5 should be demolished. Because Cabin 5 is considered historic, prior to demolition the structure shall be measured, drawn and photographed for the purposes of documenting it in accordance with §13-275-8 HAR. This has largely been completed as part of this Report. A report shall be submitted to the State of Hawaii, the DLNR, and the SHPD for review and approval prior to demolition.

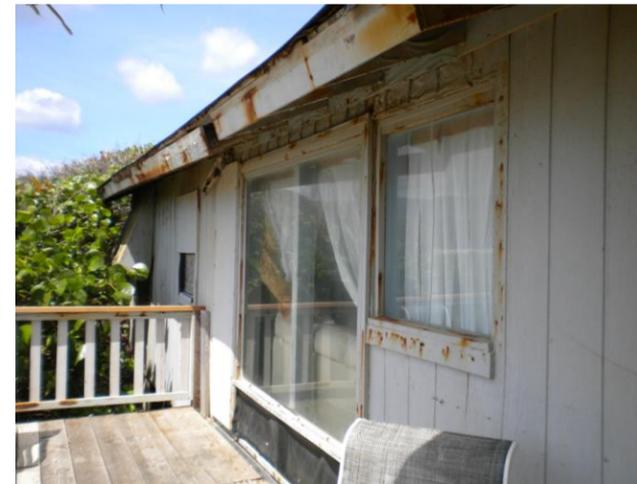
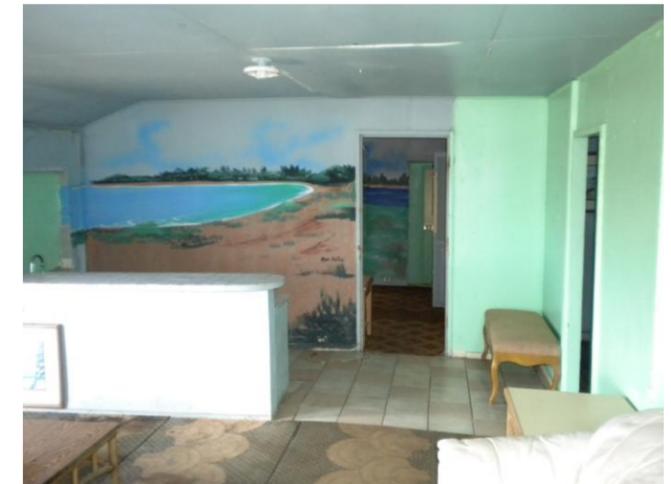
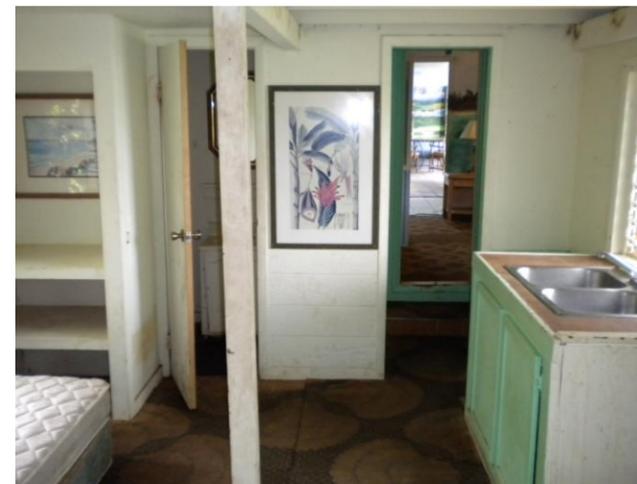
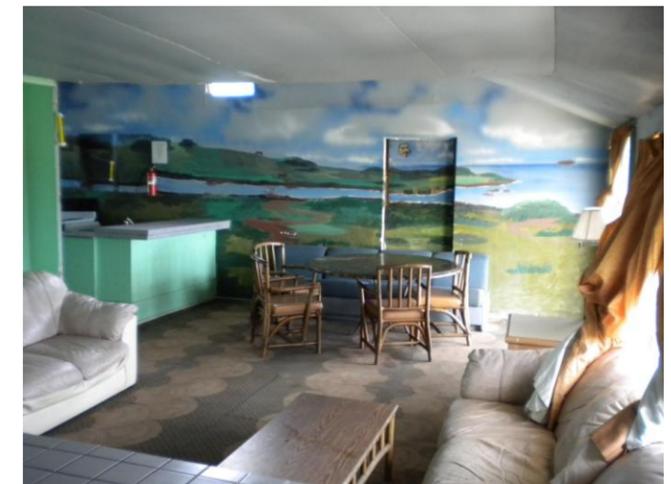
CABIN 6 AND 7 - PHOTOGRAPH A

The Cabin is located within the FEMA Flood Zone VE, which is a coastal flood zone with velocity hazard, for which the BFE has been determined to be 12'. The Cabin's finish floor elevation is extremely lower at approximately 5.69' and will therefore have to be addressed.

Per the Hazardous Materials Survey Report, Cabin 6 and 7 contains Category I non-friable ACM within the black asphaltic roofing material. It also tested positive for friable asbestos at the grey sink undercoating. Lead containing paint was detected at the cabin at the grey exterior paint on the walls, beams, ceiling, door, door frames, and windows. Arsenic was found at the interior brown fibrous ceiling material.

Due to the overall damaged condition of the Cabin, the presence of hazardous materials, and non-compliance with ADA requirements, Cabin 6 and 7 should be boarded up to prevent public entry. Cabin 6 and 7 should not be available for rent and should not be occupied.

A licensed contractor(s) approved by the State of Hawaii to properly remove and dispose of hazardous materials should be contracted by the DLNR to address the issue. Because Cabin 6 and 7 are considered historic, prior to demolition the structure shall be measured, drawn and photographed for the purposes of documenting it in accordance with §13-275-8 HAR. This has largely been completed as part of this Report. A report shall be submitted to the State of Hawaii, the DLNR, and the SHPD for review and approval prior to demolition.

Should the DLNR construct a new cabin at the same location, careful consideration should be taken so the finish floor elevation is above the FEMA BFE.

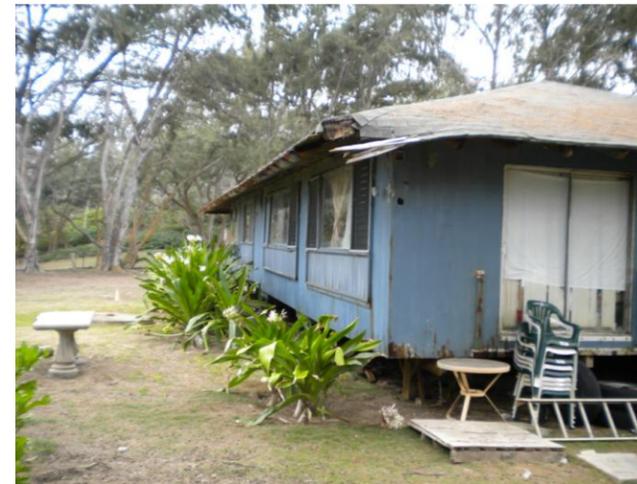
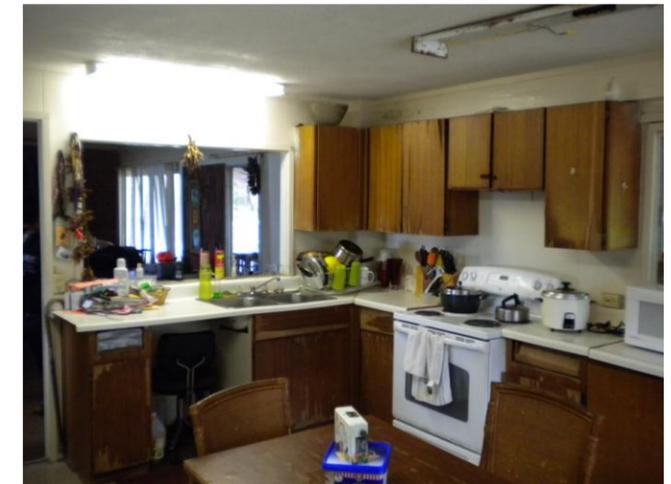
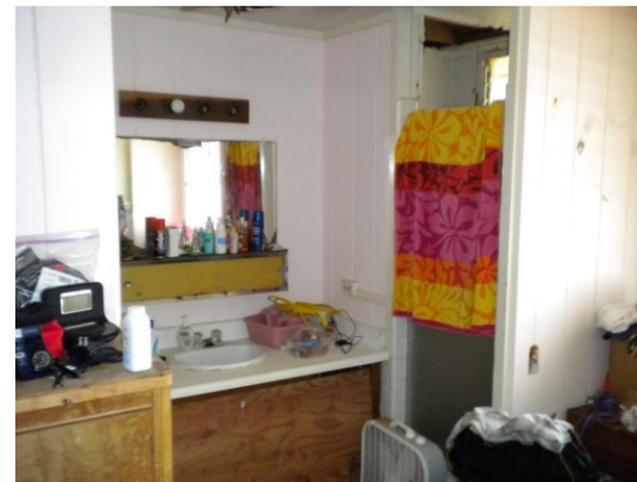
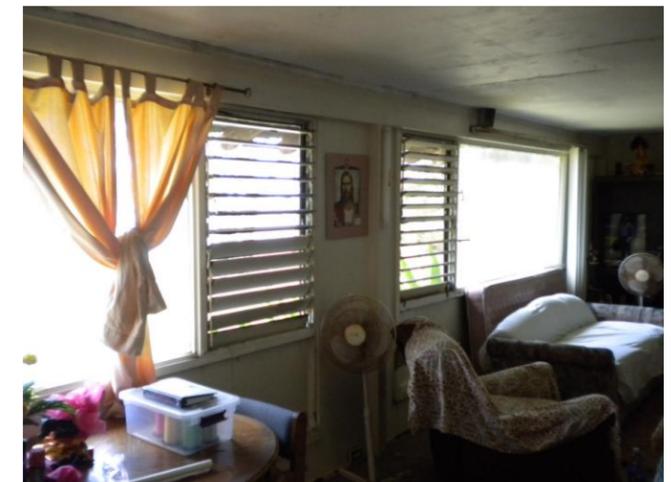
Per the Hazardous Materials Survey Report, Category I non-friable ACM was detected in the sliding door caulking. Category I friable ACM was found in the white kitchen sink undercoating. Lead containing paint was found within the Cabin at several locations including the white paint throughout the interior walls, door frames, wood and drywall ceilings, door and window frames. Lead containing paint was also found at the exterior dark blue paint throughout the walls, window frames, and beams. Mercury containing lamps were found within the Cabin.

Due to the overall damaged condition of the Cabin, presence of hazardous materials, and non-compliance with ADA requirements, the lease of the Security Residence should be terminated and the building should be boarded up to prevent public entry. The Security Residence should not be occupied.

The DLNR should proceed with the proper removal of the hazardous material, which is required to be by a licensed contractor(s) approved to perform such work in the State of Hawaii. Following the cleaning of hazardous materials, the Cabin should be demolished.

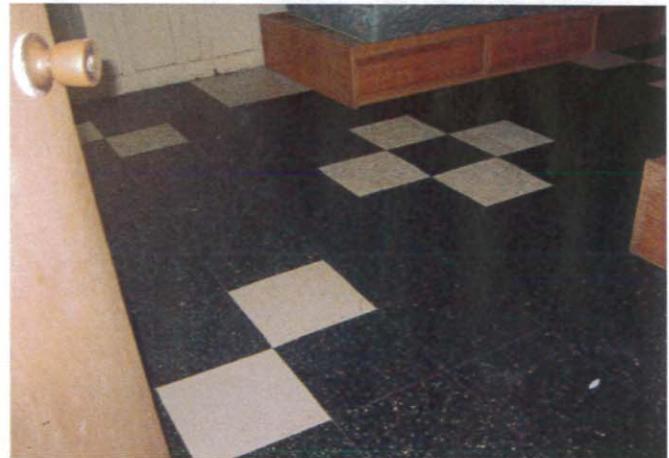
Photograph 2: 12"x12" VFT Black and White Checkered Pattern with Replacement VFT with Mastic.

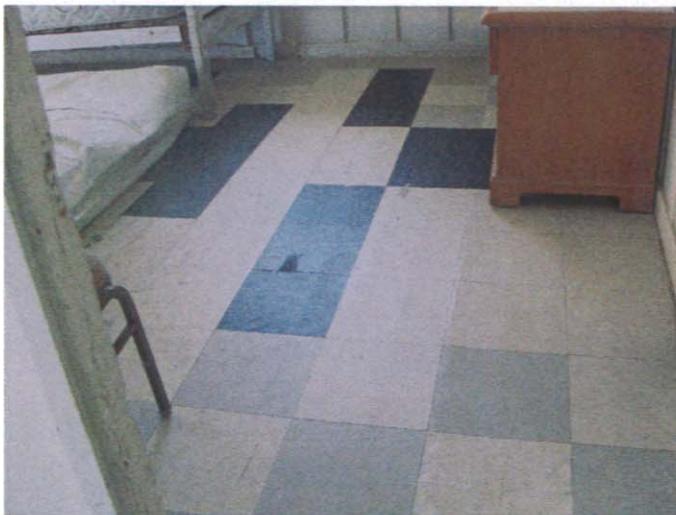
Photograph 3: 12"x12" VFT White with Replacement VFT

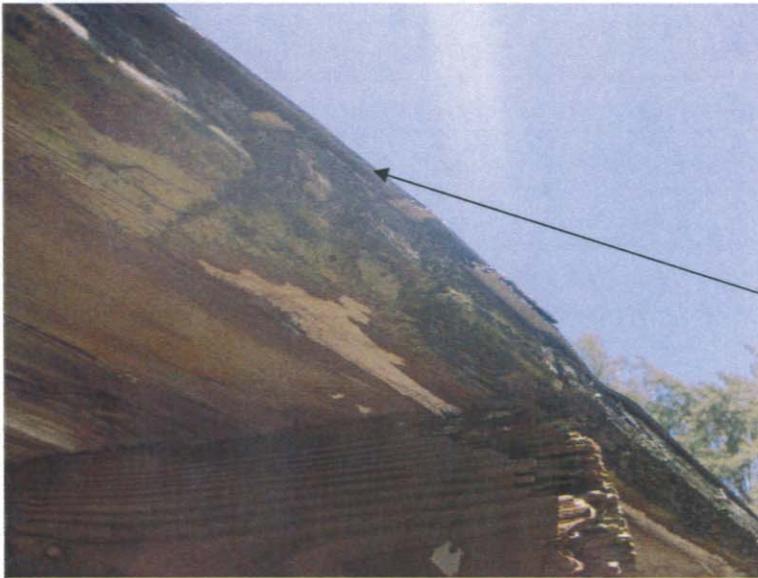
Photograph 8: Black Asphaltic Built-up Roofing Material.

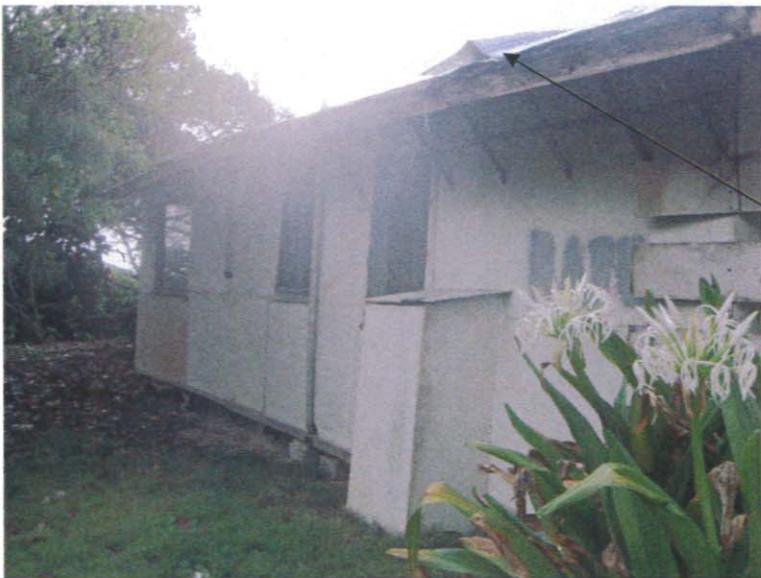
Photograph 10: Black Asphaltic Built-up Roofing Material.

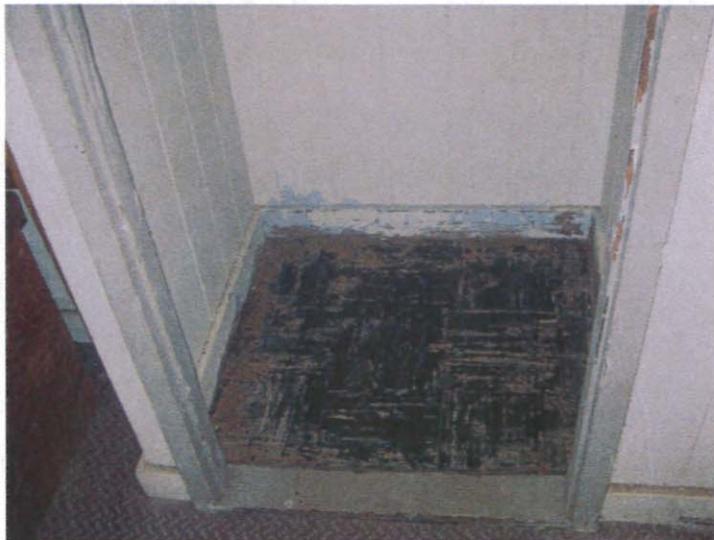
Photograph 12: 9"x9" Vinyl Floor Tile, Black, can also be found under the carpet in the bedrooms.

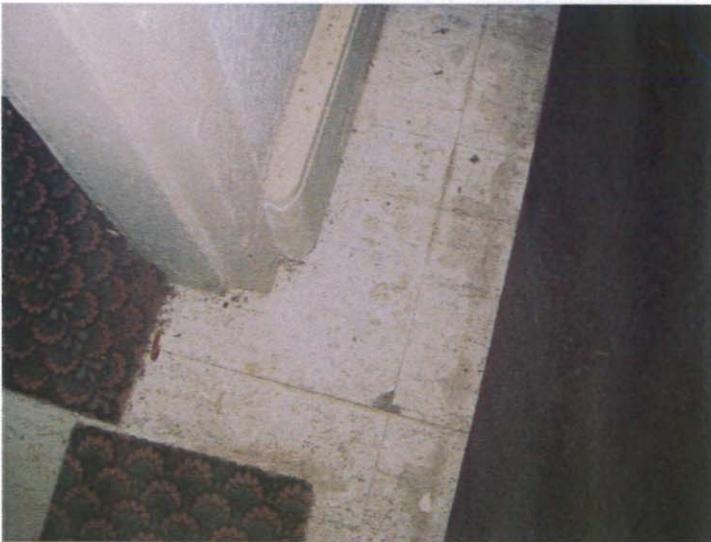
Photograph 17: 12"x12" Vinyl Floor Tile, White

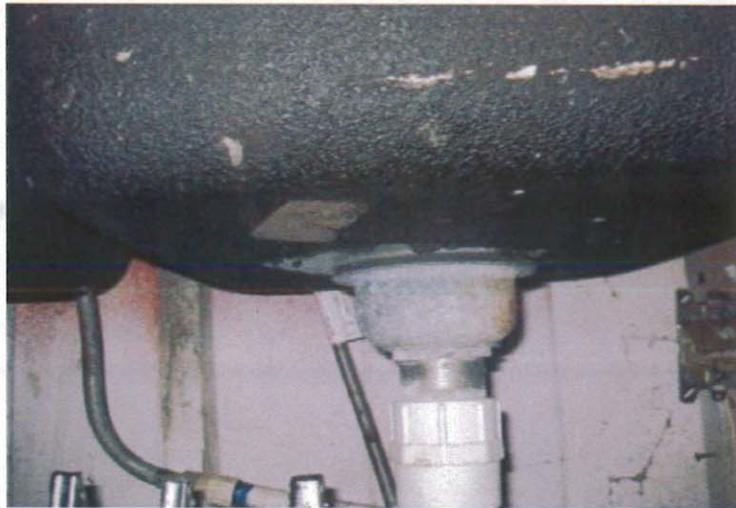
Photograph 20: Security House (Aaron Tufaga Residence)
Black Sink Undercoat
