MURAKAMI CONSTRUCTION OF 1 TO 1.5 SLOPED BOULDER REVETMENT 3/23/92

DEPARTMENT OF LAND UTILIZATION  
92/SV-01(AC)

CHAPTER 343, HRS  
Environmental Assessment/Determination  
Negative Declaration

**Coastal Engineering Report  
for the Shoreline Revetment  
Constructed in TMK 5-5-2:85  
in Laie, Oahu**

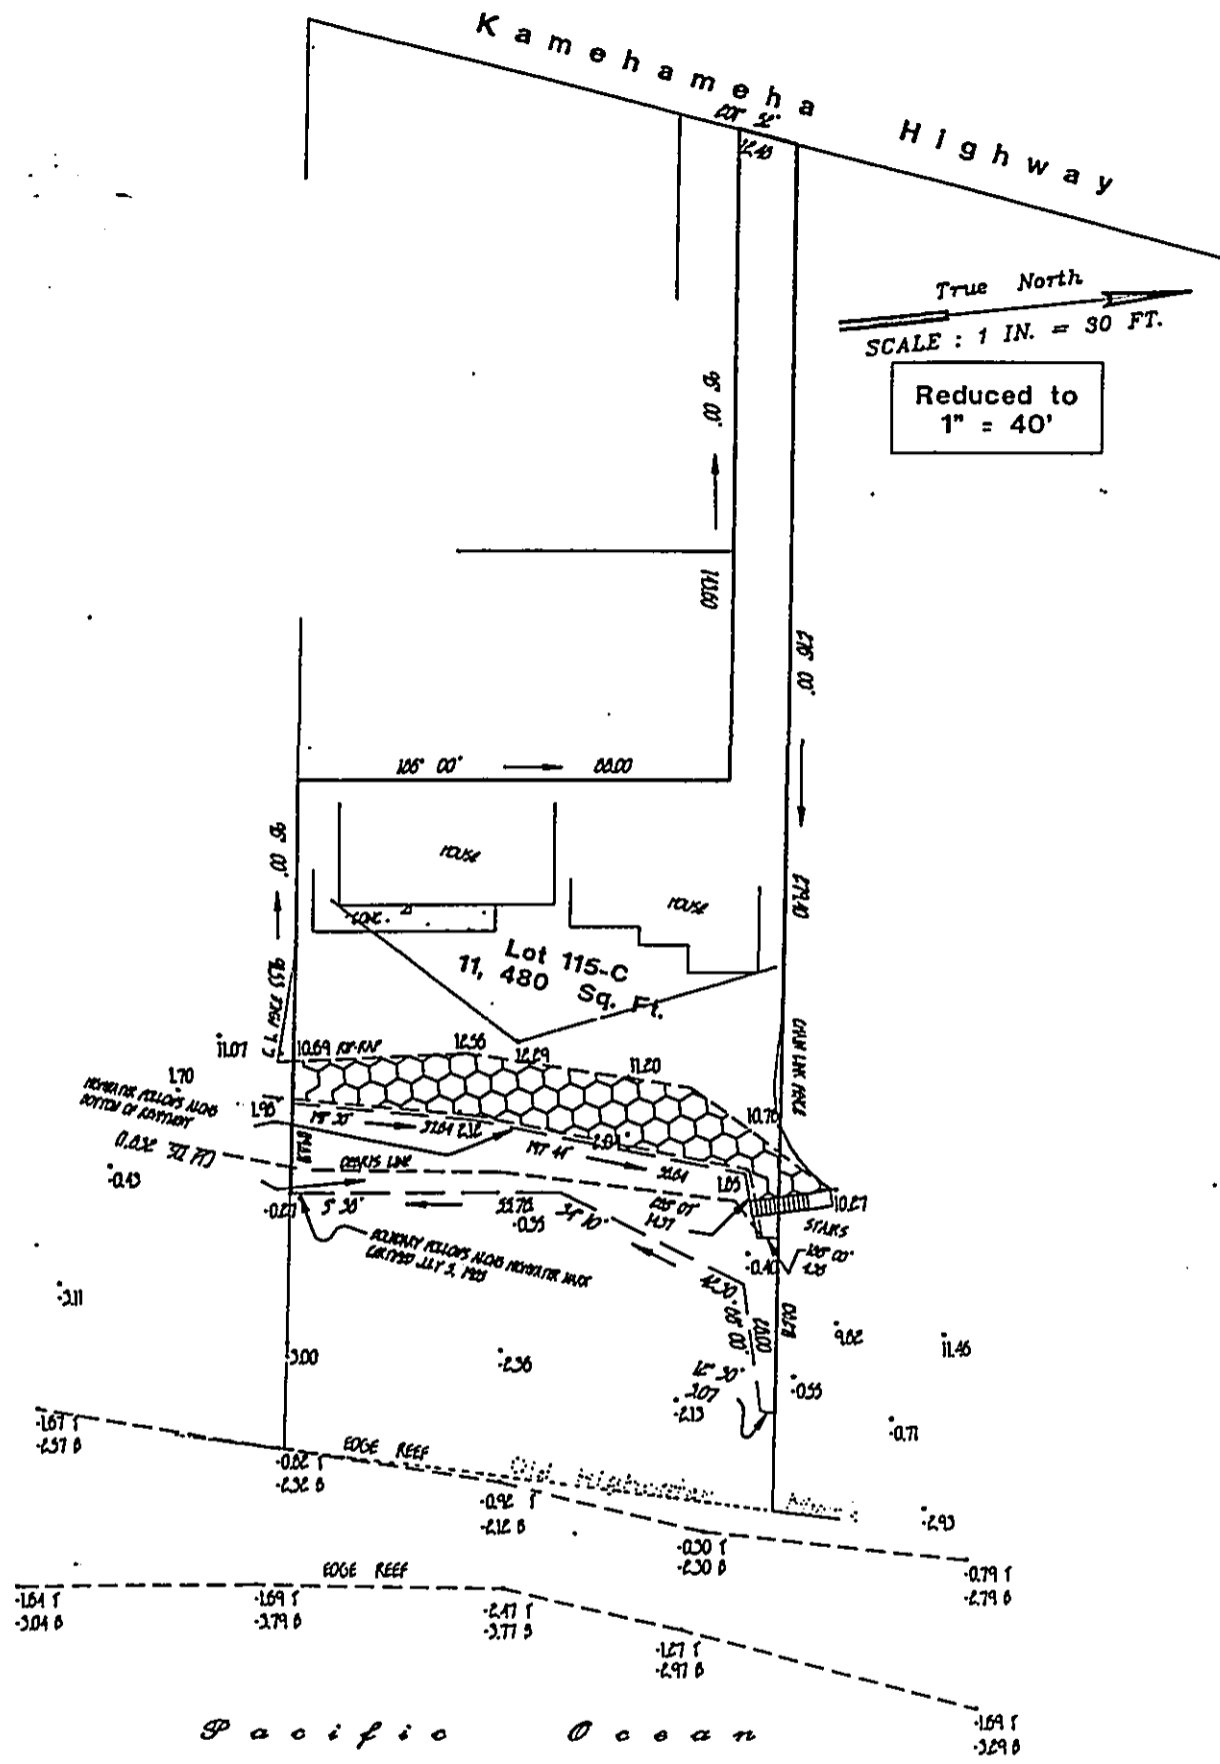
**Figure 3**  
 Survey by Engineers Surveyors Hawaii

1. The nearshore, submerged calcareous ledge (labeled as a "reef" on the survey reproduced as Figure 3) is not actually a coral reef in the traditional use of the term. This ledge is actually cemented beach sand or "beachrock". Its surface is discolored and hardened by various marine processes, mostly the work of calcareous algae, so that it looks very much like a coral formation and is often mistaken as one. When the surface is chipped away, however, its structure weakly cemented sand grains is clearly evident. The existence of the calcareous sill

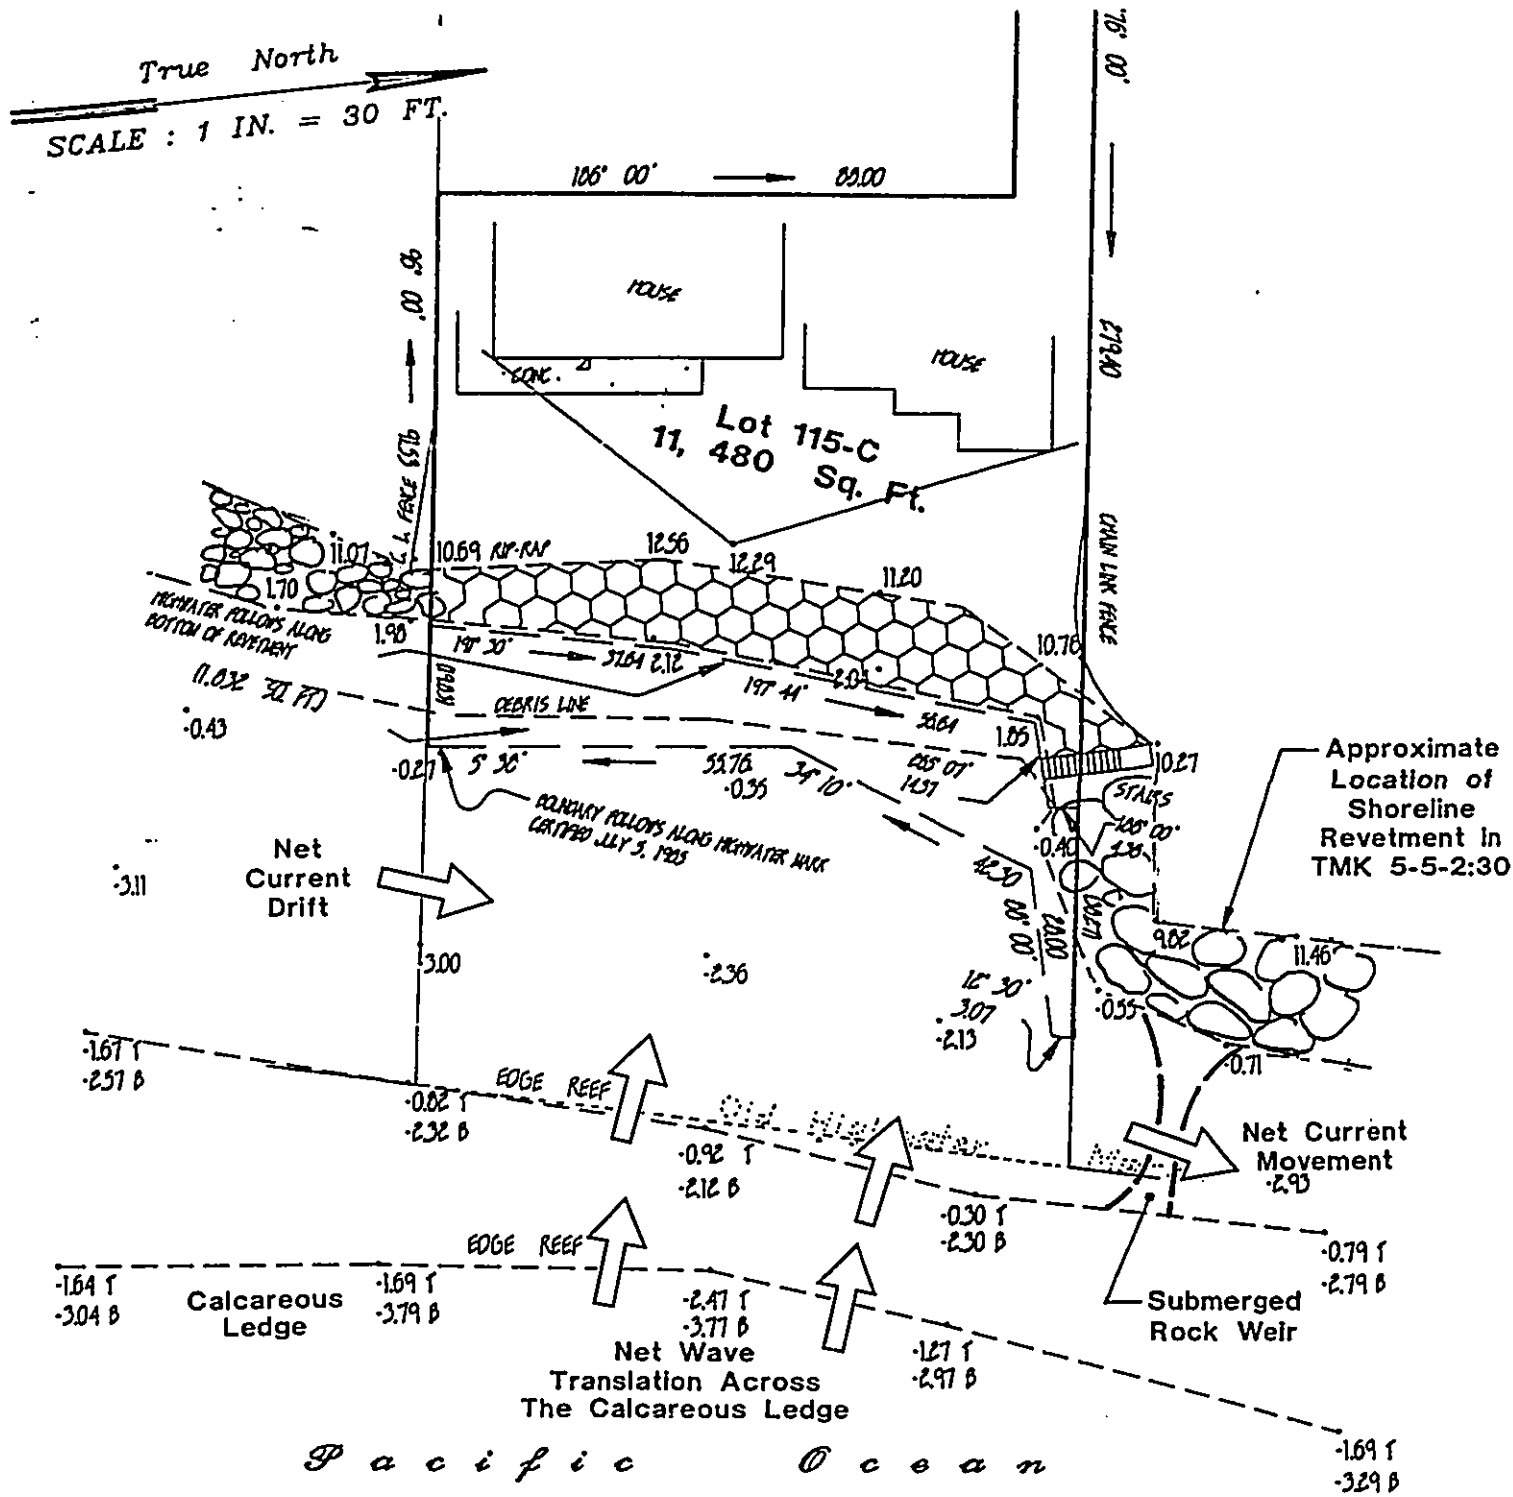
Figure 4  
Prevailing Wave-Driven  
Water Movement

2. In the small channel between the beachrock sill and the shoreline, there is a northward moving current on all phases of the tides. It is an entirely wave-driven phenomenon. Incoming waves transport water across the beachrock sill. While some of this water does drain directly back out across the sill, a significant portion escapes by moving northward parallel to the shoreline and then out across the sill in front of TMK 5-5-2:29 & 30, the two lots north of TMK 5-5-2:85.

3. The rubble rock weir that was constructed perpendicular to the shoreline in December 1988 in order to retard the northward current and thereby arrest shoreline erosion has not been a success. There are several reasons for this:

- a. The submerged weir was built up only to the level of the beachrock sill. While it does impede the current to some extent, its location is still the easiest escape point for water transported by waves over the sill into the inner channel.

- b. Wave set-up (meaning the build-up of the nearshore, still water level due to a succession of waves) can be substantial in the channel inside the beachrock sill. When waves of even modest size are occurring, the water level can be more than one foot above the tide level (as was the case during a 0.1-foot (msl) tide on the morning of November 29). For the rock weir to effectively cut off the northward current at such times, it would have to be two to three feet higher than the beachrock sill.

- c. Most importantly, the alongshore, wave-driven current was not the cause of shoreline erosion. Rather, it simply provided a transport mechanism for the escape of sand once it has been suspended by waves breaking on the beach. If the rubble rock weir had effectively cut off this current, sand suspended during wave attack could be carried directly out across the beachrock sill. Since the transport mechanisms to bring the sand back in across the sill are not as effective, beach erosion would continue to occur.

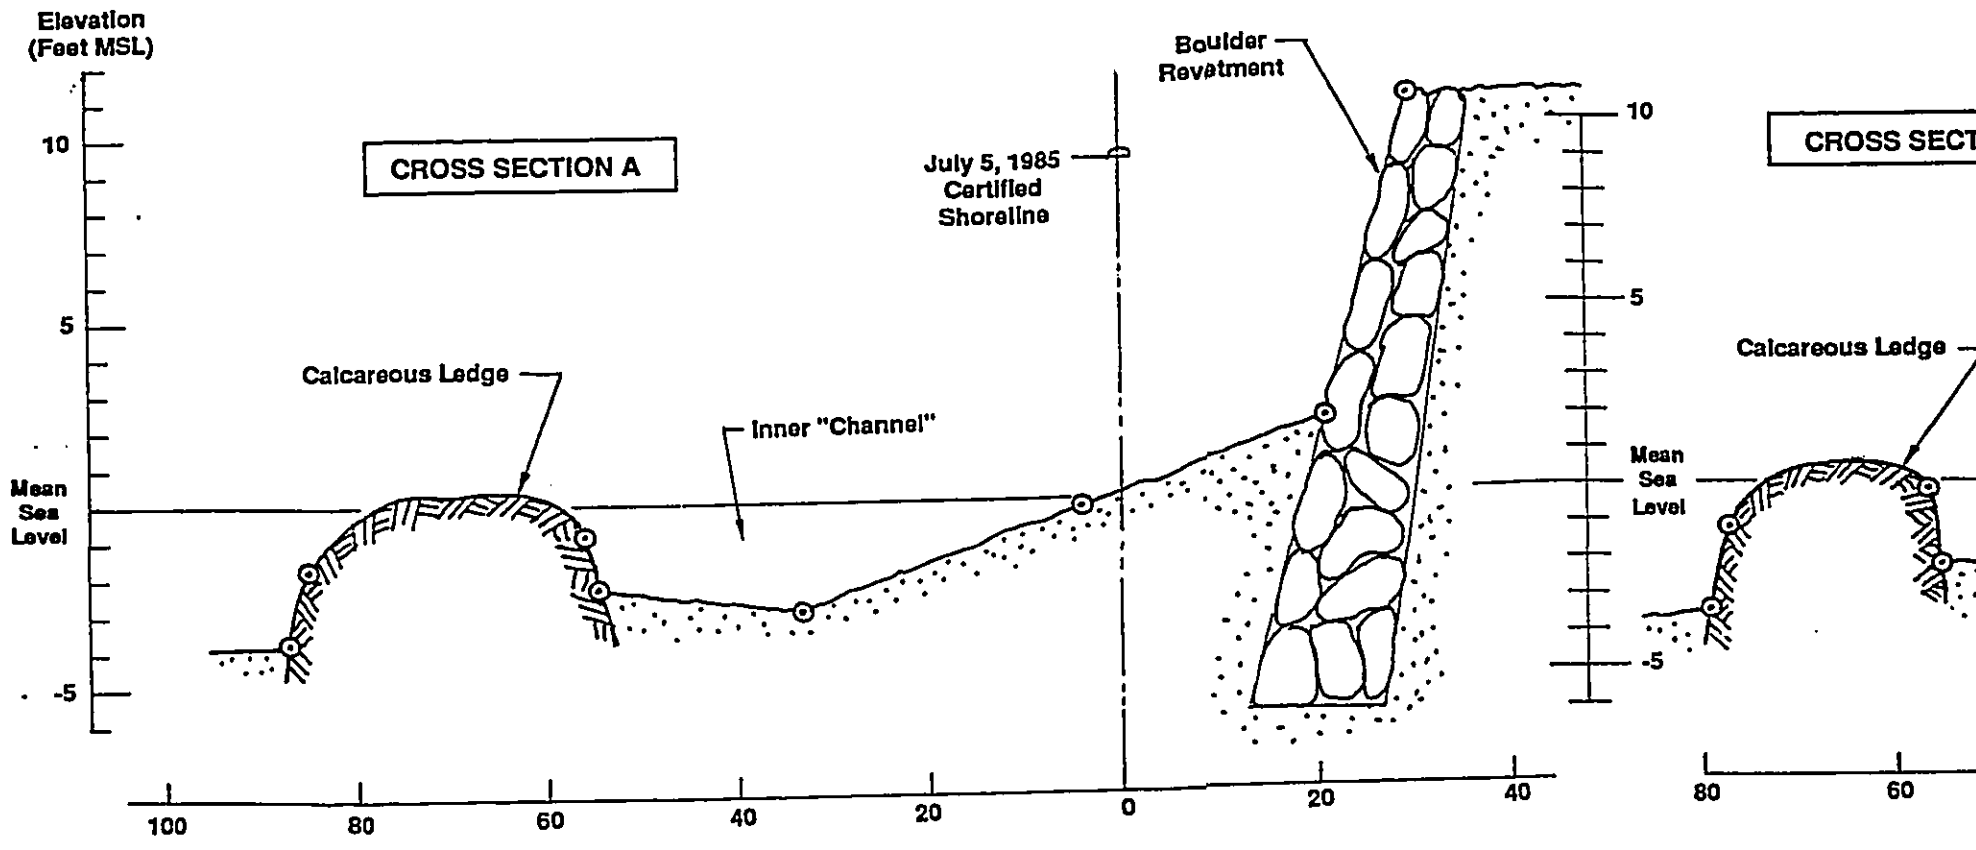
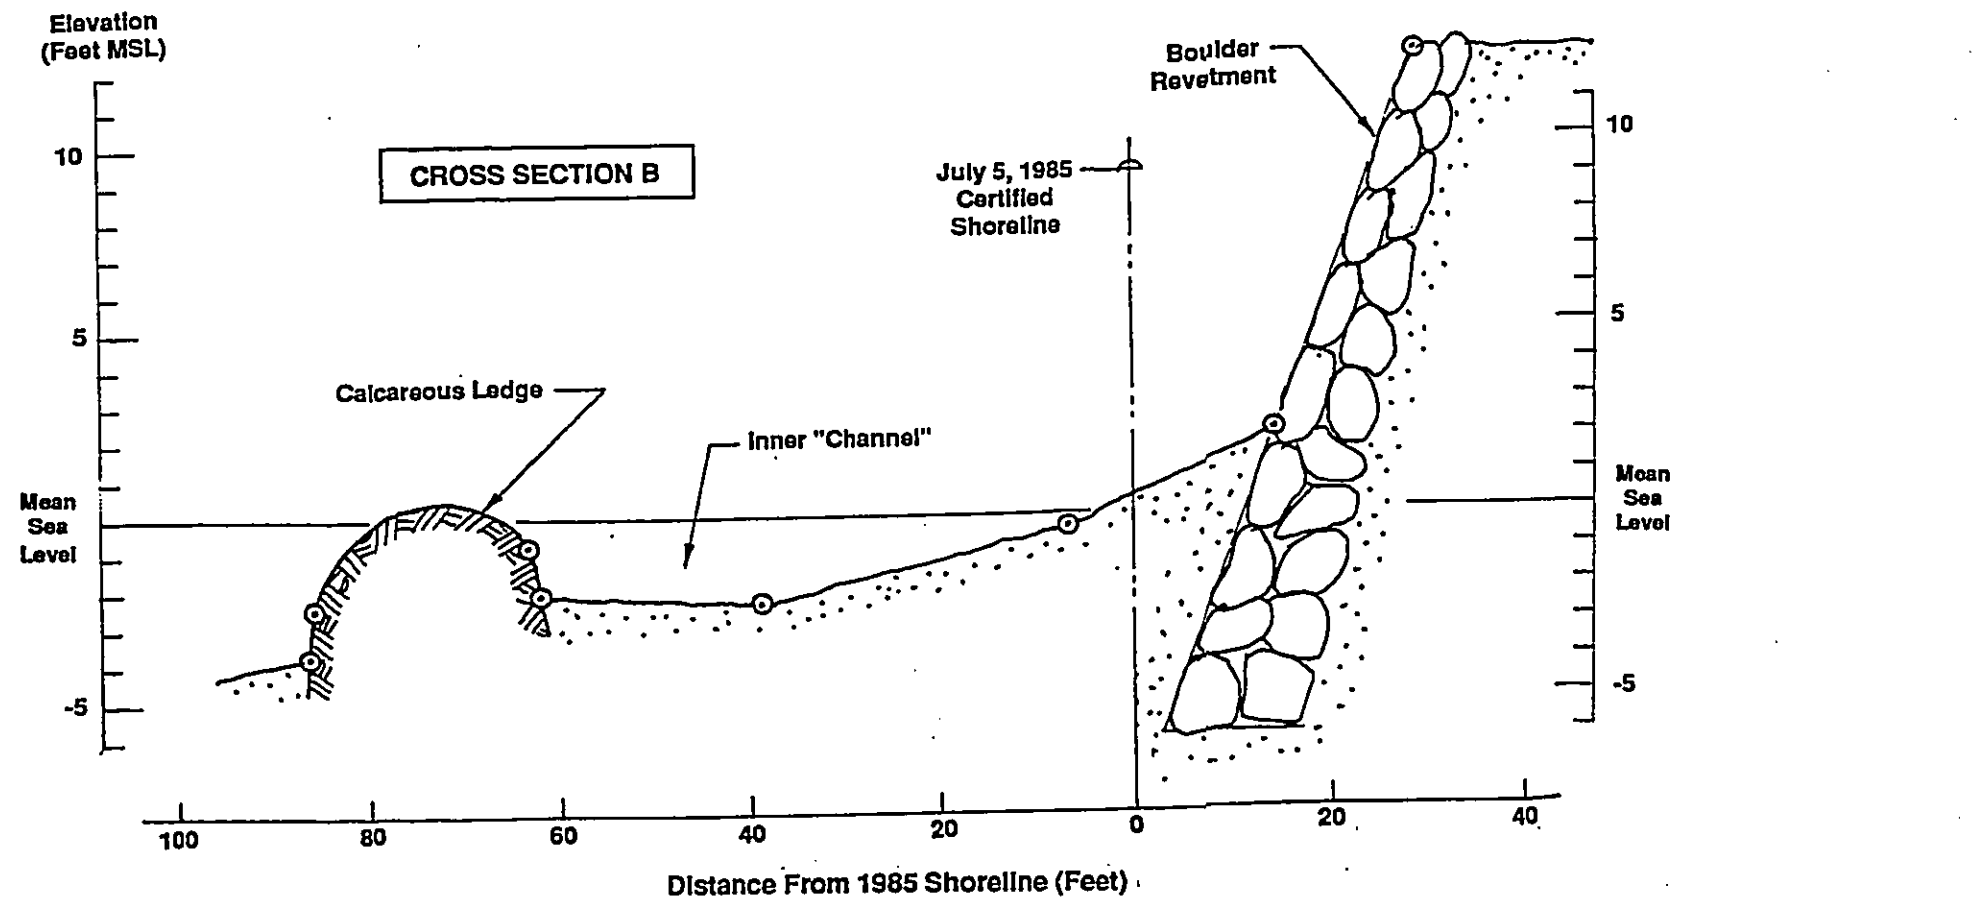
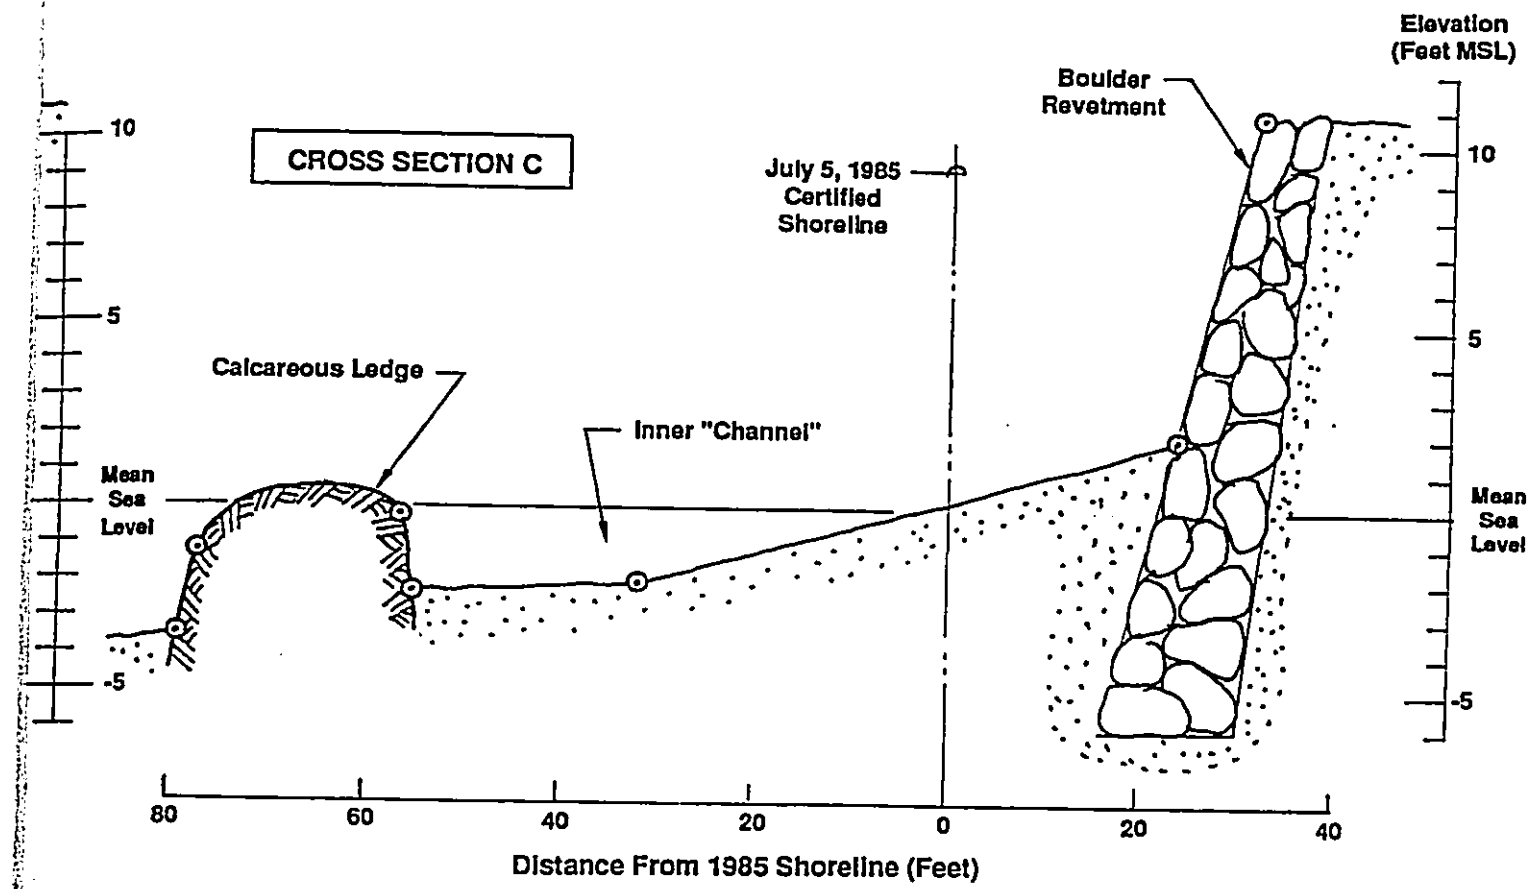
**Figure 5**

5. The revetment was constructed in August 1991. Two site visits for this evaluation were made in November 1991, three months after construction and a week following a period of very high waves. The shoreline in front of this new structure at the time of the site visits was similar in appearance to the lots to the north and south. Some sand has accumulated at the toe of the structure. This sand lies on a 1 (vertical):10 (horizontal) slope. This is typical of the adjacent lots as well (see Figure 5).

- c. The sequence of offshore submerged and partially emerged reef shelves (denoted on Figure 1) and the inner beachrock sill (shown on Figures 3, 4, and 5) provide excellent natural protection from wave attack. As a consequence, the largest wave which could break on or just in front of the shoreline revetment is constrained by the available depth. Using the most critical combination of the highest water level (tide of 1.5 feet above the beachrock sill and 2.5 feet wave set-up for a total depth of 4 feet), the existing offshore slope (approximately 0.01 as defined by the slope from 6-foot depth to the shoreline), and incoming wave periods of from 5 to 10 seconds, the depth-limited, highest breaking wave height would be 2.9 feet. All waves larger than this would break further offshore, dissipating most of their energy before reaching the revetment. The energy of this highest possible wave to break on the revetment itself is substantially less than the revetment's ability to resist wave attack. Further, the revetment's height, between 11 and 12 feet above mean sea level, is significantly

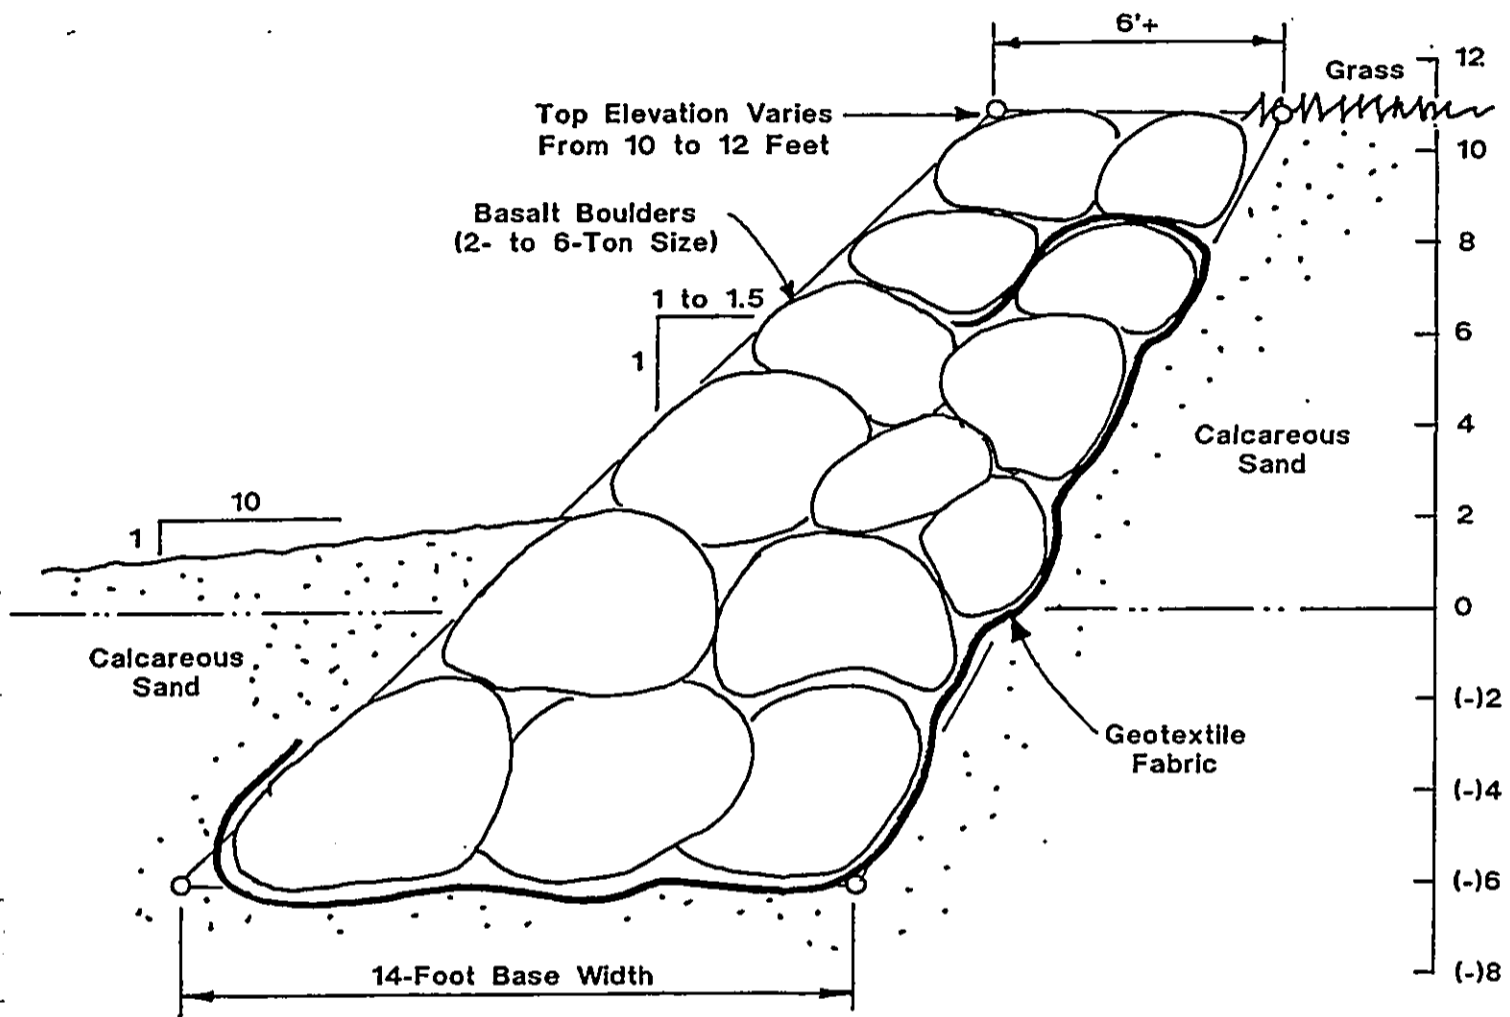
Figure 6  
As-Built Section of the Shoreline  
Revetment for TMK 5-5-2:85

- a. The structure's as-built section is detailed on Figure 6. Relevant design parameters are: use of 2- to 6-ton (basalt) armor stone; a structural slope of 1:1 at the two ends of the structure (matching the slopes of adjacent revetments) and 1:1.5 at mid-length; construction of the structure to a depth of eight feet below the existing grade at its toe; and use of geotextile fabric at the rock-sand contact surface.

- b. The Hudson formula, an empirical equation which is widely used to design rubble mound structures, indicates that the structure could withstand waves of up to 4.8 feet without damage if the least favorable combination of parameters is used in the equation (i.e. using the steepest slope and smallest armor stones):

When more typical parameters of the structure are used in the equation [mean stone size of 4 tons or 8000 pounds and average slope of 1 (vertical):1.25 (horizontal)], the Hudson formula indicates that the structure could withstand waves up to 6.5 feet high.

higher than the runup of this maximum incoming wave. Deposits of sand and debris - observed on the structure during the recent period of high waves verify this. There is evidence that maximum runup which has occurred was only to the lower half of the revetment's height.

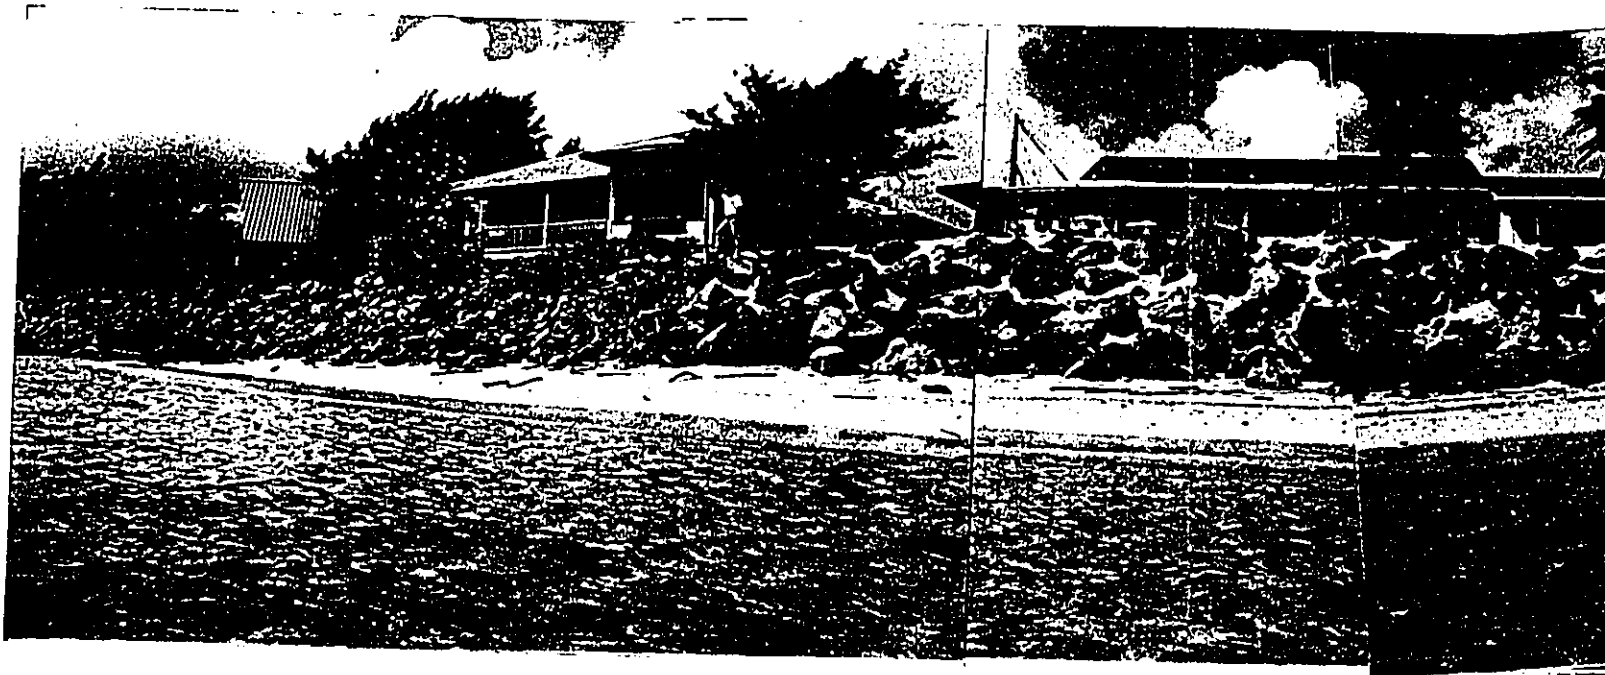
This panoramic view shows the revetment in front of TMK 5-5-2:85 which was constructed in August 1991. At 5-2:32; just visible to the right is the end of the revetment in front of TMK 5-5-2:30. Sand has accumulated at the top (horizontal) slope.

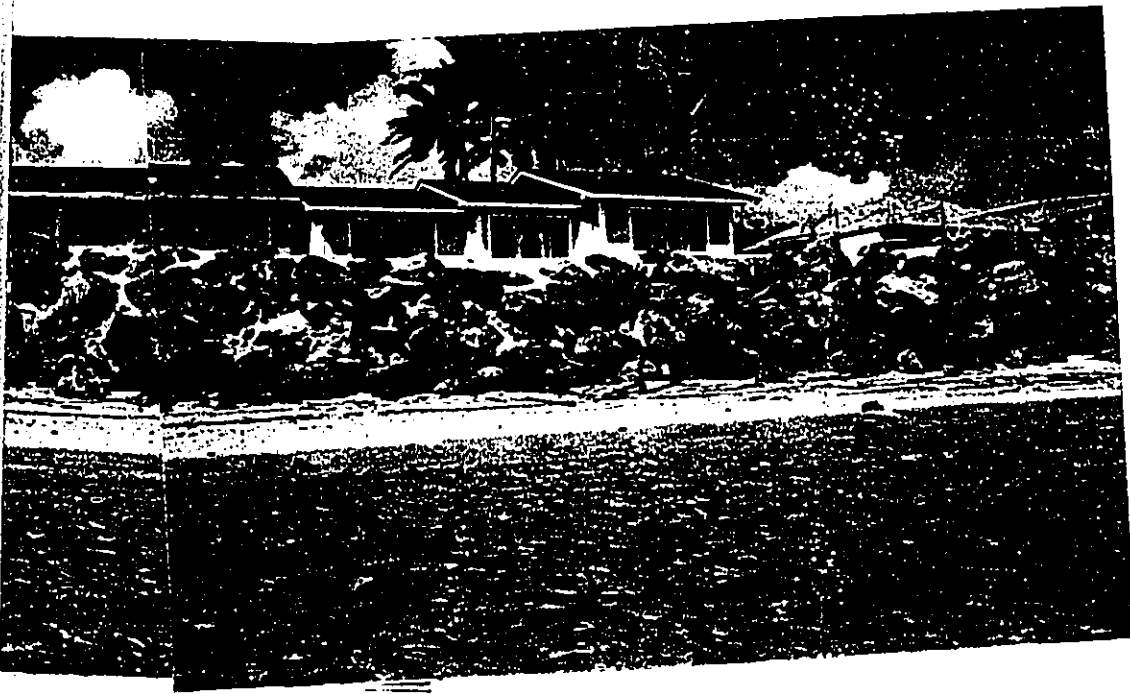
constructed in August 1991. At left is the pre-existing revetment in front of TMK 5-  
Sand has accumulated at the toe of the new revetment and sits on a 1 (vertical):10

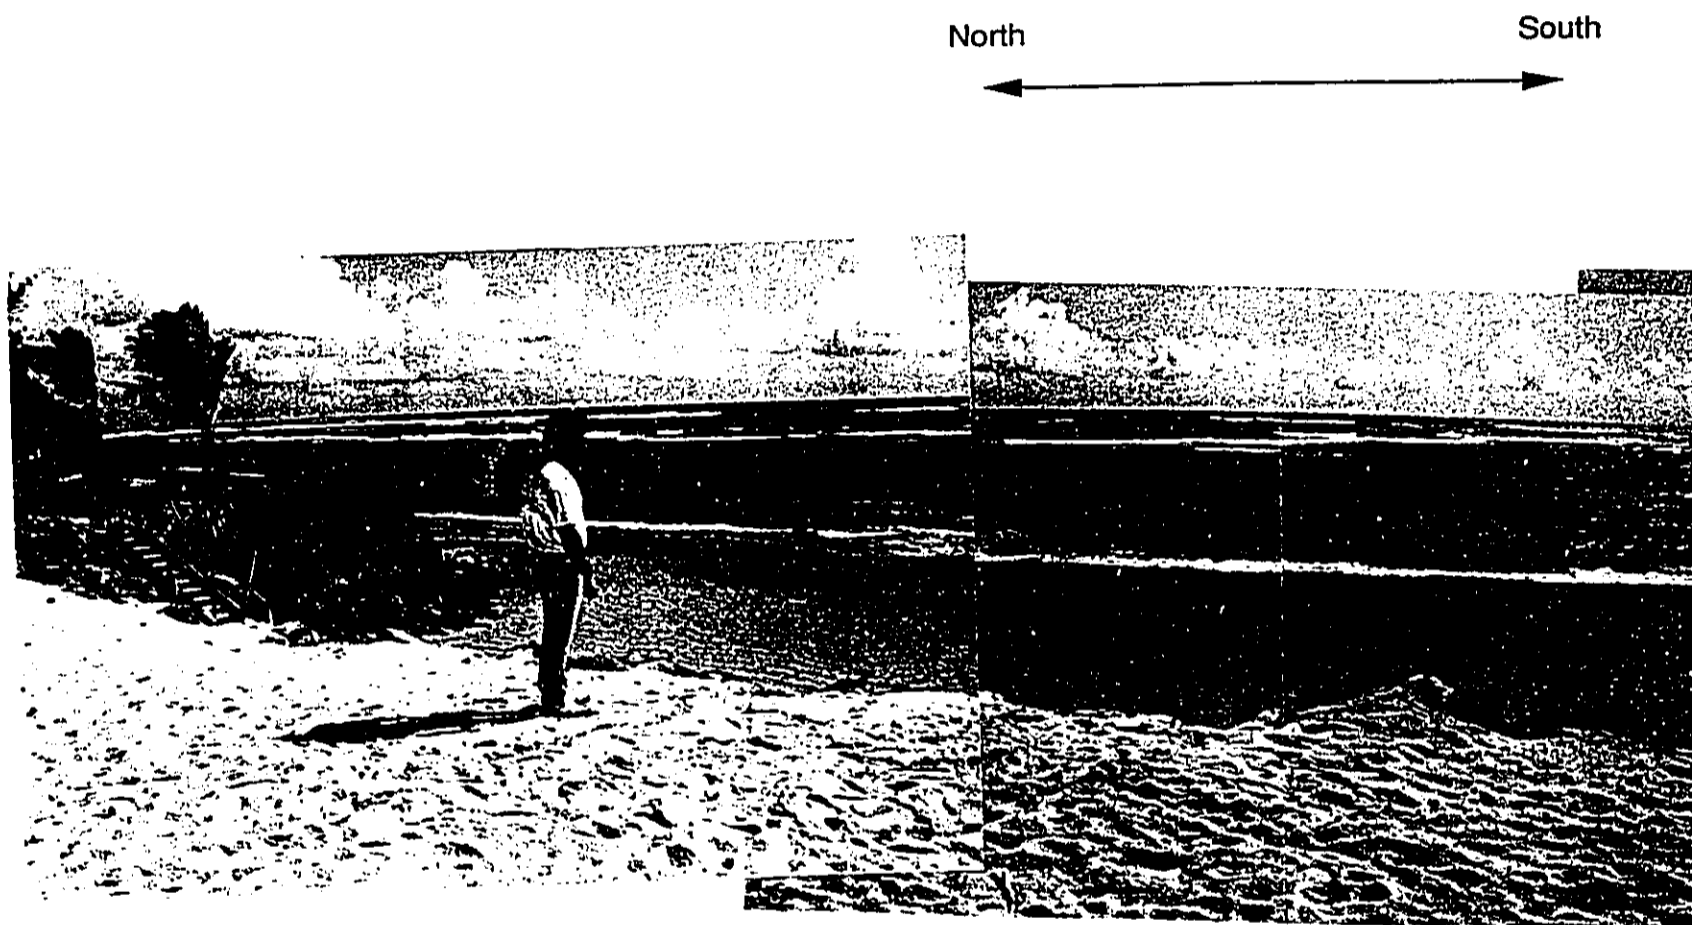
This view taken at a relatively low tide, shows the partially emerged beachrock sill about 60 to 70 feet offshore, the shoreline of the projecting shoreline revetment of TMK 5-5-2:30, the adjacent lot to the north. In the background behind the man is the shoreline of the lot which was installed in December 1988 to impede the northward moving nearshore current.

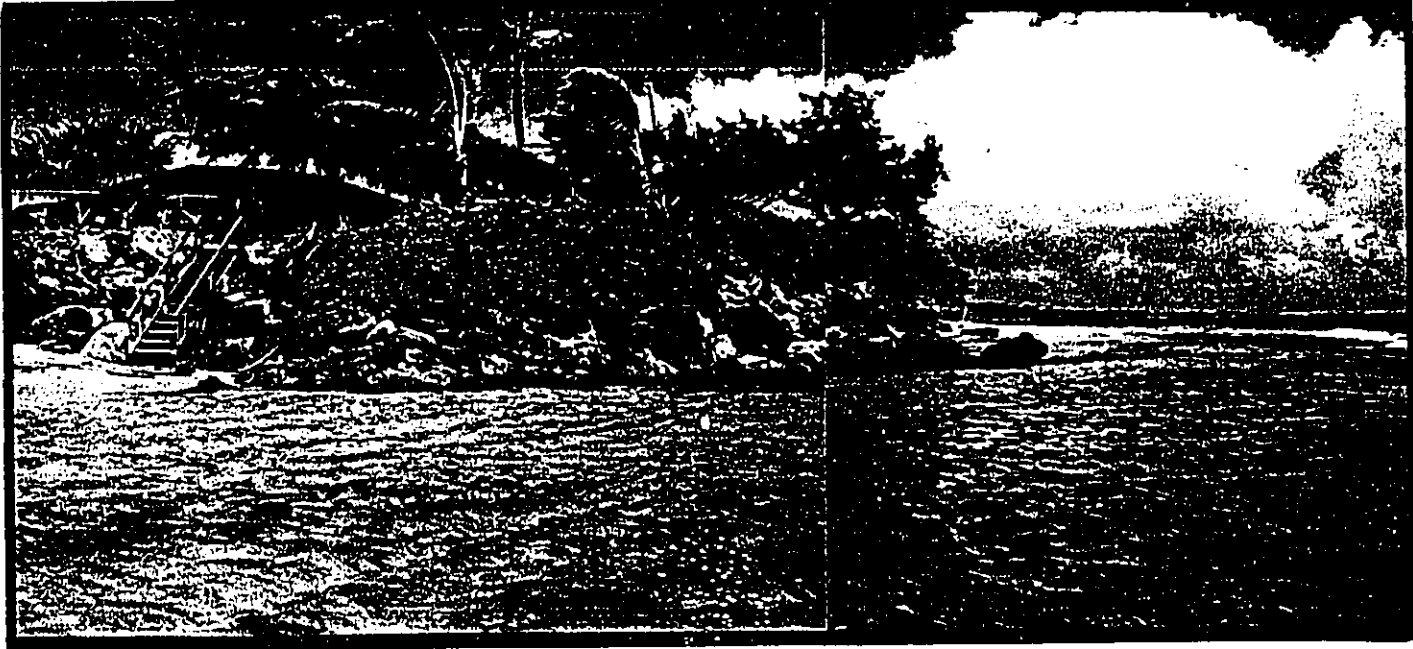
At this level of the tide and wave set-up, flow of the northward moving current over the rubble rock weir creates a small hydraulic jump just downstream.
