Draft Environmental Assessment Heinz Sea Wall Repair

October 2009

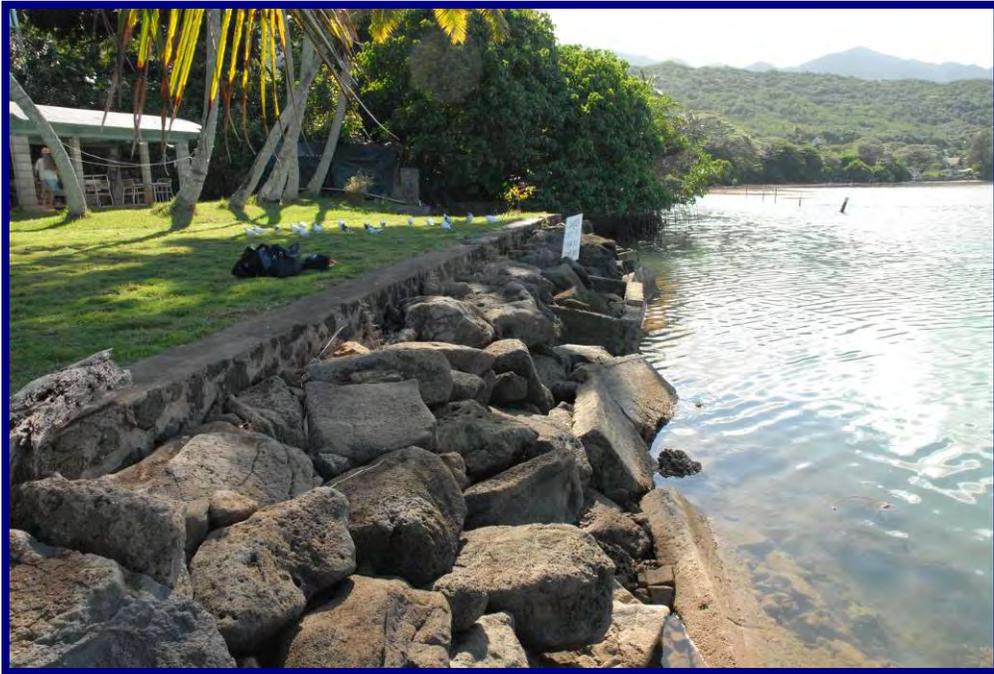
Along a 68-foot section of shoreline, the center of the property is protected by a double wall system. The wall system consists of an outer concrete seawall and an inner concrete rubble masonry (CRM) retaining wall. The space between the walls is filled with rock and gravel. Portions of the outer seawall have collapsed, allowing water to reach the inner retaining wall. A boat channel fronting the property has eroded shoreward, and probably contributed to the collapse of the outer sea wall. The owner has seen evidence that soil from the property lawn is being washed out to the bay under the inner retaining wall. The wall foundation is shallow and the wall could collapse if the rocks were removed. Soil erodes into the boat channel. Concentrated rainwater drainage may damage particular areas of the inner wall, because rainwater often ponds in the yard, indicating that the soils do not drain well. The lot's eastern shoreline is protected by a CRM wall. The western shoreline is protected by a small concrete wall that is being undermined. Portions of the wall system are shown in Figures 5 through 8. Rocks placed along the walls are encroaching into state waters (see Figure 9).

Figure 5. West Side of Central Double Wall System (taken 1/25/07)

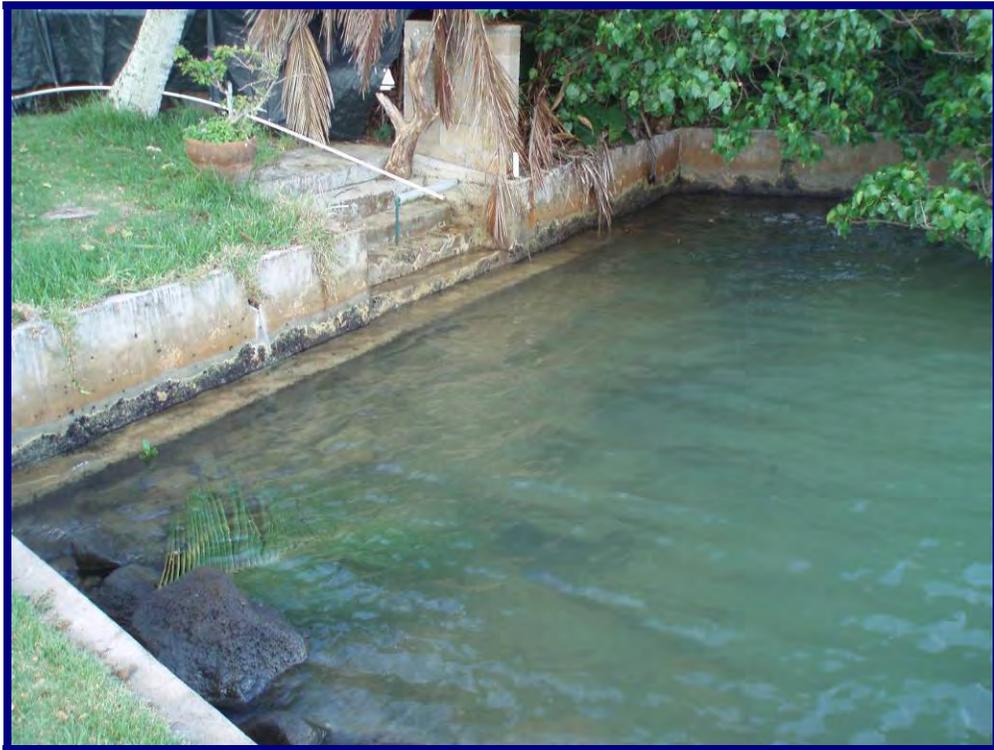
Figure 6. Concrete Wall on West Section of the Wall System (taken 1/25/07)

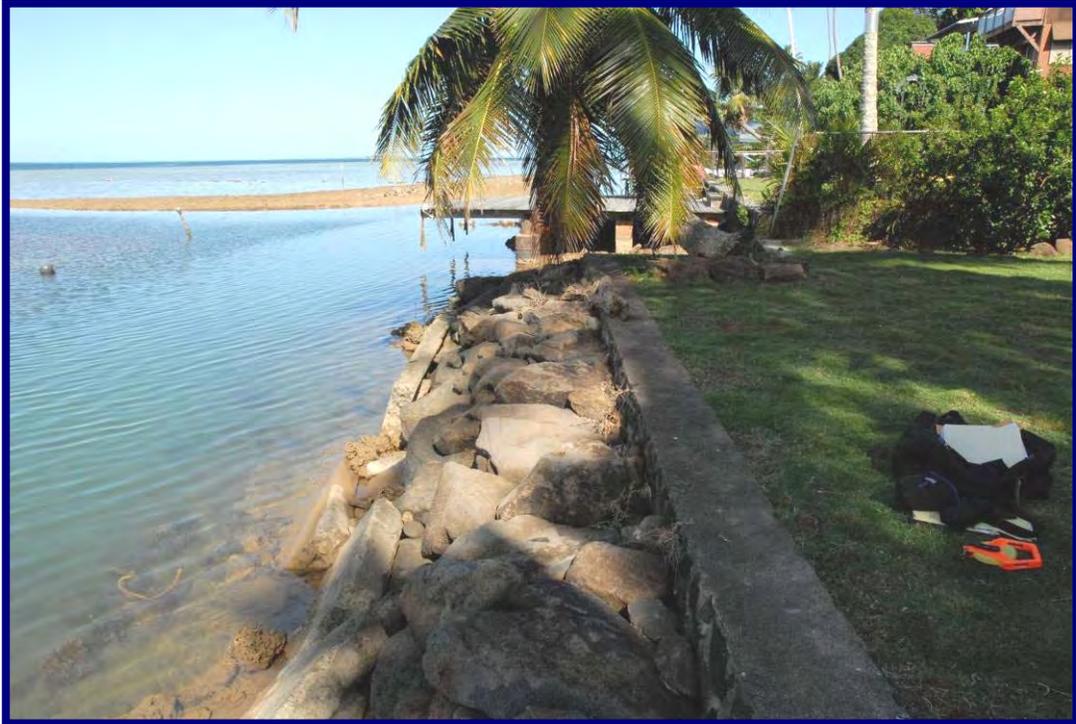
Figure 7. Eastern Portion of the Heinz Wall System (taken 1/25/07)

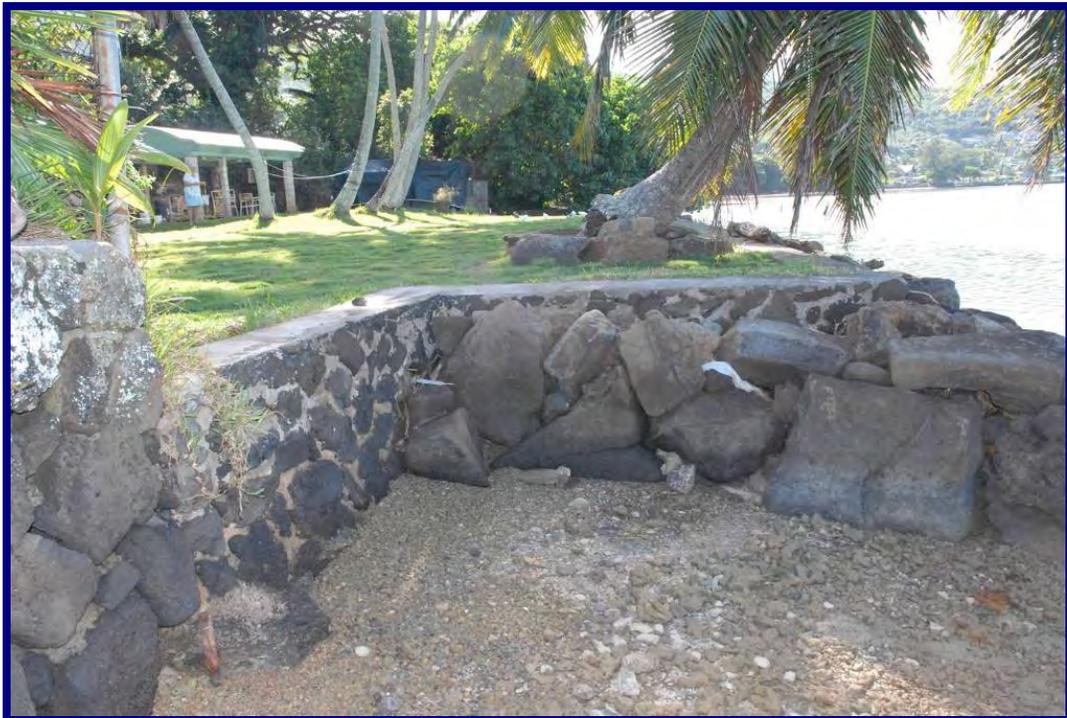
Figure 8. CRM Wall on Eastern Side of Lot (taken 1/25/07)

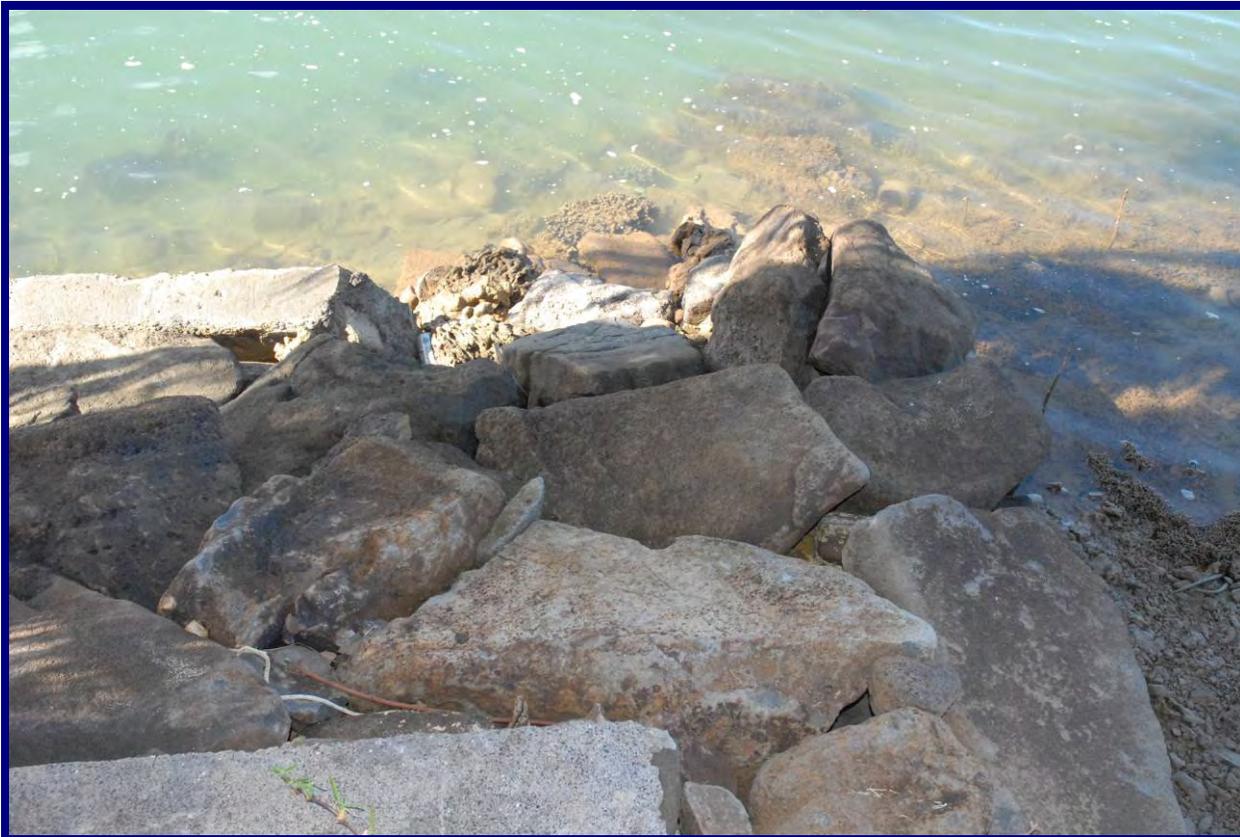
Figure 9. Rocks Encroaching in State Waters (taken 1/25/07)

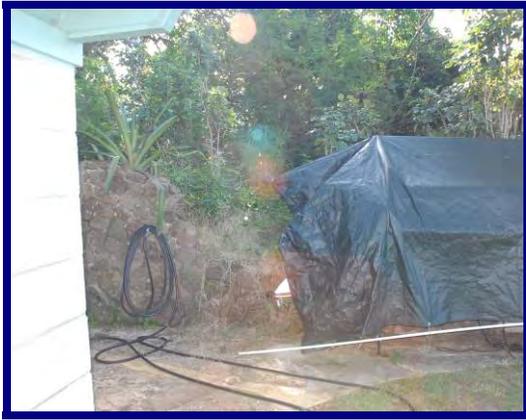
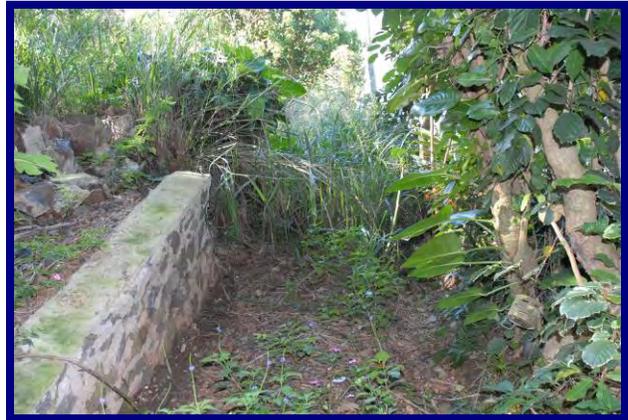
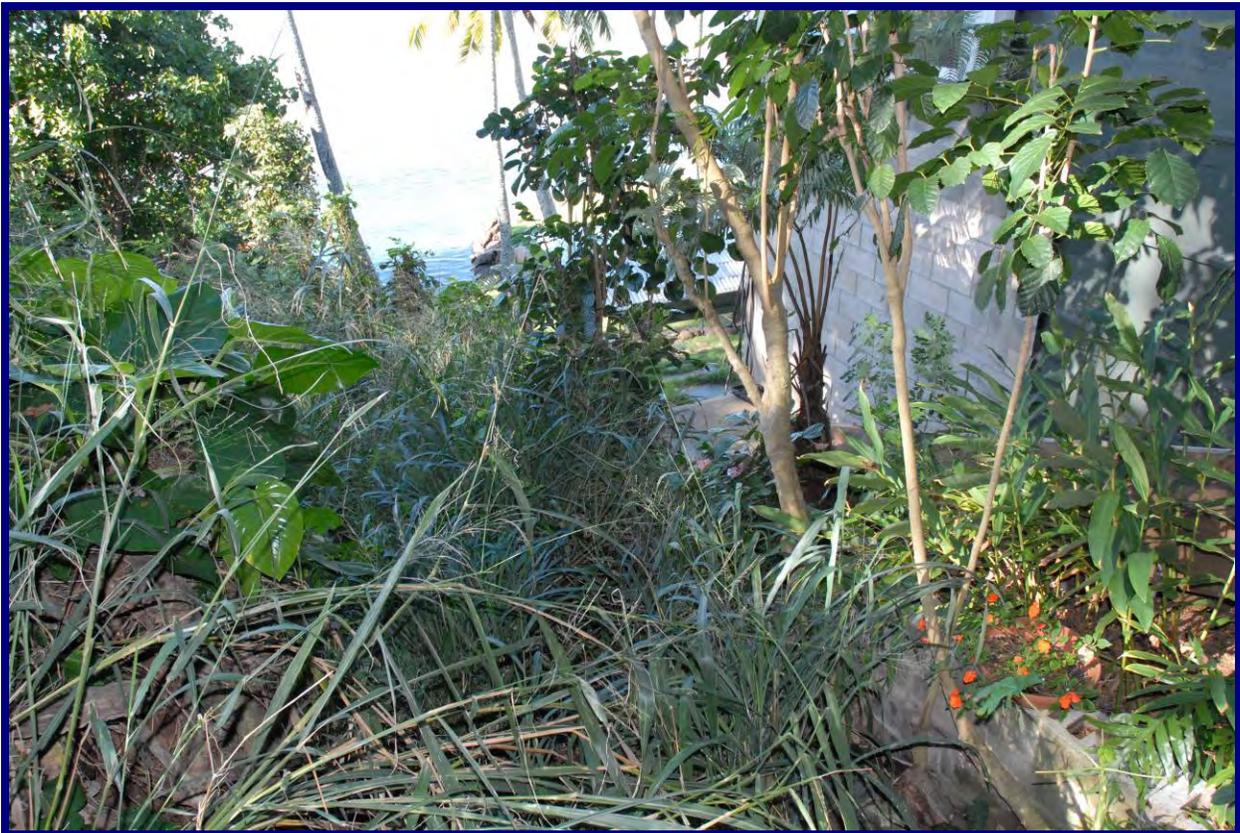
Figure 15. Construction Equipment Access Area

Top left: Only available access area available for construction equipment through neighboring property. View is from backyard of property, facing southwest. *Top right:* View going down access to backyard of property, viewed facing northwest. *Bottom:* Seaward view of access from area from west of house.
