# Update on Water Resources in the Lahaina Aquifer Sector Area

## Agenda Item B-2

### a. Wells in the Fire-Impacted Area

## Wells Inspected on CWRM Site Visit on October 17, 2023

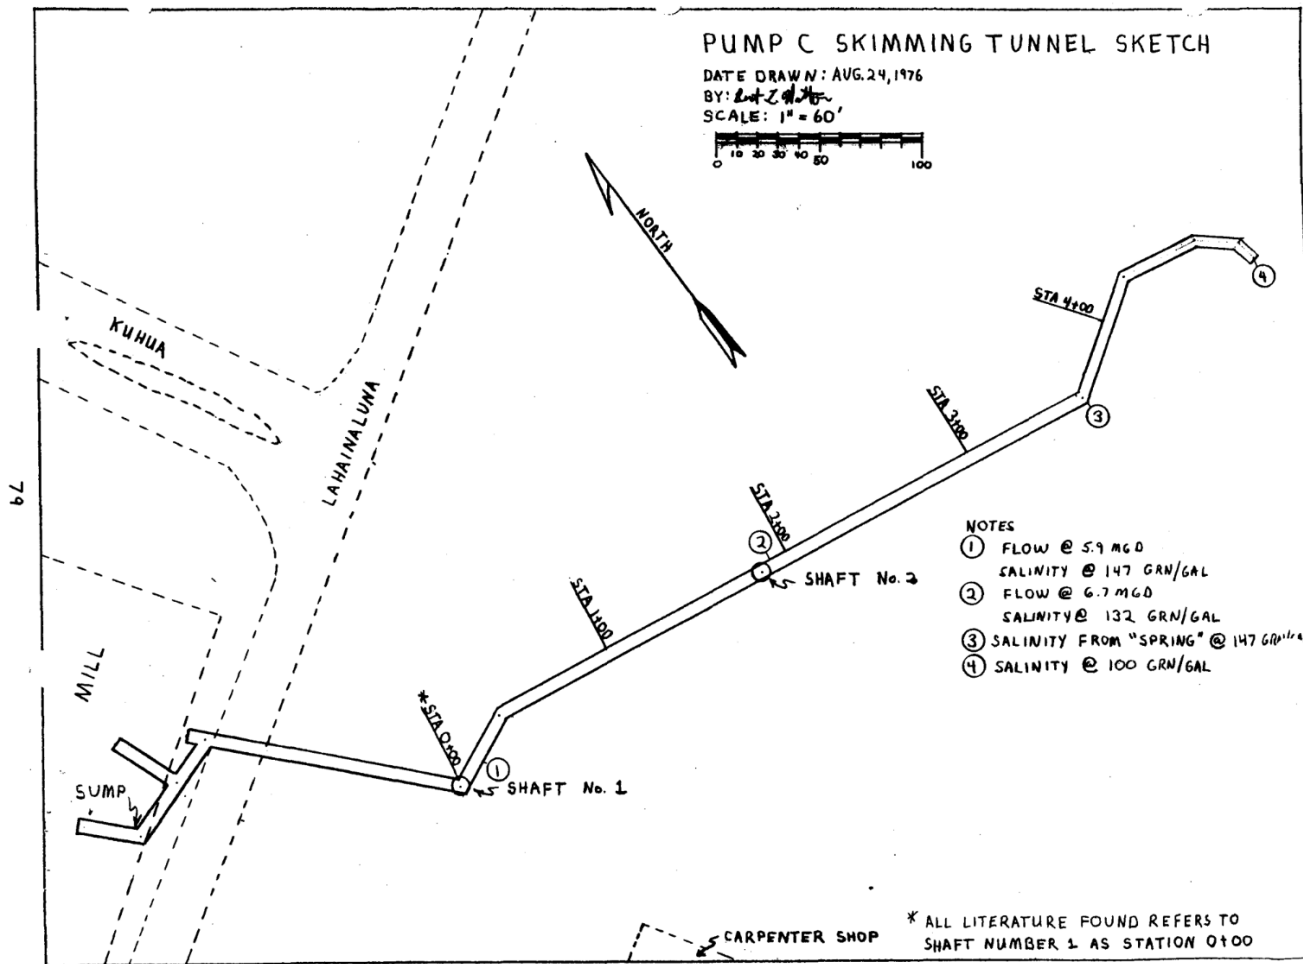
# Mill Shaft Pump C

- The sump and vault of Pump C next to the mill's smokestack were sealed and filled in 2006 by Kaanapali Land Management Corp.
- DOCARE photos were of Maui DWS water lines.
- CWRM staff found Shaft 1 and Shaft 2 on neighboring property.
- Shaft 1 and 2 are located on TMK 460270230000 owned by Wainee Land & Homes, LLC

1. Proper Abandonment via Well Abandonment Permit
  - Clean, backfill, and properly seal vertical shafts.
  - Remove existing surface structures following permitted abandonment and sealing.
2. Upgrade for Future Use
  - Assess, clean, and upgrade surface structures to ensure the vertical shafts, and the aquifer, are protected from surface contamination and vandalism.
  - Land/well owner to investigate and document condition of horizontal shaft.
  - Submit water use permit application.

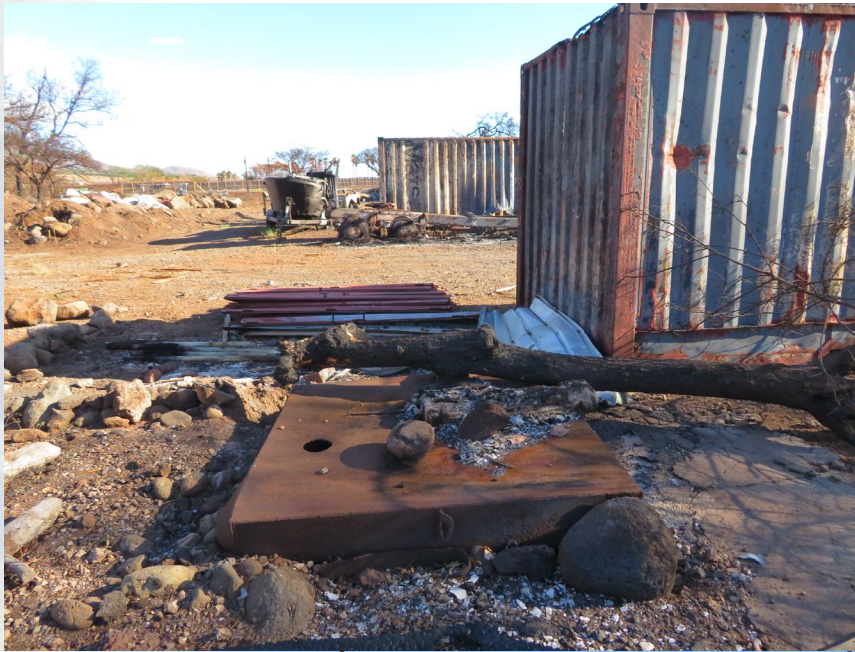
## Shaft 1

- Metal cover of vertical access portal with hole
- Groundwater exposed

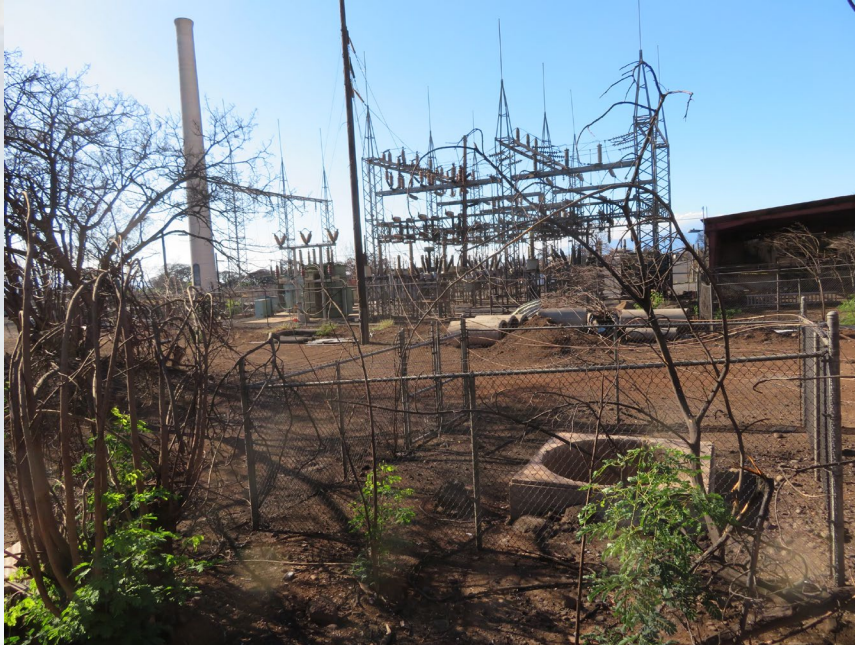
## Shaft 2

- Fenced in open vertical access portal
- CWRM couldn't determine if groundwater is exposed

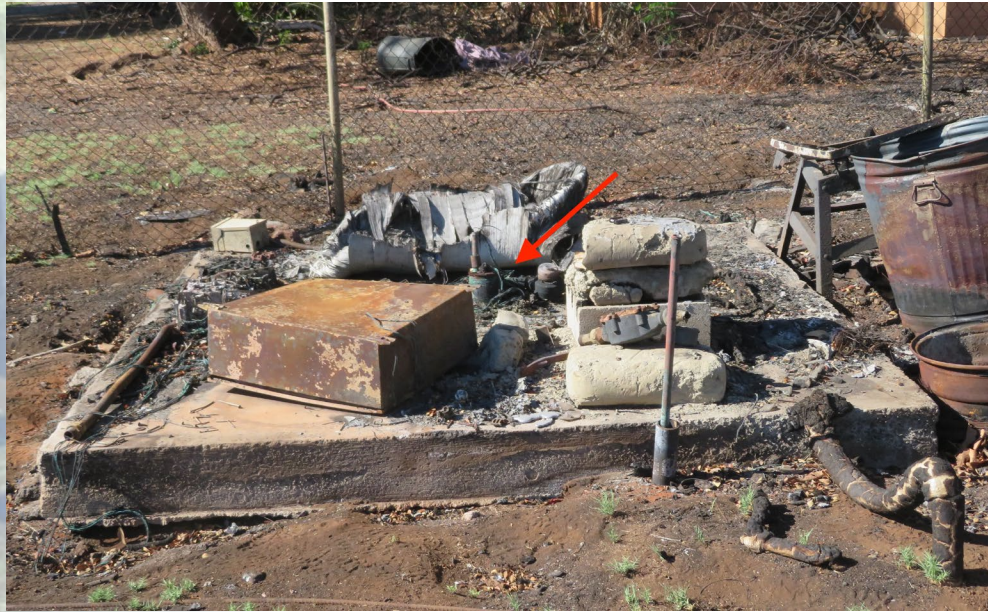
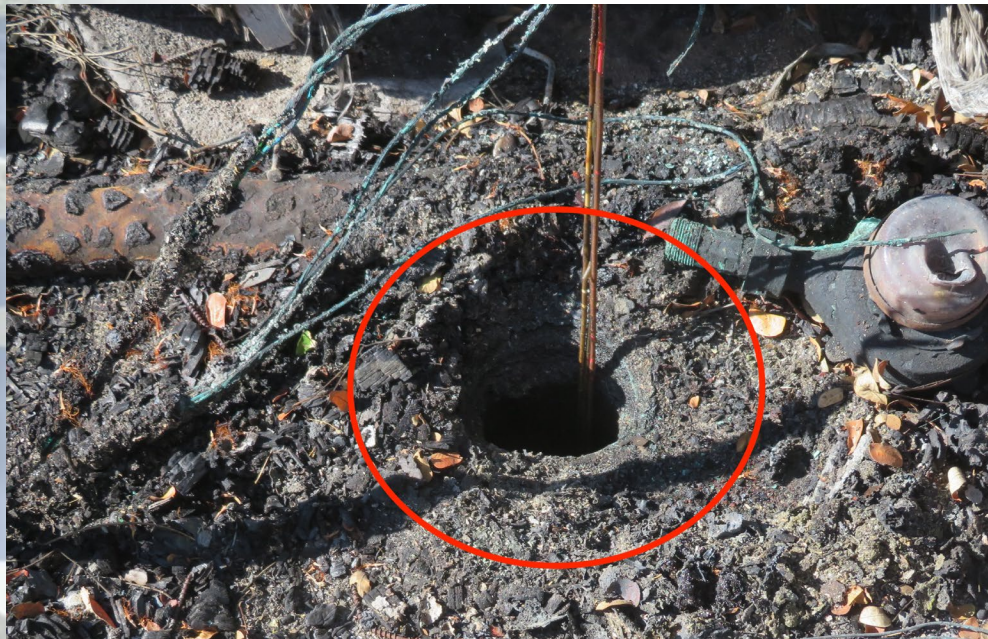
# Lahaina UMC

- Well location (red arrow)
- Top of well (note pump wires in red circle)
- Casing has burned, leaving an open hole and surface contamination pathway to the basal aquifer

1. Remove incinerated debris from around the open hole to reduce potential for ash and small objects from falling into the open well shaft.
2. Plug the open hole, and pour a cement/concrete plug over the plug to secure the boring until the well can be properly abandoned and sealed.

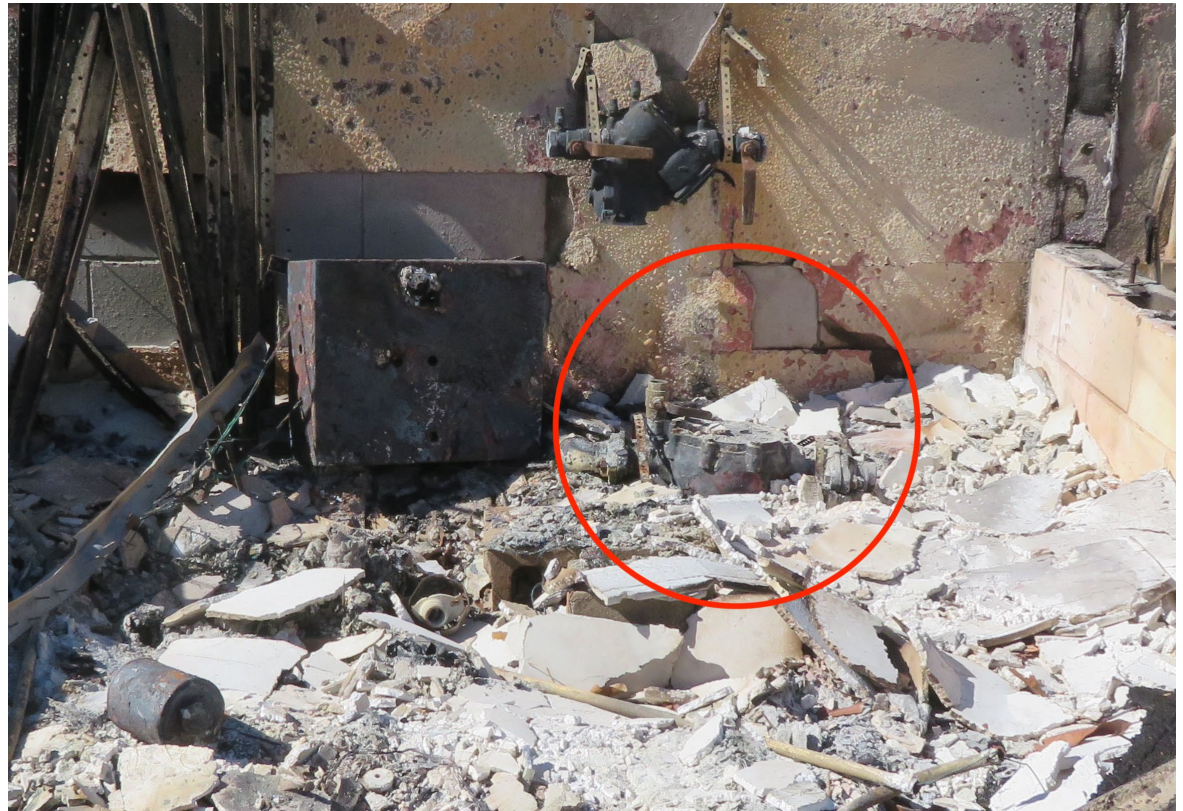
## Lahaina Surf

- Well 6-5241-0001 location was not observed during site visit. It is presumably buried beneath the incinerated debris adjacent to the remains of the water (red circle). It is likely the casing has burned, leaving an open hole for surface contamination pathway to the basal aquifer.

1. Remove incinerated debris carefully to reduce potential for ash and small objects from falling into the open well shaft.
2. Once the well boring is located, plug the open hole, and pour a cement/concrete plug over the plug to secure the boring until the well can be properly abandoned and sealed.

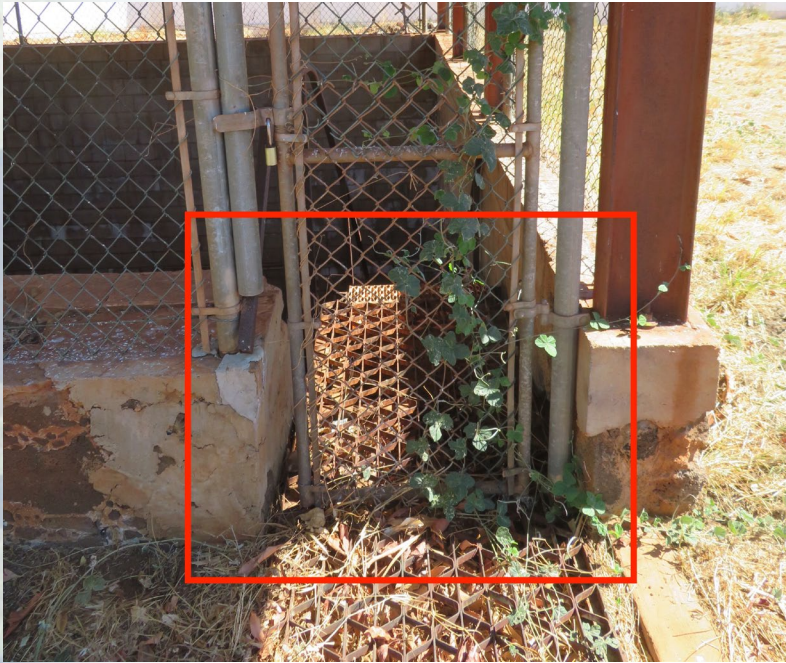
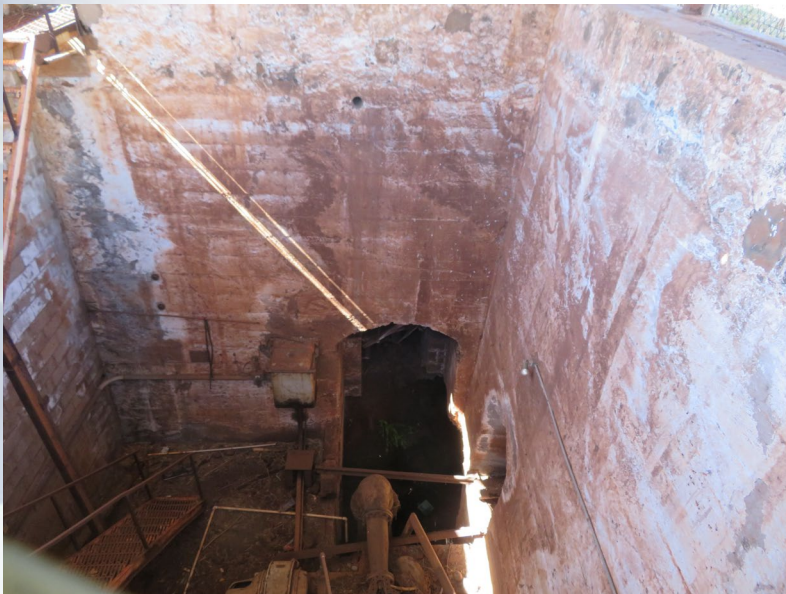
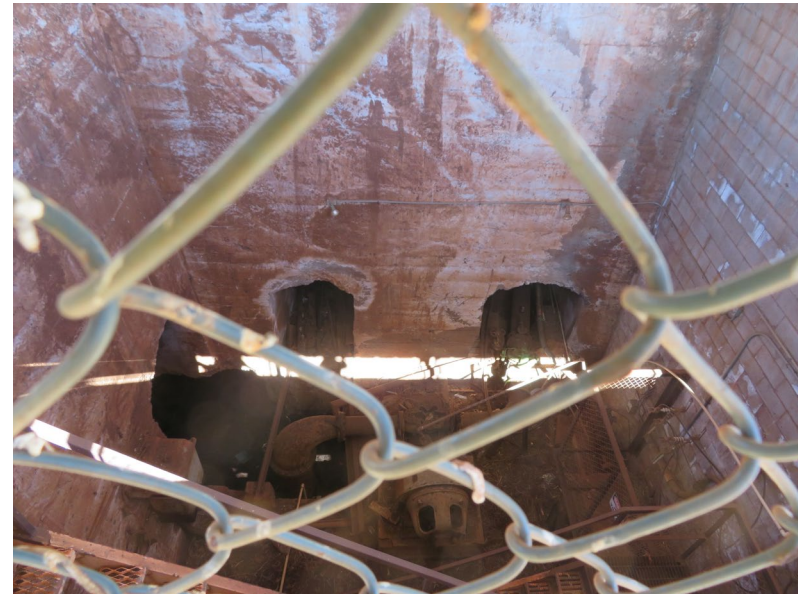
# Wahikuli Pump L

- Runoff protection for the open vault has been constructed with a low CMU wall, however protection is compromised by the lack of a berm or wall where the chain link fence gate accesses the vault.

1. Construct a low wall at the chain-link gate to match height of the CMU wall surrounding the open vault in a manner that doesn't restrict the usage of the gate.
