Assessment Report

State of Hawai'i, Department of Land & Natural Resources, Land Division

Assess Banyan Drive Properties

Prepared by Erskine Architects, Inc.

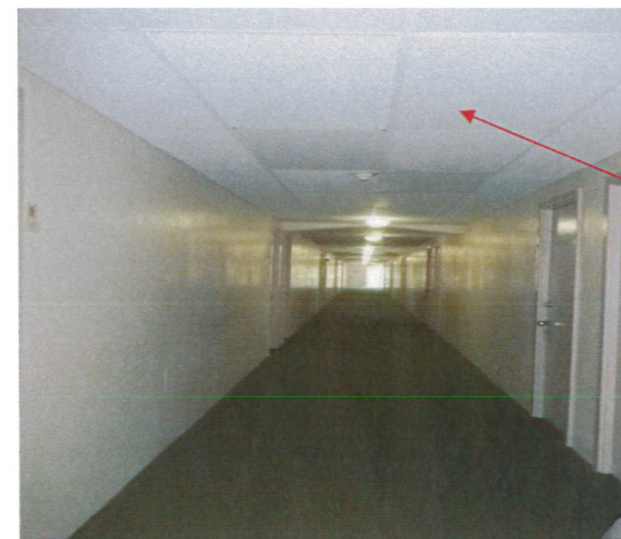
Photograph 13: Floors 1-3, 2' x 4' Fissure Ceiling Tile

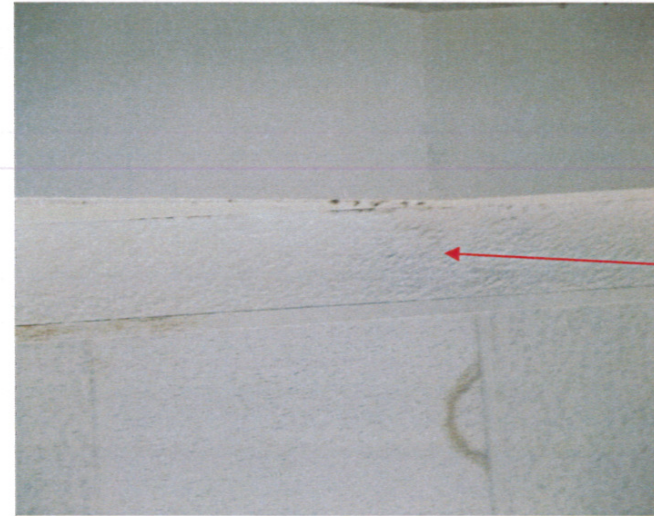
Photograph 14: Floor, 3 Spray on Ceiling Material
