STATE OF HAWAII
DEPARTMENT OF LAND AND NATURAL RESOURCES
COMMISSION ON WATER RESOURCE MANAGEMENT
 Stream Protection and Management Branch

FIELD INVESTIGATION REPORT

FI2008102703 (East Maui, Honopou Haiku Ditch, restore)

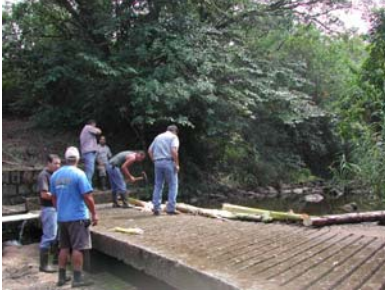
20081027013.JPG

Image Listing:	(Attach PDF of image contact sheet)		
File Name:	Brief Description:		
20081027013	EMI staff building a berm wall at Haiku Ditch on Honopou Stream by first placing banana leaves on the ditch grating structure.		
20081027015	EMI staff building a berm wall at Haiku Ditch on Honopou Stream.		
20081027017	EMI staff building a berm wall at Haiku Ditch on Honopou Stream.		
20081027018	EMI staff building a berm wall at Haiku Ditch on Honopou Stream.		
20081027020	Sanford Kekahuna helping EMI staff to gather boulders for building a berm wall at Haiku Ditch on Honopou Stream.		
20081027021	EMI staff building a berm wall at Haiku Ditch on Honopou Stream.		
20081027025	EMI staff building a berm wall at Haiku Ditch on Honopou Stream.		
20081027031	Completed berm wall at Haiku Ditch on Honopou Stream.		
20081027033	Completed berm wall at Haiku Ditch on Honopou Stream.		
20081027035	Completed berm wall at Haiku Ditch on Honopou Stream, near the three 4-inch bypass pipes.

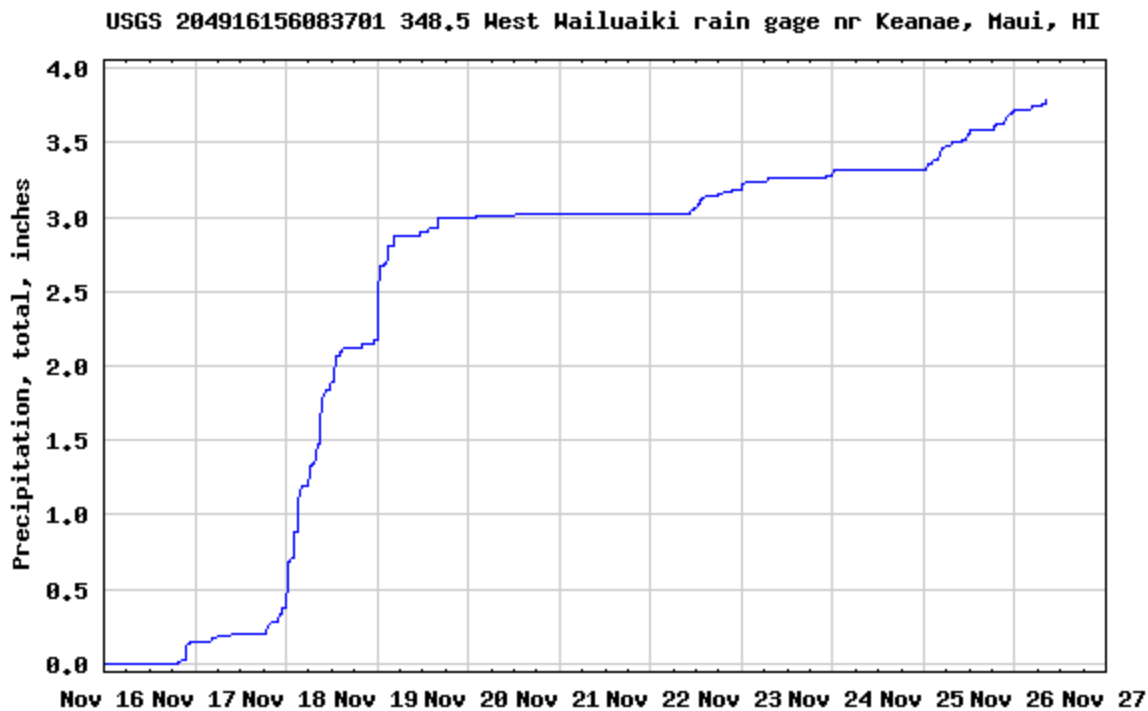
Heavy rain fell on East Maui on the morning of Nov. 18. USGS rain gage (Station 204916156083701) in West Wailuaiki near Keanae recorded 1.8 inches of rain on Nov 18, and 0.82 inches on Nov. 19. Most of the rain fell on the early morning of Nov. 18, between 12AM and 3:30AM.

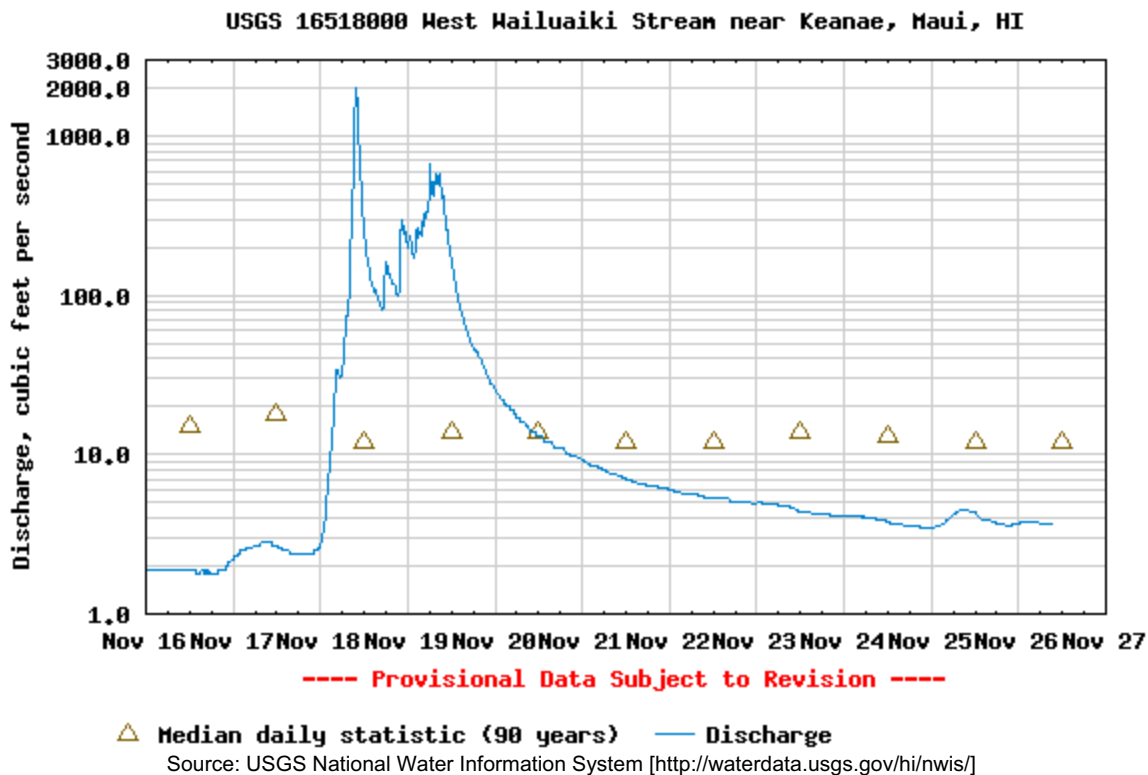
The nearest USGS active streamgage with real-time data is located on West Wailuaiki Stream (Station 16518000). At approximately 12:00AM on Nov. 18, discharge in West Wailuaiki Stream began to increase from 2.7CFS to a peak flow of 2,010 CFS at 9:45AM. By Nov. 26, streamflow returned to normal conditions at 3.7 CFS.

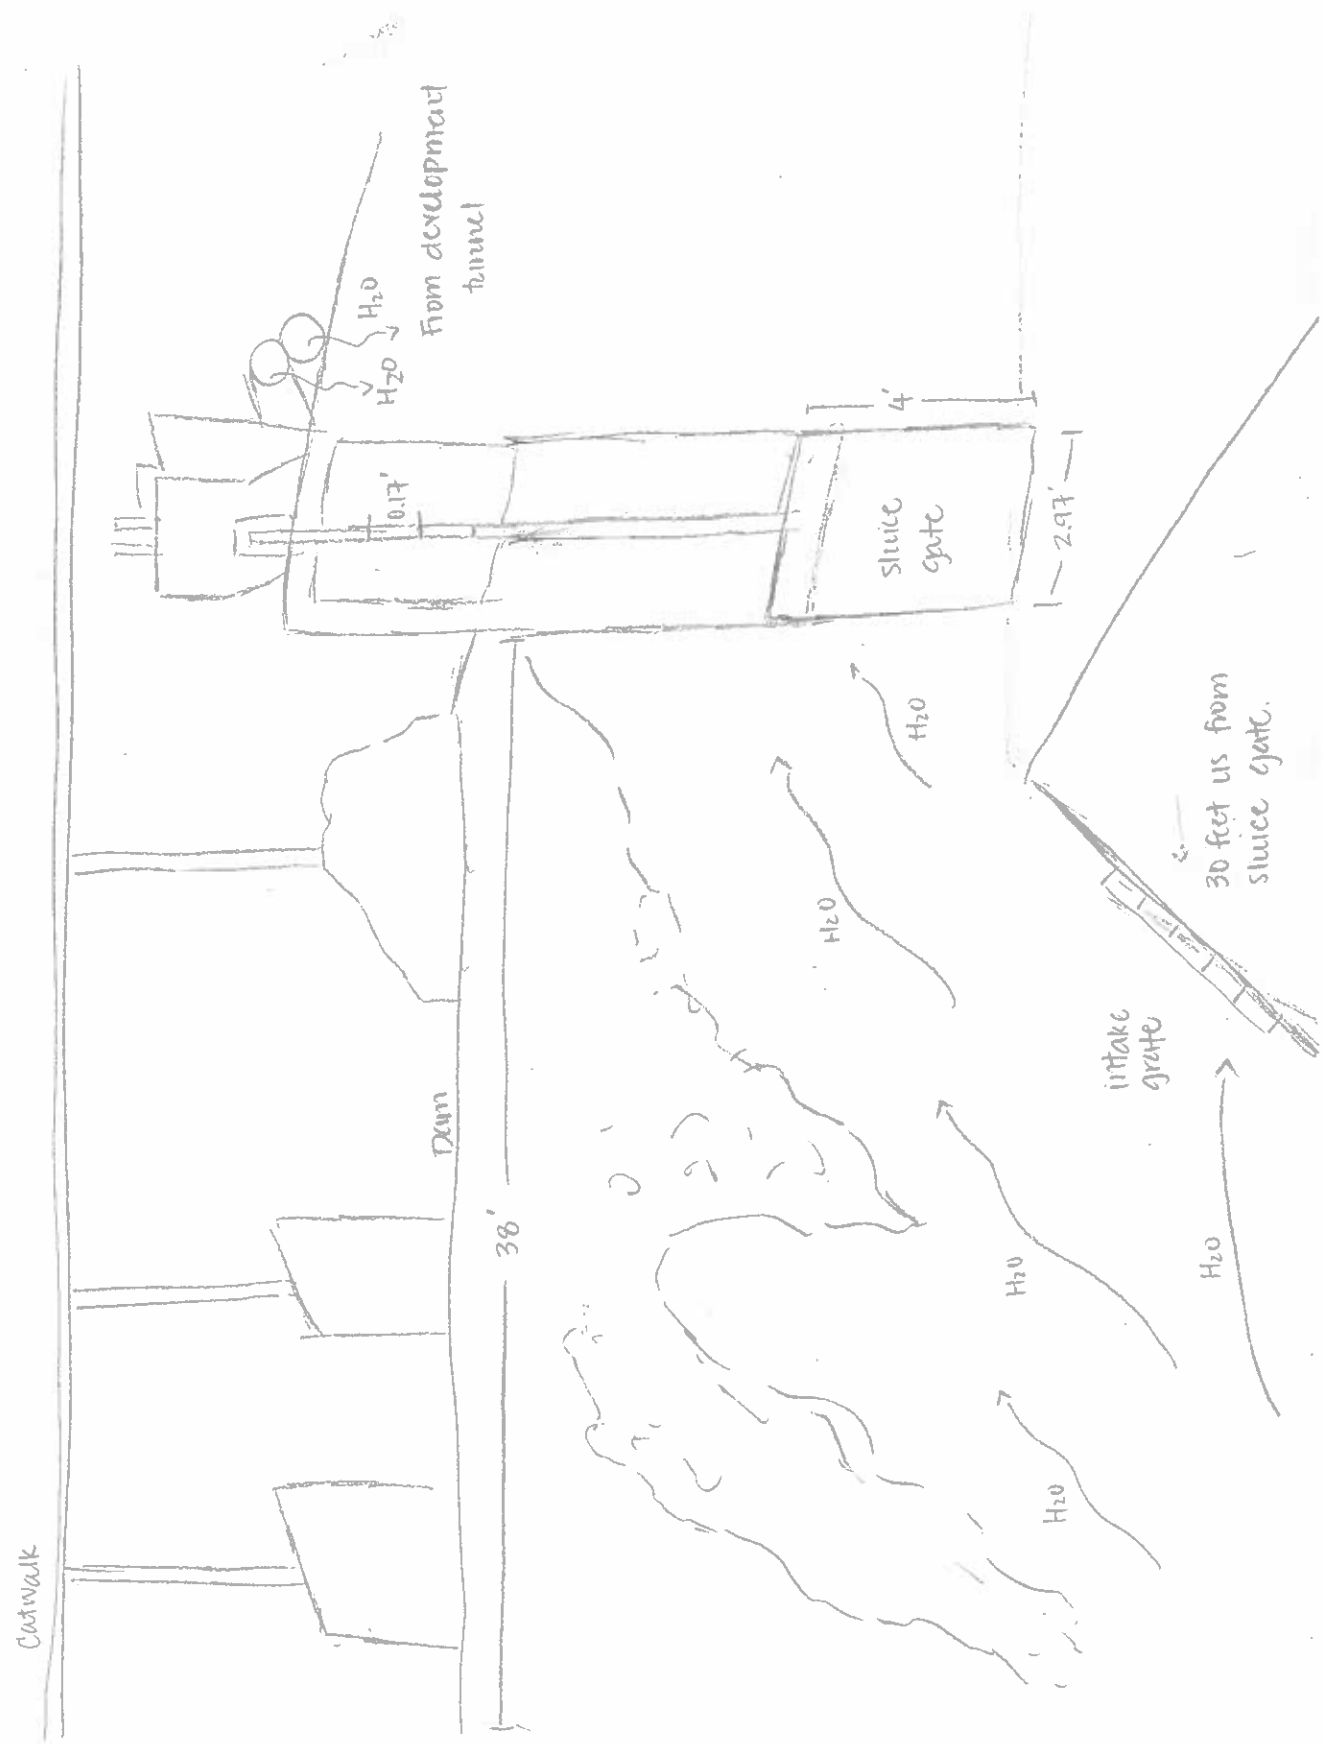
- x gate was open by mistake.
- x with water, critters can climb up diversion
- x waterfall upstream.
- x how long is dry reach below diversion?

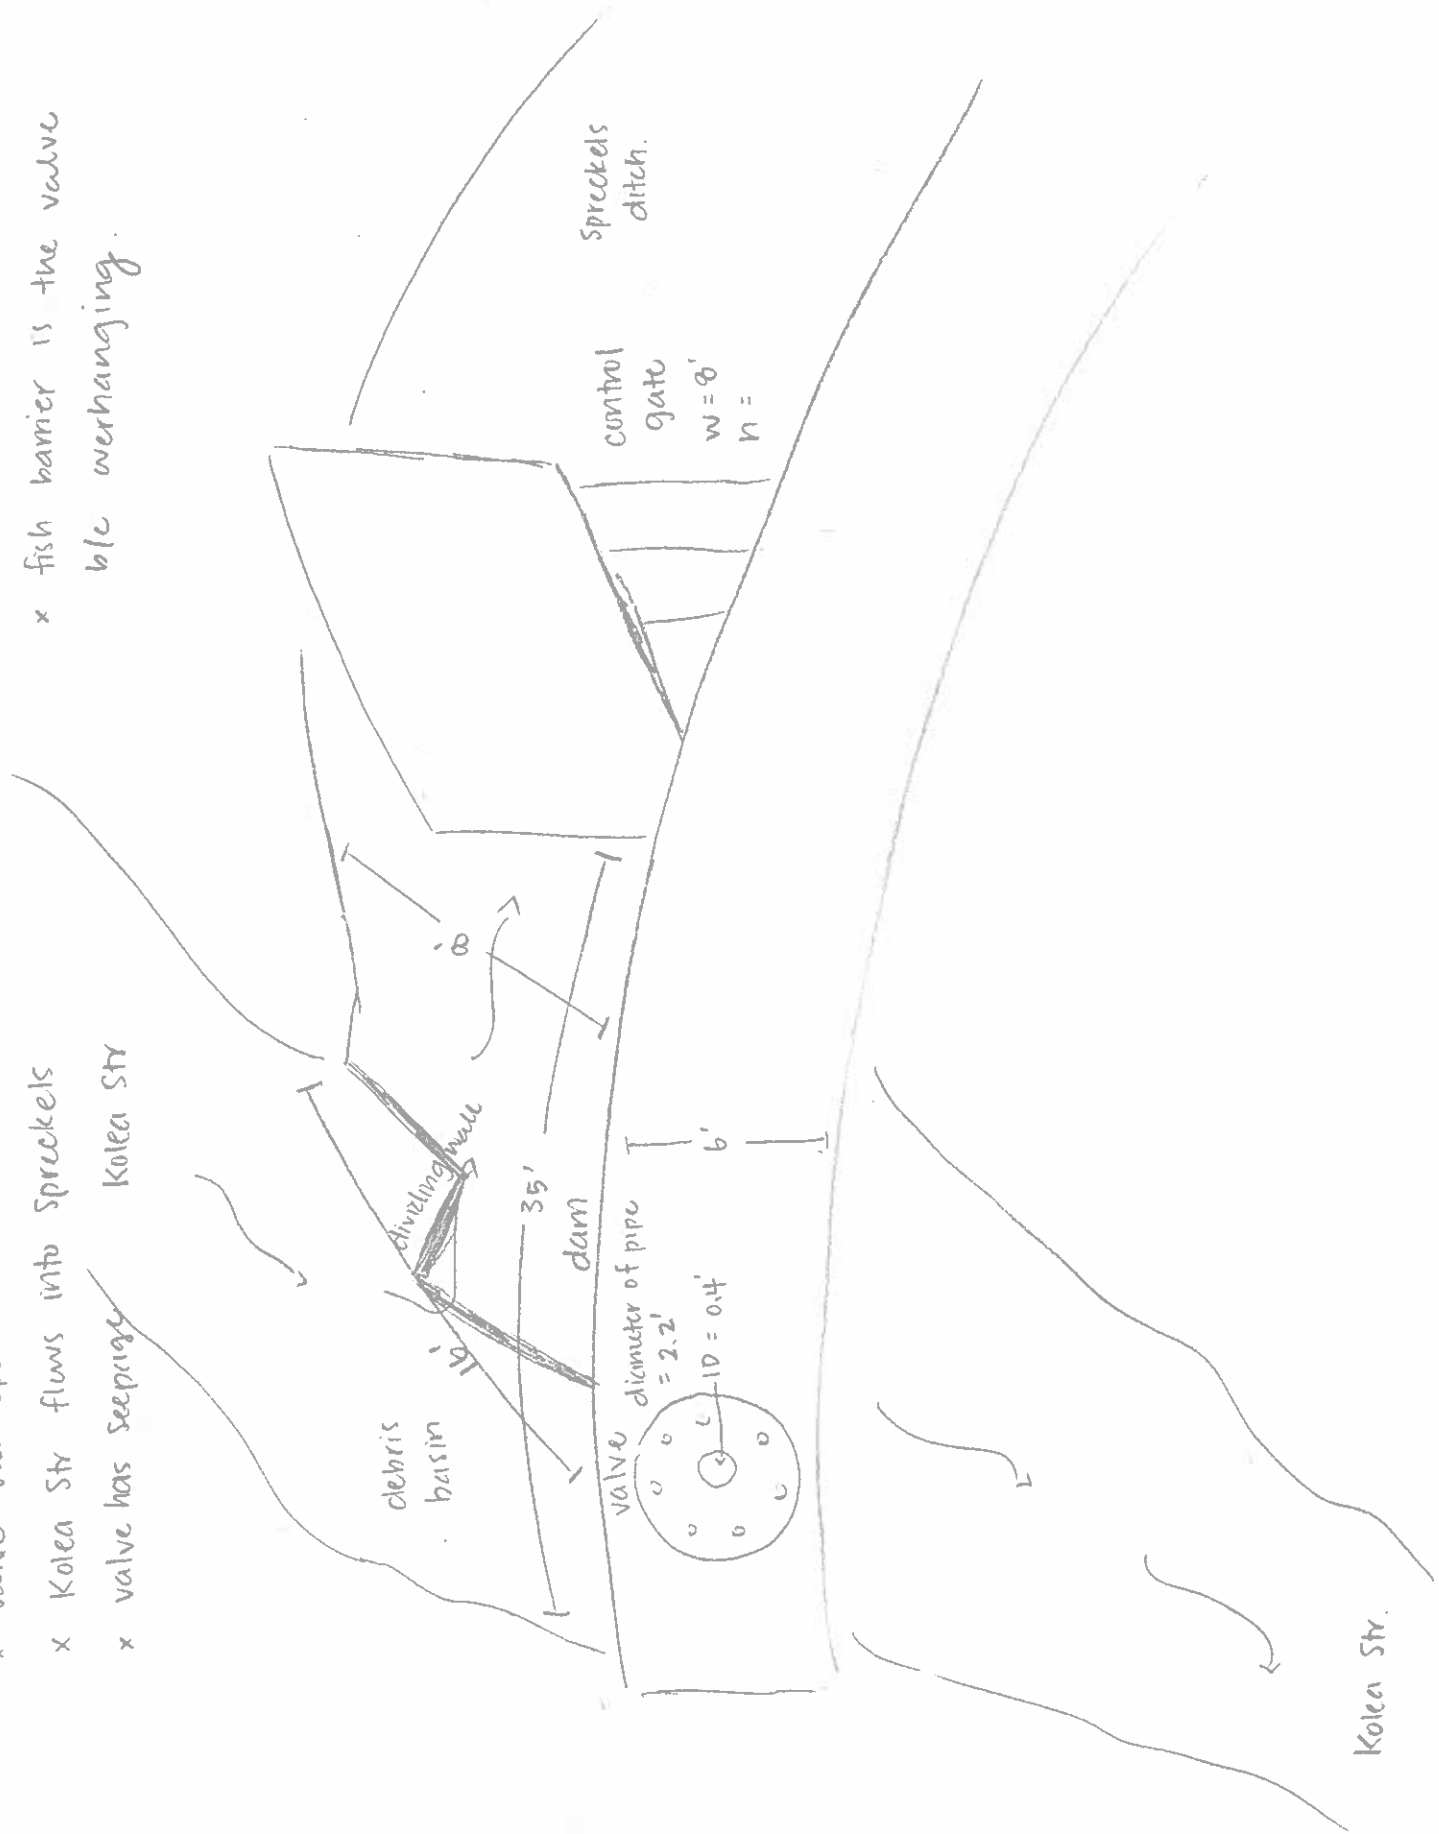
KOLEA (Kolea ditch)

- x valve was open
- x Kolea Str flows into Spreckels Kolea Str
- x valve has seepage

- x dividing wall, $h = 2.6'$
- x fish barrier is the valve b/c overhanging.

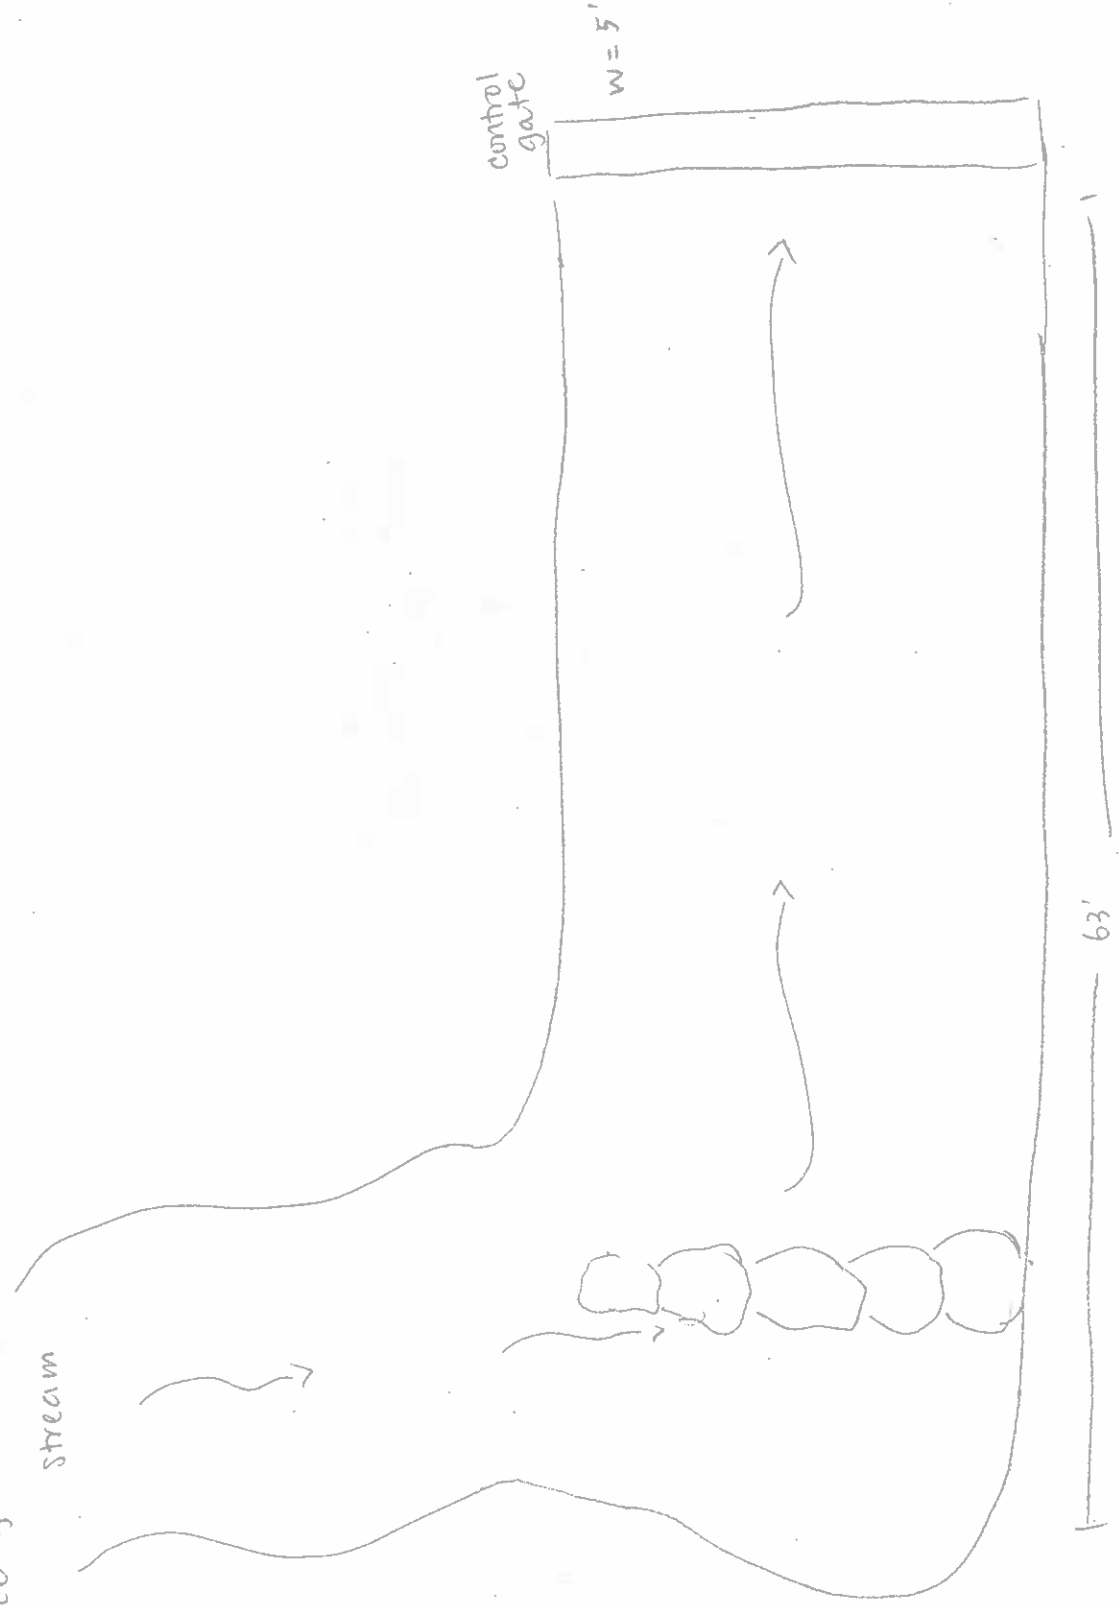
HAI PUAENA

- x spreckels ditch
- x no sluice gate
- x stream drops straight into Spreckels Ditch
- x no debris basin

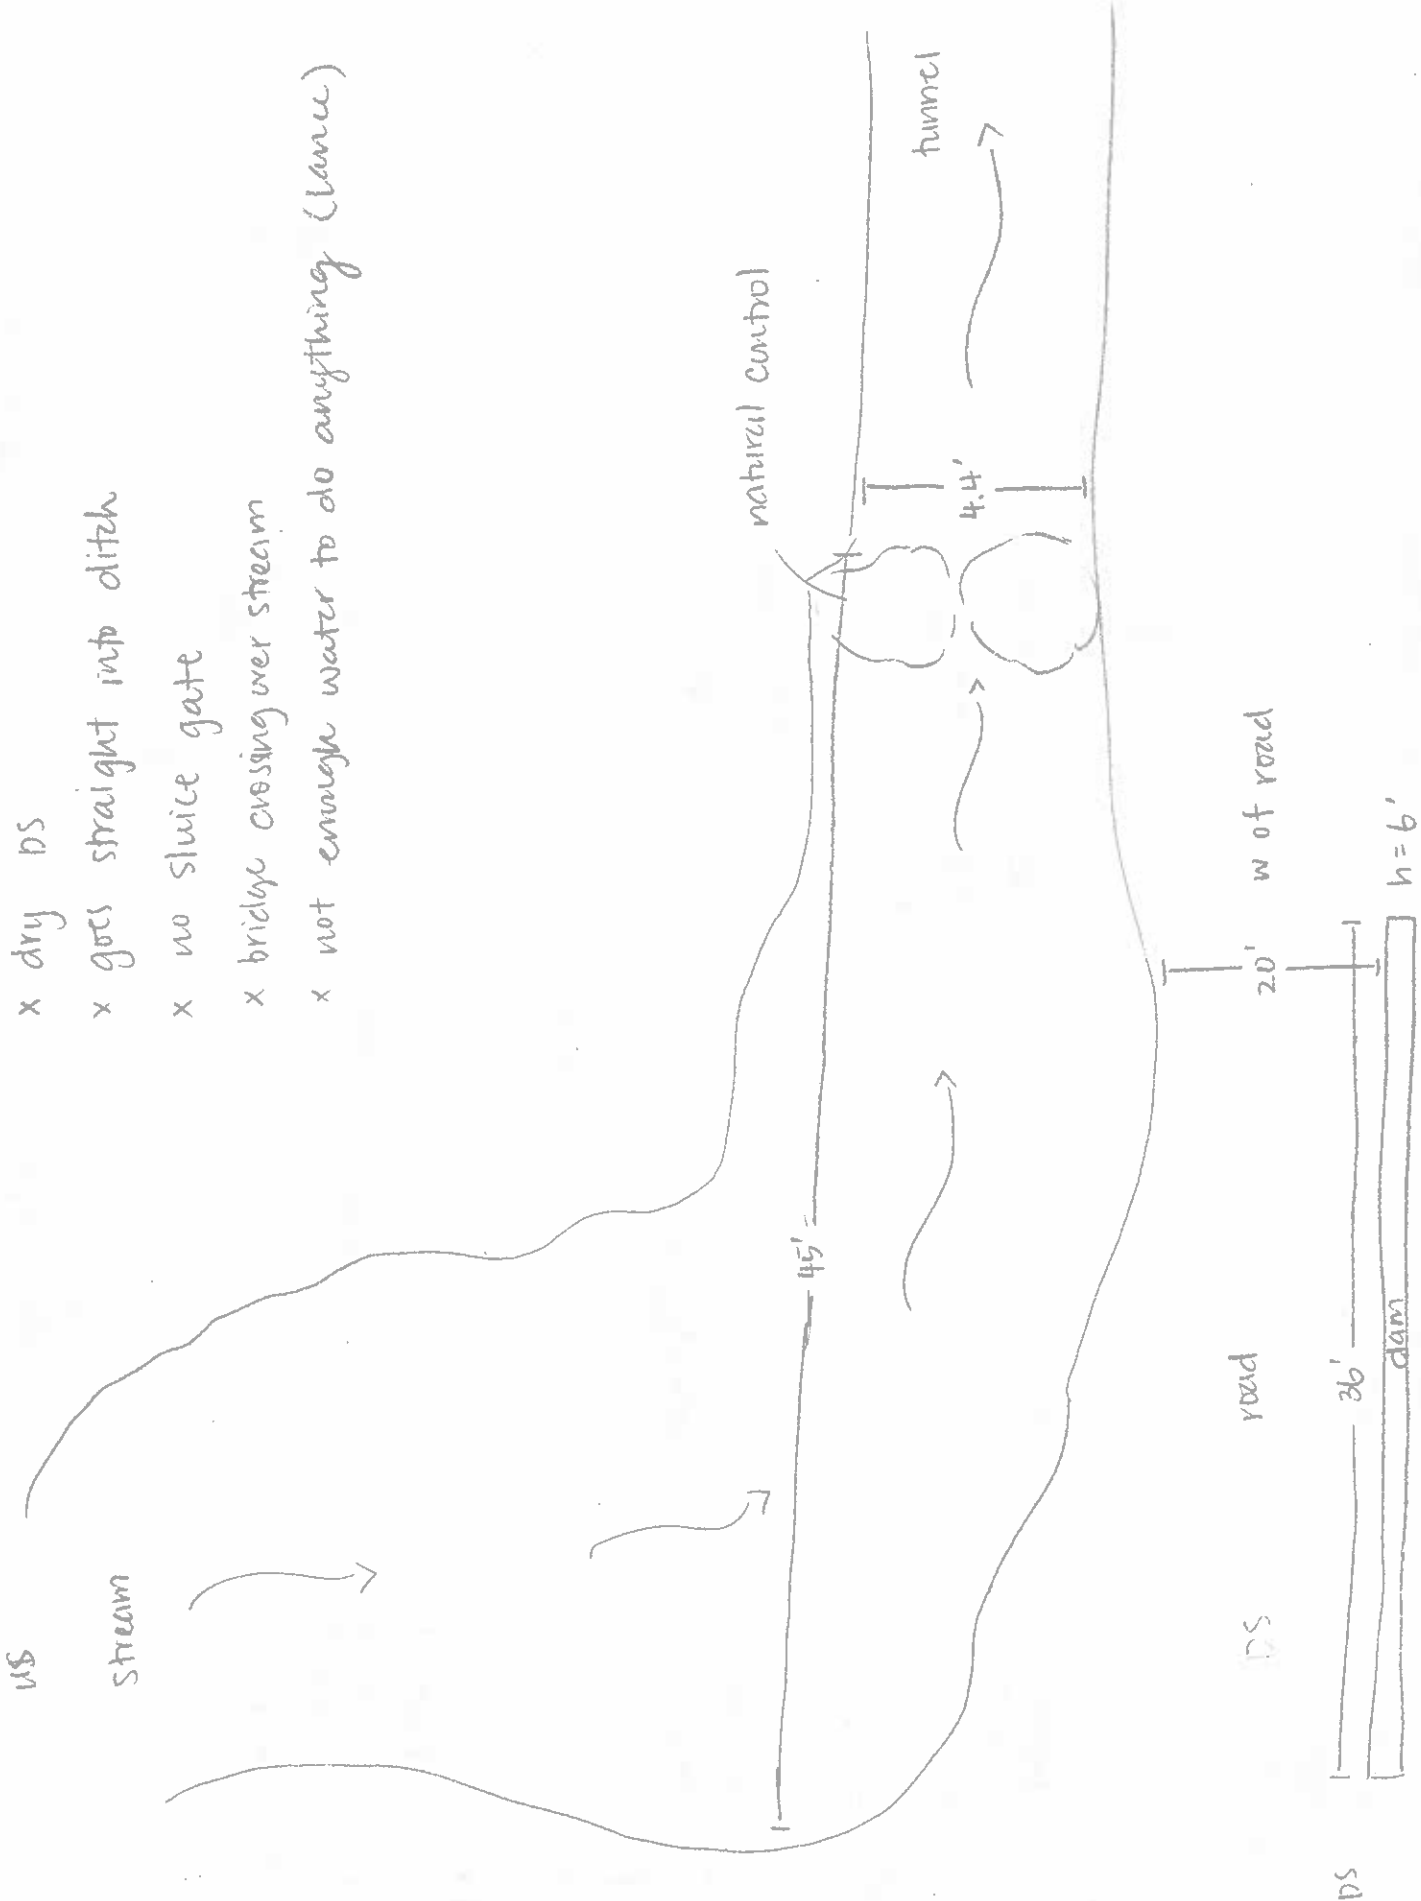
DIVERSION ML-2

- x dry DS
- x goes straight into ditch
- x no sluice gate
- x bridge crossing over stream
- x not enough water to do anything (lanau)

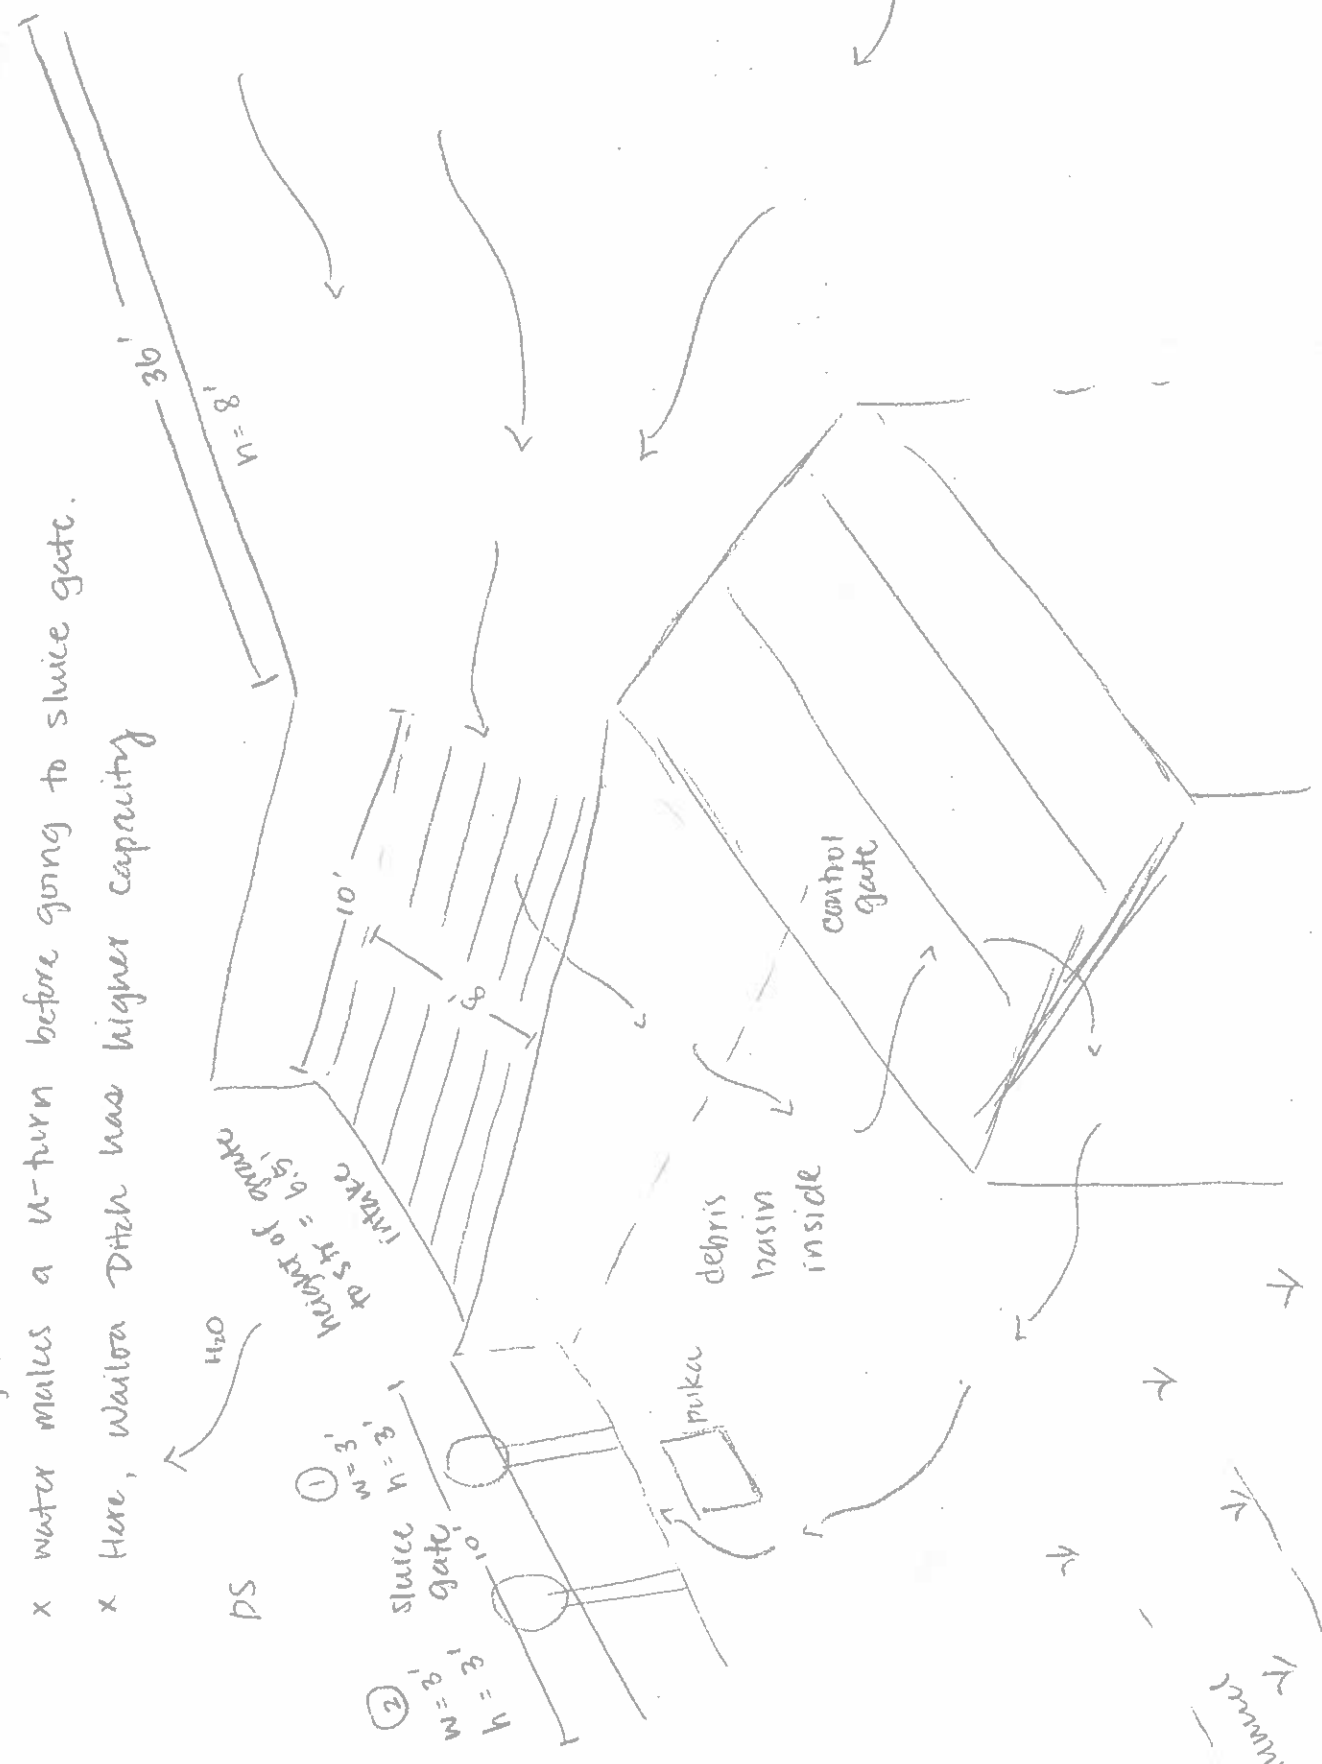
ALO (Koolau/Wailoa Ditch)

- x waterfall carries water from **DIVERSION SKETCH**.
- x 2 sluice gates.
- x water makes a u-turn before going to sluice gate.
- x Here, Wailoa Ditch has higher capacity

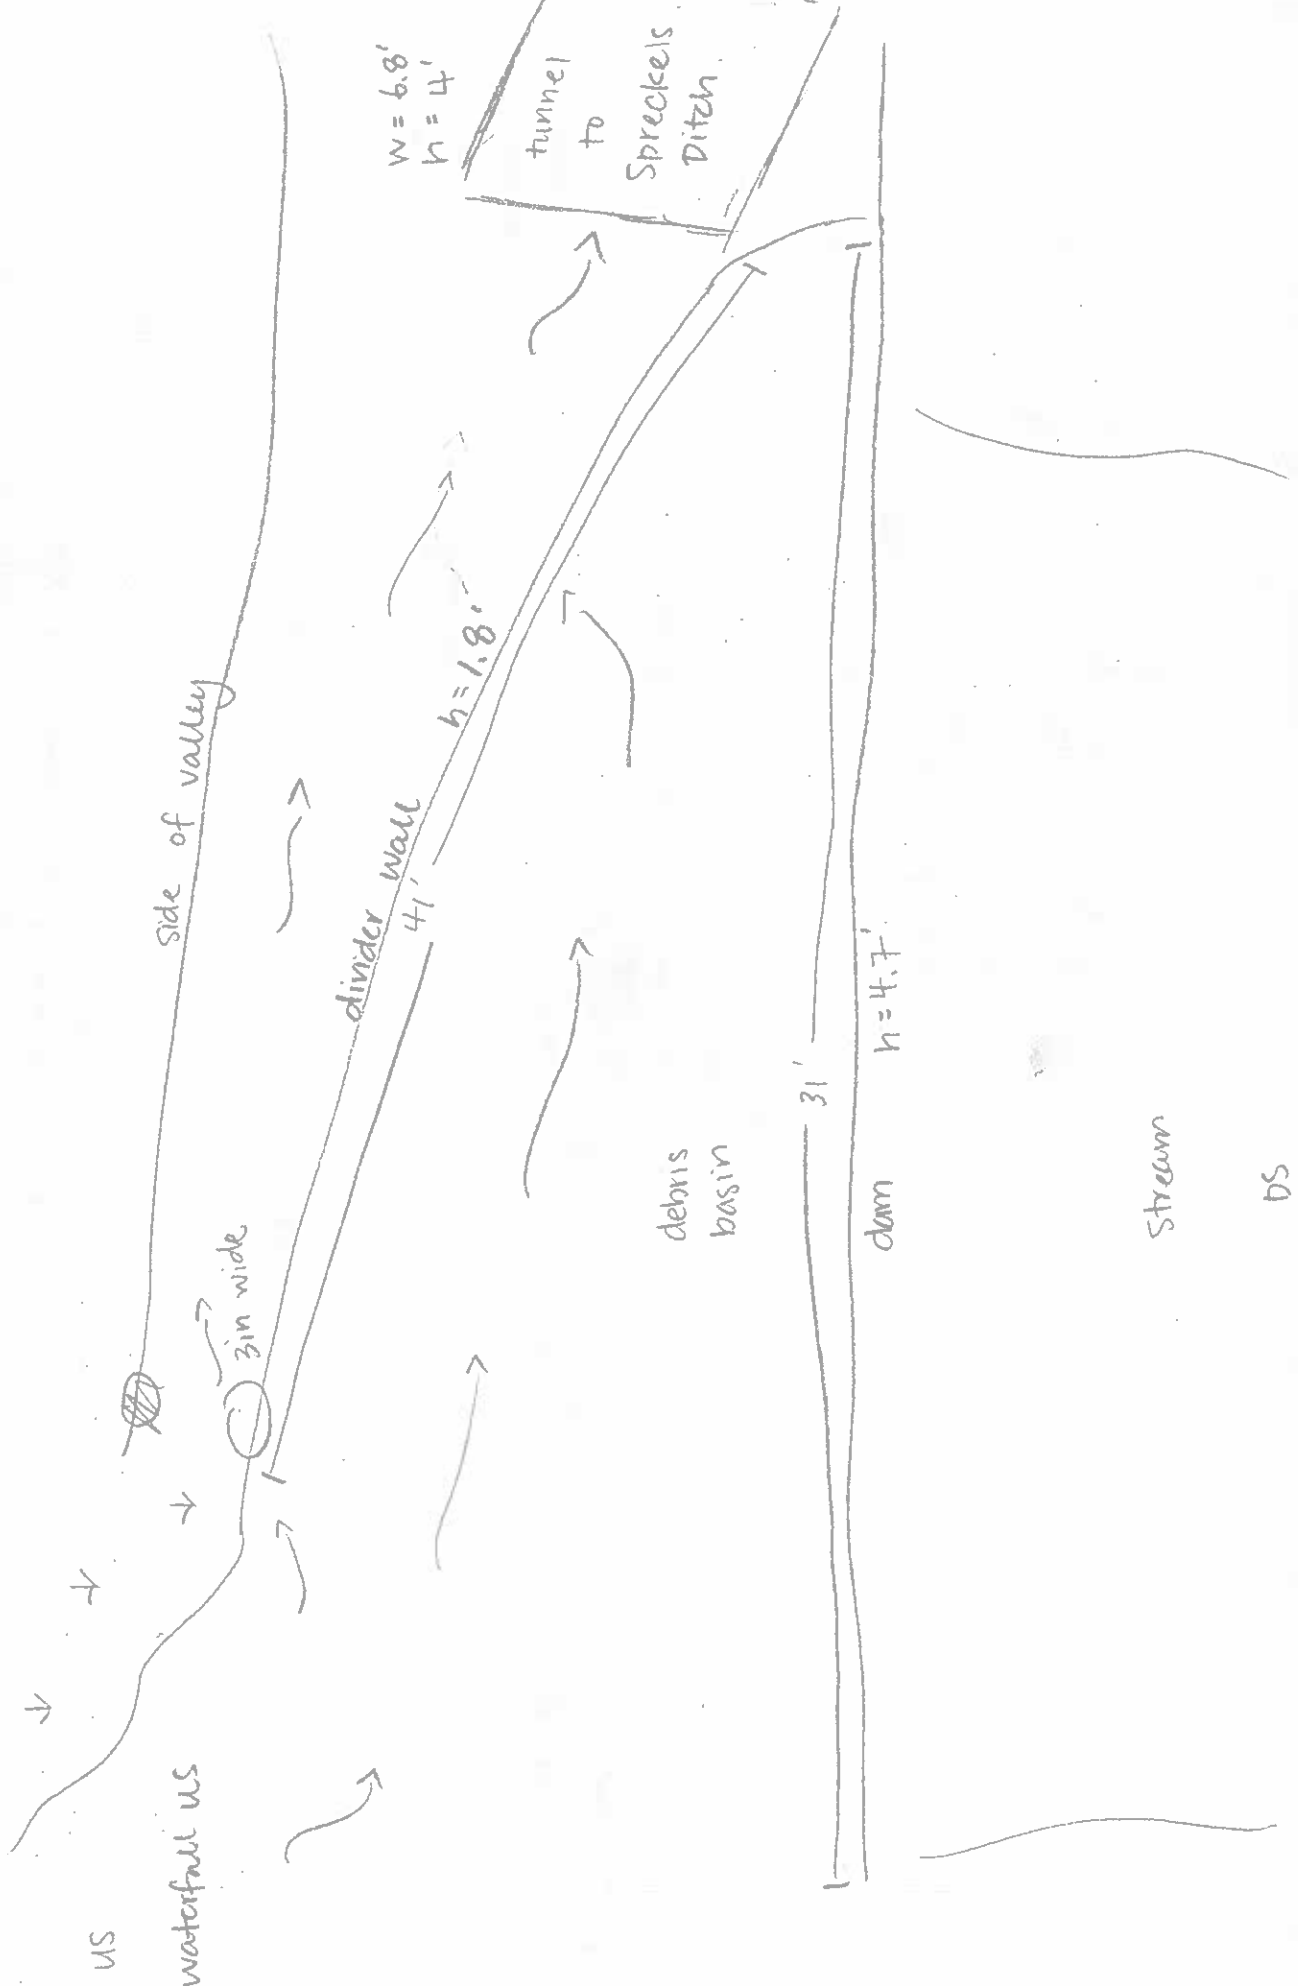
WAIKAMOI (Spreckels Ditch)

- x diverts excess water to Kokea Stream
- x no sluzie gate
- x dry DS
- x no waterfall DS

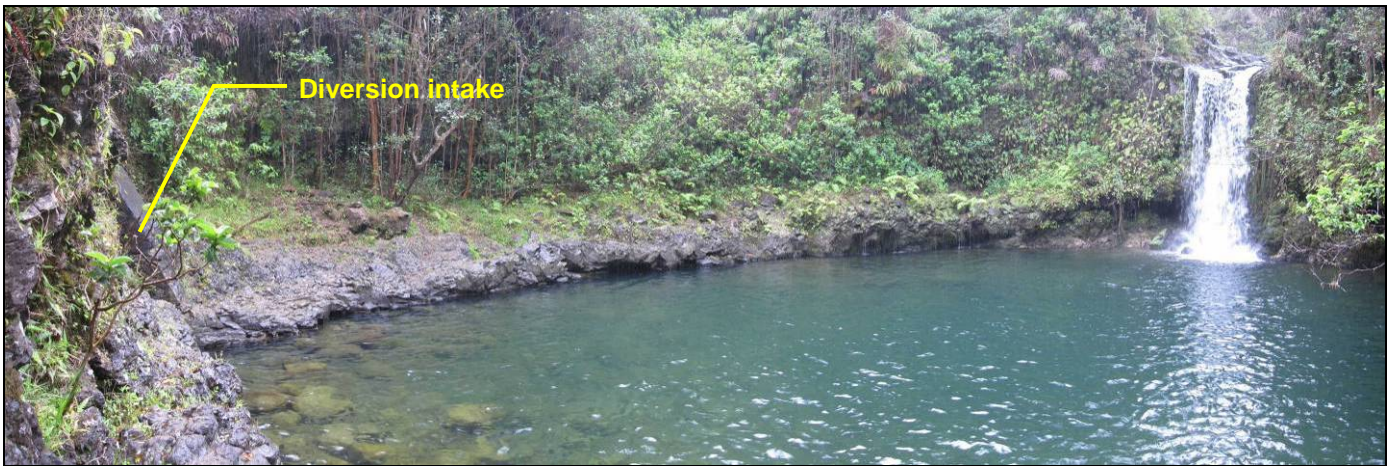
Panoramic view of right bank of Waiohue Stream with waterfall and diversion intake (left), and possible location for bypass pipe installation.
