EXHIBIT S-65 000001

Hoalua Stream Intake  
(retake of D-5)

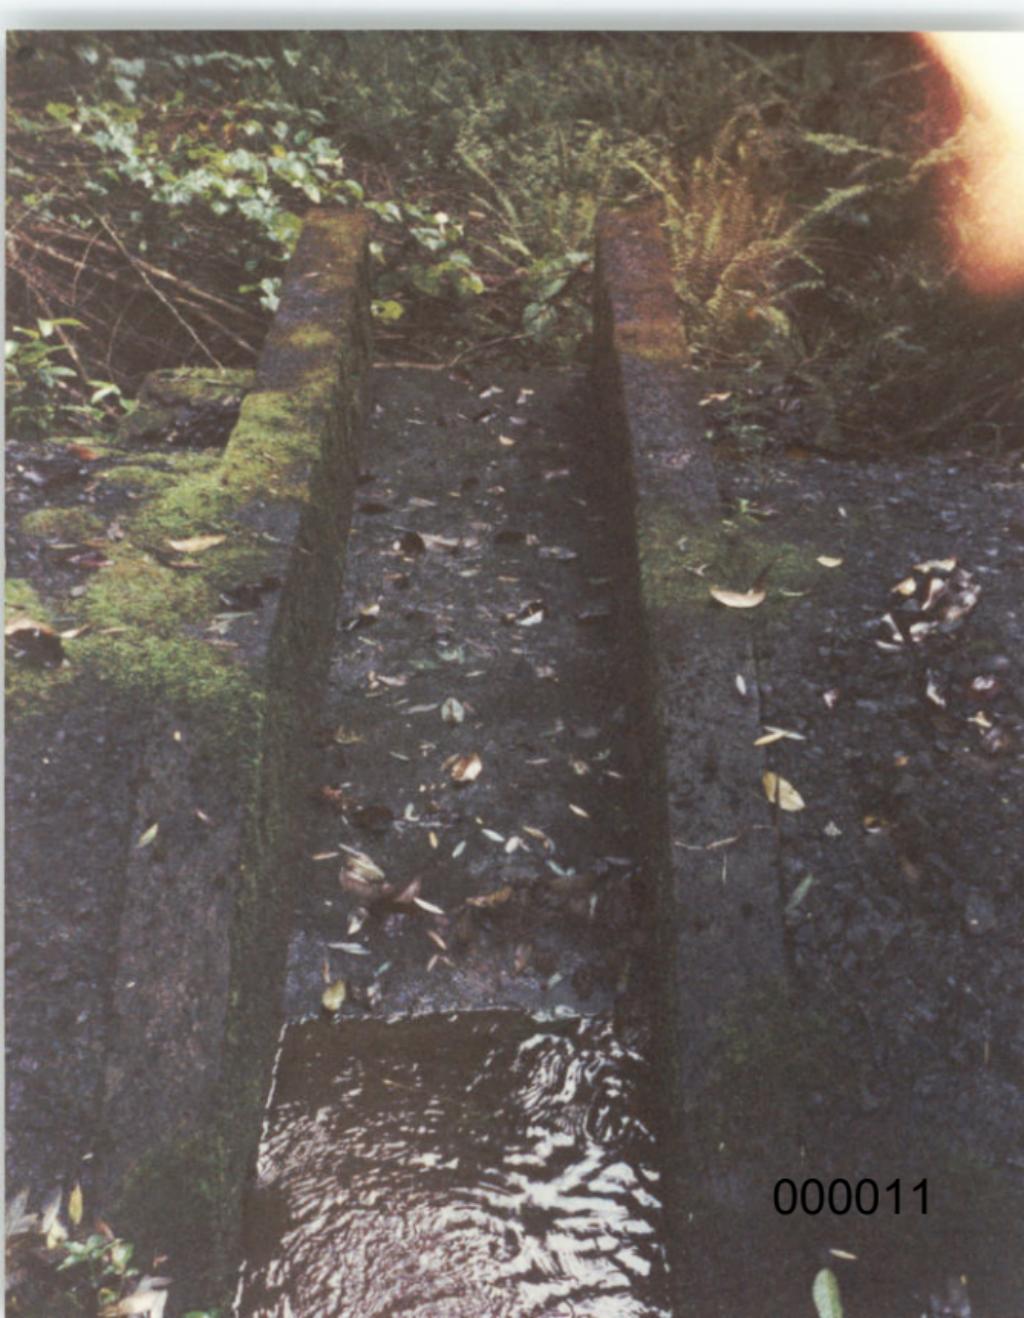
# 0-5 Wailoa Ditch- West Hoalua  
stream small intake  
000012

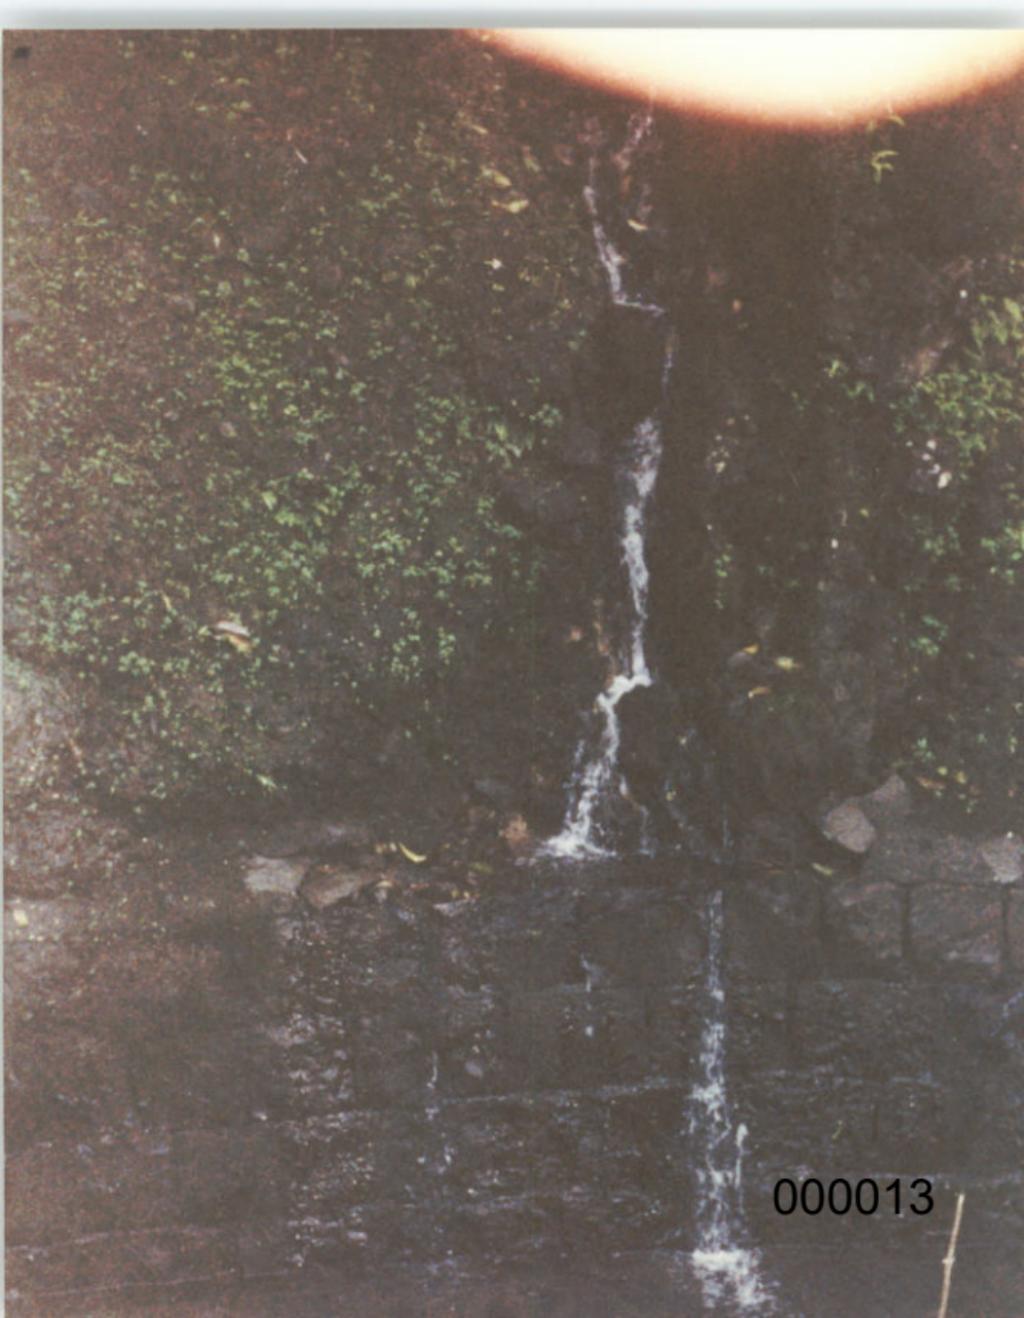
# 0-6 New Hanakau - West Hanakau  
Stream small in lake 000014

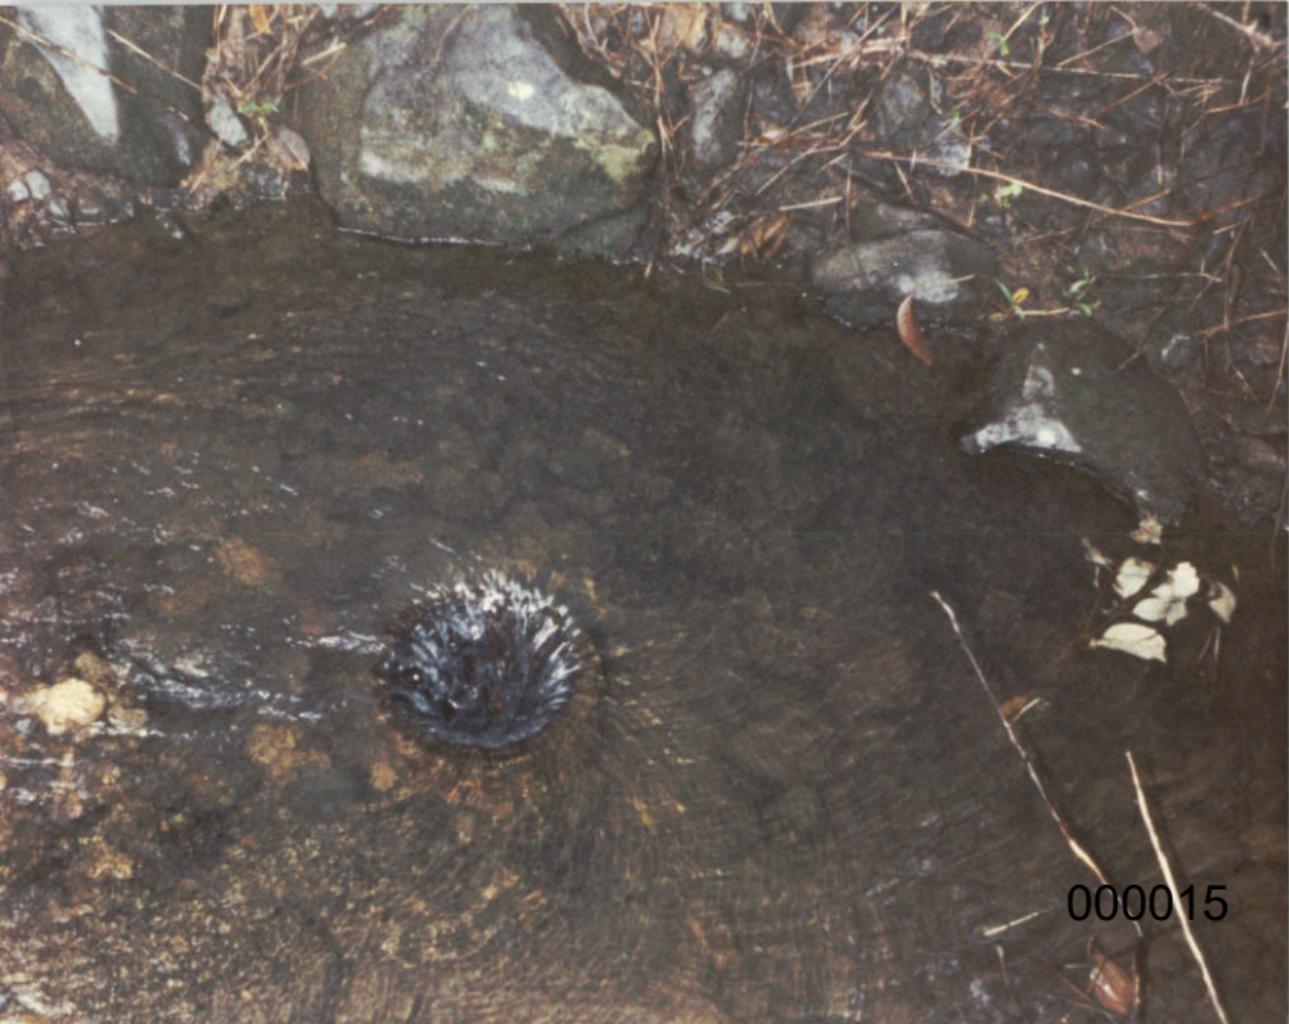
# 0-7 New Hamakua - West Hoalua stream  
small intake (Ephriems i 000016)
