EXHIBIT S-68 000001

Lowrie Ditch - Main
Nailiihaele Stream 000002

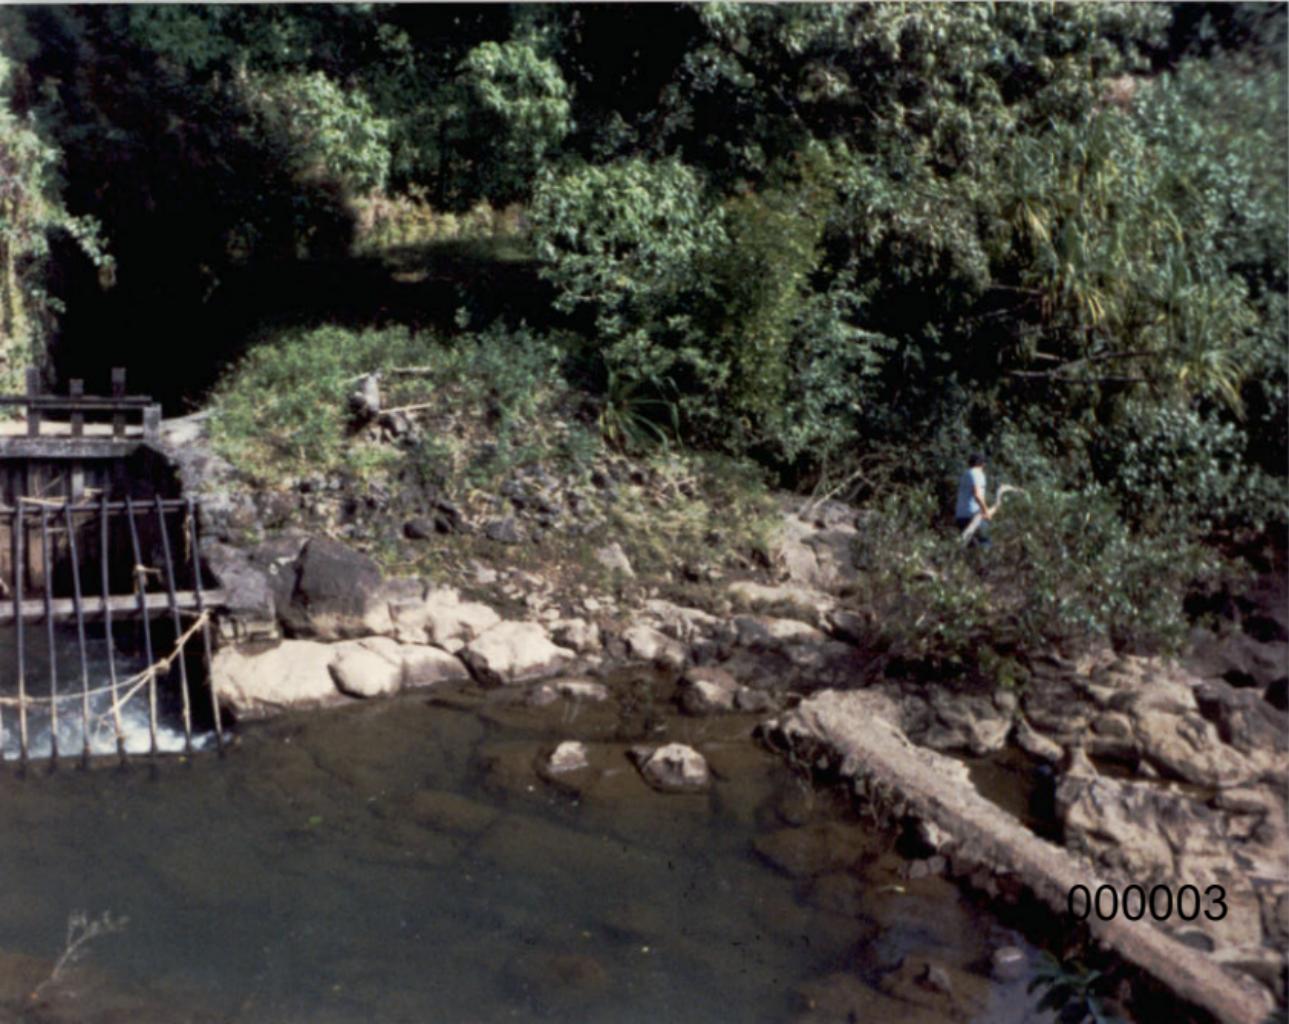
5/4/89
#J-20

Spreckels Feeder Ditch - Main
Alailiihaele Stream intake

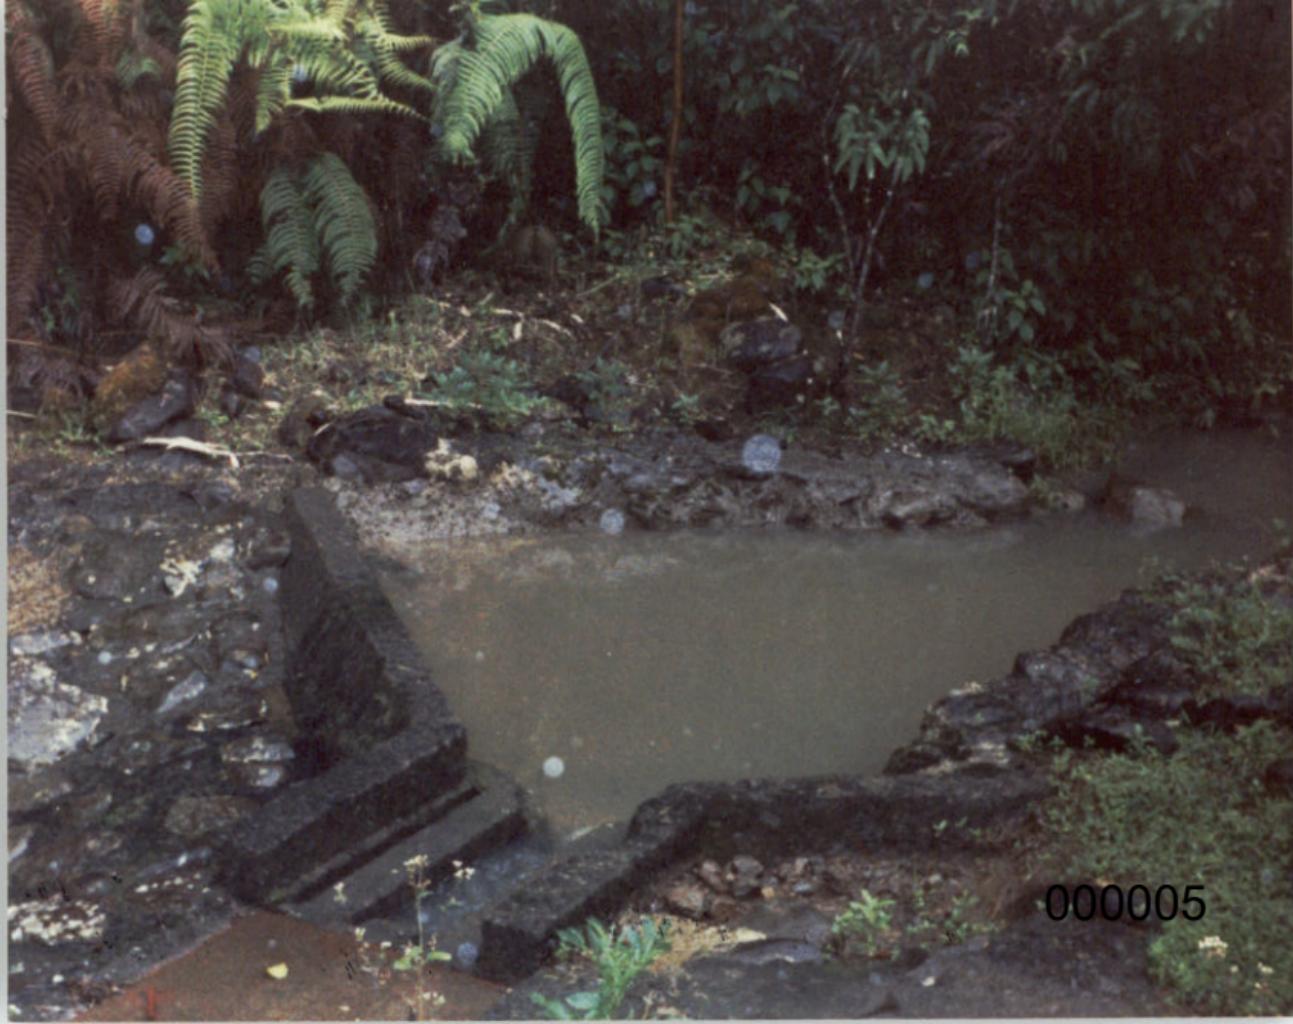
N-5 Wailoa Ditch - Alailii haele
stream - Papaea long intake 000006

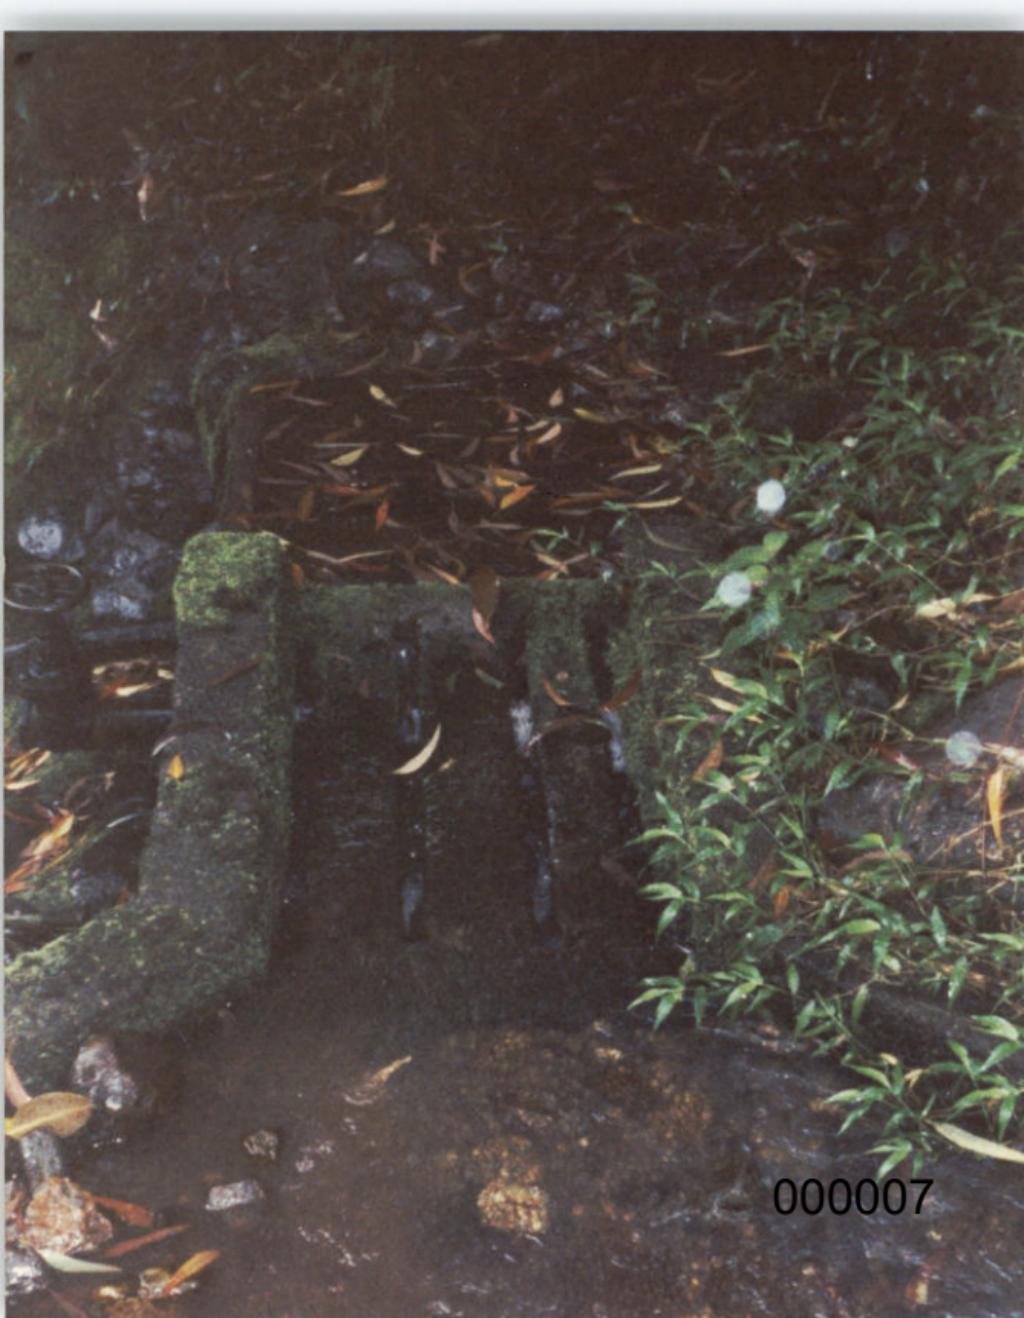
5/9/89
N-6

Waipa Ditch - Naiilihihale
stream - Papaea #3
intake 000008

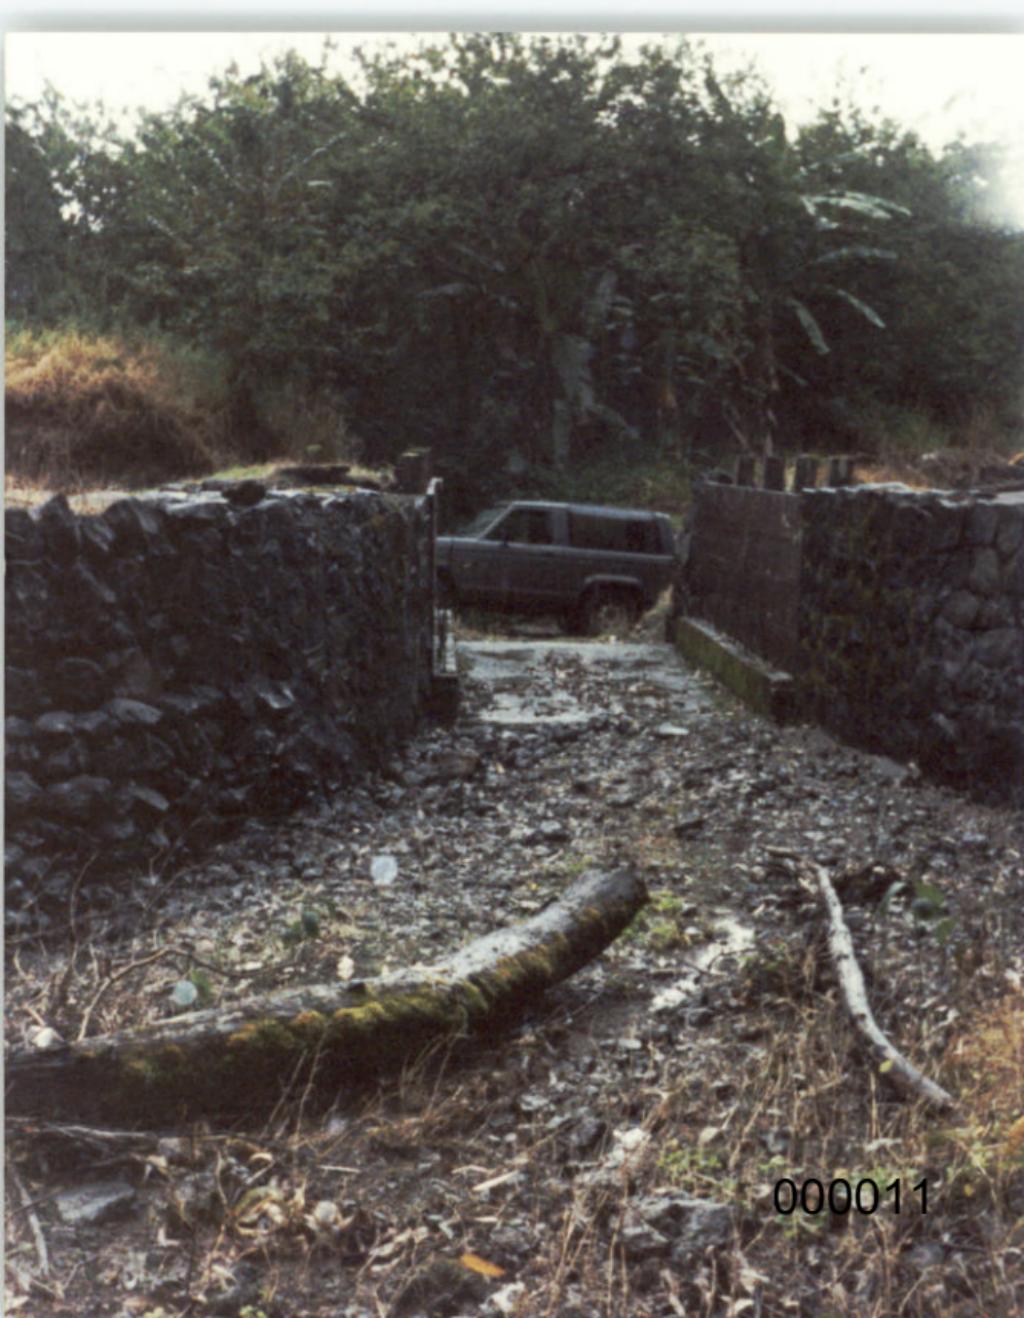
N-8 New Hamakua - Nailiihihae
stream - #2 intake/overpass
000012

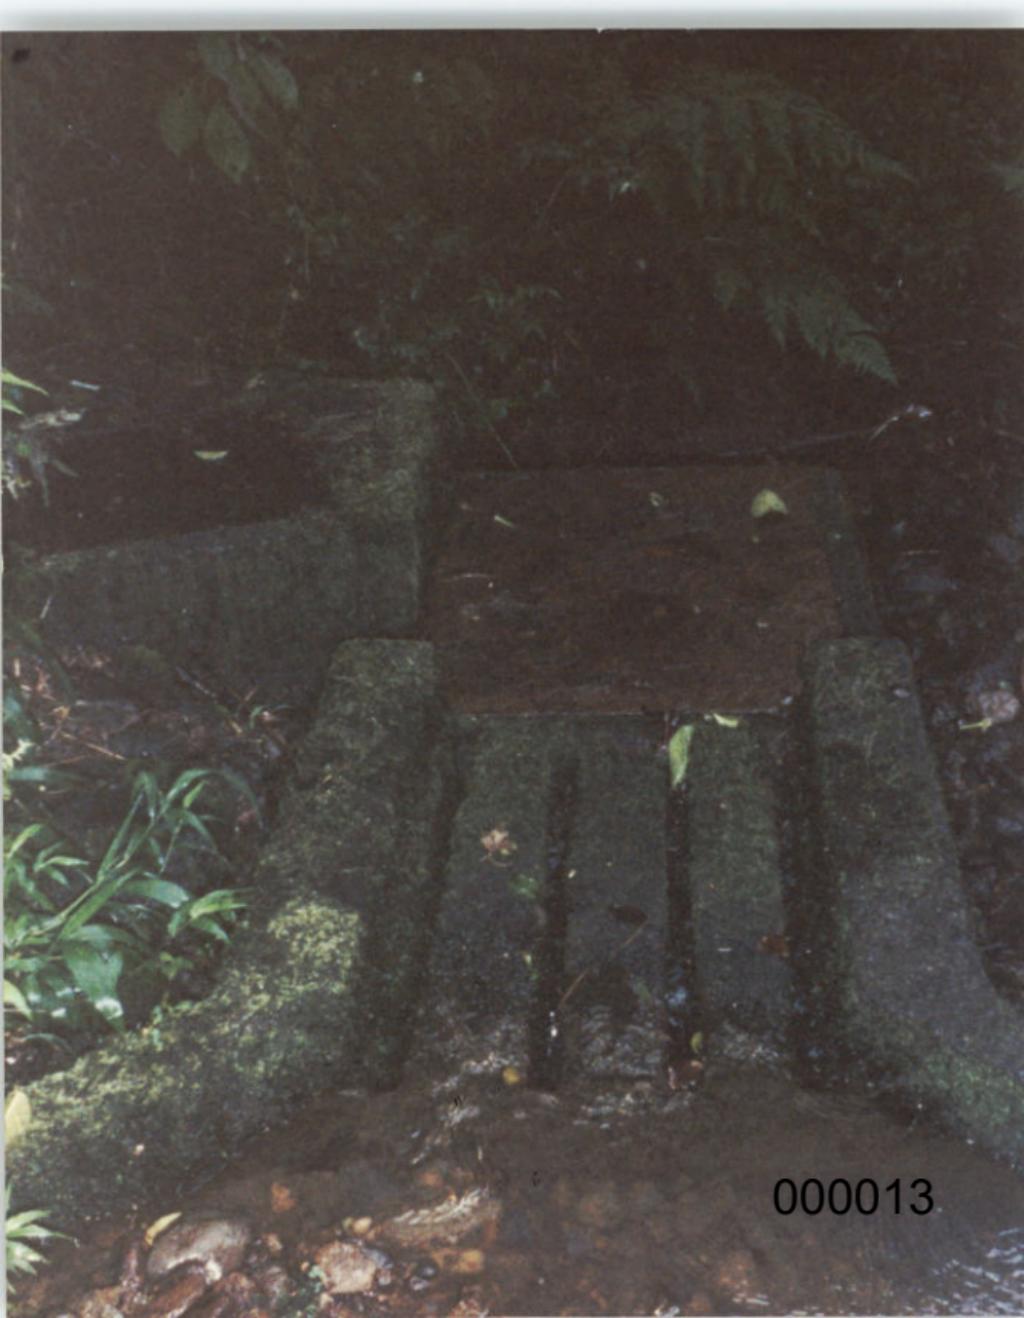
N-9 Wailoa Ditch - Kaiilihihale
stream. Papadea #3 intake 000014

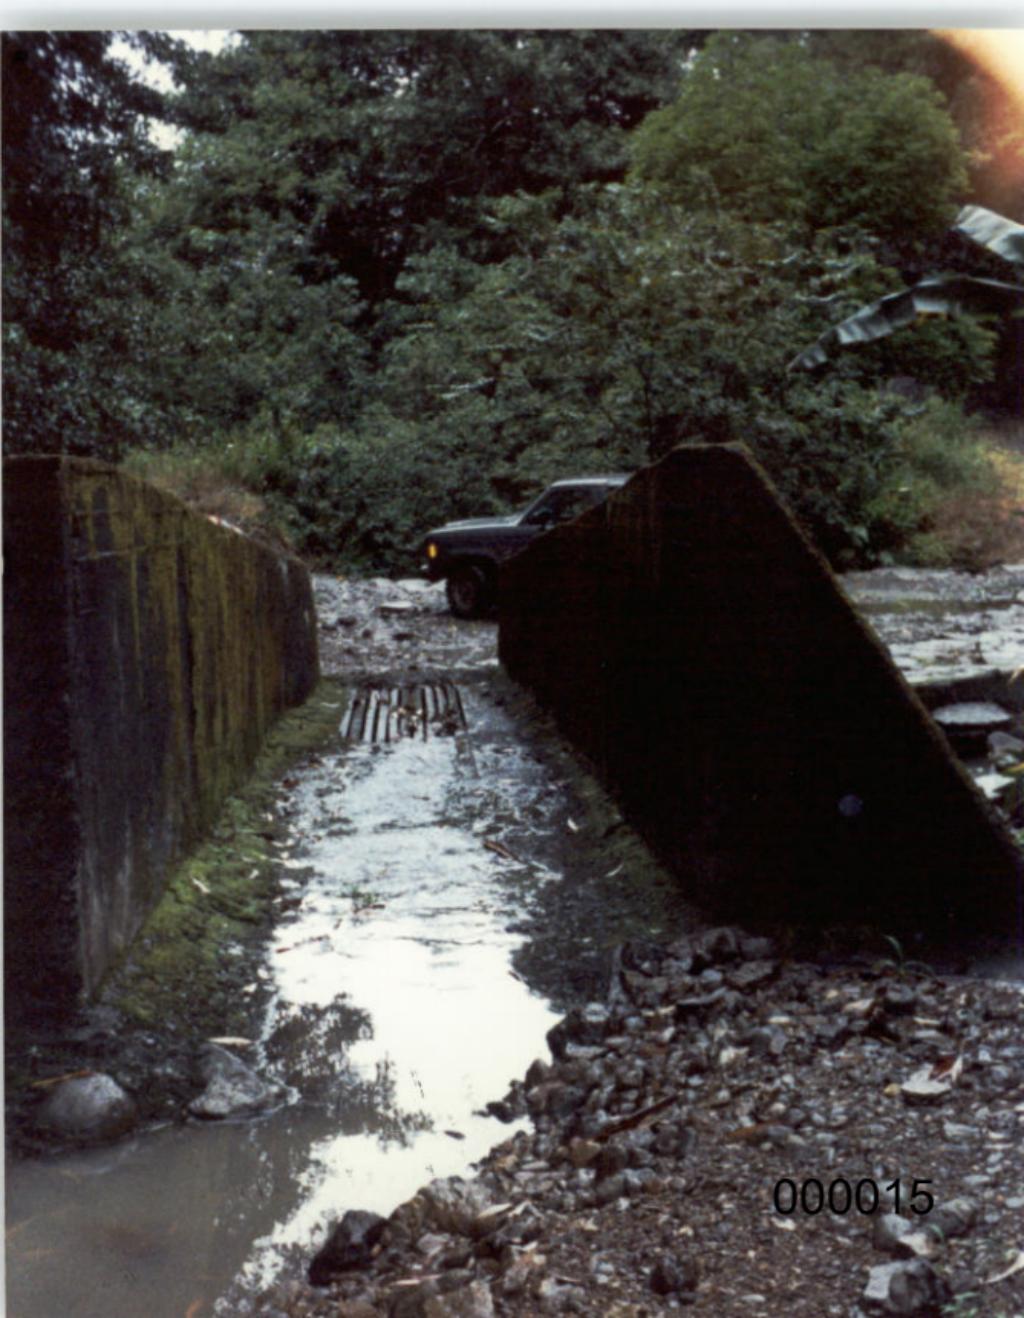
N-10 New Hamakua - Nailiihiwae
stream - Papaea #³000016
intake by control gate

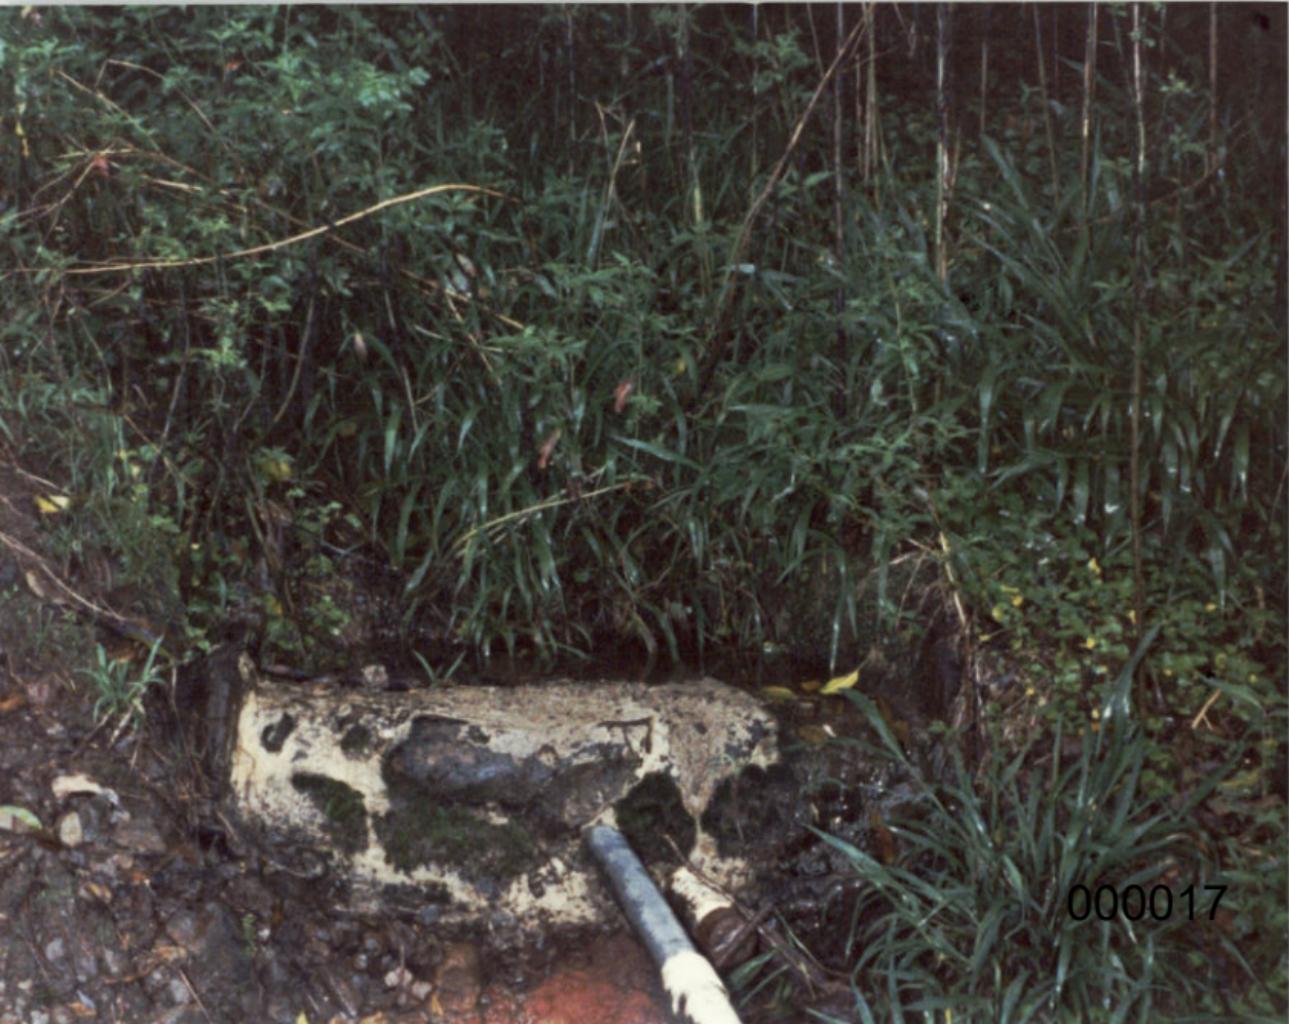
11-11 New Hamakua - Hailihale Stream -
West Papaea 2" pvc pipe intake
000018

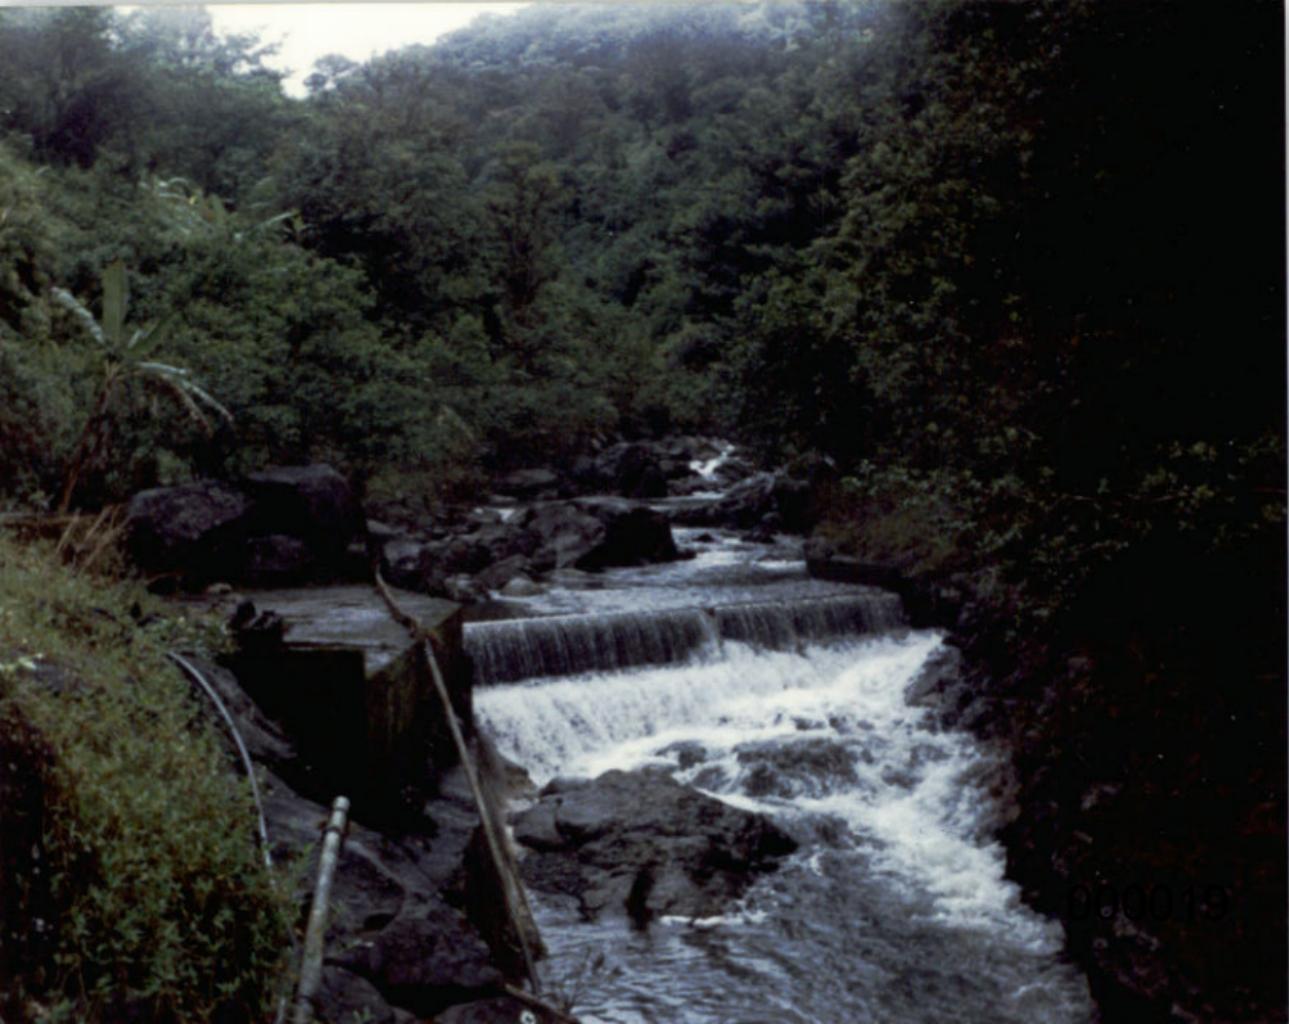
N-12 Wailoa Ditch - Naiilihi Hale stream
main intake

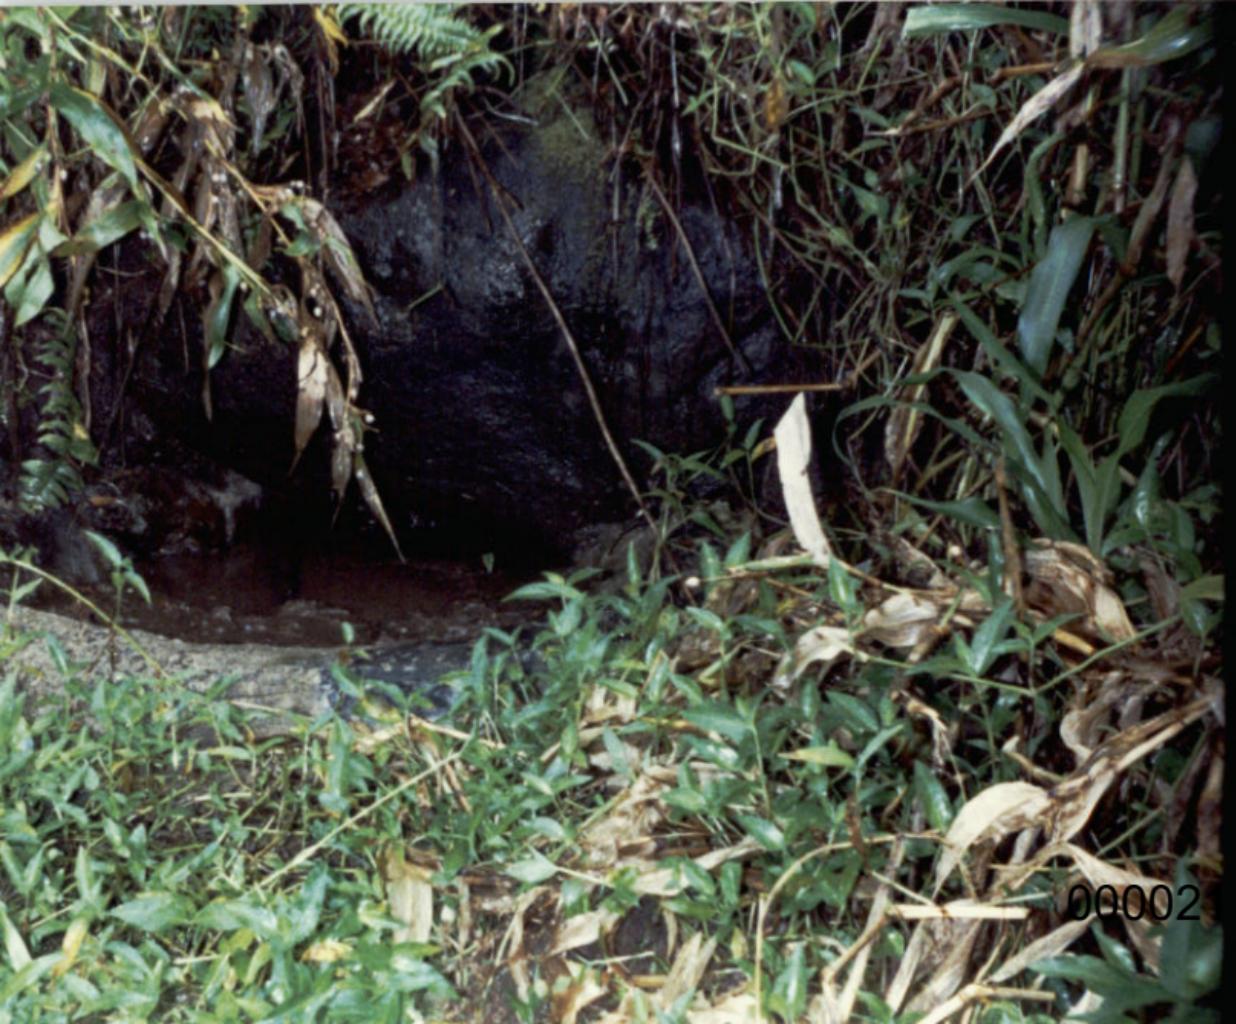
N-13 Wailea Ditch - Kaiilihiwae Stream
1" driscoe pipe intake into overflow
000022

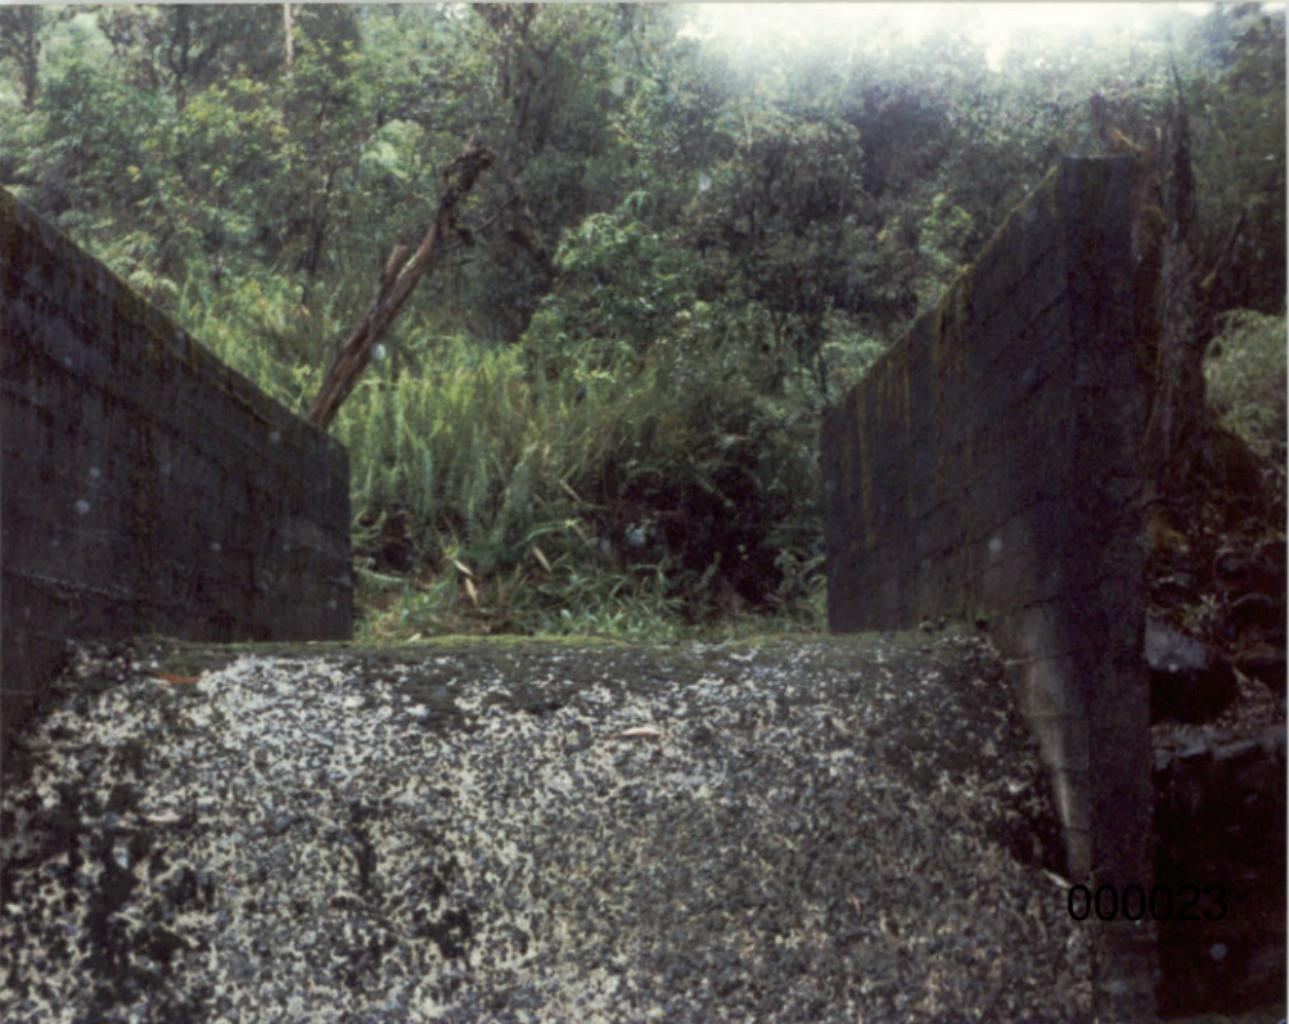
N1-4 New Hamakua - Nailiihaele Stream
Papaaca long intake/overpass
(# 1 intake) 000024

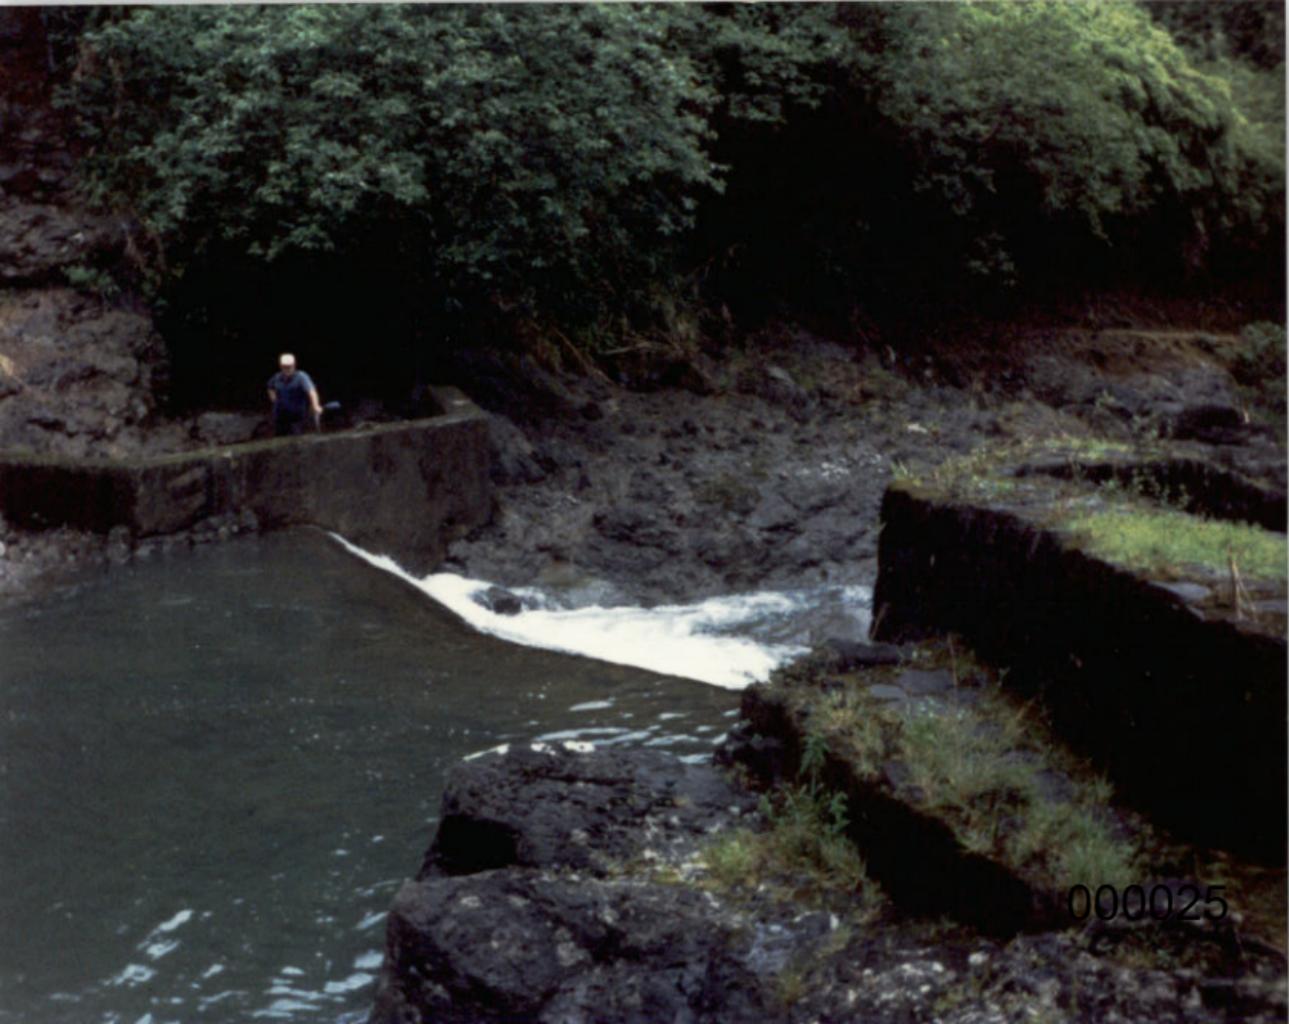
NJ-14 Nea Hamakua - Nailiiilihae
stream main intake 000026

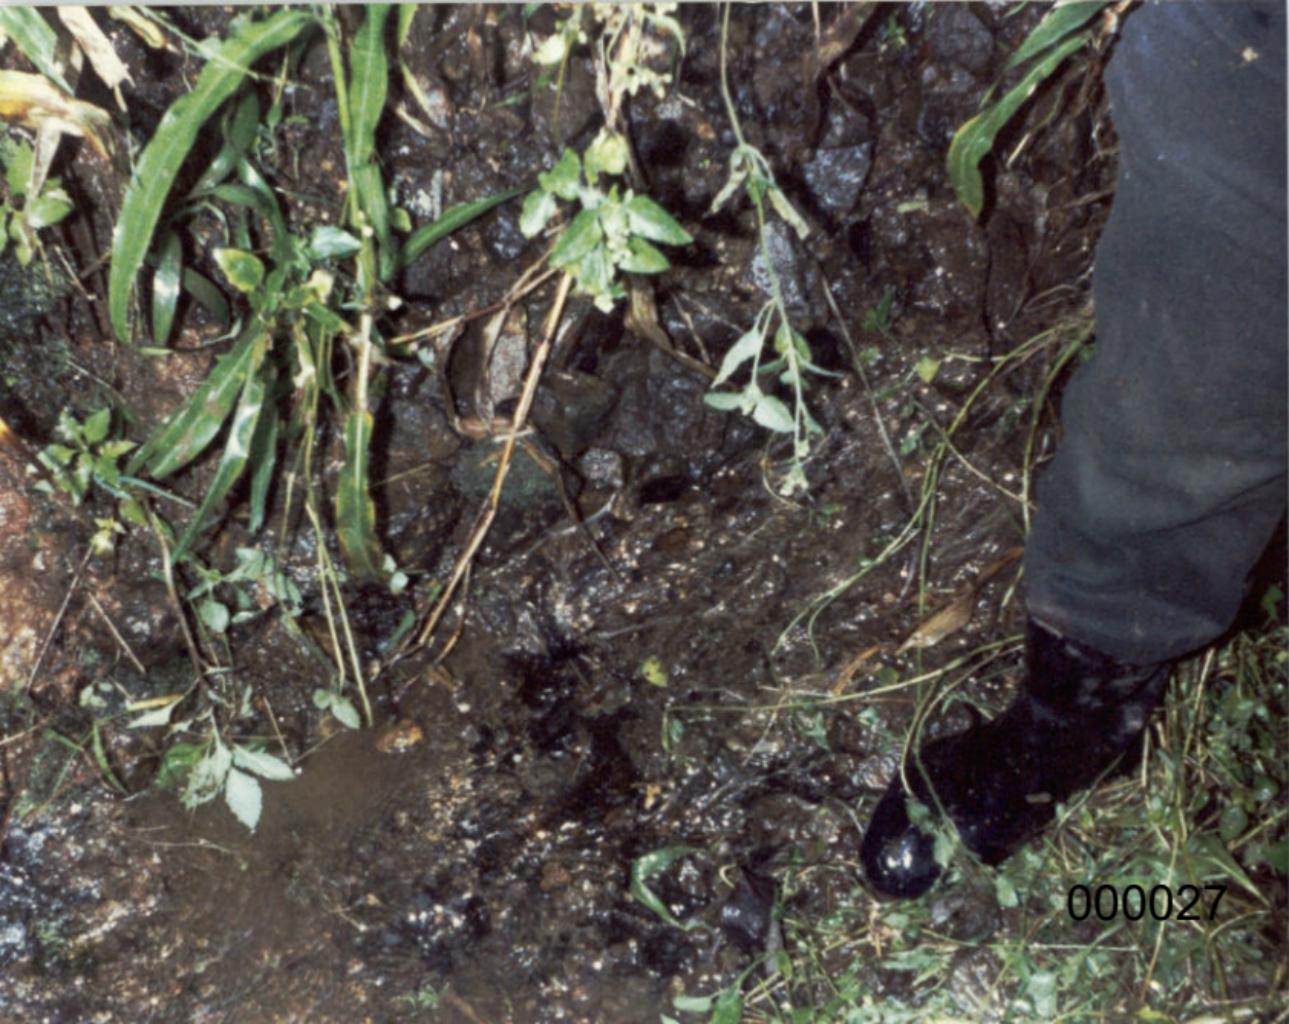
N-16

Wailoa Ditch - West Kailiilihaele
stream siphon puka intake
