WARNING LETTER / REQUEST FOR INFOMATION

Inspections at Waimanalo Gulch Sanitary Landfill Solid Waste Management Permit No. LF-0054-02

INSPECTION REPORT

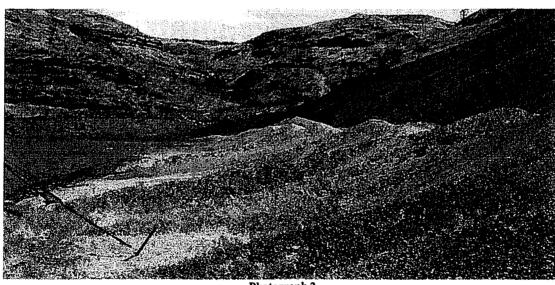
Photograph 2
Waimanalo Gulch Sanitary Landfill and Ash monofill

On May 9, 2008, SWS inspectors observed numerous stockpiles of gravel material to be utilized for the operation layer within MSW Cell E-4. The stockpiles were adjacent to the active workface area (see photograph 2).

Description: Stockpiles of gravel material for the operation layer within MSW Cell E-4.

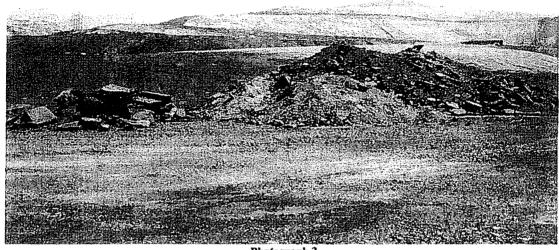
Photograph 3
Waimanalo Gulch Sanitary Landfill and Ash monofill 92-460 Farrington Highway, Kapolei

On May 16, 2008, the inspectors noted approximately 10 cubic yards of asphalt mixed with soil and concrete slabs on the top deck of ash monofill Cell 3 (see photograph 3). According to Justin Lottig, the material is to be used as wet weather material. On May 28, 2008, Mr. Whelan also stated that the material was to be used for wet weather material for the ash monofill area. The inspectors explained to Mr. Whelan that storing of asphalt material and concrete slabs mixed with soil on the top deck of the ash monofill is in violation of **Special Condition - Section D**, **Item 10**, which states: Stockpiled material within the landfill waste boundary shall be limited to cover material on the ash monofill. In addition, the SWS did not receive a written request for this operation, as required by **Special Condition - Section D**, **Item 11**.

On May 16, and May 28, 2008, the inspectors out briefed WMH on findings and potential violations related to the storage of asphalt and concrete slab and non-notification in violation of **Special Condition - Section D**, **Item 10**.

Photographer: Description: Stockpiles of asphalt and concrete material mixed with soil and stored on top of

ash monofill cell 3.

Please provide the volume of stockpiled material containing asphalt, concrete slab mixed with soil, the length of time the material has been stored at the ash monofill Cell-3, and schedule for removal/use of the material.

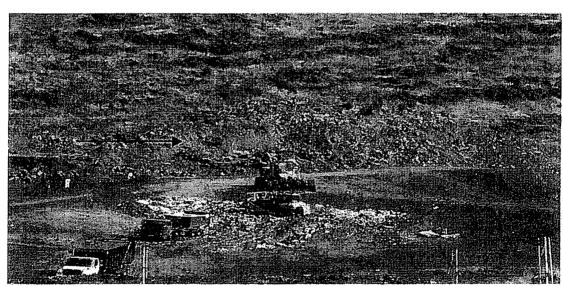
Photograph 4
Waimanalo Gulch Sanitary Landfill and Ash monofill

On May 9, 16, and 28, 2008, the inspectors noted large stockpiles of mixed boulders, rocks and fine-grained material on the top deck of MSW Cell 11 (see photographs 4, 6, 7, and 8). The stockpiles were of excavated material that was quarried during the construction of MSW Cell E-4, and were gradually created on top of MSW Cell 11 during the past year. **Special Condition - Section D, Item 10** limits the temporary storage of stockpiled material within the landfill to cover material, gravel for roads/wet weather, liner, etc.

The SWS did not receive a written request and did not approve the storage of the excavated material on top of MSW Cell 11 in violation of **Special Condition - Section D, Item 11**.

Based on our interviews with WMH staff, the material has been stored in excess of thirty (30) days and the schedule for removal was not provided. SWS staff did not observe any temporary berms or other measures to control stormwater flow in the vicinity of the storage piles. Approximately 50% of the storage piles included a significant quantity of fines and smaller graded material, which may direct surface water runoff from the piles. Approximately 50% of the storage piles included larger pieces of gravel and boulders, which would not shed water and may collect rainwater within the

The black arrow shows a large pile of excavated material that came from MSW Cell E-4 construction and stored on top of MSW Cell 11. The foreground area is

the active workface area for MSW Cell E-4 with a dozer and compactor working

the daily MSW waste.

Please provide the approximate volume of excavated material stored at MSW Cell11, the length of time the material has been stored on site, and schedule for removal/use of the material.

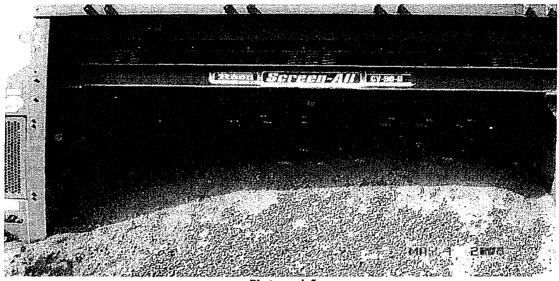
Photograph 5

On May 9, 16, and 28, 2008, the inspectors noted a screener (Read Screen-All, model CV-90-D) on the top deck of MSW Cell 10, and according to Justin Lottig, EPM for WMH, Goodfellow Brothers Inc. (Goodfellow), is currently processing the soil-rock / boulder stockpiles and utilizing the screened gravel material for the operation layer (see photograph 5). According to WMH, Goodfellow plans to process all of the material on site and use it at the facility for various projects within the landfill. The SWS did not receive a written request for this operation, as required by **Special Conditions** - **Section D, Item 11**.

Screen-All, Model CV-90-D being utilized to screen material from the stockpile

located on MSW Cell 10 &11 for the operation layer in Cell E-4.

If WMH plans to continue with the temporary storage and screening of excavated material at MSW Cell 11, please submit a written request as specified in the facility's permit with all specific requirements.

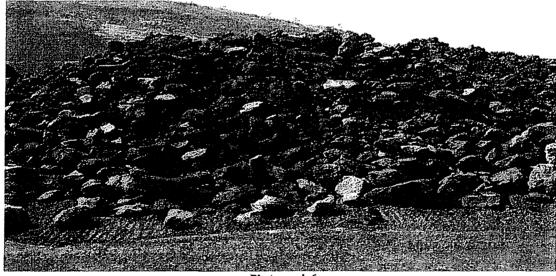
Photograph 6
Waimanalo Gulch Sanitary Landfill and Ash monofill

View of a large stockpile of sorted rocks and boulders stored on MSW Cell 11.

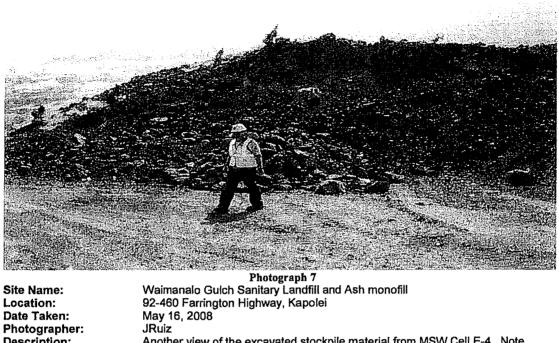
Another view of the excavated stockpile material from MSW Cell E-4. Note

vegetative growth on the stockpile.

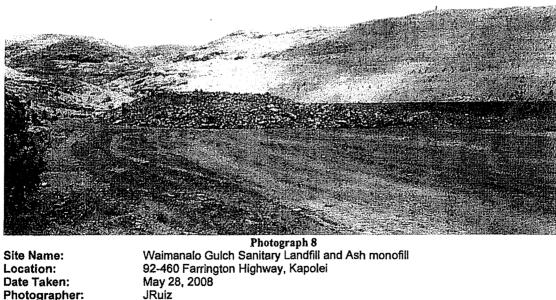
View of the excavated stockpile material removed from MSW Cell E-4, looking

from the south of MSW Cell 10.
