Environmental Summary Report
Kapolei Harborside Center
Former Hawaiian Western Steel Waste Pile
Malakole Road Parcel North of Chevron Refinery
Kapolei, Hawaii

July 6, 2006 005-11083-00

LFR Inc. 220 South King Street, Suite 1290 Honolulu, Hawaii 96813

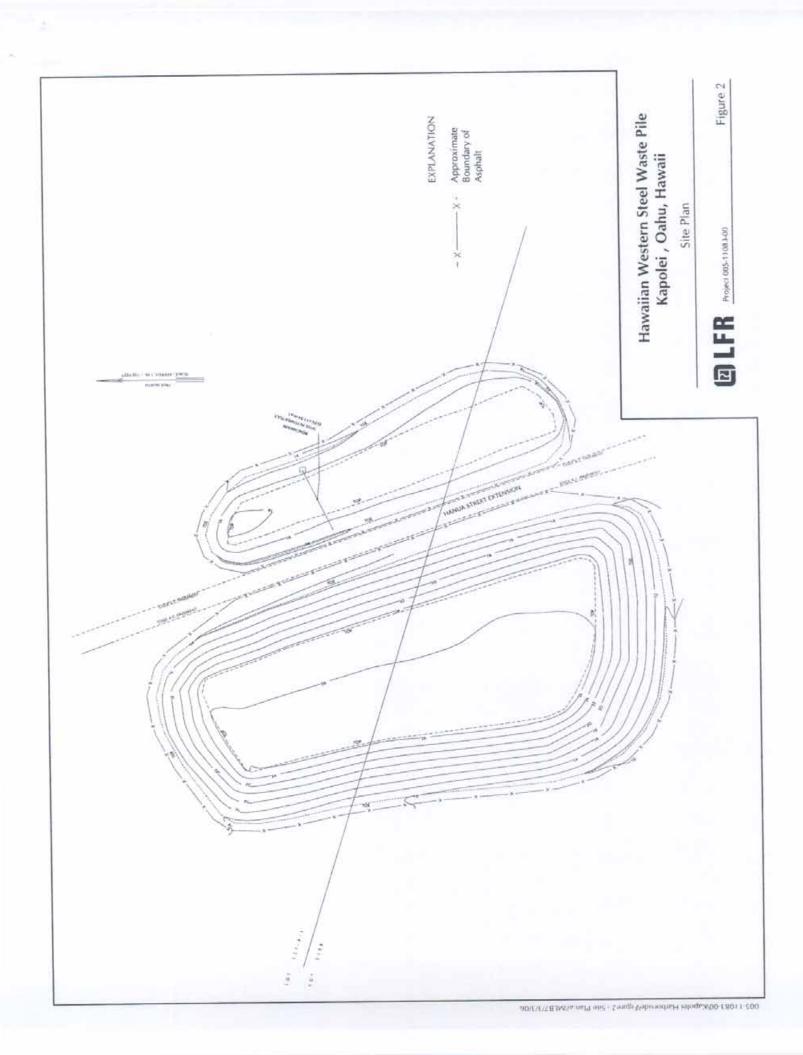
The HWS waste pile is located on an approximately 6.5 acre parcel of land within the Campbell Industrial Park, Kapolei, Oahu, Hawaii (Figure 2). The waste pile is associated with the Former Hawaiian Western Steel facility and is located one mile north of the HWS plant site (91-150 Hanua Street), just north of Malokole Road. The Waste Pile is bounded by the remnants of a large coral pile to the west and a wholesale nursery to the east. Hanua Street Extension, providing access to the Grace Pacific rock quarry to the north, bisects the Waste Pile. Historical information related to waste disposal activities at the waste pile and previous environmental investigations is presented below in Section 3.0.

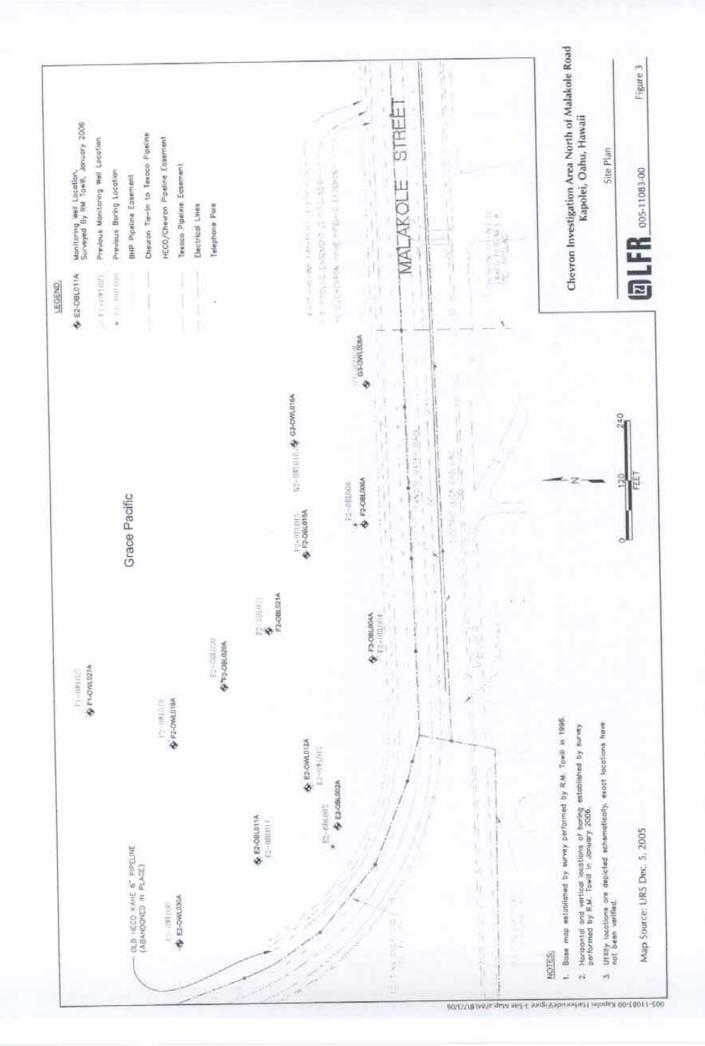
The area located on the north side of Malakole Road, adjacent to the Chevron Refinery, occupies approximately 25 acres within TMK Parcel 9-1-014:033 (Figure 3). TMK Parcel 9-1-014:033 is owned by the Estate of James Campbell (Campbell Estate) and encompasses an area of approximately 137 acres. The parcel is leased by Grace Pacific for use as a sand and gravel storage area, and by Hawaiian Earth Products, Ltd. for use as a green waste composting facility. A pipeline corridor is also located along the Malakole side of the parcel with pipelines owned and operated by Tesoro, Chevron, and Hawaiian Electric Company (HECO) (D&M 1997a). Historical information related to previous releases and environmental investigations conducted in the area north of Malakole Road is presented below in Section 4.0.
