Project No. 02-6011

September 2006

Photographic Documentation
Additional Subsurface Investigation
750 Fraser Avenue
Lanai City, Lanai, Hawaii

**Additional Subsurface Investigation
Lanai Power Plant
750 Fraser Avenue
Facility ID No. 9-400773
Release ID No. 030016**

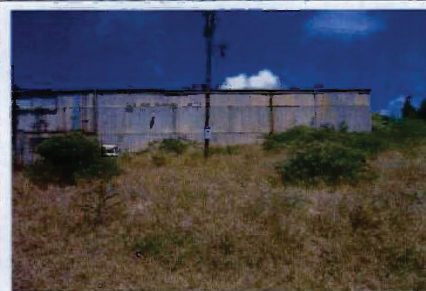
Photograph #1: View of former UST excavation area and soil stockpile area.

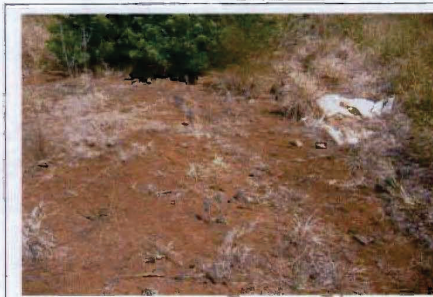
Photograph #2: View of soil stockpile.

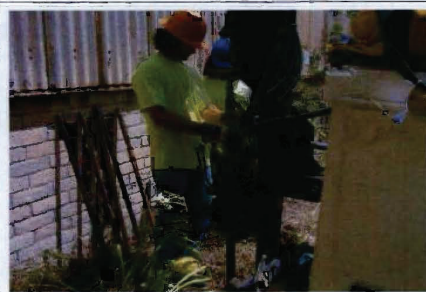
Photograph #3: ESN personnel using direct push technology to advance soil borings.
