January 26, 2011

Waste Management of Hawaii  
Waimanalo Gulch Sanitary Landfill  
92-460 Farrington Highway  
Kapolei, Hawai'i 96707

Subject: Liner Damage Assessment and Construction Quality Assurance Report for Cell E-6 and E-4 Repairs, Waimanalo Gulch Sanitary Landfill, Kapolei, HI

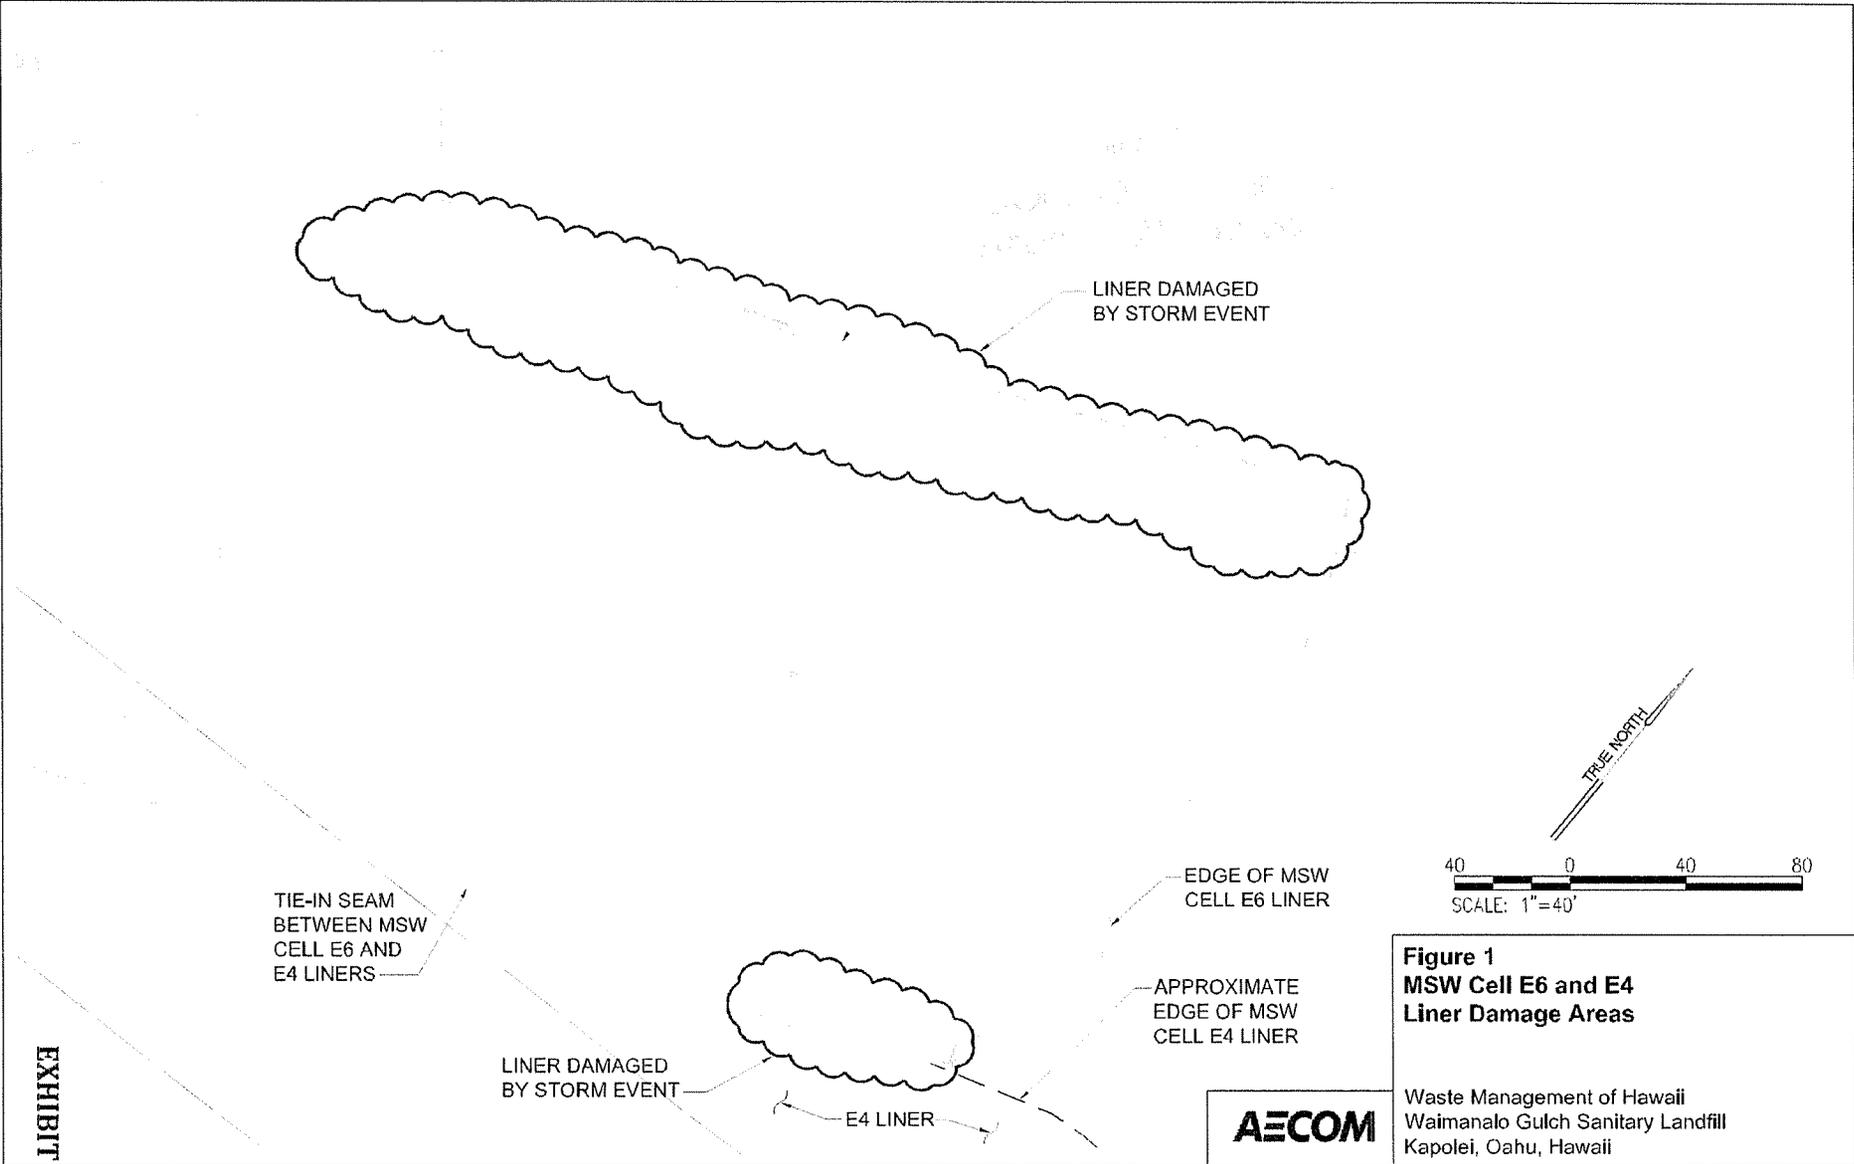
**Figure 1**  
**MSW Cell E6 and E4**  
**Liner Damage Areas**

In late December 2010, a series of storms produced high runoff resulting in damage to the northwestern (up-canyon) edge of the floor MSW Cell E6 liner system where it joins with MSW Cell E4. In early January, work began to expose the edge of liner to observe the extent of damage. However, before this work could be completed, a large storm arrived on evening of January 12, 2011 that resulted in severe flooding of the landfill and caused additional damage to this area as well as to the exposed western slope of the Cell E6 liner area. The damaged areas are shown on Figure 1, in Attachment 1. Photos of the damaged areas are presented in Attachment 2.

This letter report focuses on the damage to the edge of the liner system where MSW Cell E6 joins with E4. It is our understanding that the damaged western slope area of Cell E6 will be investigated at a later date. The high flows and sloping topography in the area at the Cell E6/E4 tie-in resulted in erosion and exposure of the leading edge of the liner. The high flows caused the leading edge to fold upward allowing rocks and debris to accumulate on top and underneath both Cell E6 and E4 liners, as well as tearing the composite liner in multiple locations.

Due to obvious liner damage to the western slope of MSW Cell E6, future MSW placement operations should be kept at least 50 ft away from this slope area to allow liner repair work to be completed.

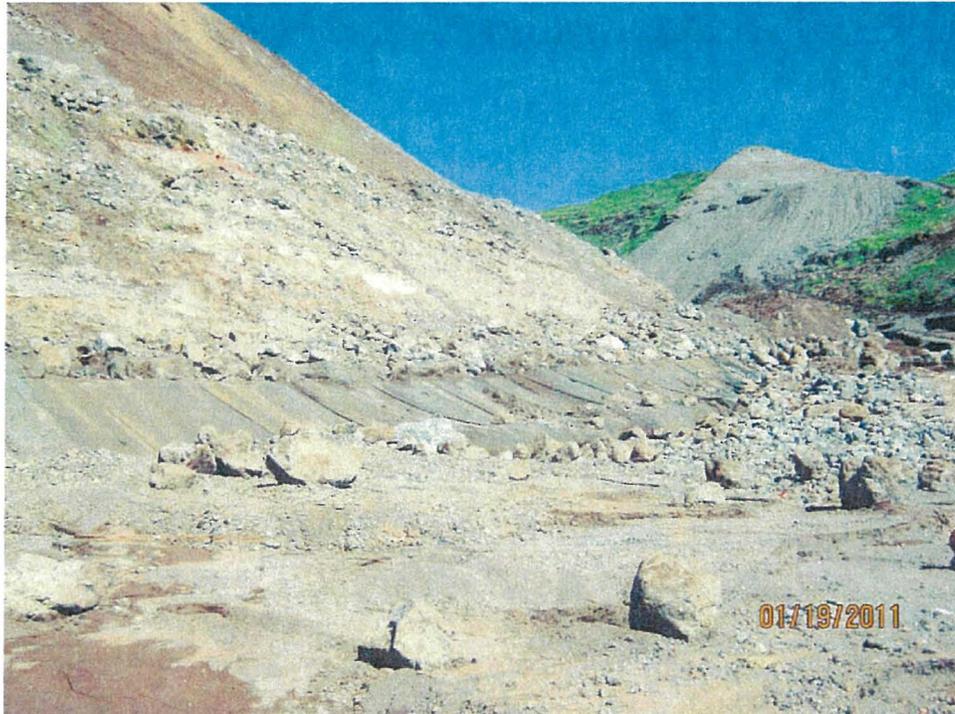
Photo 1. Storm damage to Cell E6, western slope.

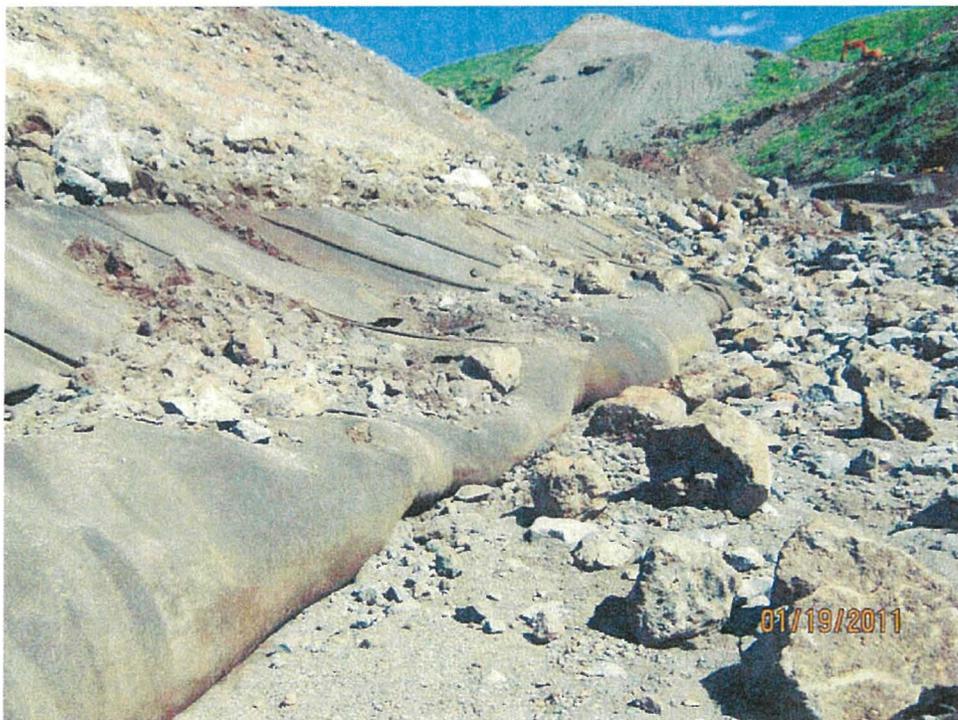
Photo 2. Storm damage to Cell E6, western slope, close-up.

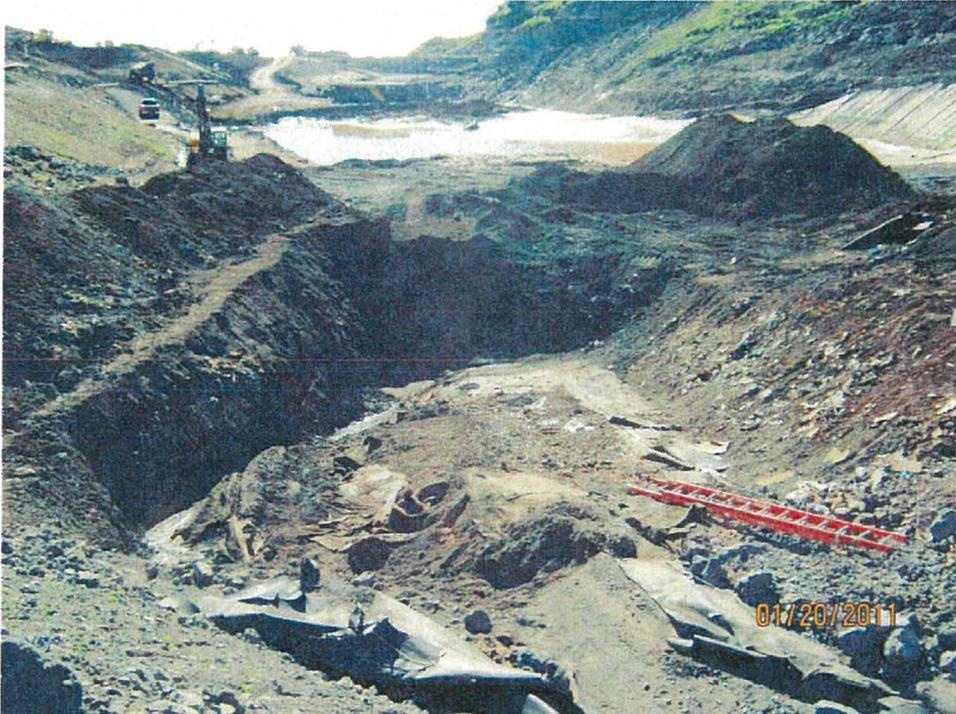
Photo 3. Storm damage, Cell E6/E4 tie-in, looking southwest.

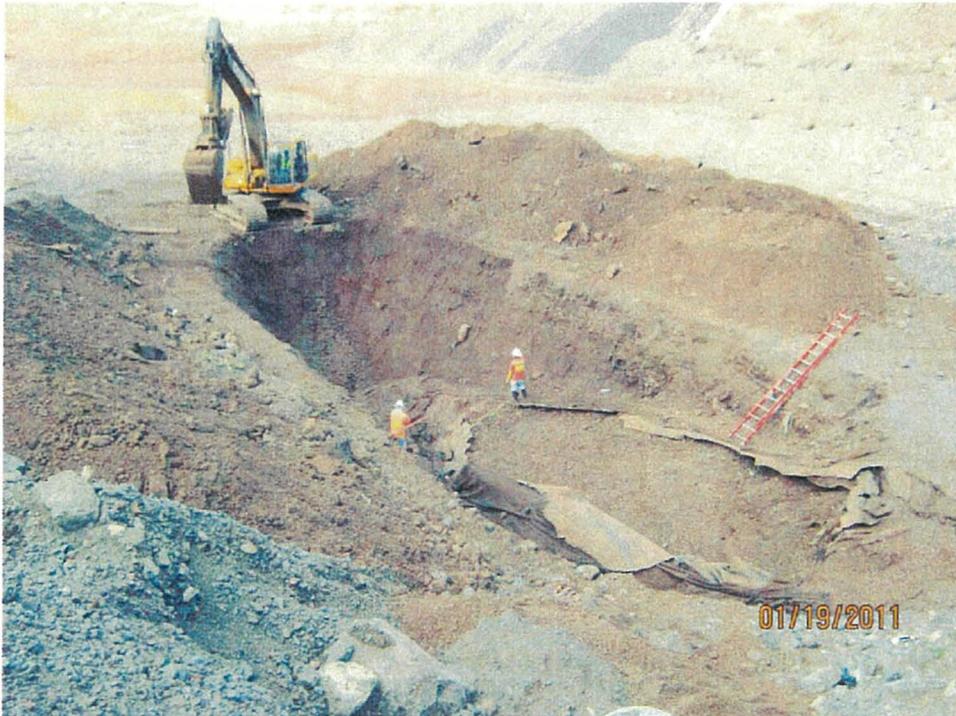
Photo 4. Storm damage, Cell E6/E4 tie-in, looking west.

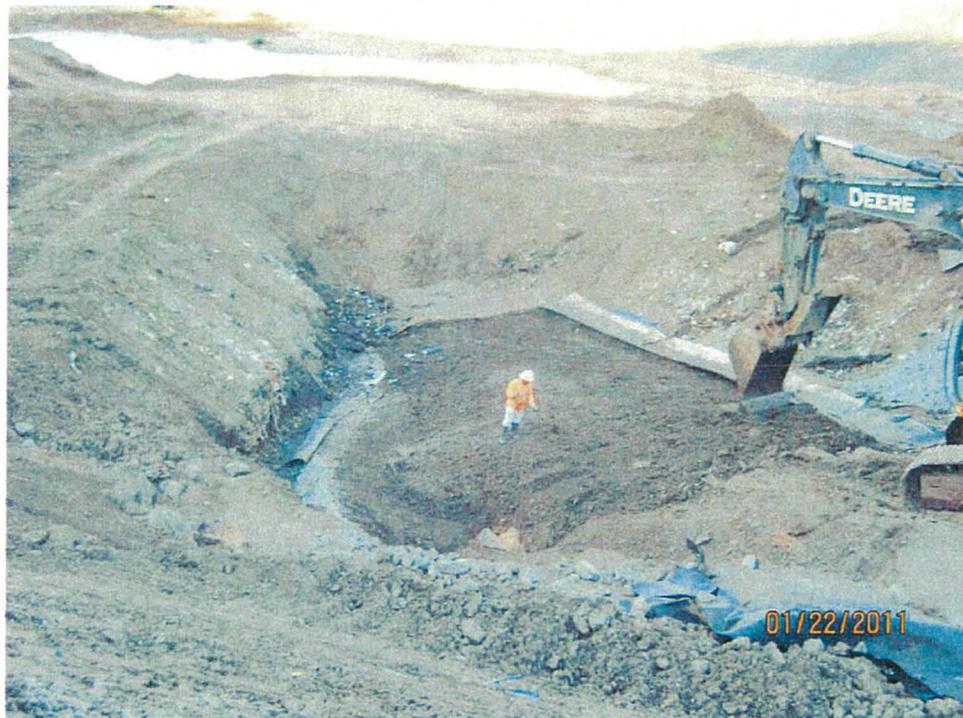
Photo 5. Clearing rocks from Cell E6/E4 tie-in subgrade.

Liner materials were removed to expose subgrade areas where gravel and rocks had been washed beneath the liner from the flooding. The loose gravel and rocks were removed using an excavator as well as hand labor to expose the underlying cushion soil. A thin layer (2 to 6 inches) of soil cushion material was then placed throughout the subgrade area using an excavator to fill in uneven areas. The soil cushion material was then compacted using a hand-held vibrator plate compactor to create a relatively smooth, unyielding surface, with no protrusions exceeding 3/8-inch. A subgrade acceptance form was completed as required by the project specifications and is presented in Attachment 5.

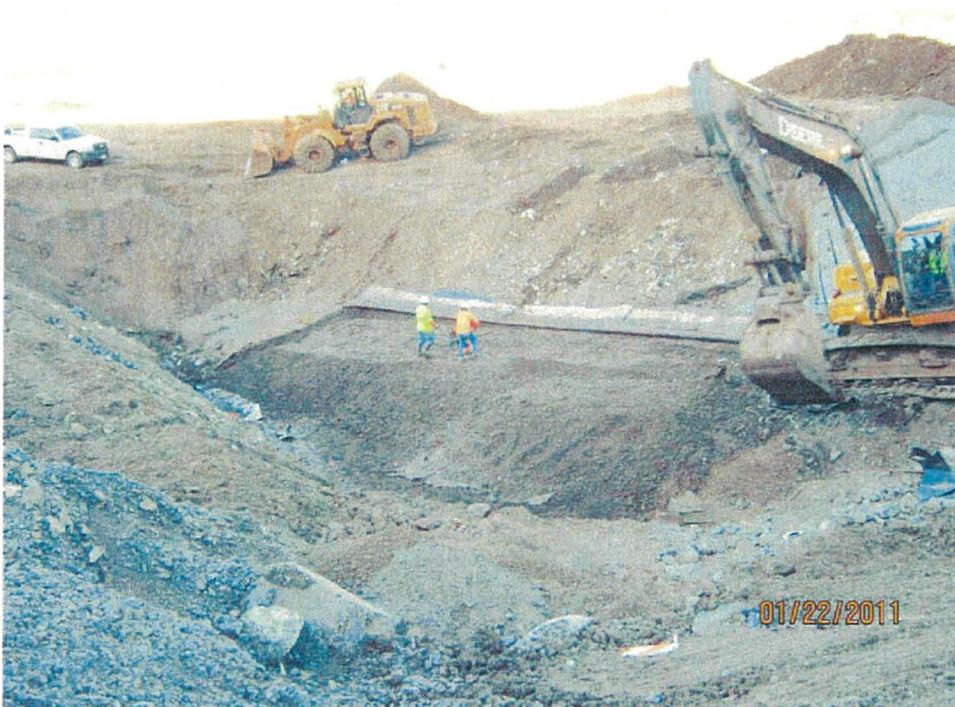
Photo 6. Cell E6/E4 tie-in, subgrade preparation.

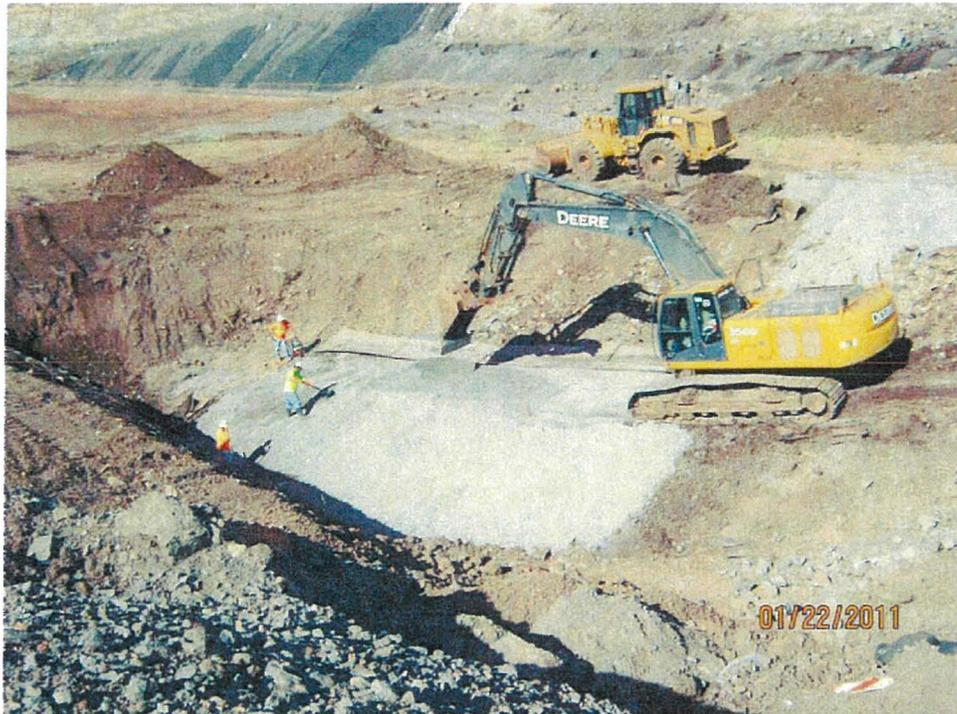
Photo 7. Placement of soil cushion material for liner subgrade.

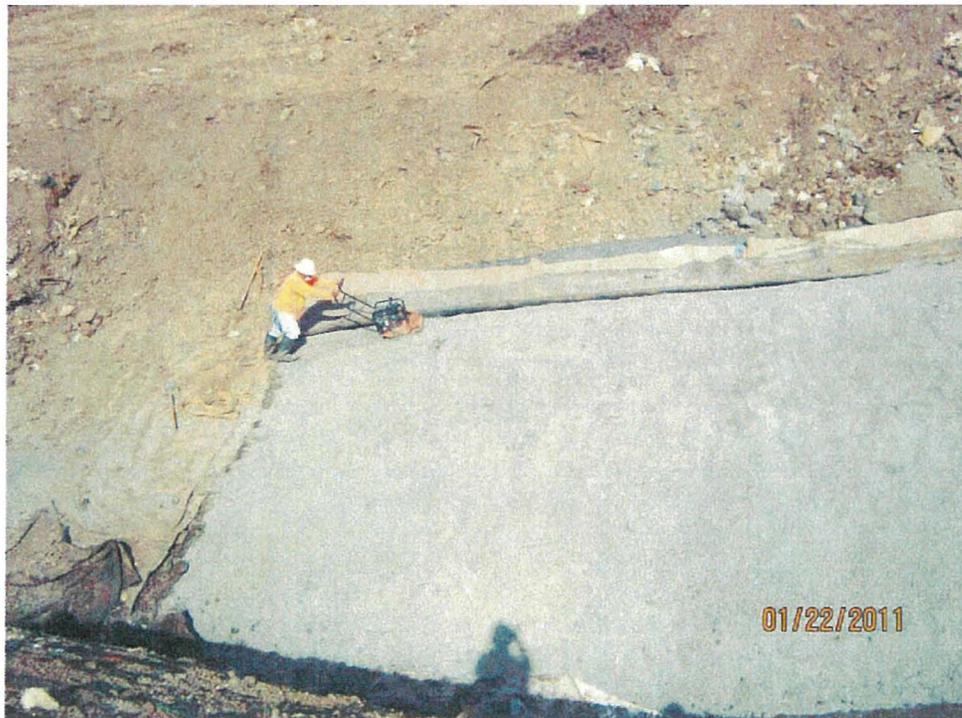
Photo 8. Compaction of soil cushion material.

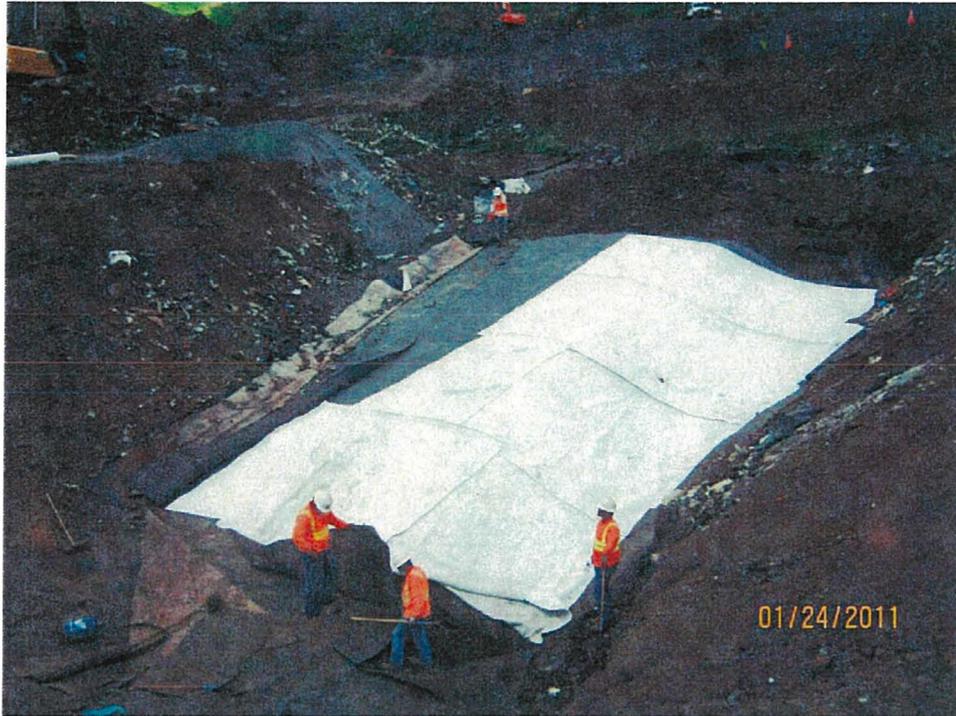
Photo 9. Placement of GCL for Cell E4 tie in, looking north.

Hydrated or otherwise damaged GCL was replaced in the designated repair area shown on Figure 2. The GCL was deployed in a manner not to entrap stones or other loose soil under the material. All adjacent panels of new GCL were overlapped a minimum of 18 inches and bentonite was applied at a rate of 1/4 pound per ft of seam. The Cell E6 GCL was connected to the Cell E4 by overlapping a minimum of 36 inches.

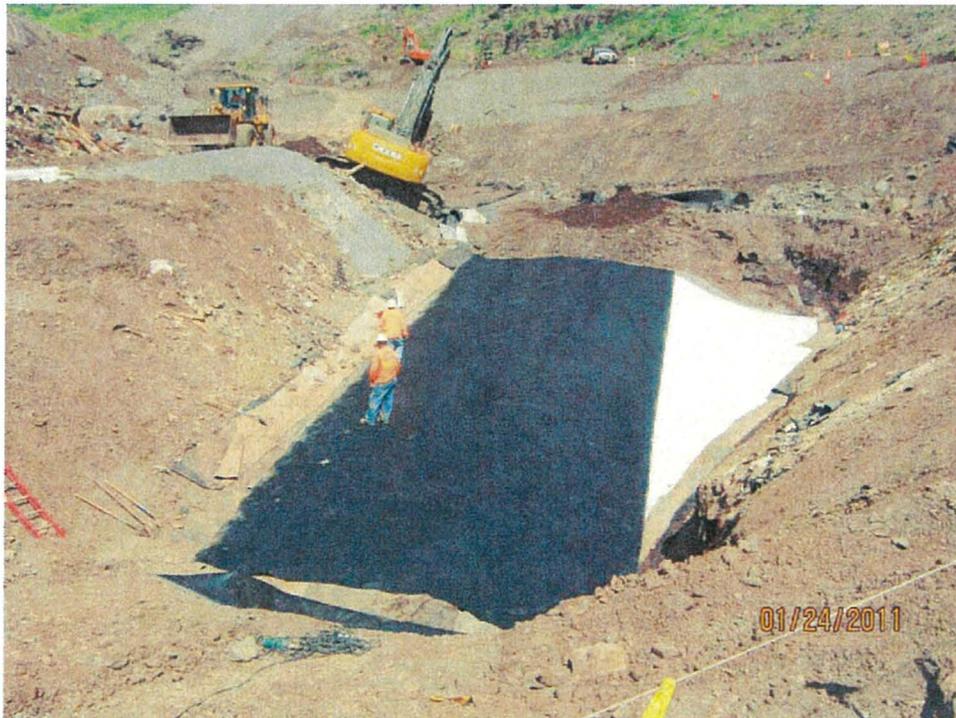
Photo 10. Placement of 60-mil HDPE geomembrane for Cell E4 tie-in.

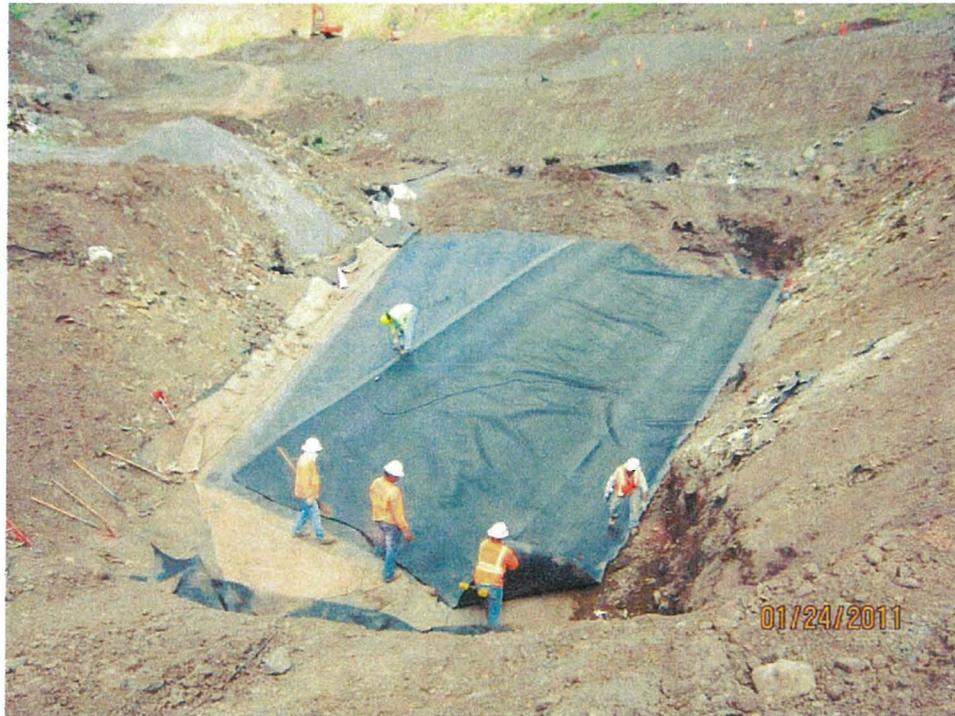
Photo 11. Extrusion welding of 40-mil HDPE geomembrane (left panel) to 60-mil geomembrane (right panel).

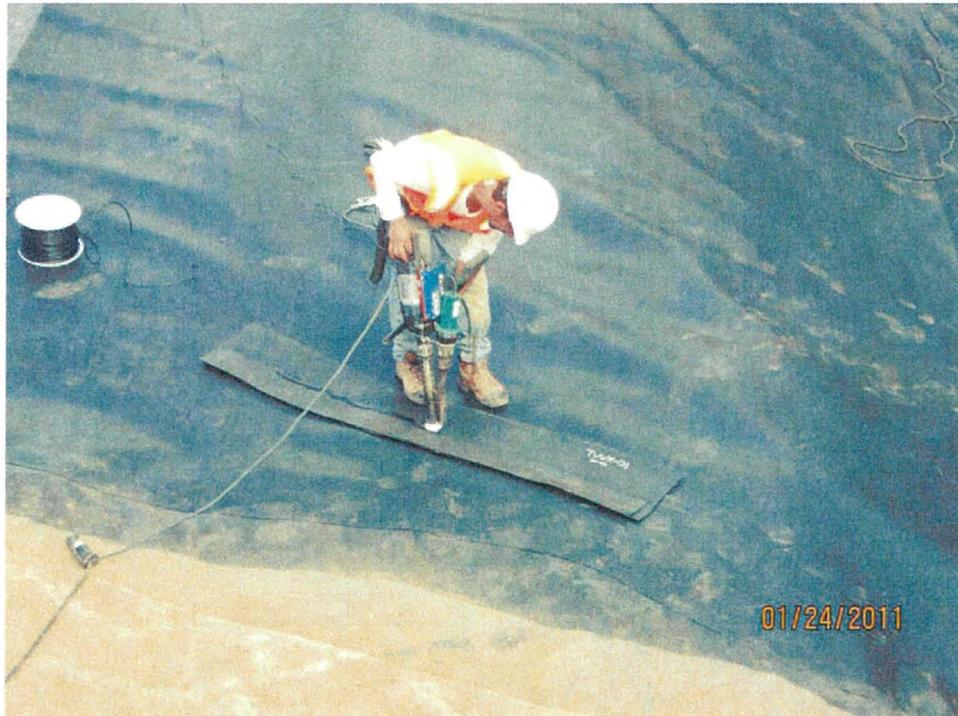
Photo 12. Trial weld.

Extrusion trial weld samples were produced several times during each day's production seaming. The seams were made by AEG technicians on representative pieces of the geomembrane to monitor each seaming apparatus and operator under the daily site conditions. At a minimum, trial welds were performed once in the morning and again during early afternoon. The trial seams were observed, monitored, and documented by AECOM.

For the 40-mil geomembrane, the specified strength for peel adhesion was 52 pounds per inch (ppi) for extrusion welds. The specified strength for shear specimens was 80 ppi. In addition to the strength criteria, specimens were required to fail outside of the weld area in a film tear bond.

For the 60-mil geomembrane, the specified strength for peel adhesion was 78 ppi for extrusion welds. The specified strength criteria for shear specimens was 120 ppi. In addition to the strength criteria, specimens were required to fail outside of the weld area in a film tear bond.

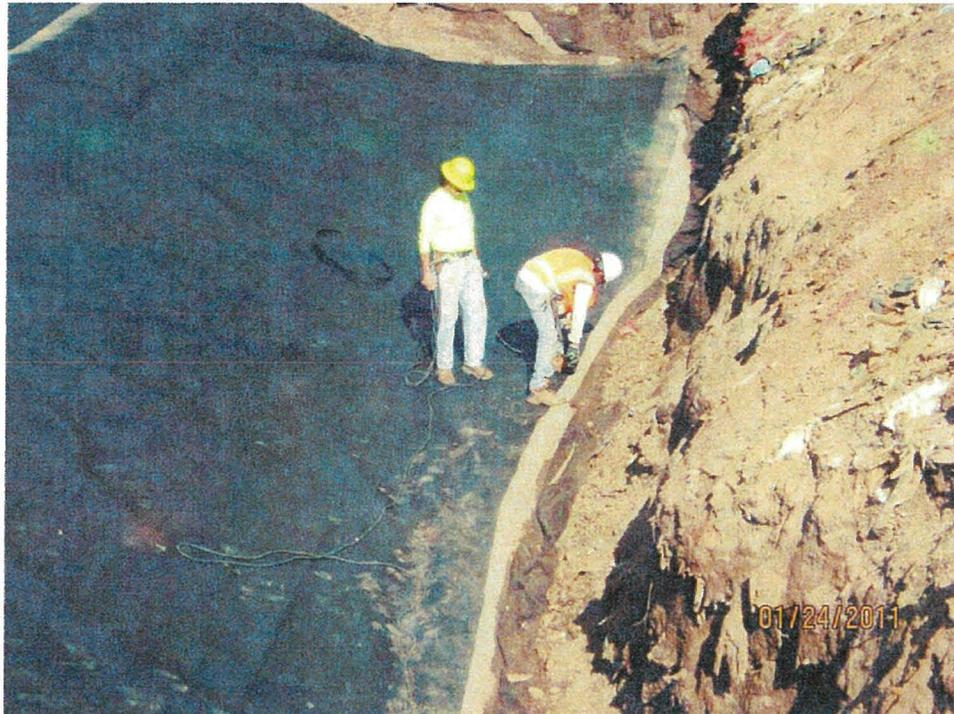
Photo 13. Preparation of extrusion weld to existing E4 60-mil geomembrane, looking northeast.

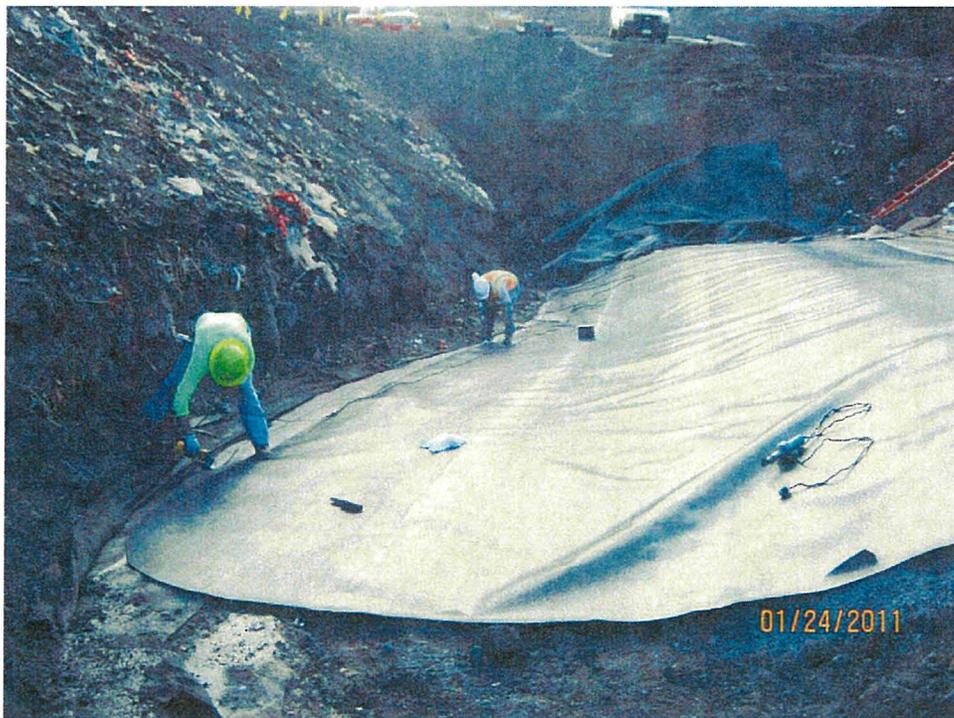
Photo 14. Extrusion weld new 60-mil HDPE to existing 60-mil HDPE Cell E4, looking southwest.

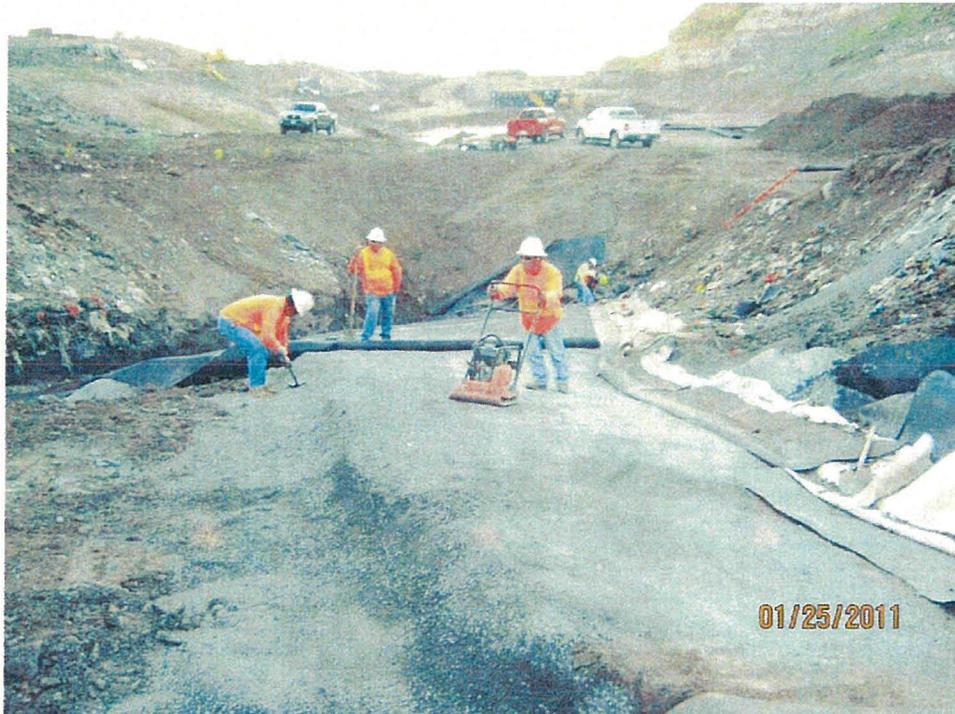
Photo 15. Compaction of soil cushion layer.

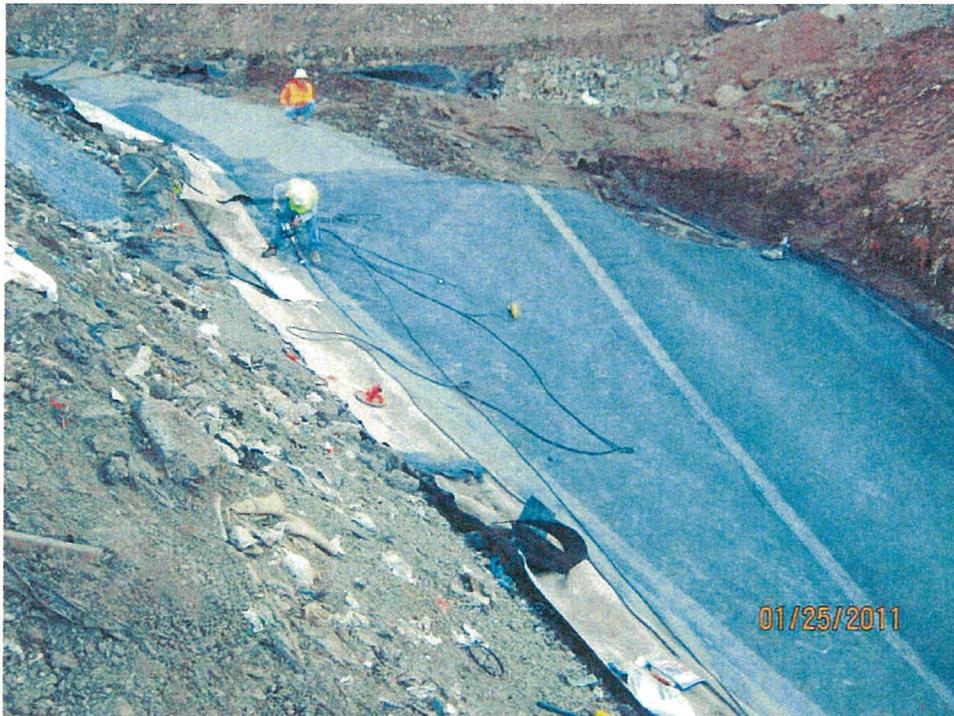
Photo 16. Extrusion weld new 40-mil HDPE to existing Cell E6 40-mil HDPE.

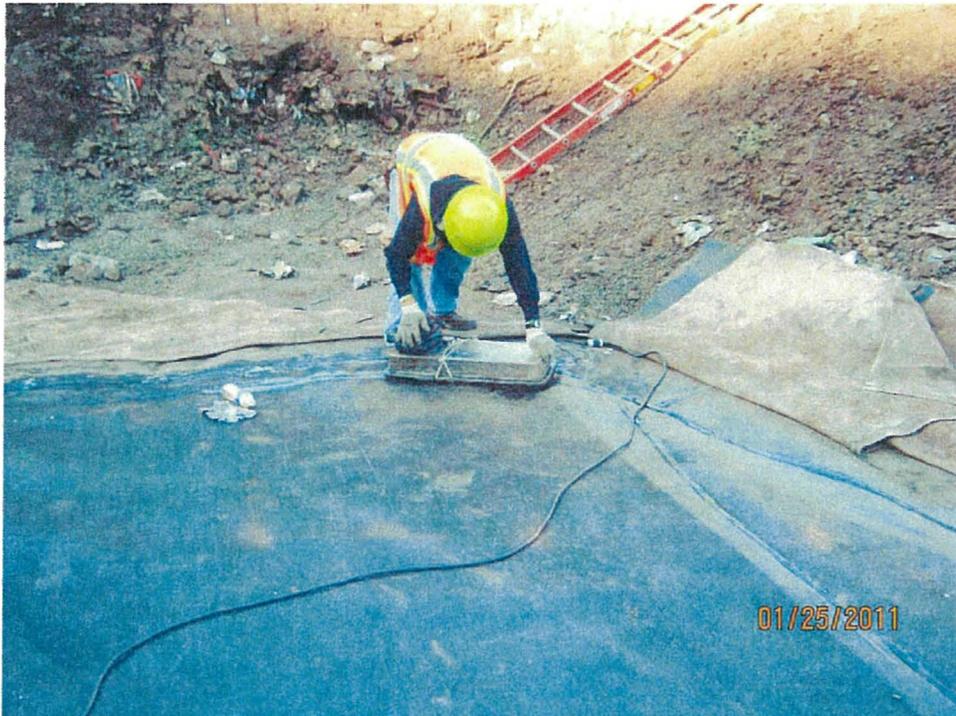
Photo 17. Vacuum box testing of extrusion weld.

Geomembrane repair sheets were heat tacked in place over the damaged geomembrane with a leister gun. An electric grinder was used on the edges of the patch and existing geomembrane prior to extrusion welding to complete the repair. For damage where the geomembrane was not penetrated, an extrusion weld bead was used. The repairs were documented by recording the date repaired, location, description of damage, size and type of repair, crew that made the repair, date, and technician that conducted the non-destructive test on the repair. Following welding of each repair, a vacuum box was used to non-destructively test the weld. All welds passed the vacuum box test and no leaks were observed.

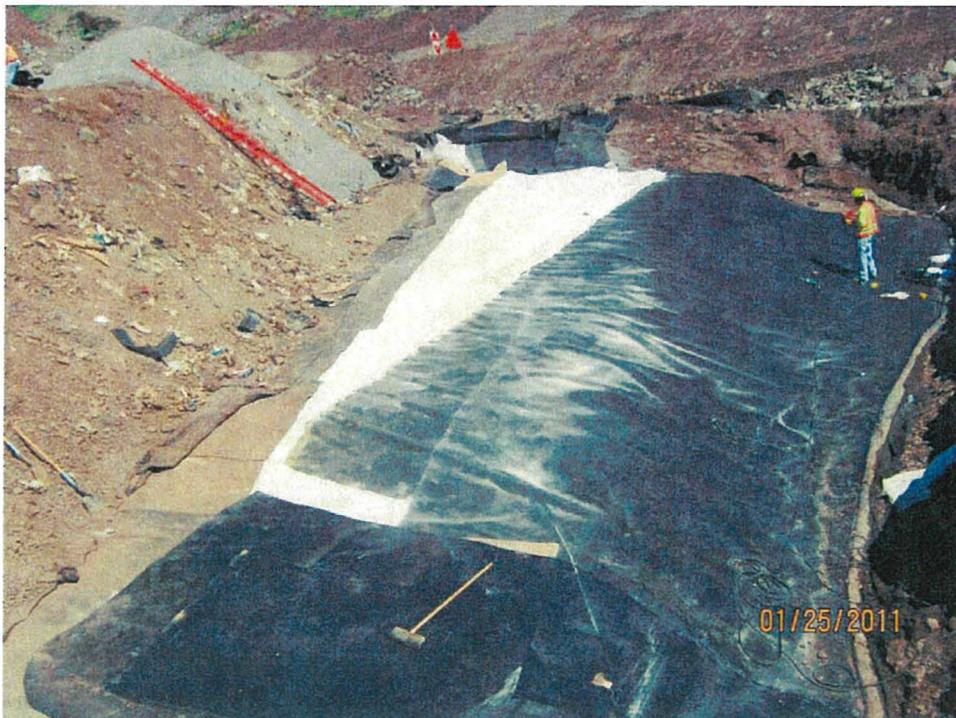
Photo 18. Cell E6, GCL layer between 40-mil and 60-mil HDPE.

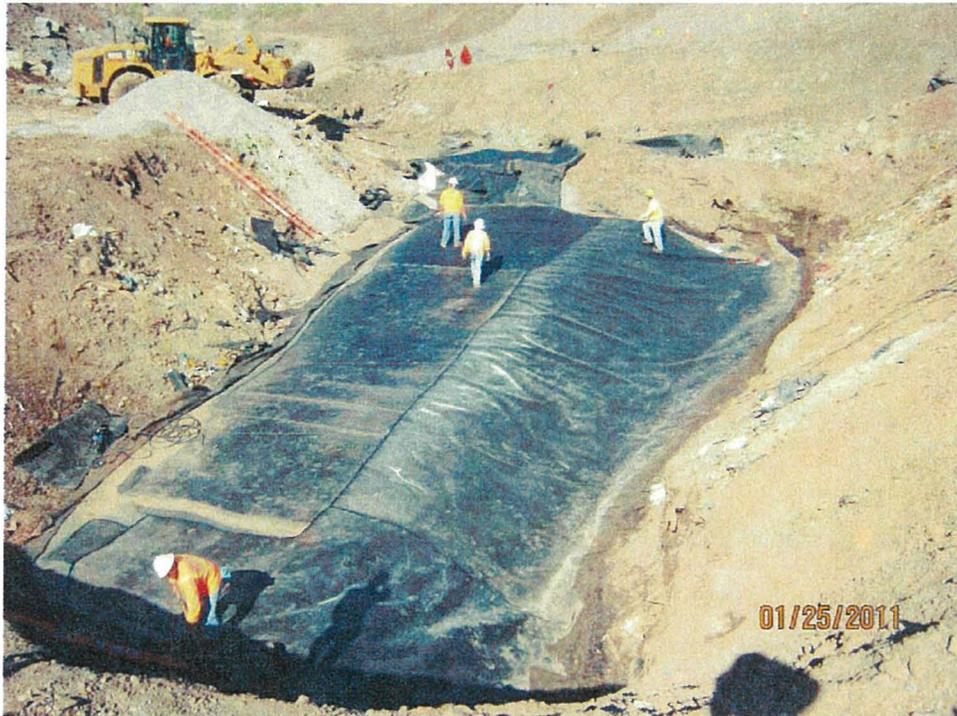
Photo 19. Cell E6, placement of 60-mil HDPE over GCL, looking northeast.

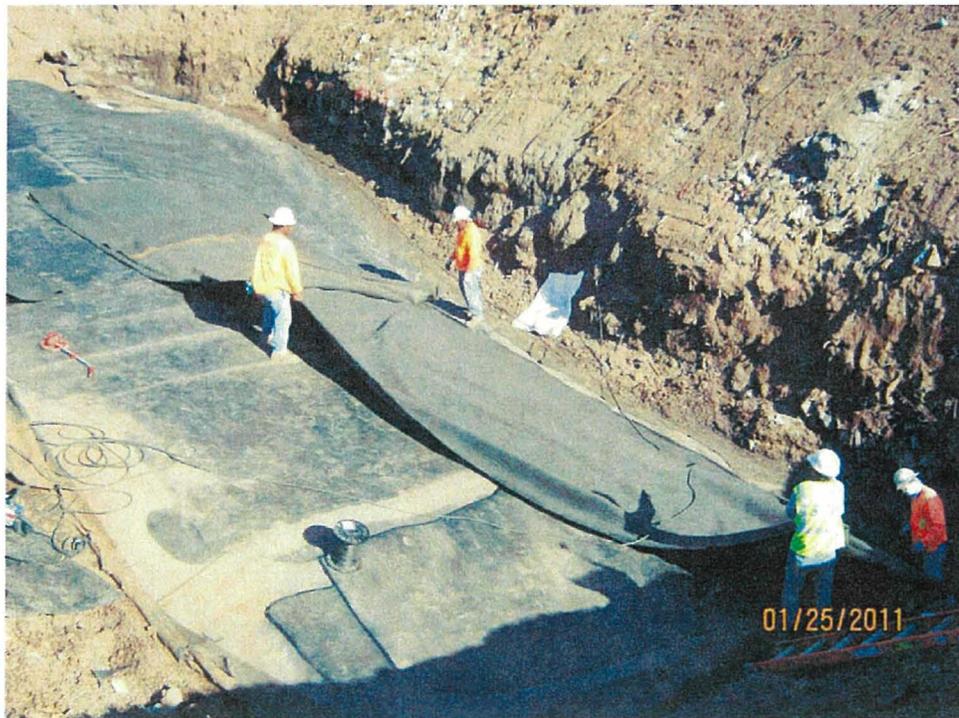
Photo 20. Placement of geotextile cushion.

Following completion of the geomembrane and GCL repairs, the 16 ounce (oz)/square yard (yd<sup>2</sup>) cushion layer geotextile was repaired using patches of new material which were sewn using a "prayer" style seam.

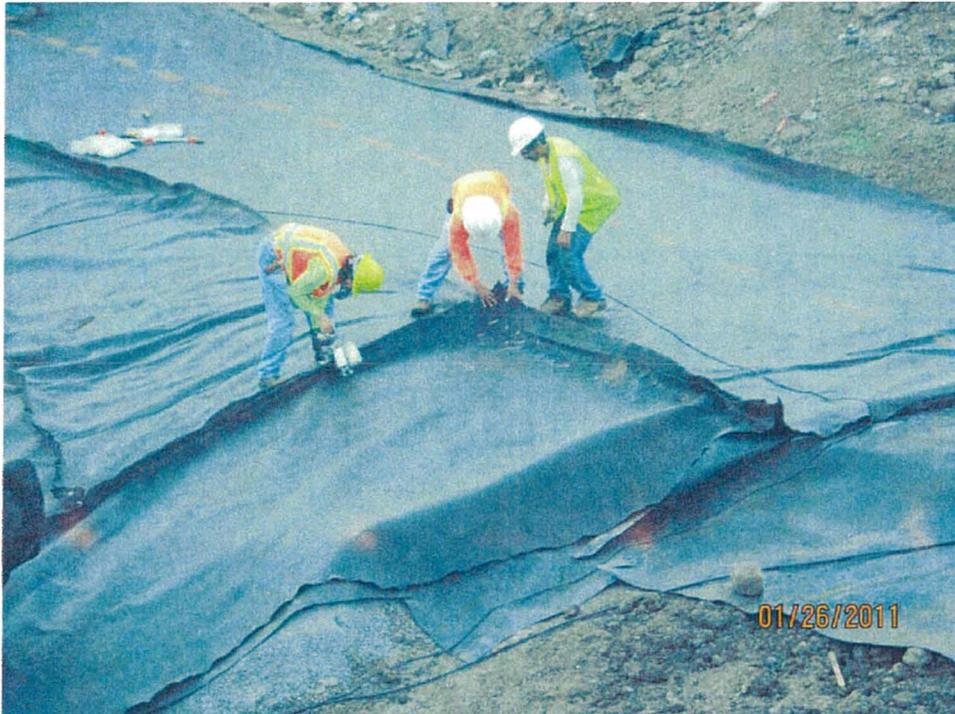
Photo 21. Sewing of geotextile cushion layer.

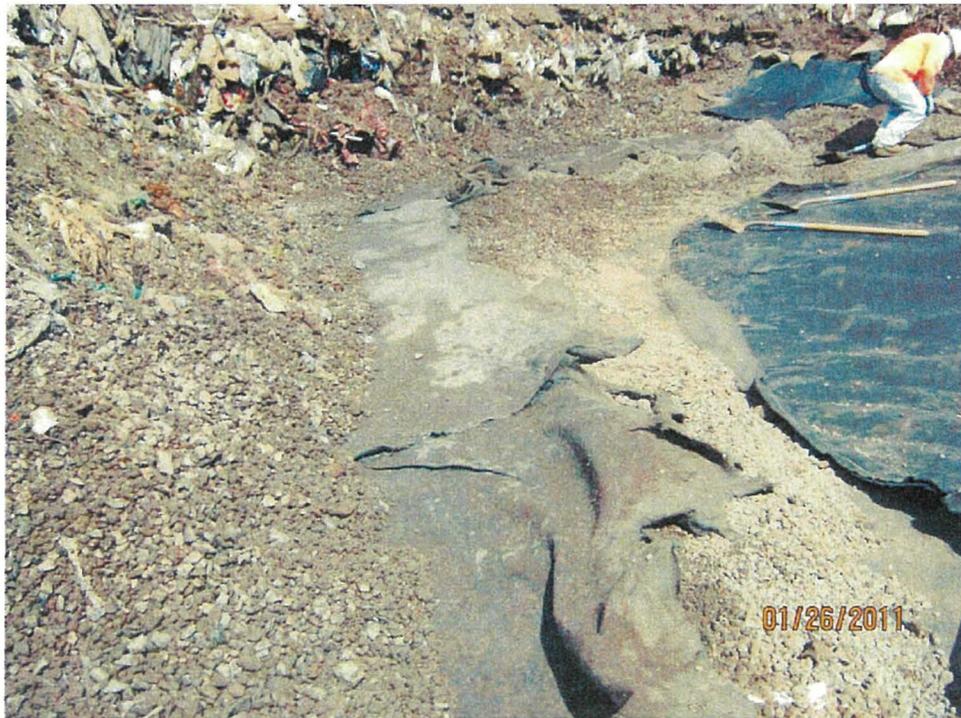
Photo 22. Cell E6, exposed LCRS drainage gravel layer with filter geotextile on top.

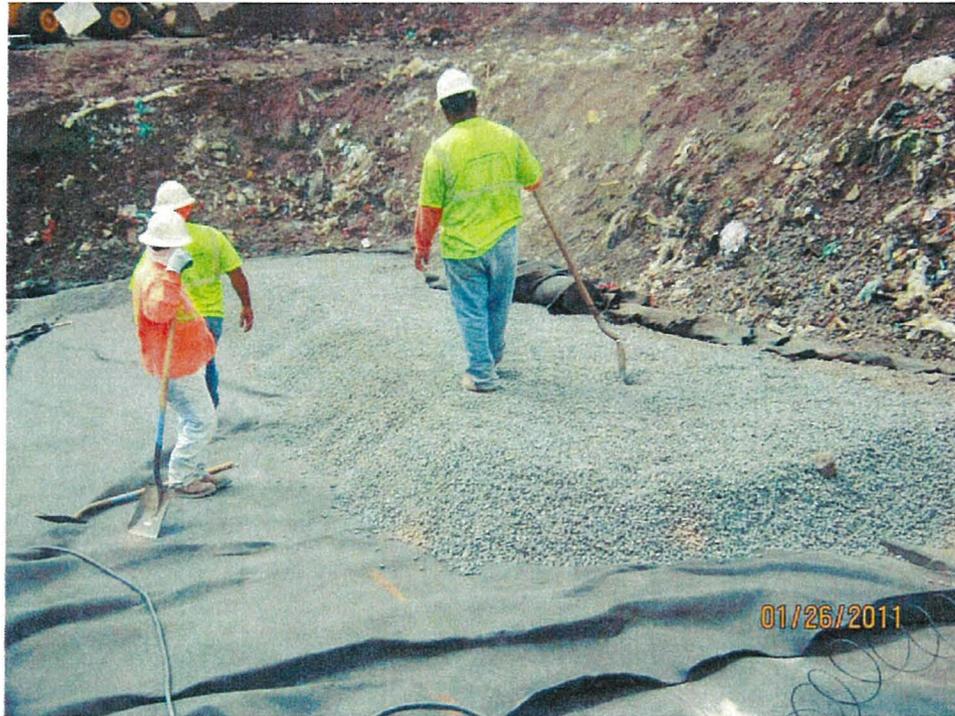
Photo 23. Cell E6, placement of new LCRS drainage gravel against existing layer.

LCRS drainage gravel was placed over the E6 liner area in a 1-ft thick layer. AECOM observed that the new drainage gravel was placed up against the existing drainage gravel material to form a continuous layer. The drainage gravel material was obtained from the remaining stockpile of approved material used to construct the original E6 LCRS. A filter layer of 10 oz/yd<sup>2</sup> geotextile was installed over the LCRS drainage gravel and was sewn using a "prayer" style seam.

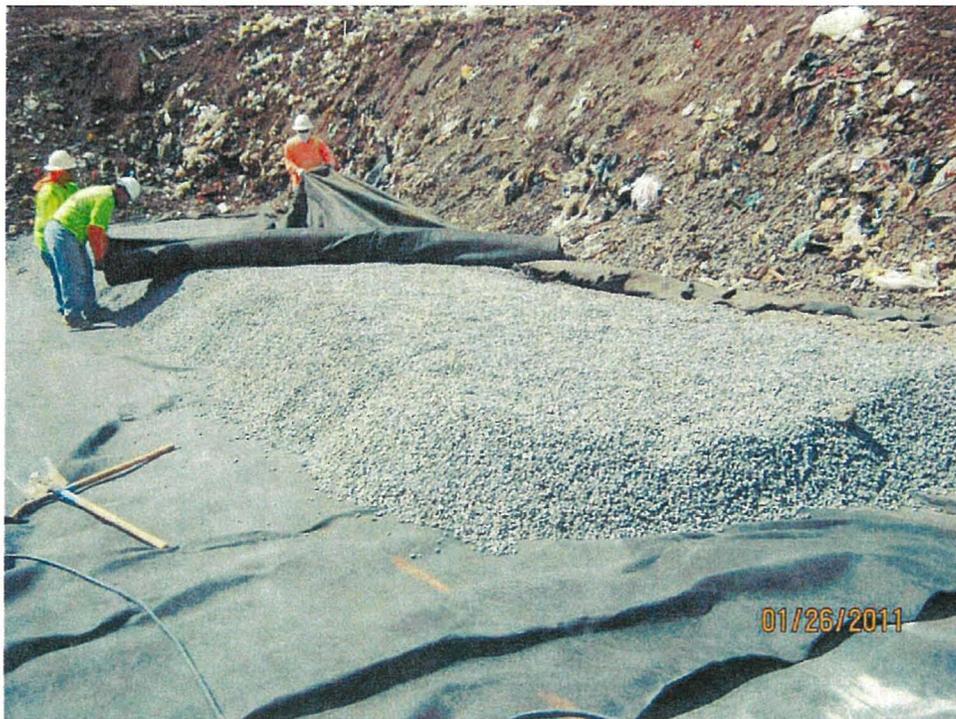
Photo 24. Placement of geotextile filter layer over LCRS drainage gravel.

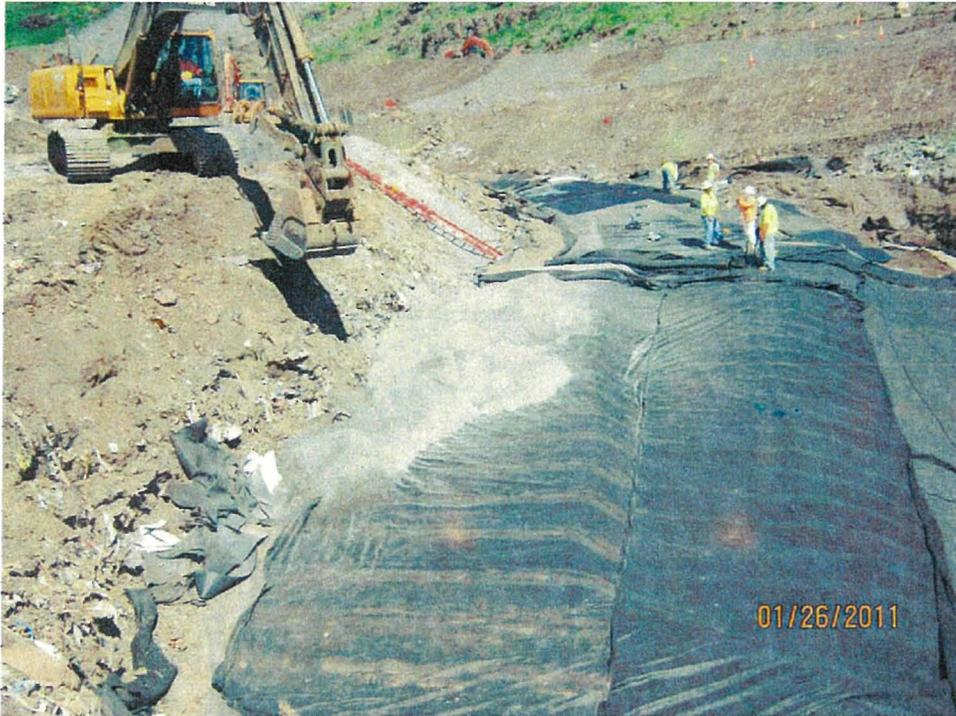
Photo 25. Placement of operations layer.

The operations layer consisted of onsite crushed/screened stone material and was placed in a 2-ft-thick (minimum) layer over the LCRS drainage gravel layer in E6 and over the cushion geotextile in E4.
