Investigation Report  
Department of Health  
Clean Water Branch

ID #: PA0991A

Date of investigation: 12/23/2010

Facility: City and County of Honolulu

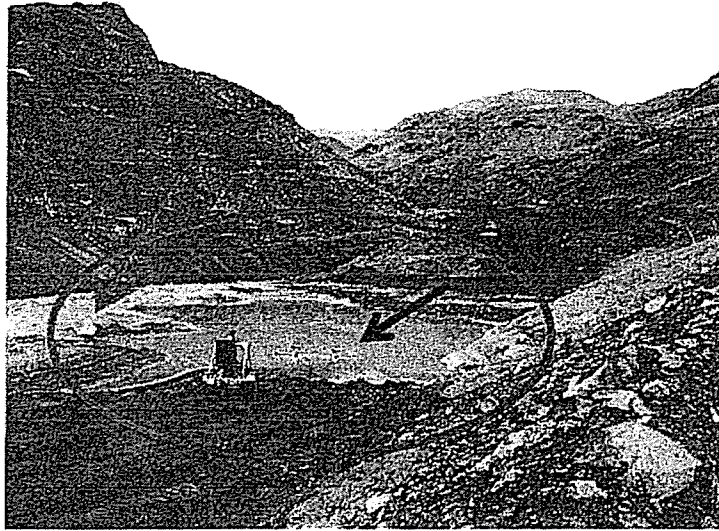
Photograph # 1

9) The Landfill's E6 cell (Photograph 1) was observed during the inspection. Ponding water was observed within the E6 cell. The E6 cell appeared to have been inundated by storm water as evidenced by high water marks observed on the sides of the cell. Significant amounts of exposed waste were not observed within the area upstream of the berm that bisects the E6 cell at the time of inspection. It appeared that the standing water saturated the E6 cell, and may have penetrated the leachate collection system while exposing solid waste which was buried in the cell.

Description: North facing view of the E6 cell upstream of the berm. Ponding water (Red Circle), an overturned porta-pottie (Red Arrow) and a submerged piece of equipment (Blue Arrow) was observed in the cell at the time of inspection. No significant amount of solid waste was observed in the area of the E6 cell upstream of the berm

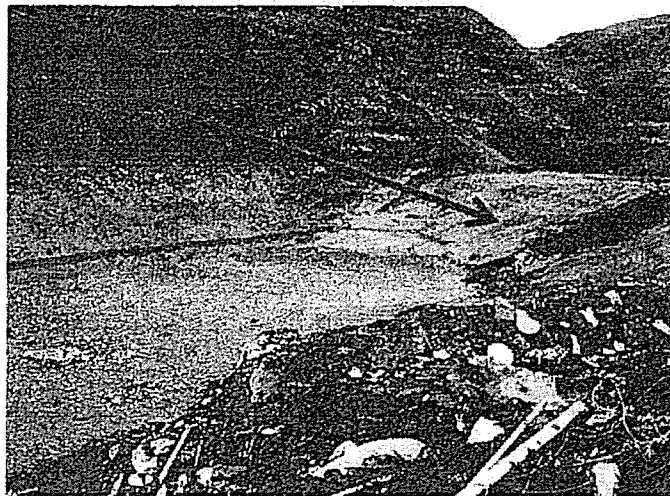
Photograph # 2

10) In the North side of the E6 cell, an overturned porta-potty and a submerged piece of Landfill equipment was observed. The South side of the E6 cell, downstream of the berm (Photograph 2) was observed at the time of inspection. Significant amounts of exposed solid waste and refuse were observed within the area downstream of the berm in the E6 cell. The earthen berm which separated the E6 cell was damaged at the time of inspection. The DOH-CWB representatives observed a section of the intermediate cover had washed away, exposing solid waste from within the berm. The Landfill's contractor appeared nearly finished with covering the

berm's exposed solid waste with new ground cover at the time of the inspection.

11)  Where the ponding water was observed percolating through the solid waste downstream area of the E6 cell, a strong odor was detected by DOH-CWB representatives. The downstream area of the cell appeared significantly polluted with a mixture of solid waste and storm water.

Description: View facing North of the E6 cell downstream of the berm. The berm (Red Arrow) bisecting the E6 cell appeared to have ruptured and exposed solid waste was observed throughout the downstream side of the E6 cell. Goodfellow Brothers. was covering the exposed solid waste with soil in an apparent attempt to repair the berm damage at the time of inspection.

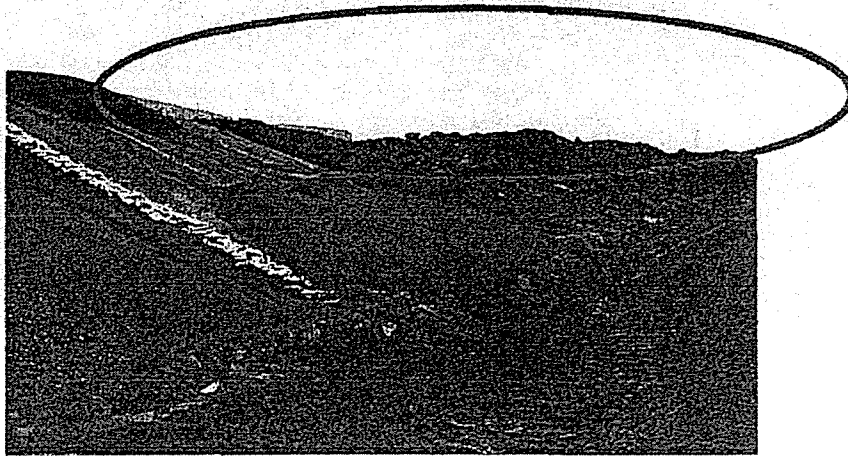
Photograph # 4

13)  No windblown litter was observed in the upper E6 cell area or in the area surrounding the E6 cell. The nearby litter fences (Photograph 4) were clean at the time of inspection. The solid waste observed within the downstream area of the E6 cell did not appear to have blown in. The solid waste appeared to originate from the E6 cell.

Description: View of a litter fence (Red Circle) above the E6 cell. No windblown litter was observed accumulated in the litter fence at the time of inspection.

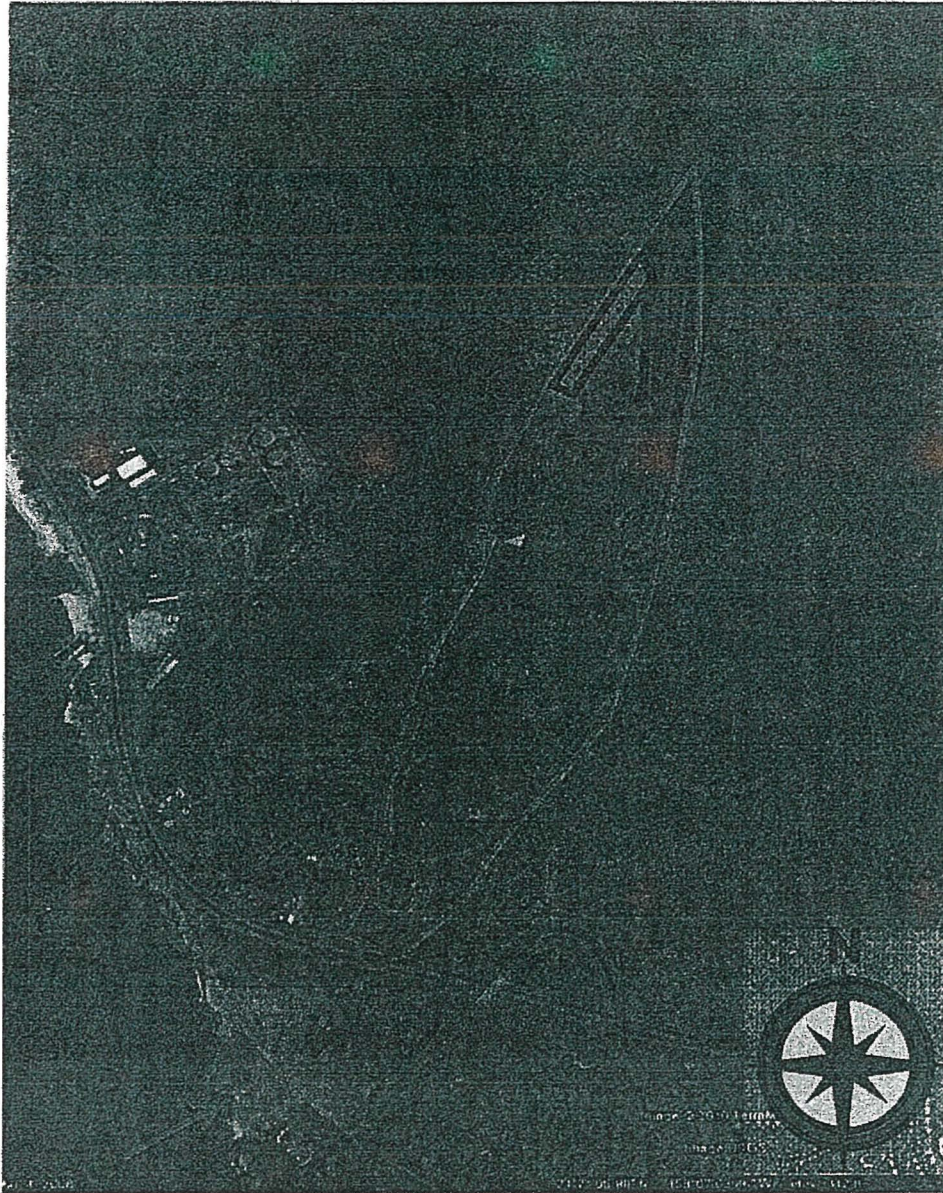
Image 1

Description: View of the Landfill (Red Outline). The E6 cell (Black Outline) was observed at the time of inspection. An earthen berm traversed the E6 cell. Discharges from the Landfill's storm water detention basin (Red Circle) enter into the Pacific Ocean at a shoreline outfall (Red Arrow) north of Ko Olina.
