**SUBJECT: Rainstorm Events, MSW Cell E-6 Damage Repairs, and Construction of
the Western Drainage System Inspection
Waimanalo Gulch Sanitary Landfill (WGLF)**

INSPECTION REPORT

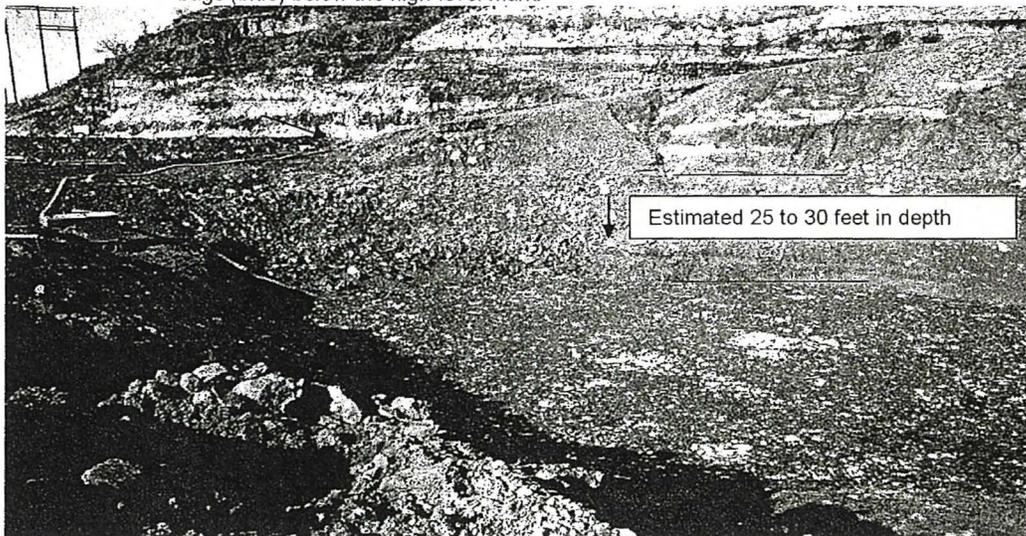
Photograph 3

Site Name: Waimanalo Gulch Landfill
Location: 92-460 Farrington Highway
Date taken: December 23, 2010
Photographer: JRuiz
Description: High-level mark from contaminated storm water on the western side of cell E-6 (red arrow). The high-level mark was estimated at 25 to 30 feet from the top level of the contaminated storm water. The side slope of the cell also shows trash and hospital waste bags (blue) below the high-level mark.

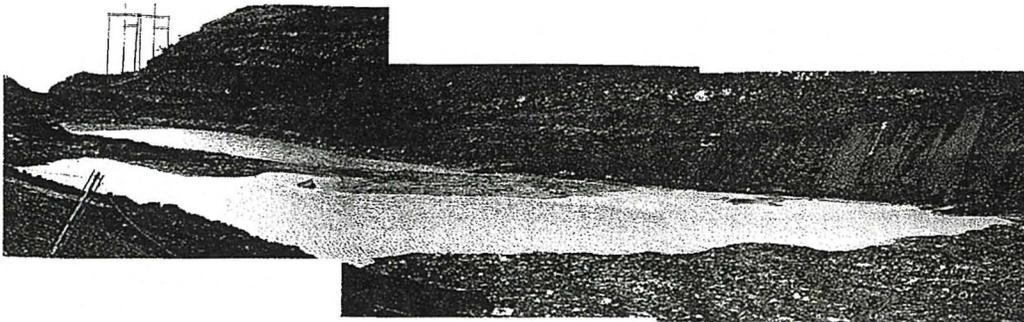
Photograph 5

Site Name: Waimanalo Gulch Landfill
Location: 92-460 Farrington Highway
Date taken: December 23, 2010
Photographer: JRuiz
Description: View of MSW Cell E-6 facing west filled with soil, trash, contaminated storm water caused by the December rainstorm. The cell side slope shows high-water demarcation line (upper red lines) in relation to current water level with floating trash (lower red line)

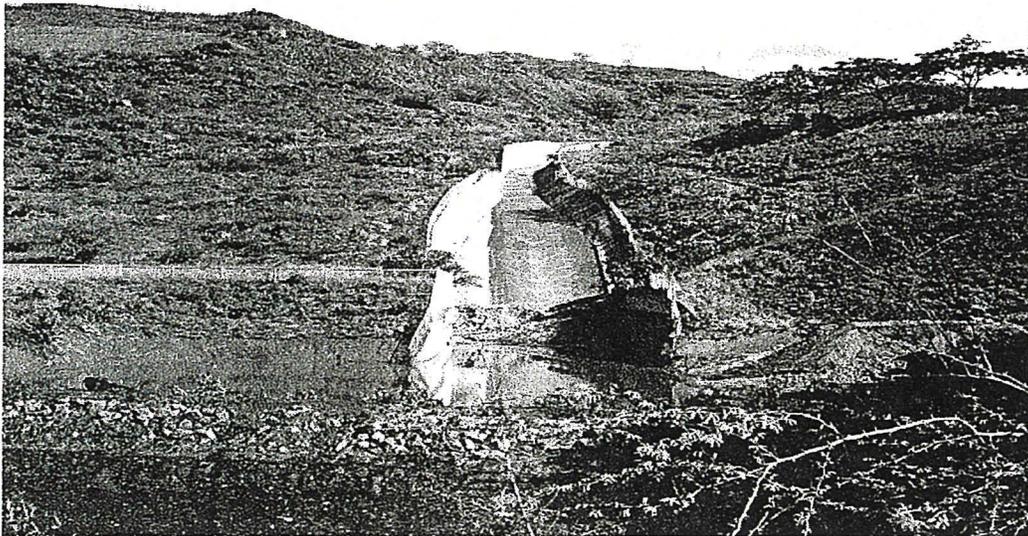
Photograph 7

The SWS inspector and engineer observed the sedimentation basin located at the bottom of the landfill and adjacent to the main office with approximately two feet of storm water mixed with soil (see photographs 7 & 8). The top of the vertical drainage pipe inside the sedimentation basin was observed with debris and a trash bag on top of the screen.

Site Name: Waimanalo Gulch Landfill
Location: 92-460 Farrington Highway
Date taken: December 23, 2010
Photographer: JRuiz
Description: Western view of the sedimentation basin at the southern end of the landfill property with debris visible at the top of the vertical drainage pipes.

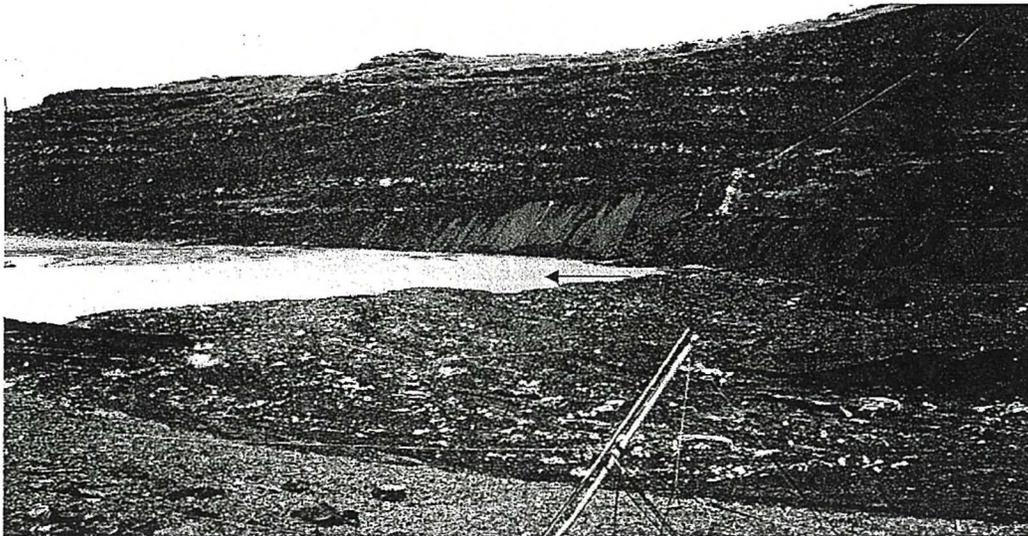
PHOTOGRAPH 1

Site name: Waimanalo Gulch Landfill
Location: 94-460 Farrington Highway
Date taken: December 28, 2010
Photographer: JRuiz
Description: Facing northwest, view of northern side of MSW Cell E-6 washed out by rainstorms and exposed waste (red arrow)

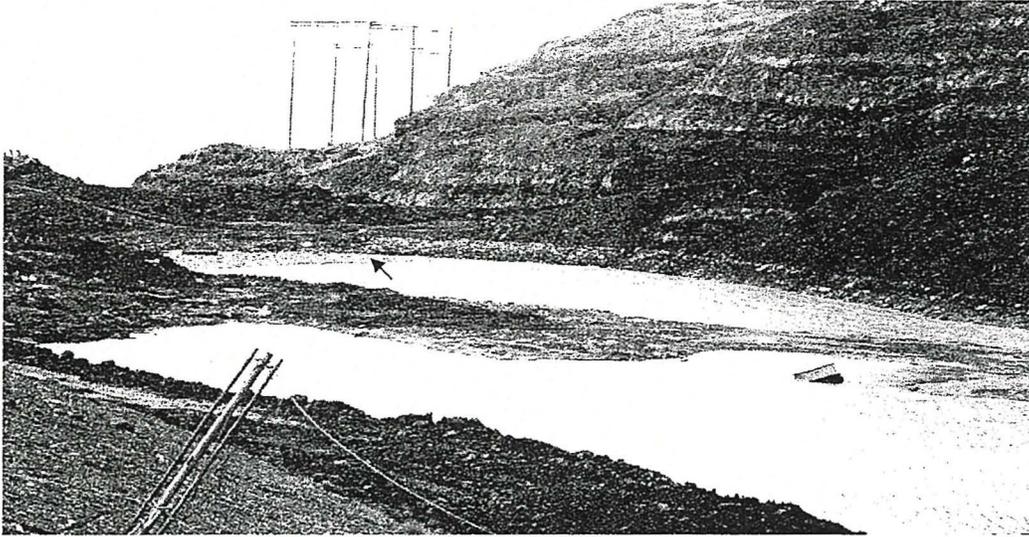
PHOTOGRAPH 2

Site name: Waimanalo Gulch Landfill
Location: 94-460 Farrington Highway
Date taken: December 28, 2010
Photographer: JRuiz
Description: Facing southwest, view of upper part of MSW Cell E-6 with exposed waste and the upper pond (red arrow) within the cell.

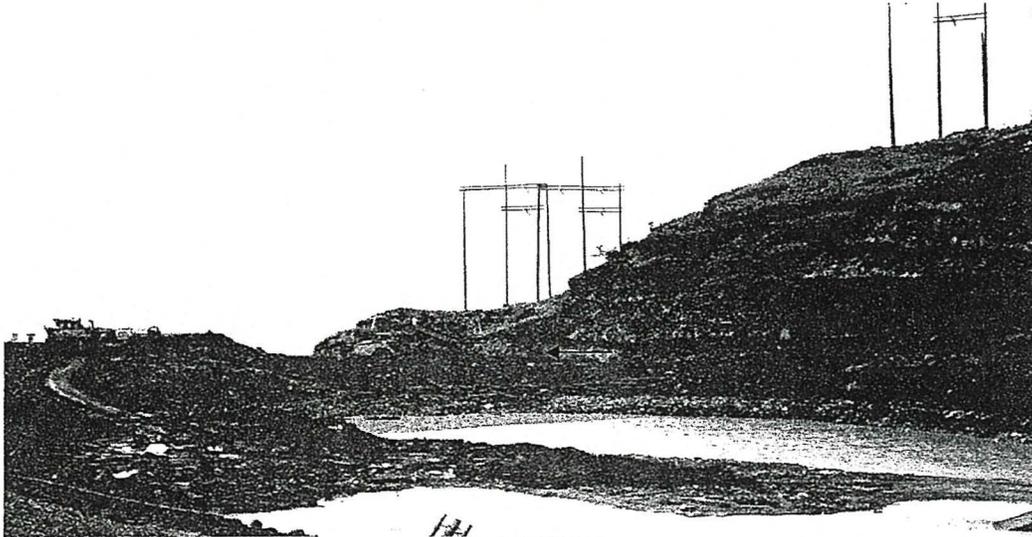
PHOTOGRAPH 3

Site name: Waimanalo Gulch Landfill
Location: 94-460 Farrington Highway
Date taken: December 28, 2010
Photographer: JRuiz
Description: Southwestern view of the lower and upper ponds within Cell E-6 with a large amount of floating solid waste accumulated at the lower end of the cell (blue arrow).

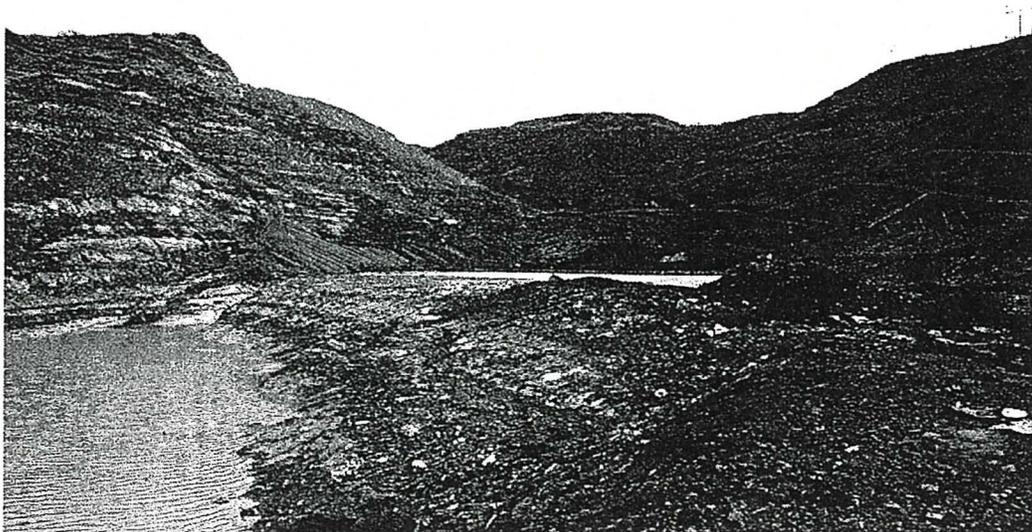
Site name: Waimanalo Gulch Landfill
Location: 94-460 Farrington Highway
Date taken: December 30, 2010
Photographer: JRuiz
Description: Western view of MSW Cell E-6 inundated with water run-on from up canyon.

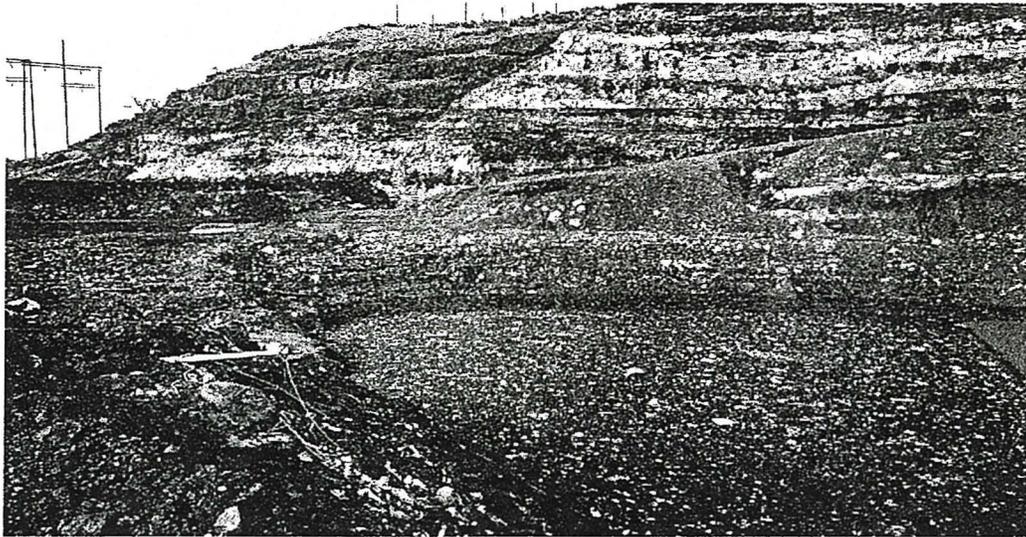
PHOTOGRAPH 2

Site name: Waimanalo Gulch Landfill
Location: 94-460 Farrington Highway
Date taken: December 30, 2010
Photographer: JRuiz
Description: Northwestern view of MSW Cell E-6 with the lower and upper ponds and exposed solid waste in the middle.

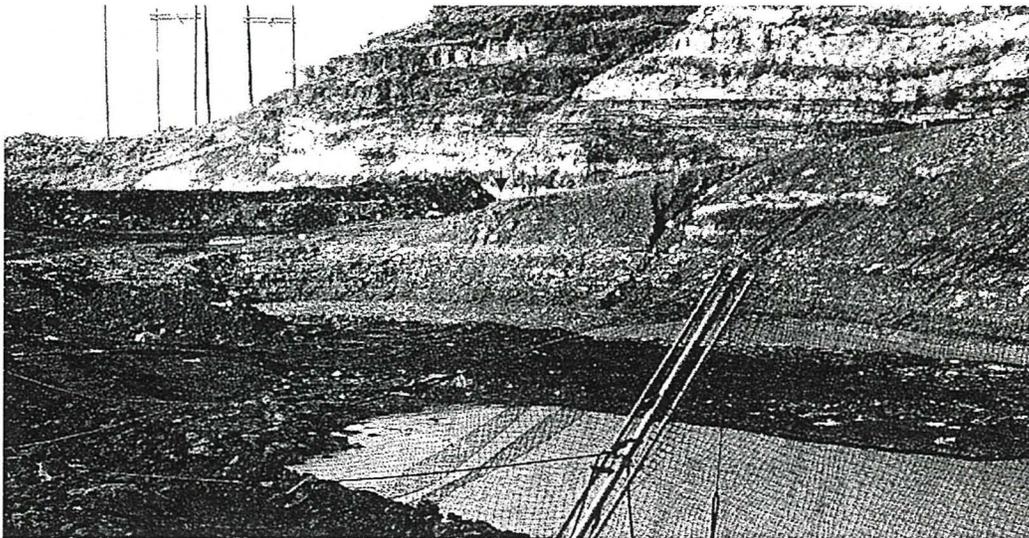
PHOTOGRAPH 3

Site name: Waimanalo Gulch Landfill
Location: 94-460 Farrington Highway
Date taken: December 30, 2010
Photographer: JRuiz
Description: Western view of the lower pond with accumulated floating solid waste from the previous storms. The high-level demarcation line with trash can be seen on the western side slope of Cell E-6.

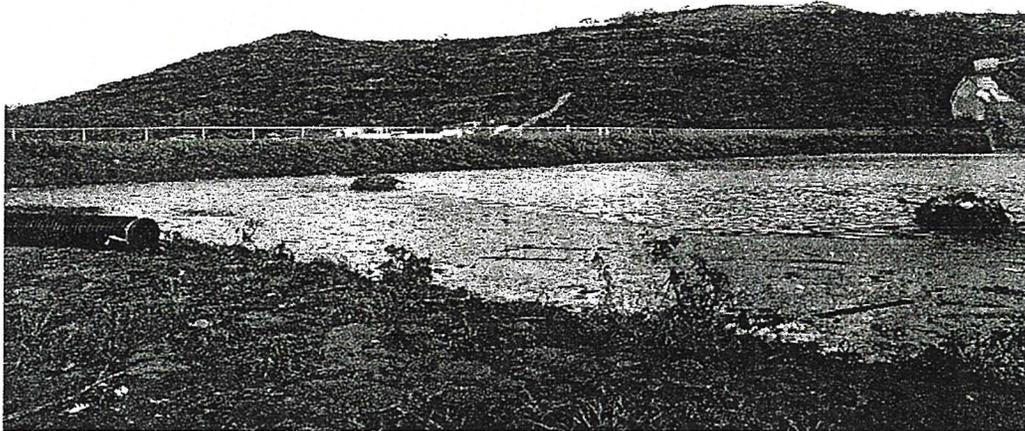
PHOTOGRAPH 4

Site name: Waimanalo Gulch Landfill
Location: 94-460 Farrington Highway
Date taken: December 30, 2010
Photographer: JRuiz
Description: Southern end of MSW Cell E-6 with accumulated trash and water. In the background is the recently constructed berm (blue arrow) and the Hobas manhole (red arrow) that leads to storm water system.

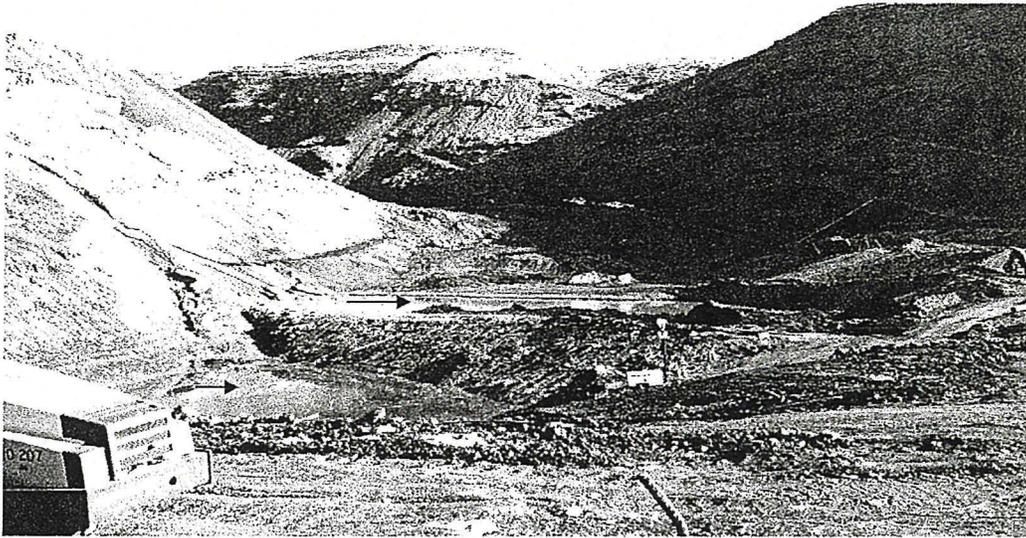
PHOTOGRAPH 5

The SWS inspector observed the water level in the sedimentation basin to be approximately two feet below the water level observed the previous day (see photograph 5).

Site name: Waimanalo Gulch Landfill
Location: 94-460 Farrington Highway
Date taken: December 30, 2010
Photographer: JRuiz
Description: Sedimentation basin filled with rainwater, debris and mud from the recent storm. Debris observed at the top of the vertical drain pipe.

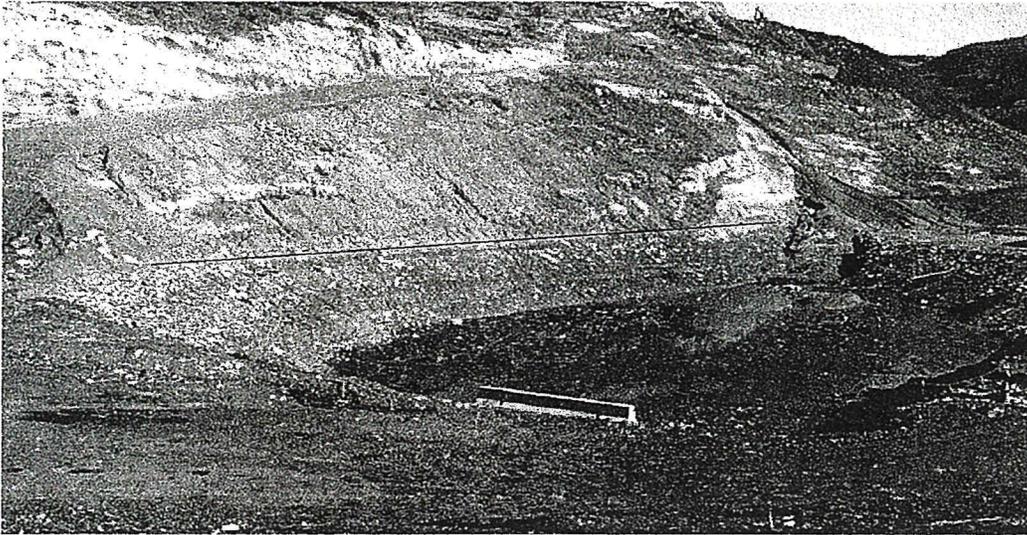
PHOTOGRAPH 1

Site name: Waimanalo Gulch Landfill
Location: 94-460 Farrington Highway
Date taken: January 6, 2011
Photographer: JRuiz
Description: Northern view from the top of the recently constructed berm, the conditions of the entire MSW Cell E-6 with two ponds, lower (red arrow) and upper (blue arrow)

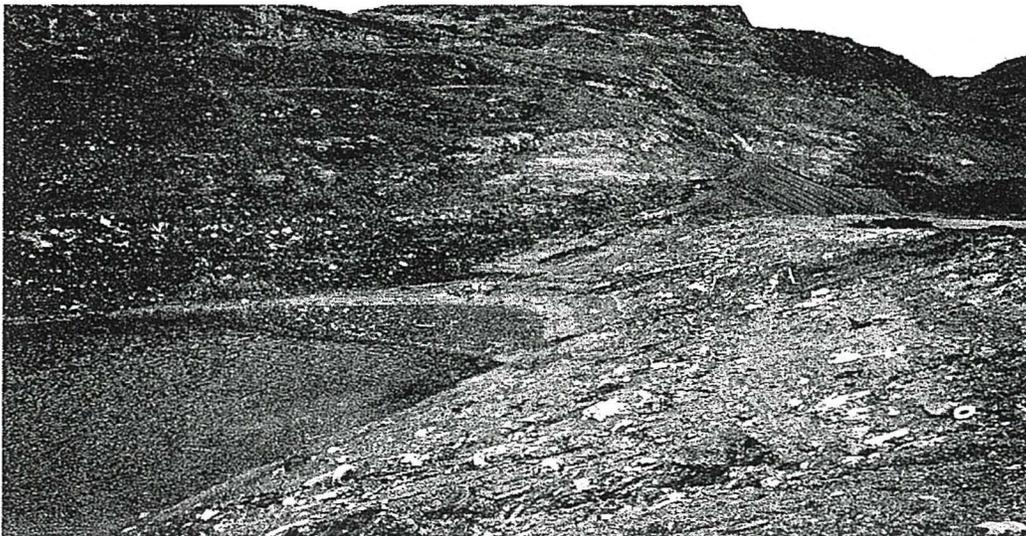
PHOTOGRAPH 1

Site name: Waimanalo Gulch Landfill
Location: 94-460 Farrington Highway
Date taken: January 10, 2011
Photographer: JRuiz
Description: Southwestern view of MSW Cell E-6 (lower pond) being pumped with hoses (black arrow) into the truck at the background and liquids transported to Waianae Waste Water Treatment Plant (WWTP).

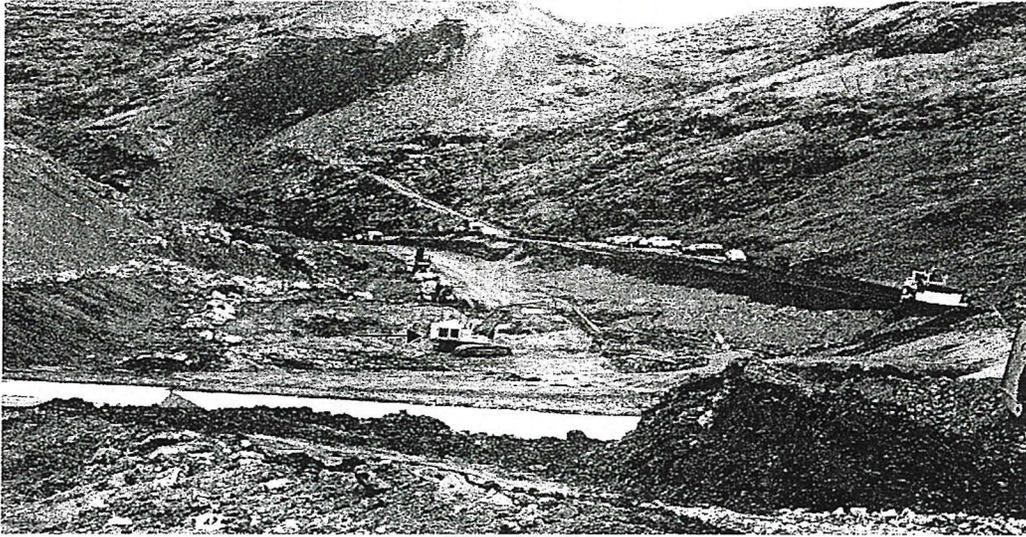
PHOTOGRAPH 2

Site name: Waimanalo Gulch Landfill
Location: 94-460 Farrington Highway
Date taken: January 10, 2011
Photographer: JRuiz
Description: Northwestern view of MSW Cell E-6 lower pond with exposed solid waste.

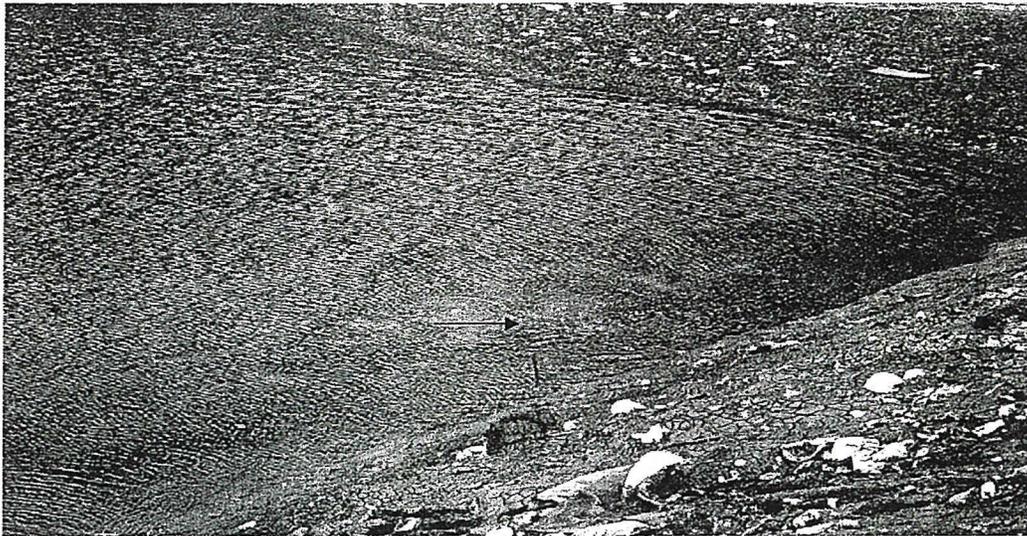
PHOTOGRAPH 4

The existing upper western lined area of Cell E-6 was damaged by boulders being pushed by

heavy equipment operators working on the Western Drainage channel above this area (see photograph 4). The SWS inspector and engineer observed the contractor's heavy equipment pushing large boulders and rocks from bench above the cell, some of which were landing on the western edge of the lined area of Cell E-6. GBI was also observed constructing a road on the east side of Cell E-6 and adjacent to Cell E-5 to facilitate the movement of construction equipment to the up-canyon work area (see photograph 3).

Site name: Waimanalo Gulch Landfill
Location: 94-460 Farrington Highway
Date taken: January 10, 2011
Photographer: JRuiz
Description: Western view of the upper MSW Cell E-6 liner, damaged by boulders and rocks (red arrows) from ongoing cell construction above E-6 cell.

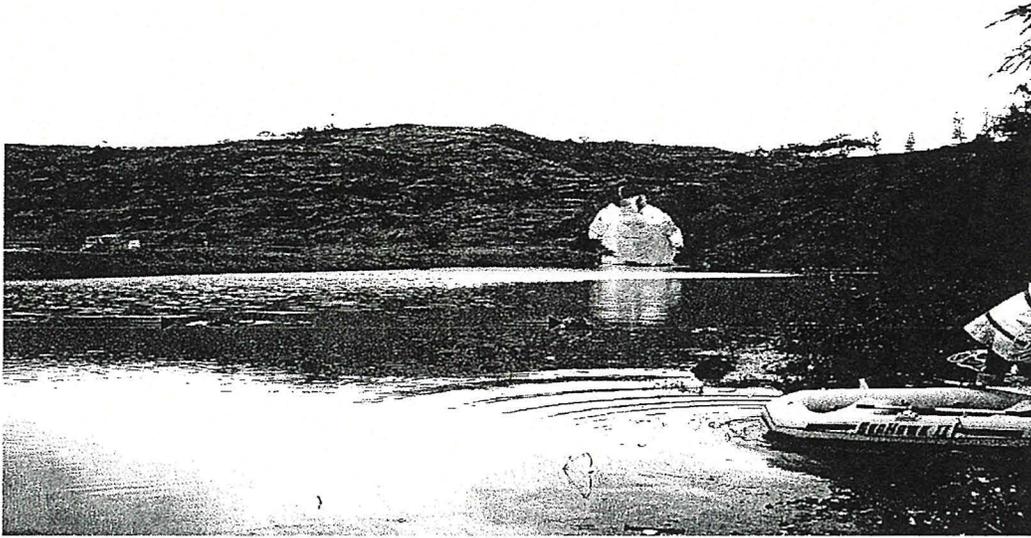
Site name: Waimanalo Gulch Landfill
Location: 94-460 Farrington Highway
Date taken: January 10, 2011
Description: Southwestern view of MSW Cell E-6 lower pond being pumped by water truck (red arrow) and heavy equipment placing soil cover at the upper pond to cover exposed waste and fill soft spots on the cell.

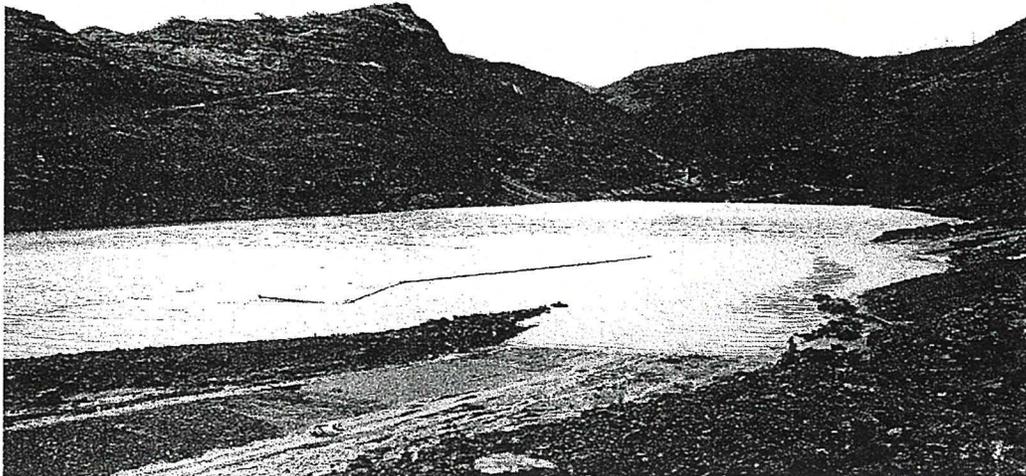
PHOTOGRAPH 5

Site name: Waimanalo Gulch Landfill
Location: 94-460 Farrington Highway
Date taken: January 13, 2011
Photographer: JRuiz
Description: Southwestern view of MSW Cell E-6, lower pond filled storm water and trash with red arrow indicating the manhole location to the Hobas drainage pipe.

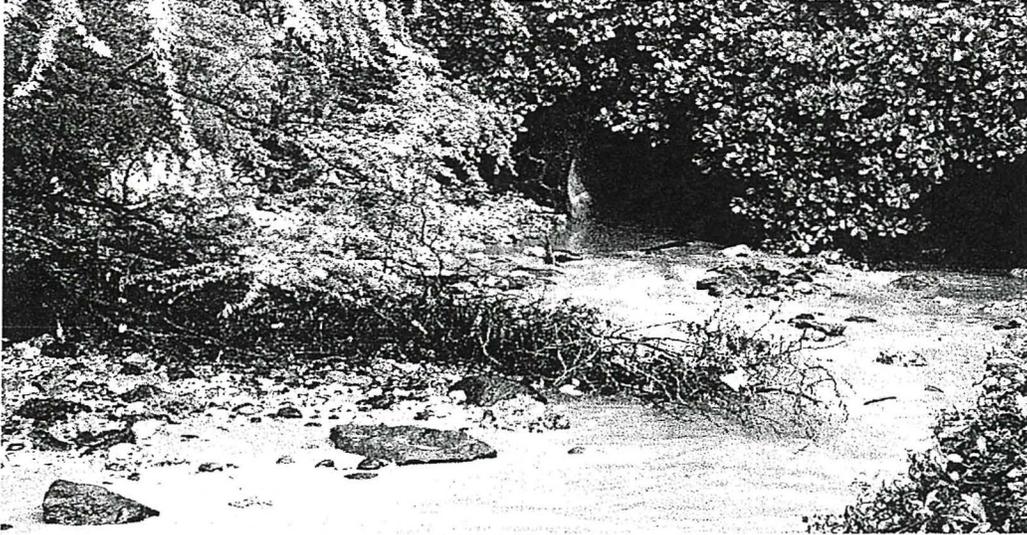
PHOTOGRAPH 6

The inspector and engineer observed an area from the western drainage system where rainwater poured down like a waterfall and rocks and boulders were observed on top of the western lined area of Cell E-6 (see photograph 6).

Site name: Waimanalo Gulch Landfill
Location: 94-460 Farrington Highway
Date taken: January 13, 2011
Photographer: JRuiz
Description: Northwestern view of MSW Cell E-6, inundated with storm water and part of the upper western MSW Cell E-6 was observed with waterfall (red arrow) with rocks and boulders noted on the upper cell of MSW Cell E-6 (black arrow).

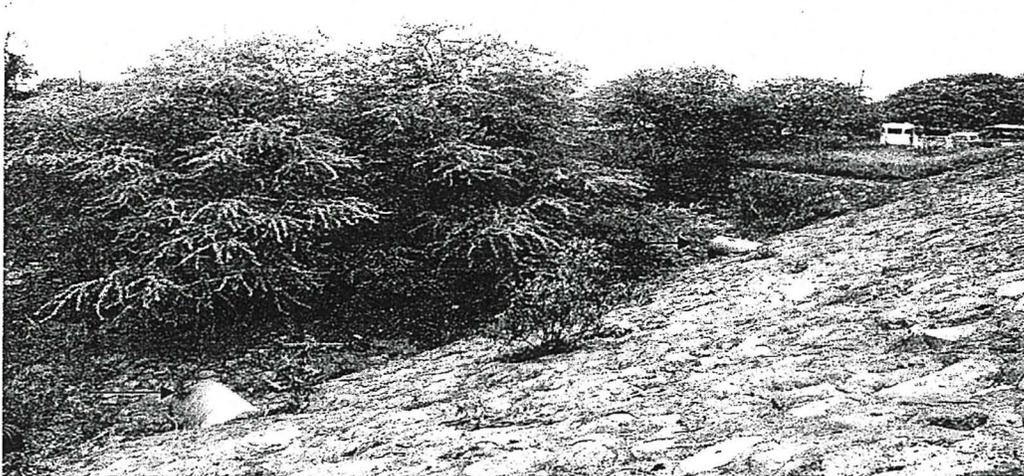
PHOTOGRAPH 7

Site name: Waimanalo Gulch Landfill
Location: 94-460 Farrington Highway
Date taken: January 13, 2011
Photographer: JRuiz
Description: View of the outfall drainage pipes by the cove, located near the ocean and immediately below Koolina residence with some trash leading into the ocean.

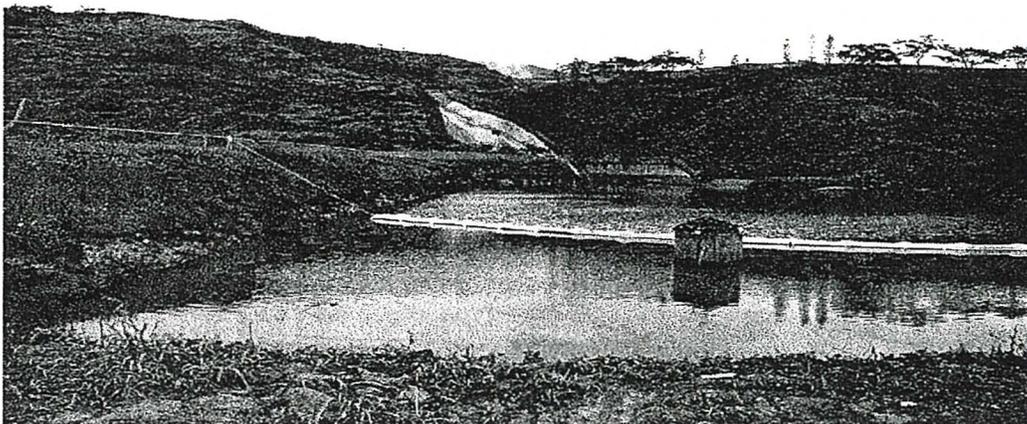
PHOTOGRAPH 1

The storm water level at the sedimentation basin has decreased by approximately two feet since the last inspections and no storm water was observed discharging from the outflow pipes under the overflow spillway (see photographs 1 & 2).

Site Name: Waimanalo Gulch Landfill
Location: 92-460 Farrington Highway
Date Taken: January 18, 2011
Photographer: JRuiz
Description: Effluent pipes (blue arrows) from the sedimentation basin overflow spillway were observed without any stormwater discharge.

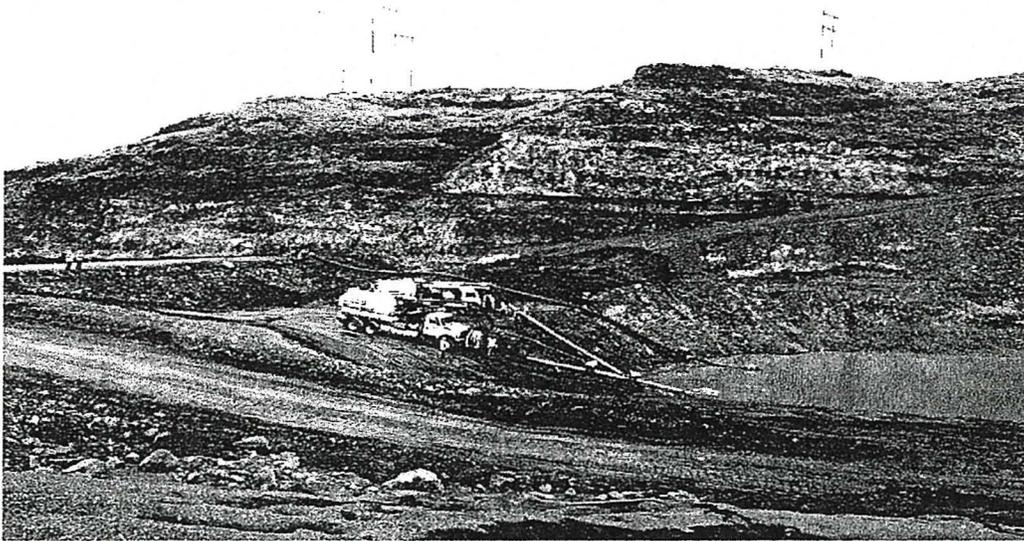
PHOTOGRAPH 2

Site Name: Waimanalo Gulch Landfill
Location: 92-460 Farrington Highway
Date Taken: January 18, 2011
Photographer: JRuiz
Description: Northern view of the sedimentation basin

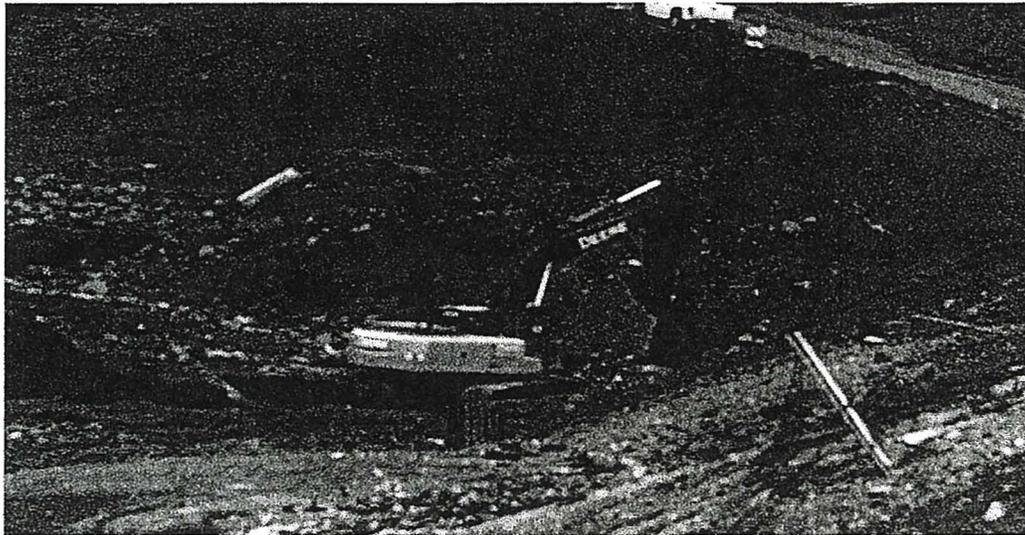
PHOTOGRAPH 7

The upper east and west edge of liner in Cell E-6 was damaged by the rainstorms and the contractor was observed exposing the eastern portion of the liner to determine the extent of the damage (see photographs 7 & 8).

Site Name: Waimanalo Gulch Landfill
Location: 92-460 Farrington Highway
Date Taken: January 18, 2011
Photographer: JRuiz
Description: Closed-up view of the damaged liner to MSW Cell E-6 due to the rainstorm and earlier upper cell construction.

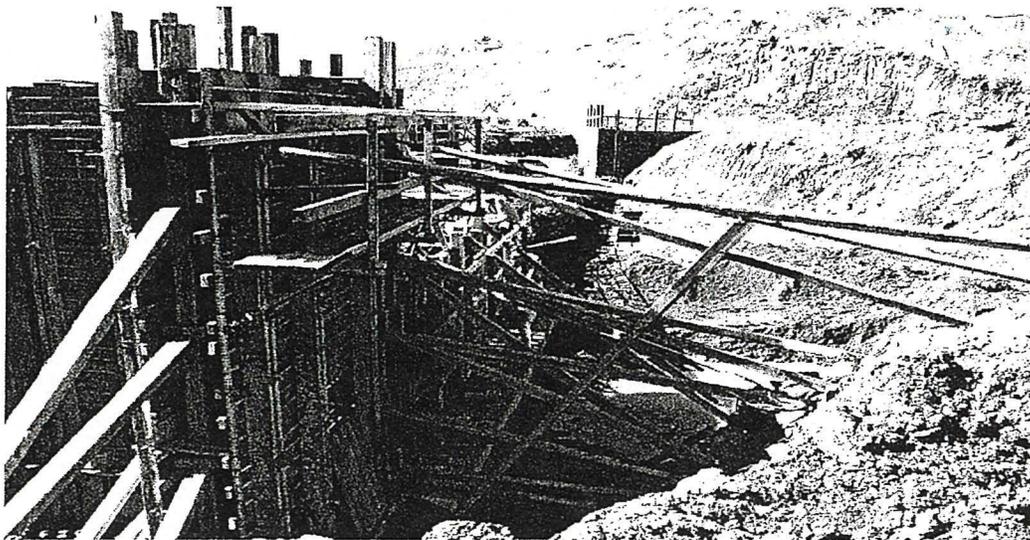
Site name: Waimanalo Gulch Landfill
Location: 94-460 Farrington Highway
Date taken: January 20, 2011
Photographer: JRuiz
Description: Northern view of the on-going construction for the western surface water drainage system located on the upper canyon of the landfill and just above the future MSW Cell E-9.

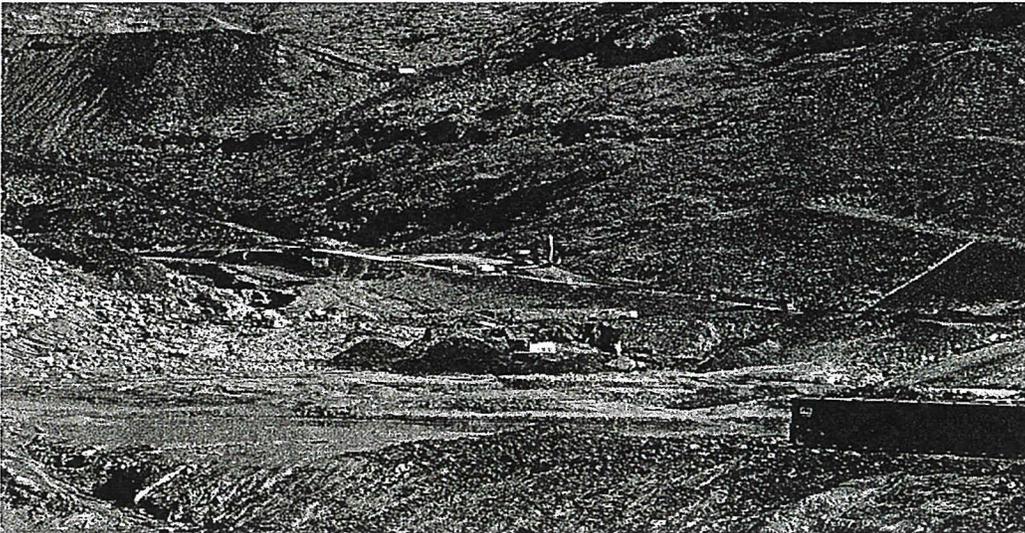
Site name: Waimanalo Gulch Landfill
Location: 94-460 Farrington Highway
Date taken: January 20, 2011
Photographer: JRuiz
Description: Northern view of MSW Cell E-6 lower pond being pumped into the PCS frac container and C&C water trucks pumping liquid from the upper pond and transporting the liquid to Waianae WWTP for disposal.

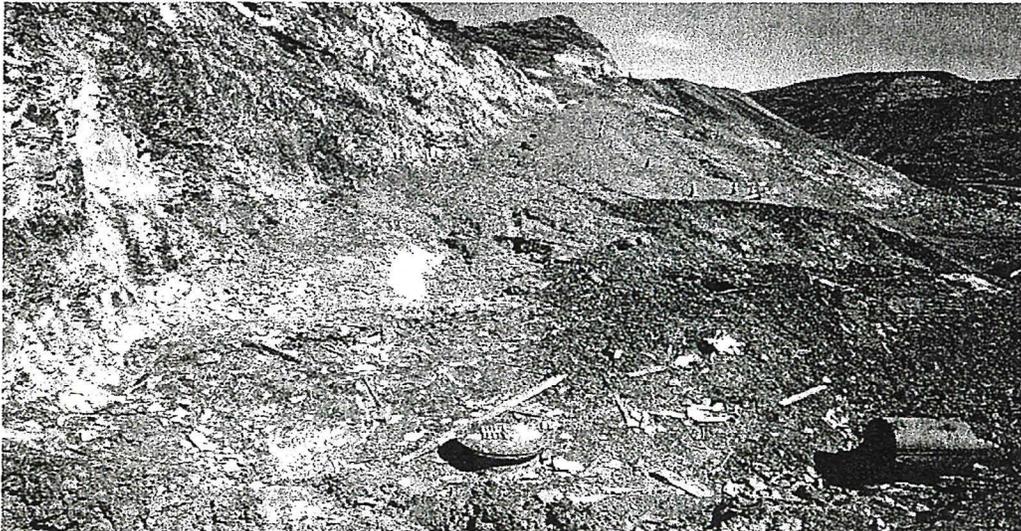
PHOTOGRAPH 9

Site name: Waimanalo Gulch Landfill
Location: 94-460 Farrington Highway
Date taken: January 20, 2011
Photographer: JRuiz
Description: Close-up view of the Hobas manhole pipe (red arrow) located southwest of MSW Cell E-6, with debris and solid waste observed around the manhole.

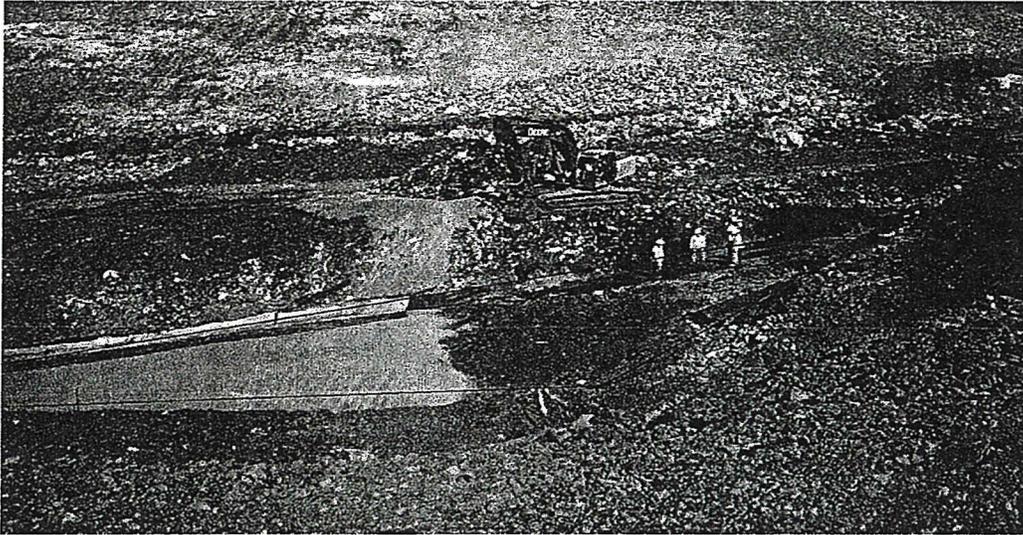
PHOTOGRAPH 2

Site name: Waimanalo Gulch Landfill
Location: 94-460 Farrington Highway
Date taken: January 24, 2011
Photographer: JRuiz
Description: Contractor exposing edge of liner (E-4) and making repairs to E-6 liner at the northeast corner of MSW Cell E-6 (where it joins cell E-4).

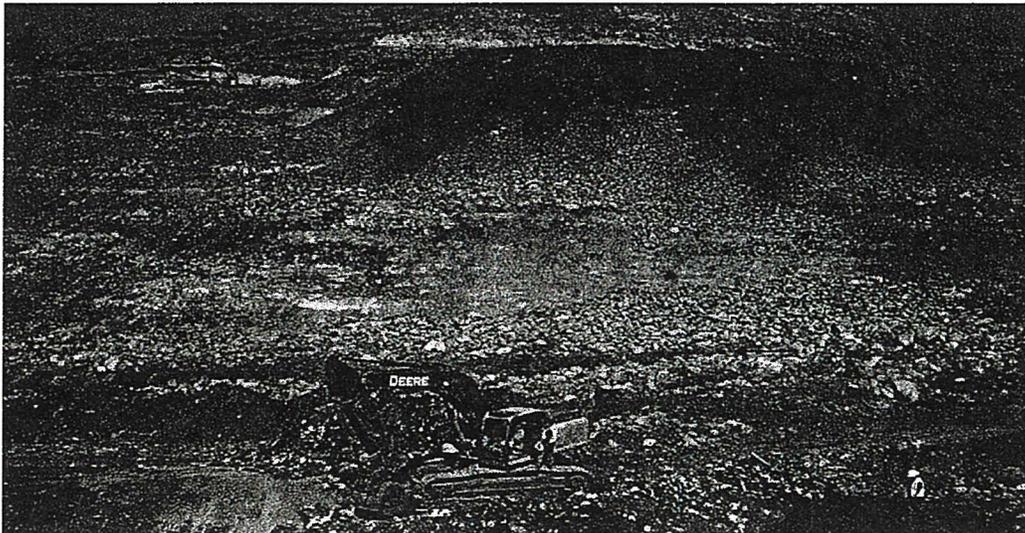
PHOTOGRAPH 3

Site name: Waimanalo Gulch Landfill
Location: 94-460 Farrington Highway
Date taken: January 24, 2011
Photographer: JRuiz
Description: Area of damaged liner in MSW Cell E-6 (red lines)

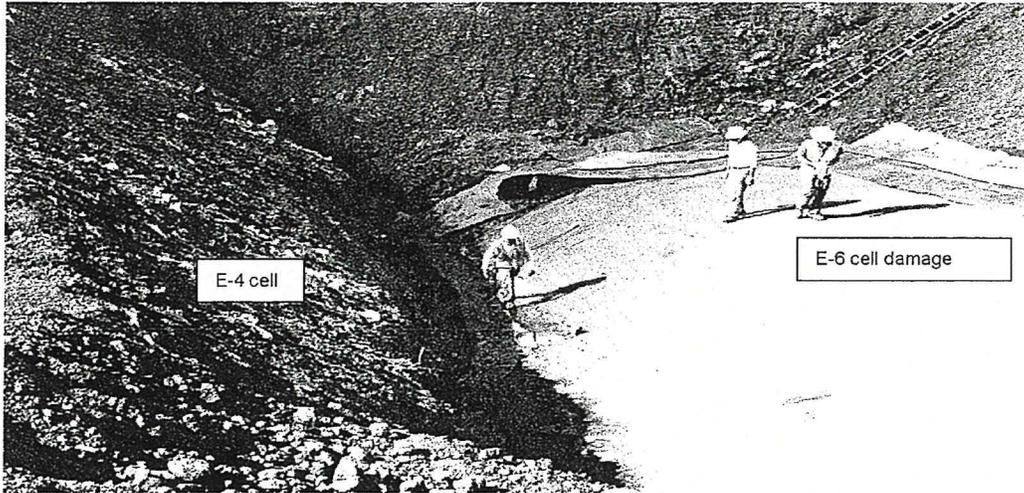
PHOTOGRAPH 4

Site name: Waimanalo Gulch Landfill
Location: 94-460 Farrington Highway
Date taken: January 24, 2011
Photographer: JRuiz
Description: On-going construction of the upper Cell E-6 (blue arrow) has added to the damage sustained by the western portion of Cell E-6 liner (red arrow).
