**WARNING LETTER /  
REQUEST FOR INFORMATION**

SUBJECT: Inspections at Waimanalo Gulch Sanitary Landfill  
Solid Waste Management Permit No. LF-0054-02  
Kapolei, Oahu

### INSPECTION REPORT

**FACILITY NAME:** Waimanalo Gulch MSWLF and Ash Monofill

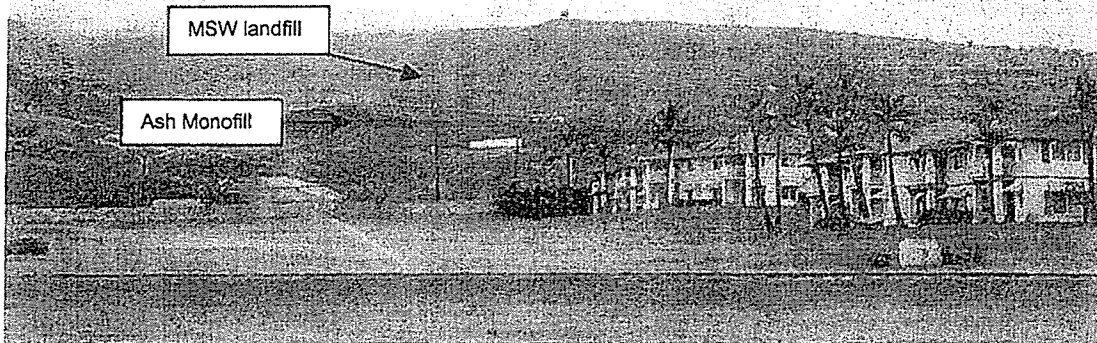
**Photograph 1**

**Site Name:** Waimanalo Gulch MSWLF and Ash Monofill  
**Location:** 92-460 Farrington Highway, Kapolei, Hawaii 96707  
**Date Taken:** March 14, 2007  
**Photographer:** JRuiz  
**Description:** View of the ash monofill and MSW landfill from KoOlina.

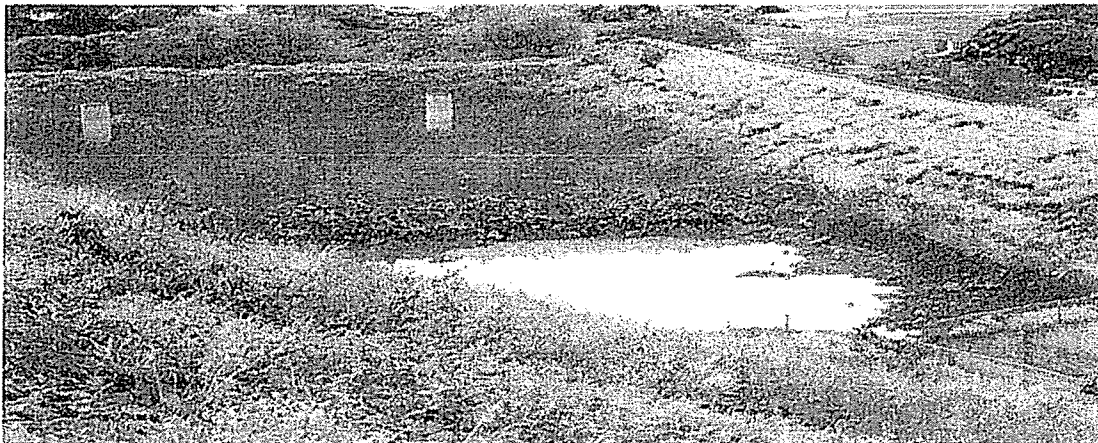
**Photograph 2**

**Site Name:** Waimanalo Gulch MSWLF and Ash Monofill  
**Location:** 92-460 Farrington Highway, Kapolei, Hawaii 96707  
**Date Taken:** March 14, 2007  
**Photographer:** JRuiz  
**Description:** Siltation pond area with some rainwater from previous day rain.

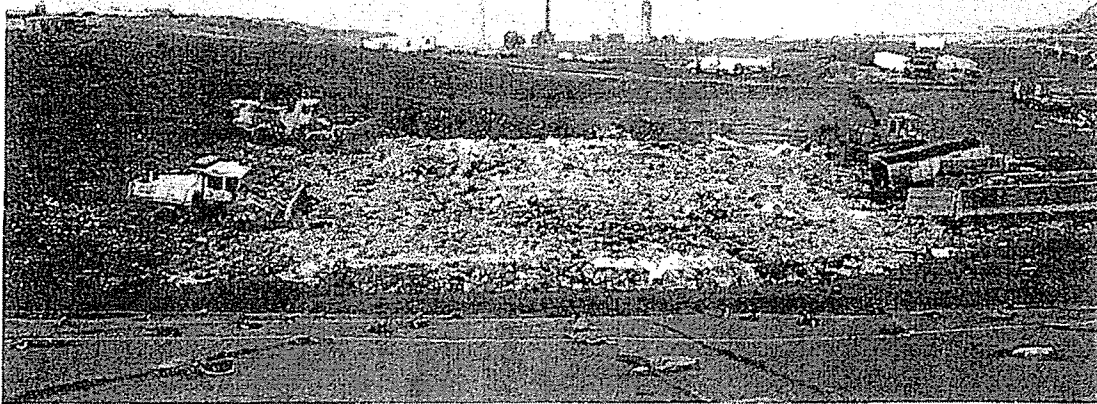
**Photograph 3**

On March 14, 2007, SWS inspectors observed two compactors and one dozer working the active workforce area of MSW Cell E-3 (see photograph 3) during H-Power partial diversion. The workforce area was adequately compacted and maintained to a workable size by operators. Litter fences were observed around the perimeter of the cell without accumulated litter and were adequately maintained.

**Site Name:** Waimanalo Gulch MSWLF and Ash Monofill  
**Location:** 92-460 Farrington Highway, Kapolei, Hawaii 96707  
**Date Taken:** March 14, 2007  
**Photographer:** JRuiz  
**Description:** View of the active workforce (Cell E-3) area for MSW during partial diversion from H-Power with two compactors and one dozer operating the workforce area.

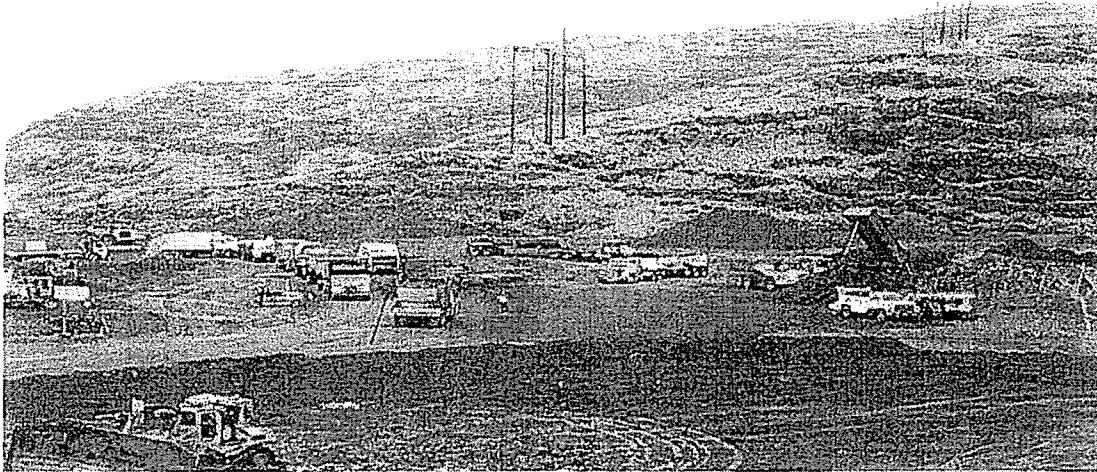
**Photograph 4**

**Site Name:** Waimanalo Gulch MSWLF and Ash Monofill  
**Location:** 92-460 Farrington Highway, Kapolei, Hawaii 96707  
**Date Taken:** March 14, 2007  
**Photographer:** JRuiz  
**Description:** Spotter directing traffic to the workforce area. The ground is muddy due to heavy rain earlier in the day and a mud strip for trucks leaving the workforce is located somewhere within the red arrow.

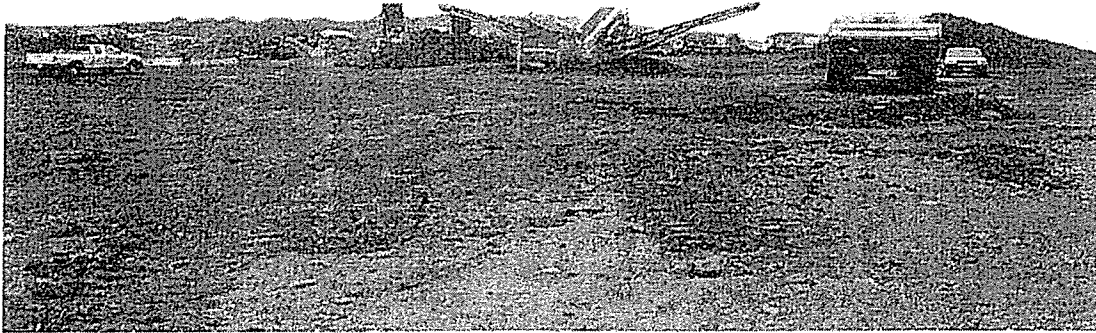
**Photograph 5**

**Site Name:** Waimanalo Gulch MSWLF and Ash Monofill  
**Location:** 92-460 Farrington Highway, Kapolei, Hawaii 96707  
**Date Taken:** March 14, 2007  
**Photographer:** JRuiz  
**Description:** MSW Cell 11 not adequately crowned with soil cover and with potential of ponding water.

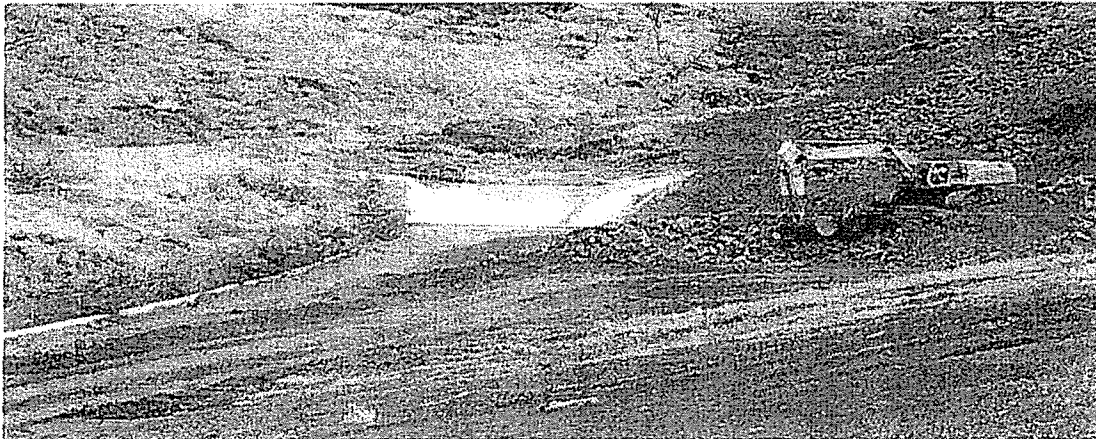
**Photograph 6**

**Site Name:** Waimanalo Gulch MSWLF and Ash Monofill  
**Location:** 92-460 Farrington Highway, Kapolei, Hawaii 96707  
**Date Taken:** March 14, 2007  
**Photographer:** JRuiz  
**Description:** The stormwater channel located at the top side of MSW Cell-11 to divert run on water was previously identified for not having a safety fence around the perimeter of the channel area. As a temporary corrective action, an orange plastic fence has been placed on the perimeter of the stormwater channel area.

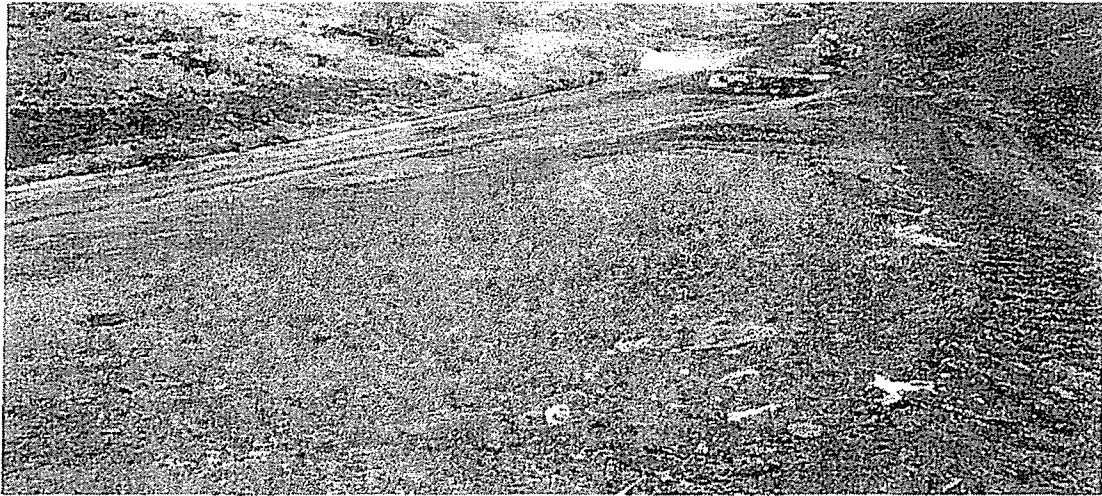
**Photograph 7**

3. Inadequate soil cover was observed on the top deck and side slopes of the east, west and north areas of MSW Cell-11, including part of MSW Cell-10 top deck area. The side slopes and part of the top deck of MSW Cell-11 has since been corrected and covered with soil based on photographs submitted by WMH. SWS has not verified the adequacy of the corrective actions taken by WMH and a follow-up inspection will be conducted in the near future.

**Site Name:** Waimanalo Gulch MSWLF and Ash Monofill  
**Location:** 92-460 Farrington Highway, Kapolei, Hawaii 96707  
**Date Taken:** March 14, 2007  
**Photographer:** JRuiz  
**Description:** A large portion of the northwest side slope of MSW Cell-11 with exposed waste and inadequately covered with intermediate soil.

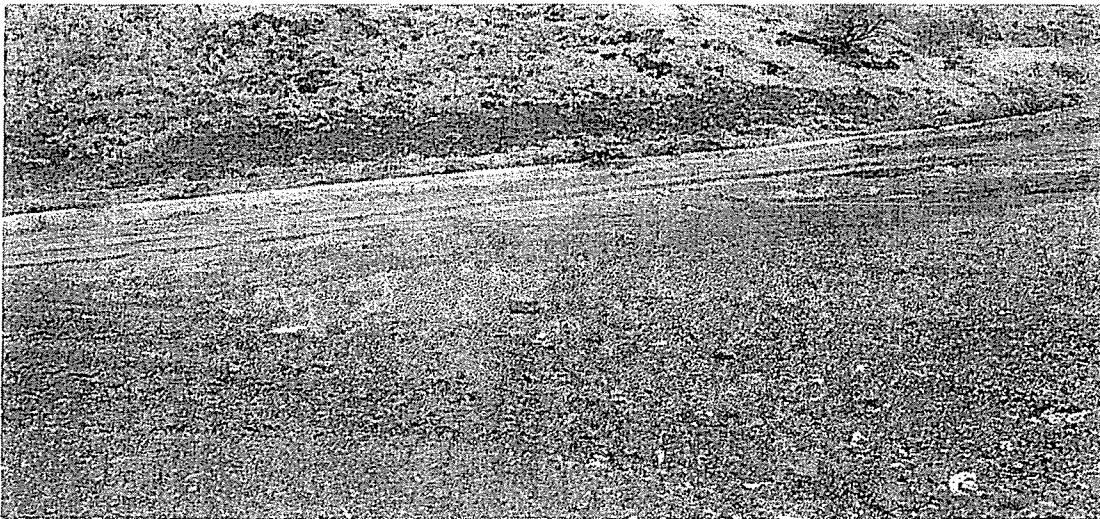
**Photograph 8**

**Site Name:** Waimanalo Gulch MSWLF and Ash Monofill  
**Location:** 92-460 Farrington Highway, Kapolei, Hawaii 96707  
**Date Taken:** March 14, 2007  
**Photographer:** JRuiz  
**Description:** Northwestern side slope of MSW Cell 11 with exposed trash and not adequately covered with intermediate soil.

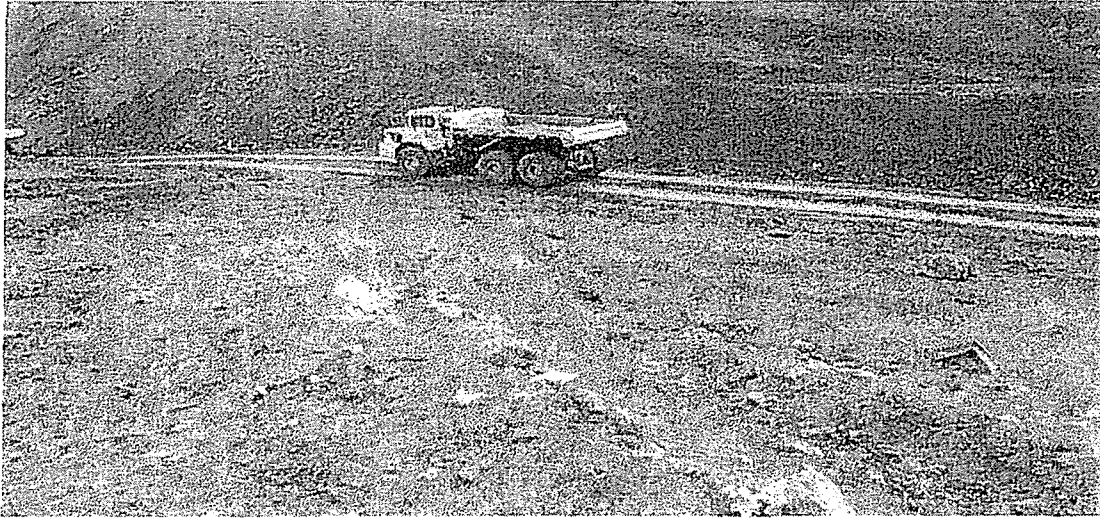
**Photograph 9**

**Site Name:** Waimanalo Gulch MSWLF and Ash Monofill  
**Location:** 92-460 Farrington Highway, Kapolei, Hawaii 96707  
**Date Taken:** March 14, 2007  
**Photographer:** JRuiz  
**Description:** A large portion of the northwest side slope of MSW Cell 11 with exposed trash and other exposed debris.

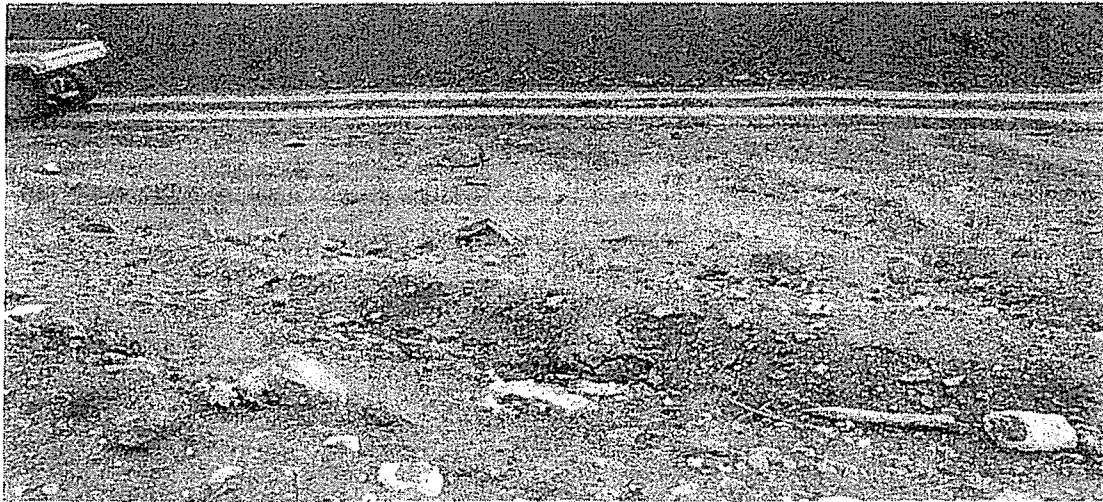
**Photograph 10**

**Site Name:** Waimanalo Gulch MSWLF and Ash Monofill  
**Location:** 92-460 Farrington Highway, Kapolei, Hawaii 96707  
**Date Taken:** March 14, 2007  
**Photographer:** JRuiz  
**Description:** Another view of the northwest side slope of MSW Cell 11 with exposed trash and debris.

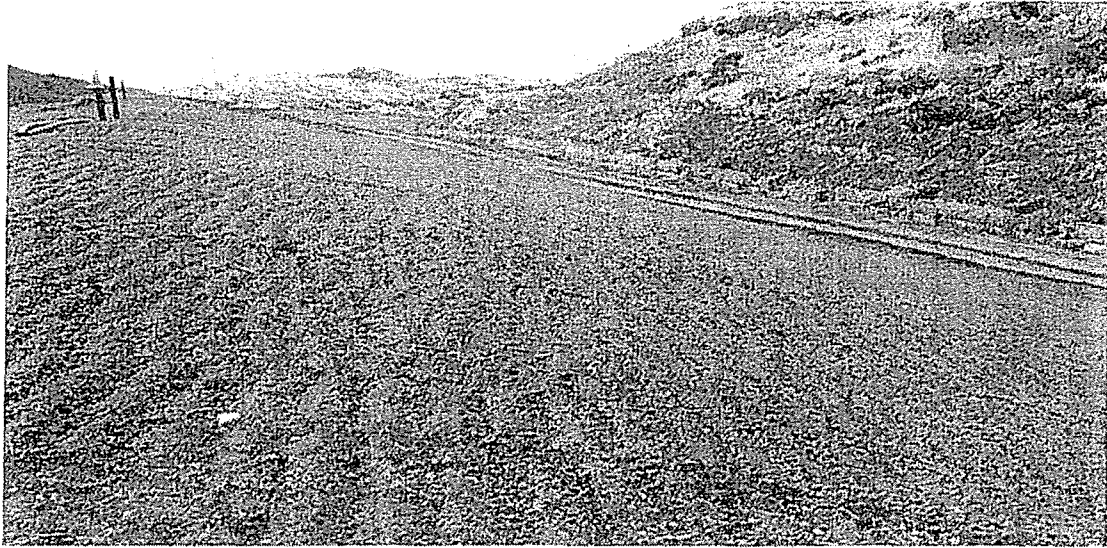
**Photograph 11**

**Site Name:** Waimanalo Gulch MSWLF and Ash Monofill  
**Location:** 92-460 Farrington Highway, Kapolei, Hawaii 96707  
**Date Taken:** March 14, 2007  
**Photographer:** JRuiz  
**Description:** View of the northeast side slope of MSW Cell 10, well covered with intermediate soil and track-walked.

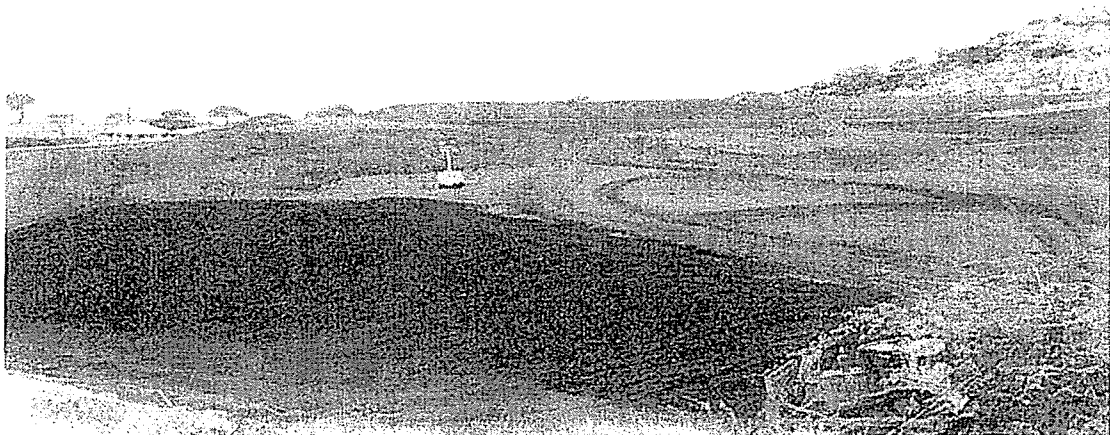
**Photograph 12**

**Site Name:** Waimanalo Gulch MSWLF and Ash Monofill  
**Location:** 92-460 Farrington Highway, Kapolei, Hawaii 96707  
**Date Taken:** March 14, 2007  
**Photographer:** JRuiz  
**Description:** View of Ash Cell-4 workforce area on the background from top of E-2 leachate sump area.

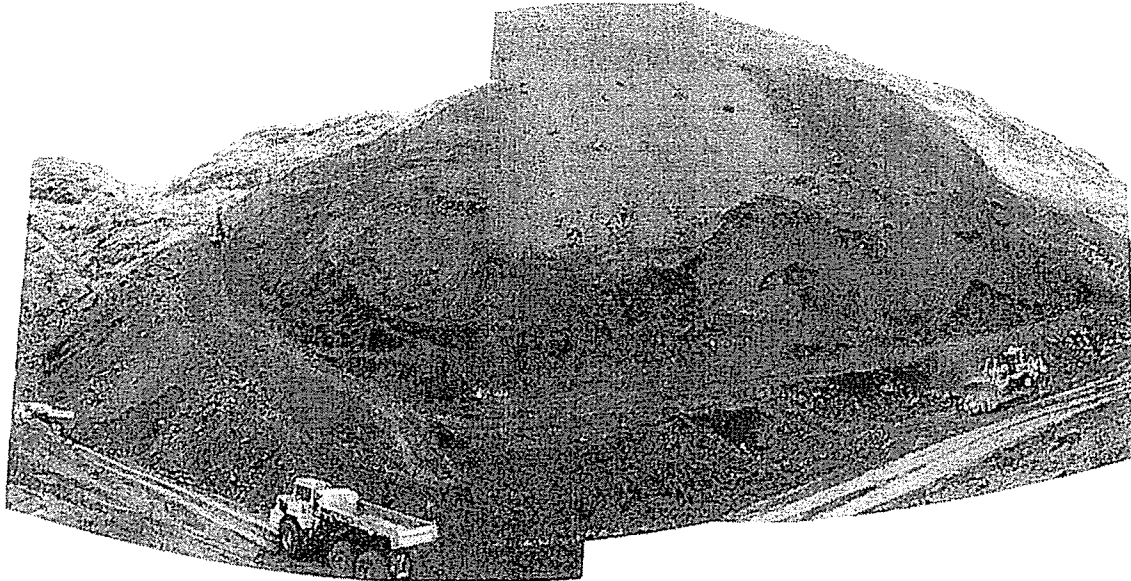
**Photograph 13**

Goodfellow Brothers, Inc., continues with the construction of the new E-4 cell and a large volume of soil was noted being mined from the cell slope (see photograph 13). Due to heavy equipment moving about the top deck of MSW Cell 11 and the new cell being built, part of the east, west and north slope areas of MSW Cell 11 were noted without adequate soil cover (see photographs 7-10). In addition, the top deck of MSW Cell 10/11 requires additional soil cover and crowned to prevent ponding water and promote water run-off (see photograph 5). The northeast side slope of MSW Cell 10 was adequately covered with intermediate soil and track-walked (see photograph 11). North, east, and west slopes of MSW Cell 11 were covered with soil and track-walked and photograph documented as of March 29, 2007, per e-mail received March 29, 2007 from Ms. Pankenier. In addition, Goodfellow Brothers Inc. is presently working on corrective actions for MSW Cell 10 to improve the grade in the area to promote water run-off. The repairs and corrective actions taken by WMH have not been verified by SWS and future inspection of the site will be conducted.

Composite photographs of the E-4 cell slope being mined by Goodfellow Brothers Inc. with large amount of soil cover being excavated from the recently mined area.

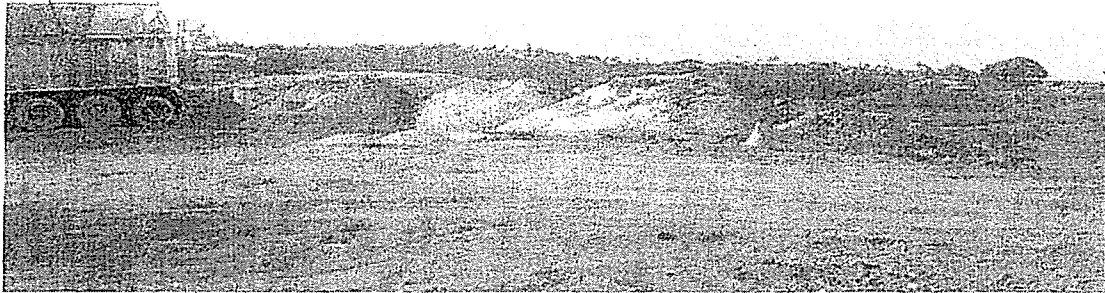
**Photograph 1**

**Ash Monofill landfill:** At the time of inspection, a Covanta truck from H-Power was discharging ash onto the monofill workface area of Cell-2 (see photograph 1). Approximately seven stockpiles of ash had been received at the monofill for the day. The previous workface area located in Cell-8 was covered the day before with intermediate soil and appears to satisfy permit conditions (see photograph 2). From top of E-cell leachate sump, a D-6 dozer was observed grading the ash workface area (see photograph 5).

**Site Name:** Waimanalo Gulch MSWLF and Ash Monofill  
**Location:** 92-460 Farrington Highway, Kapolei, Hawaii 96707  
**Date Taken:** March 7, 2007  
**Photographer:** JRuiz  
**Description:** Ash monofill cell workface area in cell-2, after the inspection the ash stockpile was graded with a D-6 dozer.

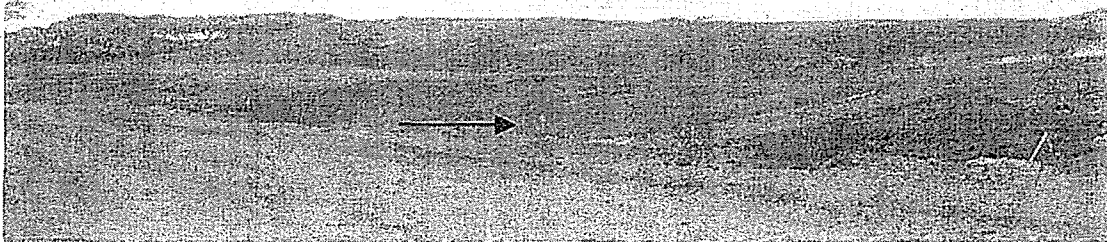
**Photograph 2**

**Site Name:** Waimanalo Gulch MSWLF and Ash Monofill  
**Location:** 92-460 Farrington Highway, Kapolei, Hawaii 96707  
**Date Taken:** March 7, 2007  
**Photographer:** JRuiz  
**Description:** Former workface area adequately covered the previous day.

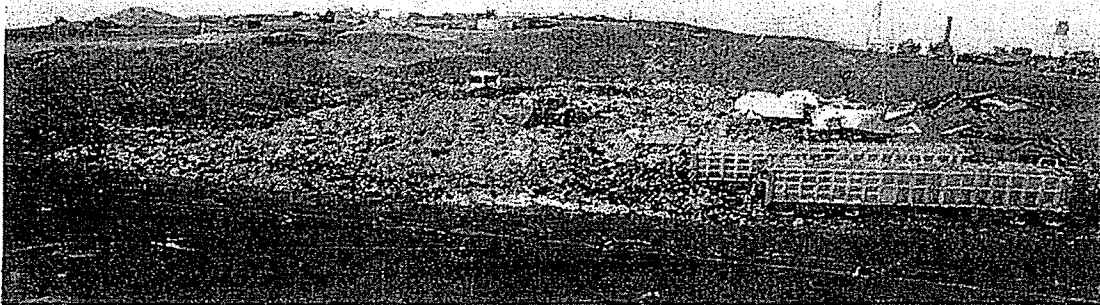
**Photograph 3**

On the morning of March 7, 2007, WMH was scheduled to receive full H-Power solid waste diversion. SWS inspectors observed two dozers (D-7 & D-9) and one bomac compactor working the active workface area of MSW Cell E-3 (see photographs 3& 4). No flying litter was observed from the east ridge of the cell and litter fences were observed and effectively placed for flying litter on the E-Cell perimeter.

**Site Name:** Waimanalo Gulch MSWLF and Ash Monofill  
**Location:** 92-460 Farrington Highway, Kapolei, Hawaii 96707  
**Date Taken:** March 7, 2007  
**Photographer:** JRuiz  
**Description:** MSW Cell E-3 during full H-Power diversion with two dozers and one compactor handling the waste. Litter fences were placed adequately within the cell perimeter.

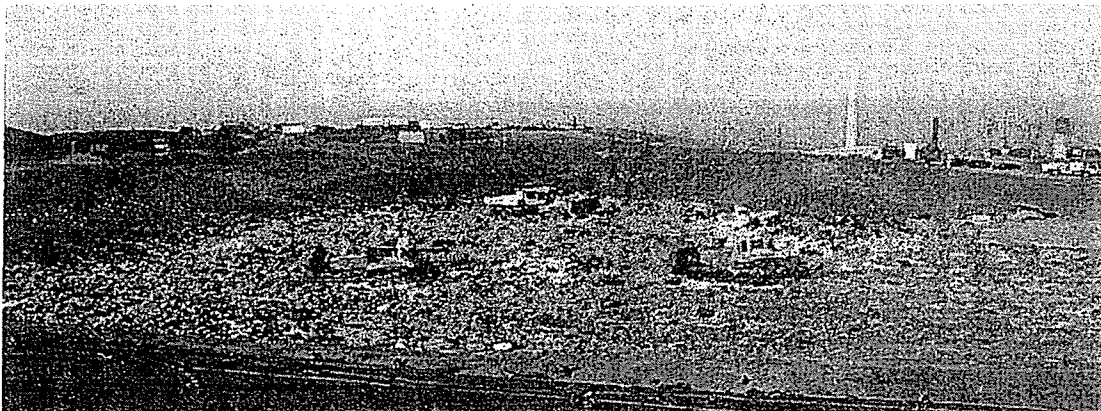
**Photograph 4**

**Site Name:** Waimanalo Gulch MSWLF and Ash Monofill  
**Location:** 92-460 Farrington Highway, Kapolei, Hawaii 96707  
**Date Taken:** March 7, 2007  
**Photographer:** JRuiz  
**Description:** Another view of Cell E-3 workforce area during full H-Power diversion.

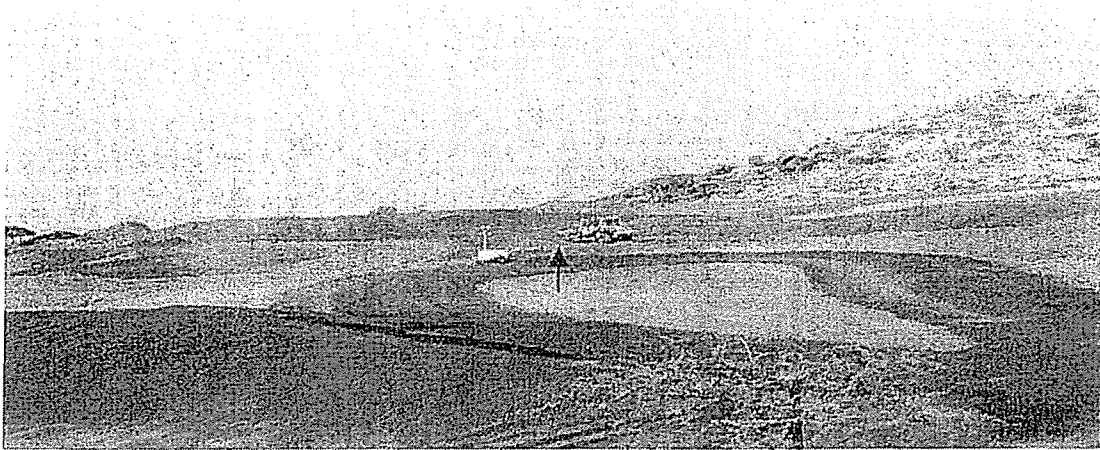
**Photograph 5**

**Site Name:** Waimanalo Gulch MSWLF and Ash Monofill  
**Location:** 92-460 Farrington Highway, Kapolei, Hawaii 96707  
**Date Taken:** March 7, 2007  
**Photographer:** JRuiz  
**Description:** Ash monofill workface area being graded with a D-6 dozer.

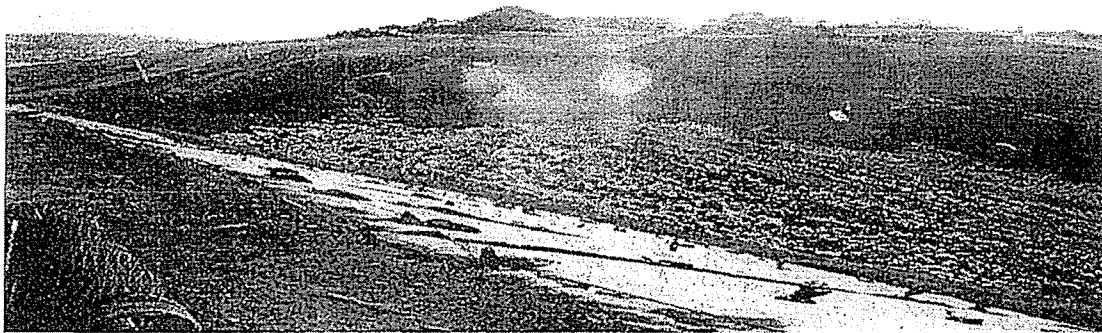
**Photograph 6**

**Site Name:** Waimanalo Gulch MSWLF and Ash Monofill  
**Location:** 92-460 Farrington Highway, Kapolei, Hawaii 96707  
**Date Taken:** March 7, 2007  
**Photographer:** JRuiz  
**Description:** Cell E-3 workface area at 5:00 PM, after landfill closure.

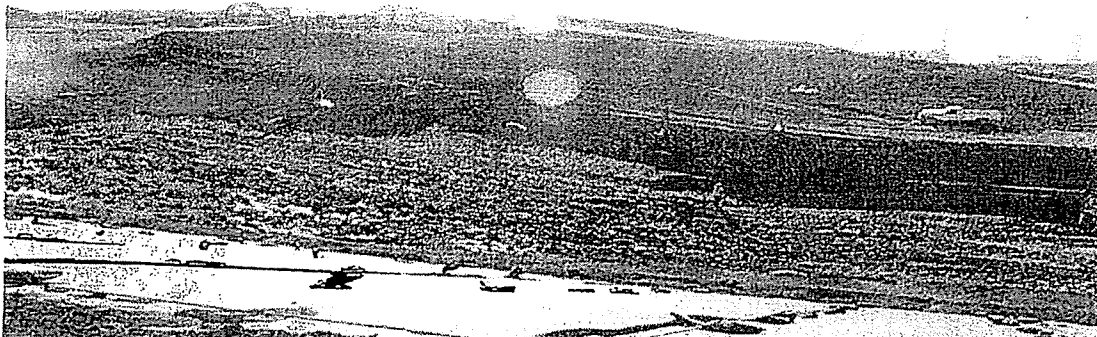
**Photograph 7**

**Site Name:** Waimanalo Gulch MSWLF and Ash Monofill  
**Location:** 92-460 Farrington Highway, Kapolei, Hawaii 96707  
**Date Taken:** March 7, 2007  
**Photographer:** JRuiz  
**Description:** Another view of Cell E-3 with soil cover being placed and litter pickers working the area (arrow).

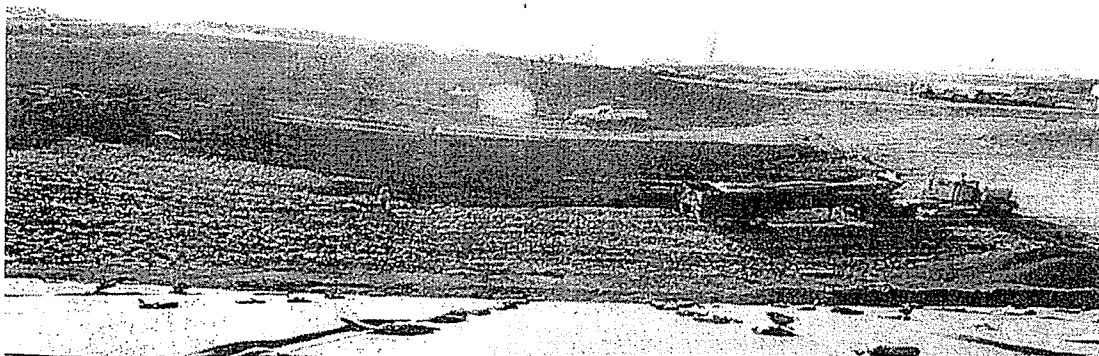
**Photograph 8**

**Site Name:** Waimanalo Gulch MSWLF and Ash Monofill  
**Location:** 92-460 Farrington Highway, Kapolei, Hawaii 96707  
**Date Taken:** March 7, 2007  
**Photographer:** JRuiz  
**Description:** Additional soil cover being delivered to the workforce area at the end of the day.

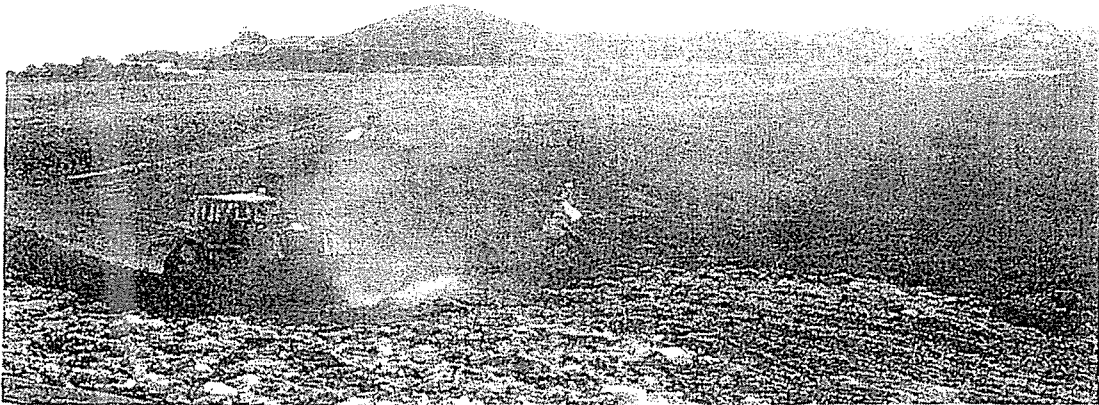
**Photograph 9**

**Site Name:** Waimanalo Gulch MSWLF and Ash Monofill  
**Location:** 92-460 Farrington Highway, Kapolei, Hawaii 96707  
**Date Taken:** March 7, 2007  
**Photographer:** JRuiz  
**Description:** Dozer operator covering the MSW at the end of the day.

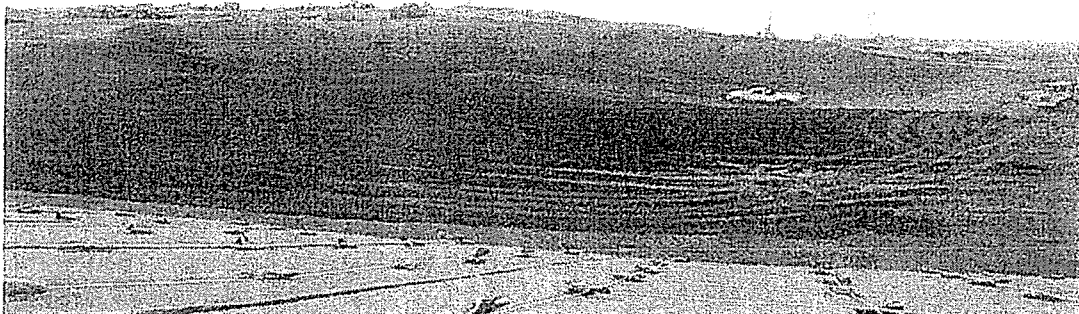
**Photograph 10**

The inspector conducted a second inspection of the landfill after the landfill was closed for the day. The dozer operator had already covered a large portion of the workface area and four litter pickers were observed collecting litter from the covered area (see photographs 6 & 7). Semi-trucks were also observed delivering soil cover to the workface area for daily cover of the workface (see photograph 8). The day's workface area was adequately covered with soil at 6:30 PM (see photograph 10).

**Site Name:** Waimanalo Gulch MSWLF and Ash Monofill  
**Location:** 92-460 Farrington Highway, Kapolei, Hawaii 96707  
**Date Taken:** March 7, 2007  
**Photographer:** JRuiz  
**Description:** MSW Cell E-3 completely covered with adequate soil at the end of the day (6:30 PM).
