**URBAN PHASE III
ARCHAEOLOGICAL
INVENTORY SURVEY
(VOL. III)**

ARCHAEOLOGICAL INVENTORY SURVEY
OF URBAN PHASE III PARCEL
LILI'UOKALANI TRUST LANDS
IN KEAHUOLŪ, NORTH KONA
ISLAND OF HAWAII
[TMK: (3) 7-4-008:002 (por.)]

VOLUME III:
APPENDICES
(Newly Documented Sites, Table of Lava
Excavations, Isolated Finds,
GPS Site Locations)

Prepared by:
Rowland B. Reeve, M.A.
Paul L. Cleghorn, Ph.D.
Tanya Lizama, M.A.
and
Reid Yamasato, B.A.

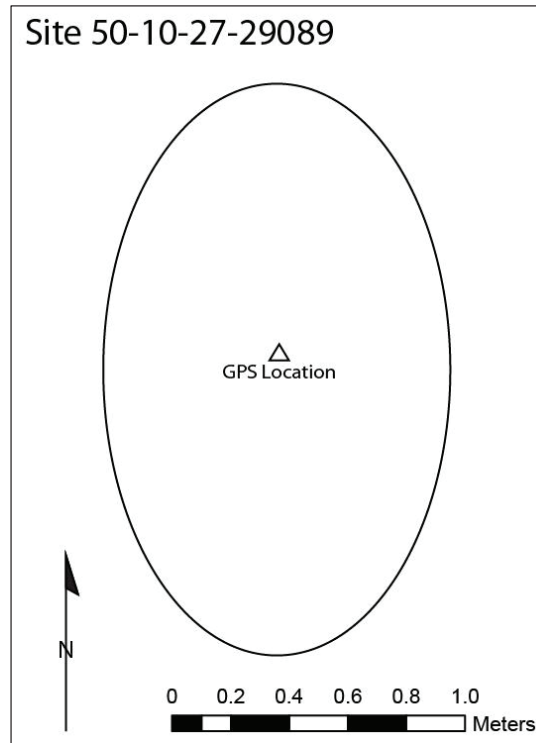
The remnants of the mound appear irregular in shape, comprising a scatter of small to medium sub-angular boulders and cobbles. The scatter of tumbled stones measures approximately 1.96 meters in length (north to south) by ca. 1.18 meters in width (east to west) with a maximum height of ca. 0.23 meters. No cultural material was observed in or around the site. The structure appears to be badly disturbed and its original shape indeterminate. Due to its disturbed condition, it is difficult to determine the mound's original function. It is likely, however, that it may have served as a marker. Site 29089 appears to be pre-Contact and/or early post-Contact in age.

Figure C.3. GPS-based map of Site 50-10-27-29089 stone mound.

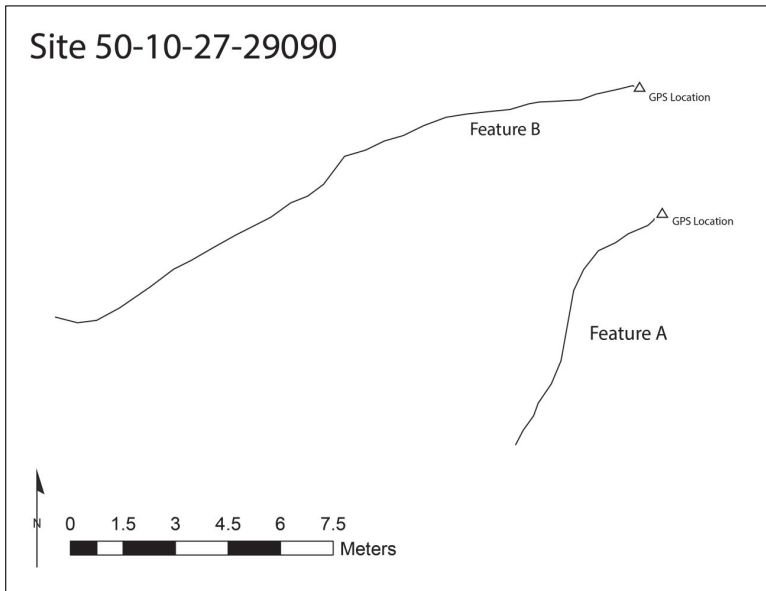
Both Features A and B are roughly linear trail segments that cross over a finger of rough 'a'ā lava connecting one area of *pāhoehoe* lava with another area of *pāhoehoe*. The trails are narrow and are constructed of crushed 'a'ā clinkers with some *pāhoehoe* slabs placed as stepping stones. Features A and B run roughly parallel but are oriented at a slight angle from each other. Both trails run roughly northeast to southwest. The northeast end of Feature A is approximately 3.39 meters south (170°) from the northeast end of Feature B. No surface cultural material was observed at or around the trail segments. Site 29090 is fair to good condition. Some lava excavations were noted to the southwest and northeast of the trail segments, but these do not appear to be directly associated with the trail. Additional trail segments (Sites 29091 and 29092) have been recorded on the western (opposite) side of the QLCC entrance road. These appear to roughly align with Site 29090 and may possibly form part of the same trail system.

Site 29090 was most likely constructed and used during the pre-Contact and/or early post-Contact periods to allow easy access across this rough area of 'a'ā lava. Both trail segments may extend beyond the 'a'ā, but their courses are not visible on the smoother *pāhoehoe*.

Figure C.5. GPS-based map of Site 50-10-27-29090 trail segments.

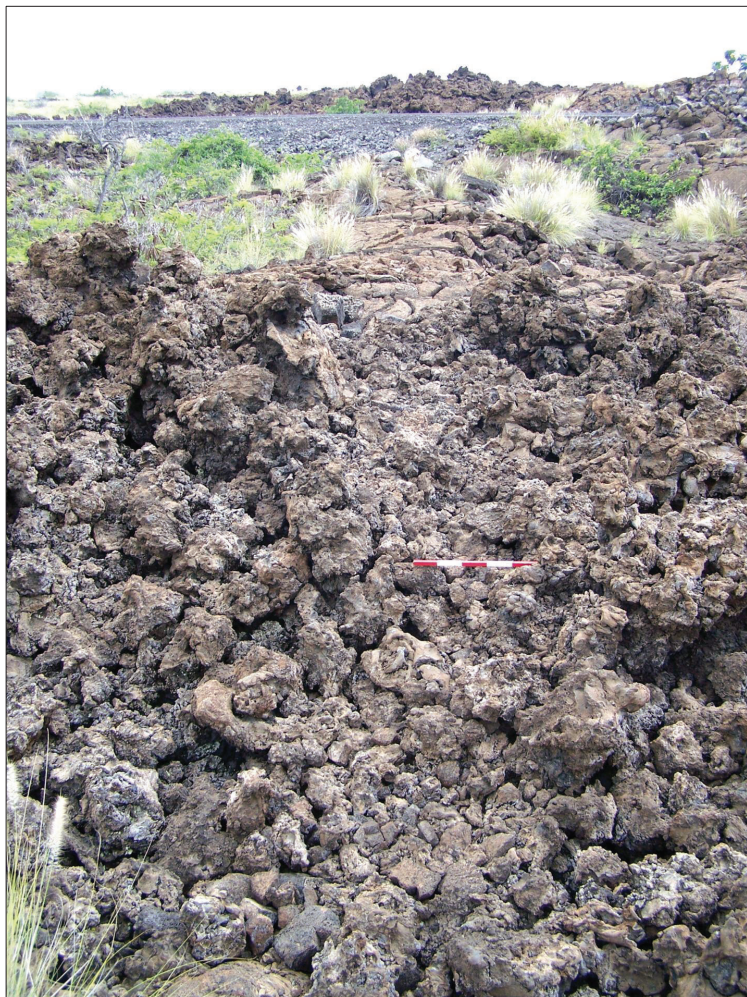
No cultural material was observed in or around the feature. Feature A is in good condition. A few large sub-angular 'a'ā cobbles have tumbled into the central stretch of the trail from the surrounding 'a'ā flow. Its location, in a rough 'a'ā flow between two relatively smooth stretches of *pāhoehoe*, suggests that Feature A may have functioned as a foot path used to travel more easily across the rougher 'a'ā lava. The surface of the trail has been crushed and leveled by foot traffic. Based upon its construction style, Feature A may have been built and utilized during the pre-Contact and/or early post-Contact periods.

Figure C.6. Site 50-10-27-29090, Feature A trail segment (view southwest).

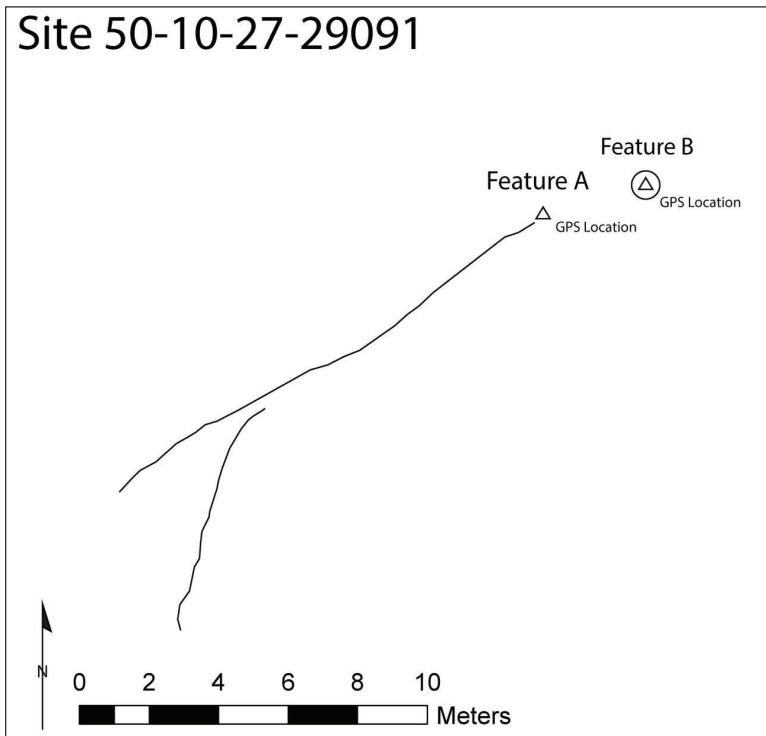
No cultural material was observed in or around the site. Site 29091 is in fair to poor condition. The Feature A trail segment is in fair condition and contains a few boulders that have tumbled in from previous bulldozing along the southwestern end of the trail. The Feature B stone mound is in poor condition and contains tumble in all directions.

Based on its construction and location, Site 29091 appears to have been built and utilized during the pre-Contact and/or early post-Contact periods. Considering the close proximity of Feature B to Feature A, it is possible that the stone mound may have served as a marker for the trail.

Figure C.8. GPS-based map of Site 50-10-27-29091 complex.

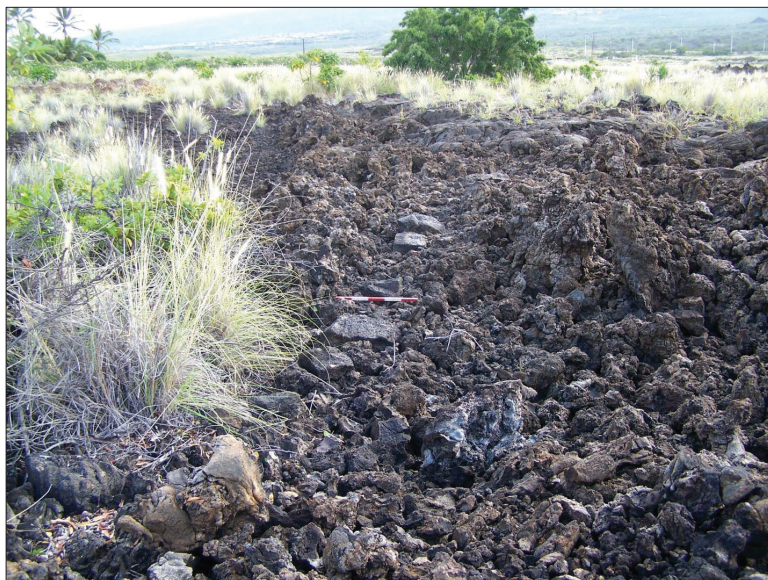
No cultural material was observed in or around the feature. The trail is in fair condition. However, there are a few small boulders that have tumbled onto the trail due to bulldozing at the southwestern end of the main trail.

Feature A was most likely constructed to allow for travel across a stretch of rough 'a'ia lava. Its construction style suggests that this footpath was built and utilized during the pre-Contact and/or early post-Contact periods.

Figure C.9. Site 50-10-27-29091, Feature A trail segment (view northeast).

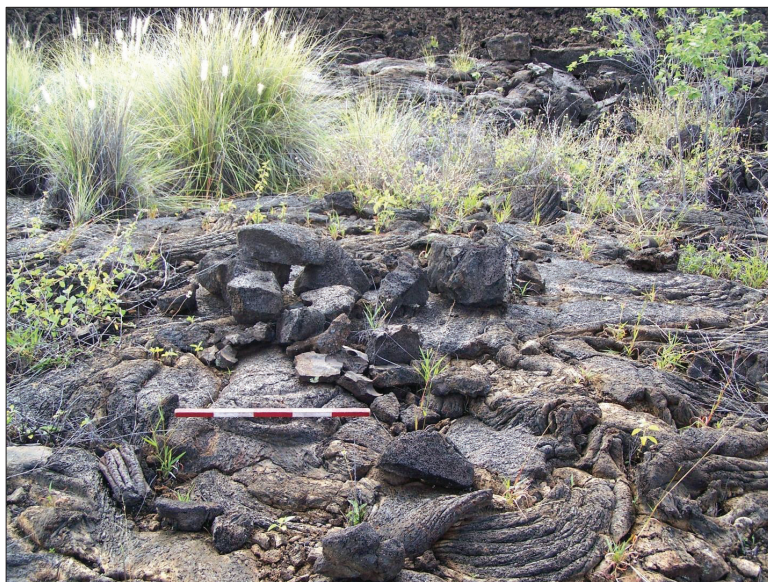
The remnants of the stone mound consist of a scatter of small to medium sub-angular basalt boulders and large *pāhoehoe* cobble slabs. The original mound appears to have measured approximately 0.75 meters (north to south) by ca. 0.70 meters (east to west). The original height of the mound could not be determined, but its current maximum height measures ca. 0.29 meters. No cultural material was observed in or around the feature. Feature B is in poor condition and the mound has been badly tumbled in all directions, with the majority of tumble on the south side.

Due its close proximity to the Feature A trail segment, it is likely that the mound may have served as a marker for the trail. This association suggests that the Feature B mound was built and utilized during the pre-Contact and/or early post-Contact periods.

Figure C.10. Site 50-10-27-29091, Feature B stone mound (view east).

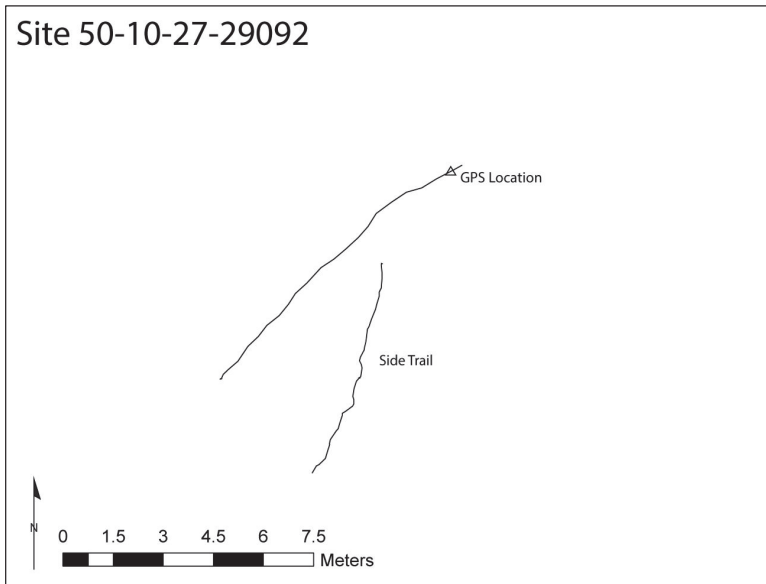
No surface cultural material was observed at or around the Site 29092 trails, which are both in good condition. The main Site 29092 trail appears to be aligned with the Site 29090 and Site 29091 trail segments, which are located to the northeast and southwest respectively. These three trail segments may form part of a single larger trail which is only visible where it crosses stretches of rougher 'a'ā lava. It appears that these trail segments were most likely constructed and utilized during the pre-Contact and/or early post-Contact periods for travel over rough sections of 'a'ā lava.

Figure C.11. GPS-based map of Site 50-10-27-29092 trail segment.

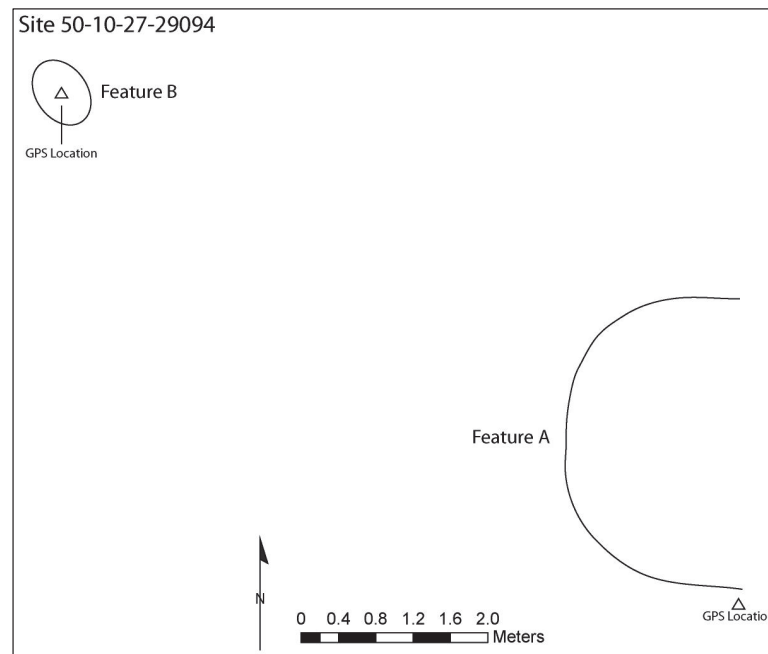
Description: Site 50-10-27-29094 is a complex consisting of two features: a remnant C-shaped alignment (Feature A) and a badly disturbed stone mound (Feature B) (Figure C.14). The site is located in the eastern portion of the project area, in the center of a large depression caused by the collapse of a large lava tube. It is situated approximately 44 meters northwest (286°) from Site 50-10-27-29093. The surrounding terrain consists of sloping *pāhoehoe* lava with a ground cover of fountain grass.

No cultural material was observed in or around the site. Site 29094 is in poor condition and both Features A and B appear tumbled and disturbed.

The function of Feature A is uncertain. The alignment strongly resembles temporary windbreak shelters located elsewhere in the project area. The ground surface within the C-shape alignment, however, is somewhat broken and uneven, making it an uncomfortable area for a shelter. It is possible that the fracturing of the underlying lava took place during seismic activities, which occurred after the abandonment of the feature. In this case, Feature A may well have served as a very crude windbreak shelter. Based on its construction style, Feature B may have functioned as a possible marker. However, what the mound was marking remains unclear. It appears likely that both features of Site 29094 may have been built and utilized during the pre-Contact and/or early post-Contact periods.

Figure C.14. GPS-based map of Site 50-27-29-29094 complex.

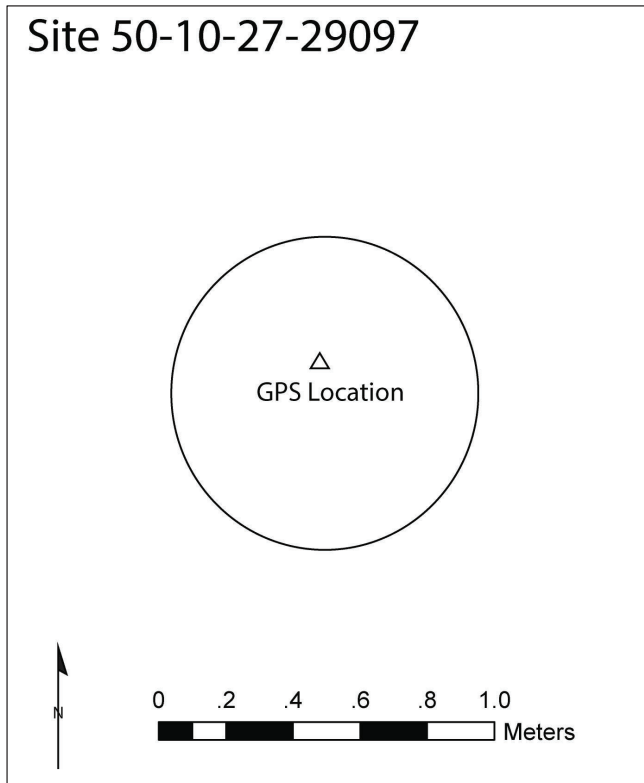
The Site 29097 stone mound is constructed of very loosely piled small to medium sub-angular basalt *pāhoehoe* boulders. The original shape of the mound could not be determined due to its poor condition. In its present condition, the mound measures approximately 0.90 meters in length (east to west) by ca. 0.87 meters in width (north to south) with a maximum height of ca. 0.33 meters. No cultural material was observed in or around the site. Site 29097 is in poor condition. The mound is badly disturbed, and many stones have tumbled to the south and southwest. The Site 29097 stone mound may have functioned as a marker that was built and utilized during the pre-Contact and/or early post-Contact period.

Figure C.19. GPS-based map of Site 50-10-27-29097 stone mound.

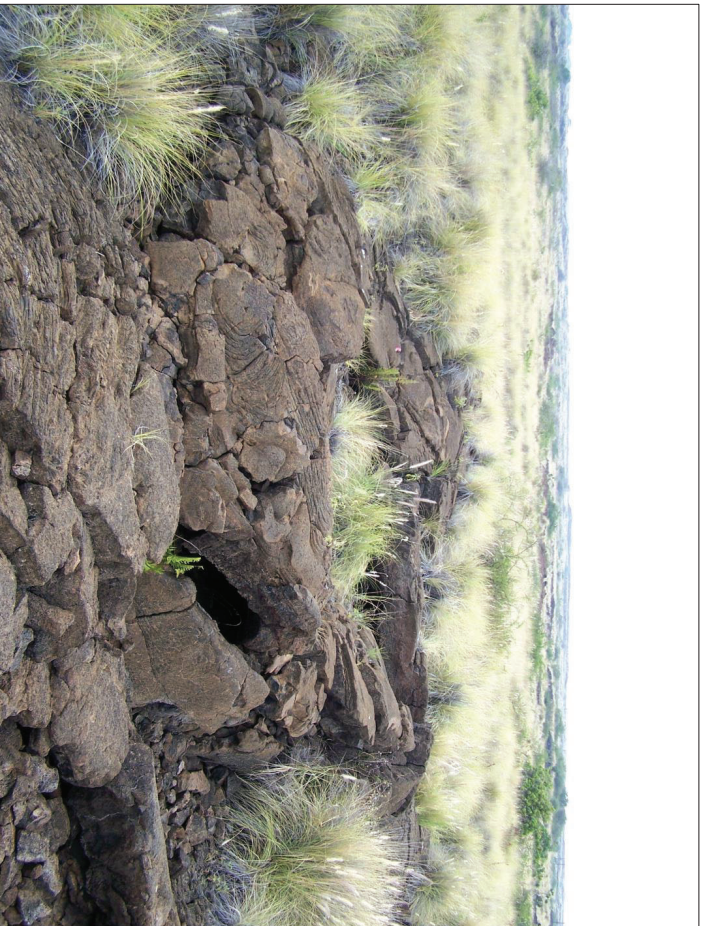
No surface cultural material was noted at the site. Site 29098 is in good condition, and the images are somewhat faint, but fairly visible. The subject matter and style of execution suggest that the petroglyphs at Site 29098 were created during the pre-Contact and/or early post-Contact periods. Why the images at this site consist solely of representations of feet is uncertain, though it may be in some way related to the natural feature that resembles a foot with toes.

Figure C.22. Site 50-10-27-29098 collapsed lava blister with petroglyphs (view northwest).

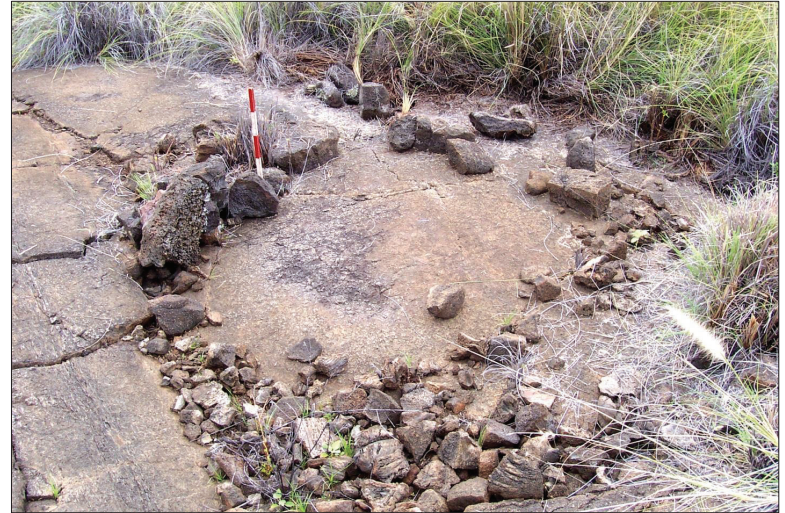
No surface cultural material was observed at this feature. Site 29099, Feature A is in poor condition.

Feature A was most likely built and occupied as a temporary shelter during the pre-Contact and/or early post-Contact periods. The larger stones along its southern edge may originally have been loosely stacked to serve as a windbreak or may have held down the edge of a mat or other perishable shelter.

Figure C.28. Site 50-10-27-29099, Feature A enclosure (view southwest).

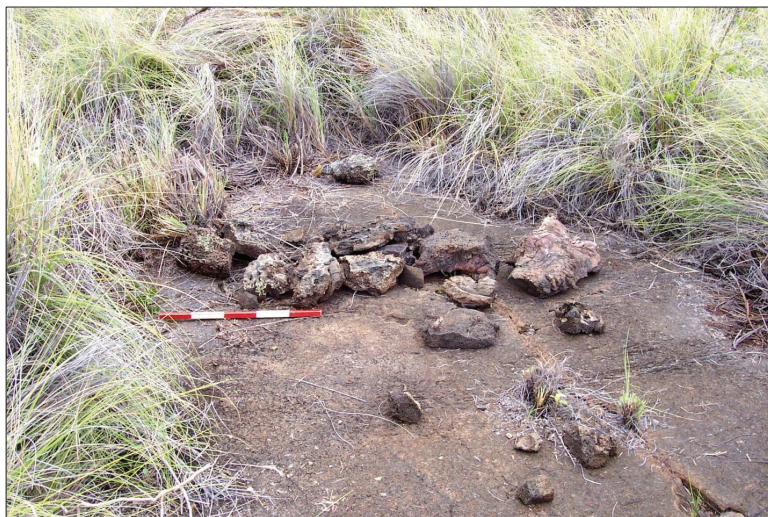
No cultural material was observed in or around the alignment. Feature B is in fair condition and appears to be slightly disturbed with some stones scattered around it. The Feature B alignment may have been used as a small, temporary windbreak shelter or the base of a perishable shelter during the pre-Contact and/or early post-Contact periods.

Figure C.29. Site 50-10-27-29099, Feature B alignment (view south).

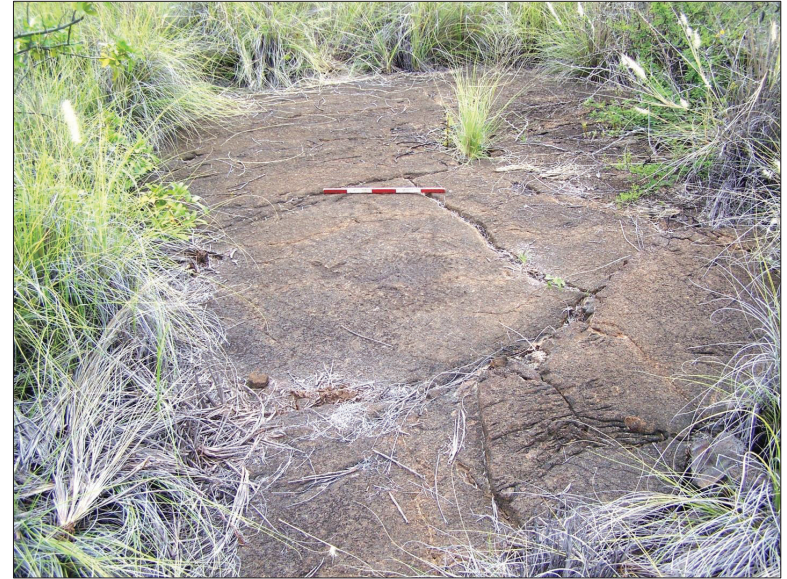
No cultural material was observed at Feature D. The petroglyphs are in fair condition. It is unclear exactly what the deeper of the two images represents, although the fainter image may have originally been a portion of a human figure. Both images may possibly date from the pre-Contact and/or early post-Contact periods.

Figure C.31. Site 50-10-27-29099, Feature D, one (possibly two) petroglyphs (view northwest).

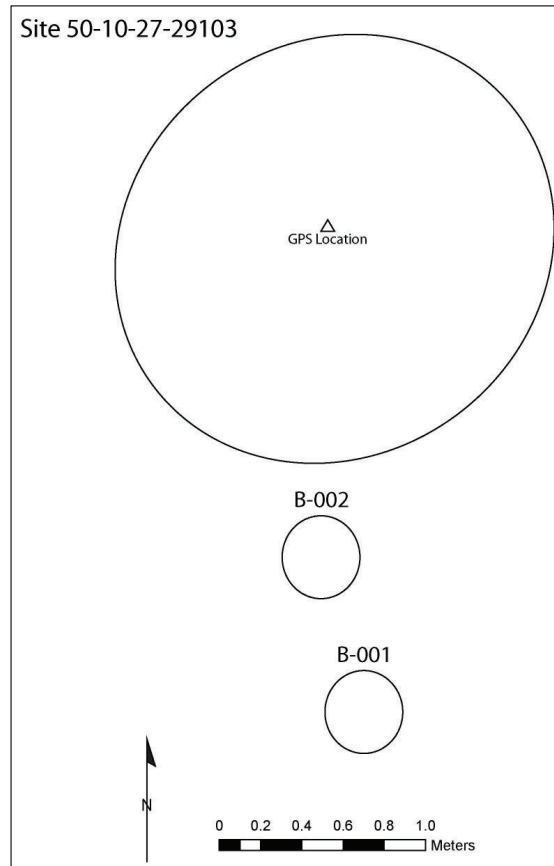
No cultural material was observed in or around the feature. The Site 29103 mound is in poor condition and appears to be completely collapsed, with tumbling in all directions. Due to its disturbed condition, it is difficult to determine the mound's original function. It is likely, however, that it may have served as a marker. The two areas of battering may be associated with a processing activity conducted at the site during the Pre-Contact and/or early Post-Contact periods, although it is uncertain as to what was being processed.

Figure C.38. GPS-based map of Site 50-10-27-29103 stone mound.

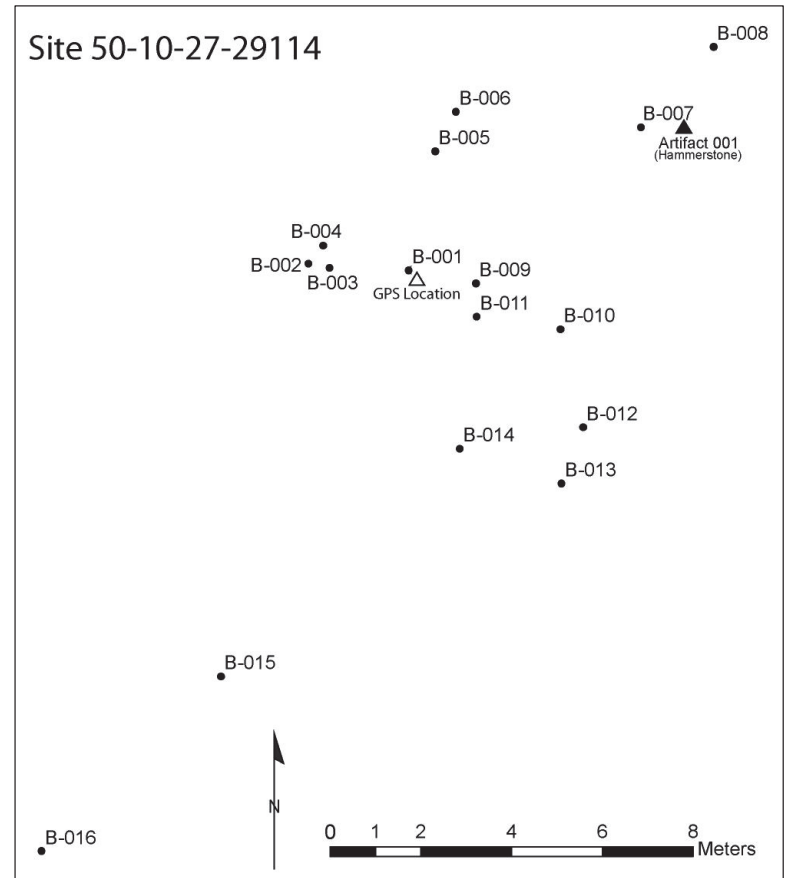
Site 29114 is in fair condition. Bulldozer tracks have scarred the *pāhoehoe* bedrock in the northeastern area of the site. The former Swing Zone driving range has also impacted the southeastern portion of the site. The presence of both circular battering and linear chisel tool marks suggests that Site 29114 was utilized during both the pre-Contact and/or early post-Contact and historic periods. The vast amount of battering and the presence of a boulder hammerstone suggest that the site may be associated with some processing activity. It is uncertain, however, what kind of processing took place here. It is possible that during the pre-Contact and/or early post-Contact periods, endemic plants used for fish poisoning grew in the vicinity, and this area served as a place for processing the fish poison plant by pounding it. This, however, would not appear to account for the linear chisel marks.

Figure C.64. GPS-based map of Site 50-10-27-29114 battering.

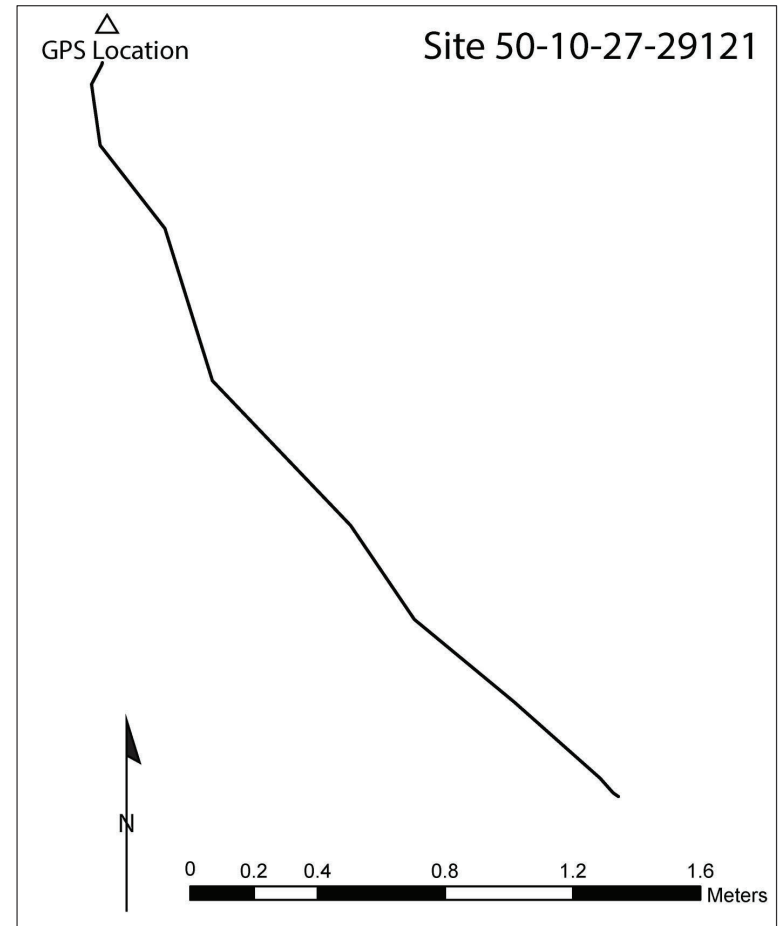
No cultural material was observed. Site 29121 is in poor condition and appears to have been badly disturbed. Due to its poor condition, it is difficult to determine the original shape of this structure. It is likely, however, that this linear alignment may have served as a temporary windbreak shelter during the pre-Contact and/or early post-Contact periods.

Figure C.80. GPS-based map of Site 50-10-27-29121 stone alignment.

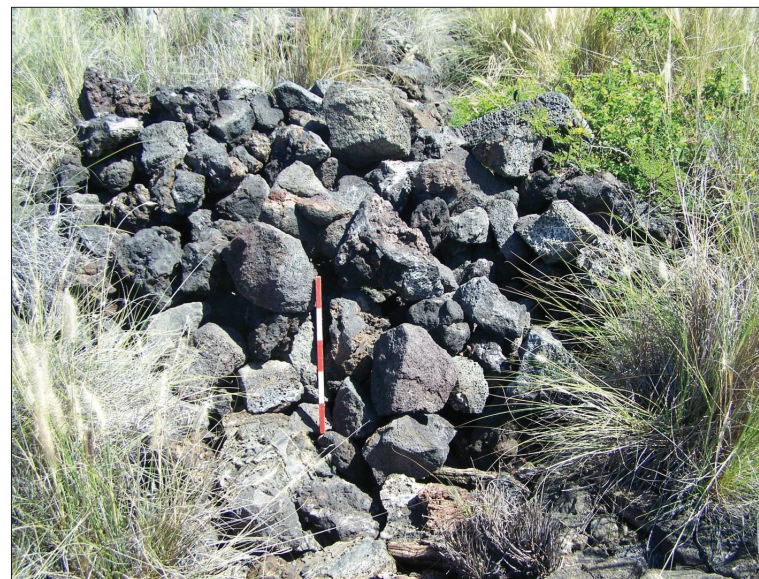
No cultural material was observed around the site, but modern rubbish is present throughout the area. Feature A is in good condition, and the mound appears to be jumbled as opposed to collapsed or tumbled. There is evidence of high amount of bulldozing just southwest of the site area. The close proximity to the dozing activity and non-local material of the mound, with the presence of modern rubbish, suggest that this mound is modern, though its function remains unclear.

Figure C.90. Site 50-10-27-29125, Feature A, stone mound (view north).

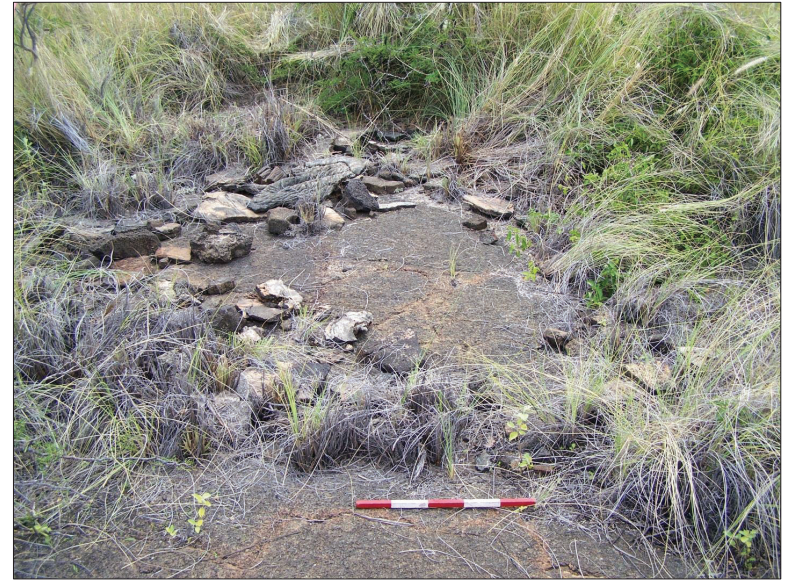
Figure C.150. Site 50-10-27-29147, Feature A, badly disturbed enclosure (view west).

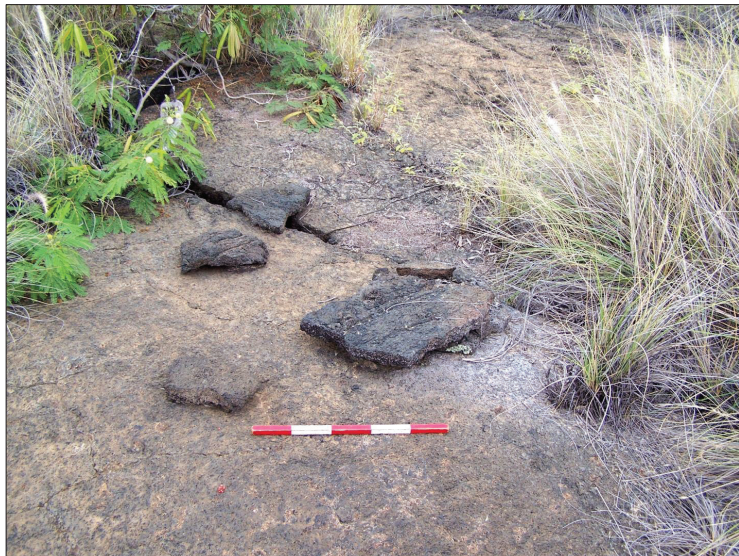
Figure C.205. Site 50-10-27-29173 Feature A, remnant stone mound (view southeast).
