RE: PUBLICATION OF THE ENVIRONMENTAL ASSESSMENT TITLED ADAPTATION PATHWAYS: SEAWALL REMOVAL AND DUNE RESTORATION

Adaptation Pathways: Seawall Removal and Dune Restoration

Draft environmental assessment and anticipated finding of no significant impact (DEA-AFNSI)

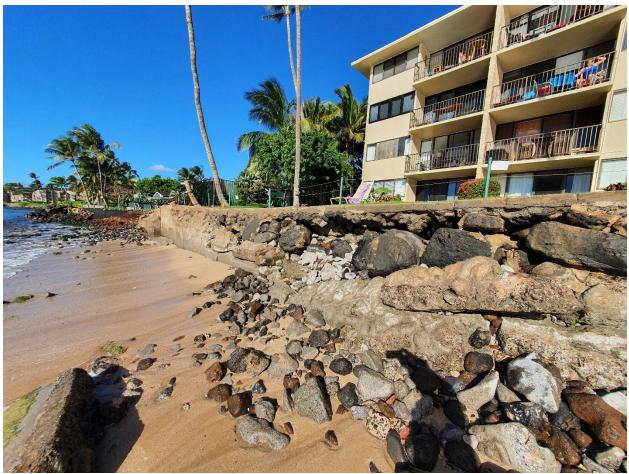
Figure 3: Shoreline Section 1 (east)

Section 1 consists of approximately 90 linear feet of shoreline that is fronted by a CRM seawall. The seawall is approximately 30 to 35 feet seaward of the west wing of the Kanai A Nalu building.. The seawall is approximately 5 to 6 feet high and appears to be constructed of mortared stone for the top 2 to 3 feet of wall height with a combination of precast concrete pavers and cast-in-place concrete fill at the lower 2 to 3 feet. It appears that the concrete fill was added to address undermining of the original stone wall as well as missing stones, with possibly more than one layer of concrete fill placed at different times. The wall thickness is unknown.

An approximately 3.5-foot-wide concrete cap has been cast on the top of the wall with the bottom of the stone portion of the wall below extending about 1 foot out beyond the cap on average. It appears this cap may have been cast over a previous cap, possibly to address cracked, displaced or missing portions of the original cap. The center portion of the concrete cap appears to have sagged downward, indicating the center portion of the wall may have settled downward.

Cracks, separations in the mortar, and voids in portions of the wall are also indicators of wall displacement.

Almost the entire wall length is undermined along the base of the wall, with voids between the bottom of the wall and top of the sand fronting the wall base varying in height from less than an inch to several inches and varying in depth up to several feet in from the front face of the wall. At the time of the site inspection, the beach sand elevation was below the elevation of the base of the seawall exposing the majority of the footing including undermined portions of the seawall foundation. The undermined portion beneath the seawall footing was measured and found to be up to 18 inches in height below the bottom of the footing and extending horizontally up to 12 feet under the footing (measured from the seaward face of the wall). No observable rotation of the seawall was noted. However, vertical deformation (gaps) between the building blocks was measured up to 6 inches.

In summary, the following damages and structural deficiencies were observed in Section 1:

- Erosion and loss of mortar due to weathering and wave action.
- Undermining and void formation due to erosion of loose sandy material.
- Wall displacement and settlement due to loss of subgrade support.
- West adjacent seawall is damaged and appears to be failing.

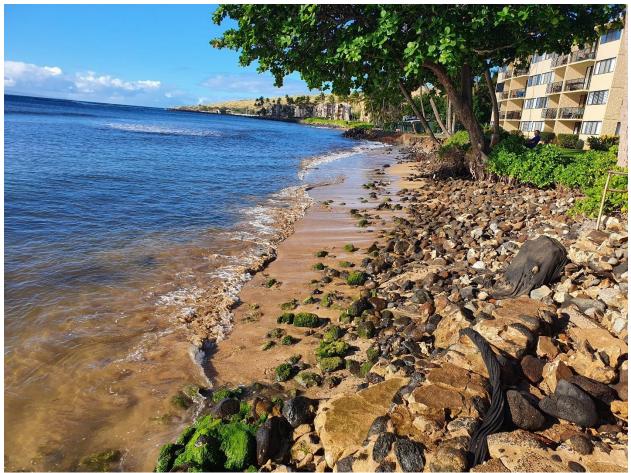
Figure 4: Shoreline Section 2 (middle)

The erosion scarp is approximately 4 to 5 feet above the current sand elevation. There is evidence of undermining, particularly around the tree root structures. In some areas, the undermining extends 4 to 6 feet landward of the edge of the erosion scarp. There is evidence of active erosion and several of the trees located along the edge of the scarp appear to be leaning in a seaward direction, which suggests they are at risk of falling. A pile of loose cobble and debris material

This section of the shoreline was previously fronted by a CRM seawall. The seawall was damaged, and minor repairs were performed in 2006. The seawall ultimately failed and was removed in 2006. The embankment was graded, a small amount of beach fill was added, and the area was replanted with salt-tolerant grass and Naupaka. The erosion scarp currently appears to be relatively stable; however, the undermining appears to be progressive.

In summary, the following issues were observed in Section 2:

- Shore protection failed and was removed.
- Active erosion.
- Undermining due to wave action.
- Loss of backshore soils.

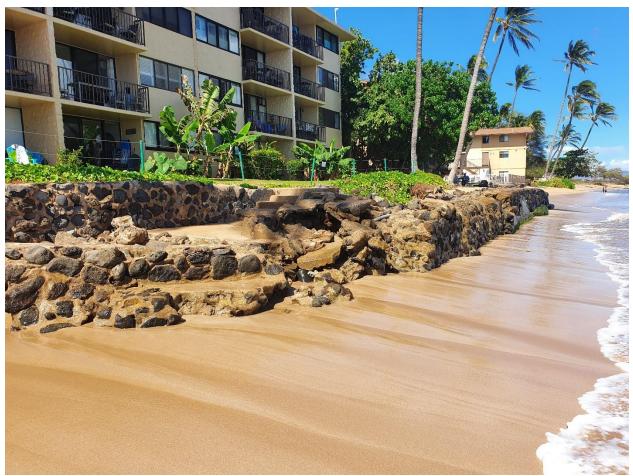
Figure 5: Shoreline Section 3 (west)

The seawall is about 5 to 6 feet high and appears to be constructed of mortared stone for the top 3 to 4 feet of wall height with concrete fill at the lower 1 to 3 feet. It appears that the concrete fill may have been added later to address undermining of the original stone wall as well as missing stones. The thickness of the wall is unknown. A CRM stair leading to the ocean is located at the west end of the wall. Portions of the stairs are undermined, and the stairs and wall are cordoned off for safety.

An approximate 3-foot-wide concrete cap has been cast on the top of the wall with the bottom of the stone portion of the wall below appearing to be nearly plumb with the outside edge of the cap. Some portions of the cap have cracked and become displaced, and some stones have been dislodged, apparently by wave action. An approximate 20-foot portion of the wall east of the stairs is heavily deteriorated, with missing top caps, missing portions of wall, and apparent vertical and lateral displacement of portions of the wall. Similarly, the east end of the wall is cracked and dislodged. Multiple repairs appear to have been performed over the years.

Probing found the bottom of the seaward face of the wall to be several inches below the existing sand elevation. Kanai A Nalu staff reported that the sand has receded in the past to the degree that voids are visible beneath the wall. The depth from the bottom of the wall to a more erosion-resistant layer of substrate is unknown. Under the presumption that the top of the seawall was built at a consistent elevation, portions of the seawall were observed to have settled more than 12 inches. Outward rotation of the seawall was also observed. However, measurement of the amount of rotation was difficult due to the deteriorated condition of the seawall.

In summary, the following damages and structural deficiencies were observed in Section 3:

- Erosion of mortar, cracking, and dislodged stones due to weathering and wave action.
- Vertical and lateral displacement of portions of the wall.
- Undermining due to erosion of the loose sandy material.
- Outward rotation of the seawall.
- East adjacent seawall is damaged and appears to be failing.

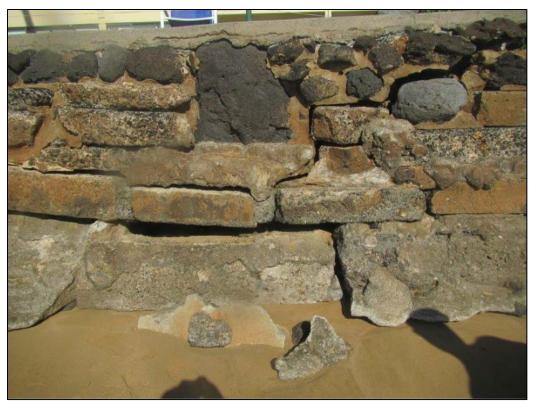
Figure 4-6 Cracks, mortar separation, and voids

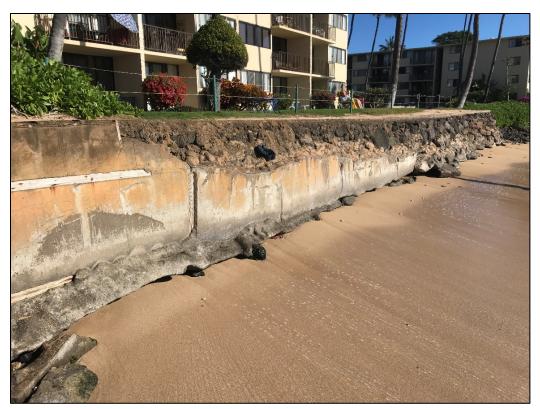
Figure 4-7 Undermining along toe of seawall

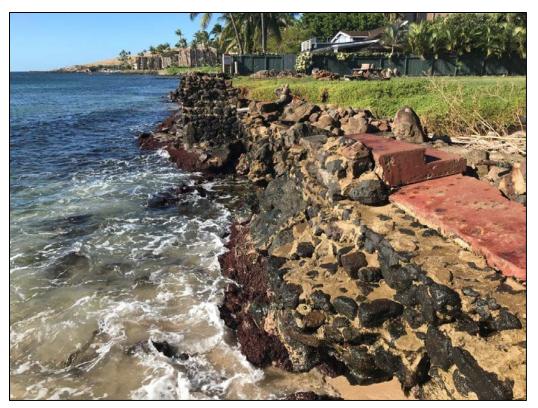
Figure 4-9 Damaged seawall on west adjacent property

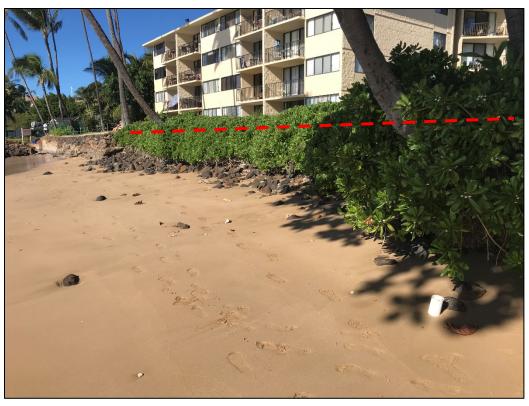
Figure 4-10 Approximate location of erosion scarp (dashed line)

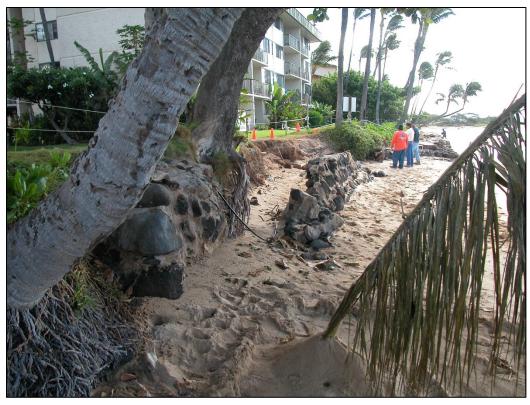
Figure 4-14 Failed seawall section (2009)

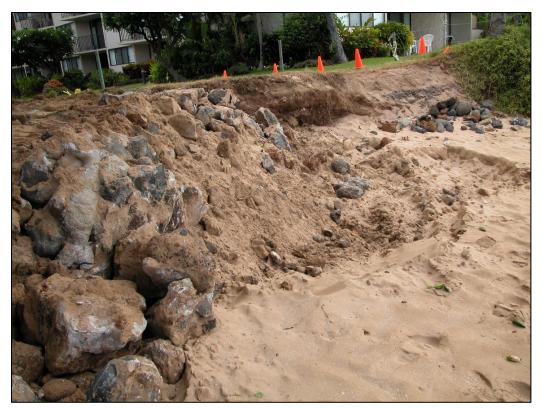
Figure 4-15 Removal of failed seawall section (2009)

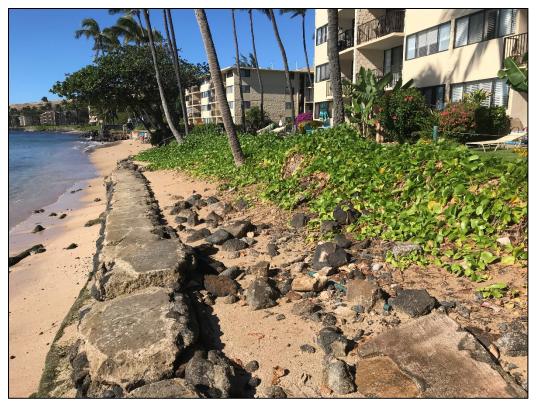
Figure 4-19 Cracking along concrete cap

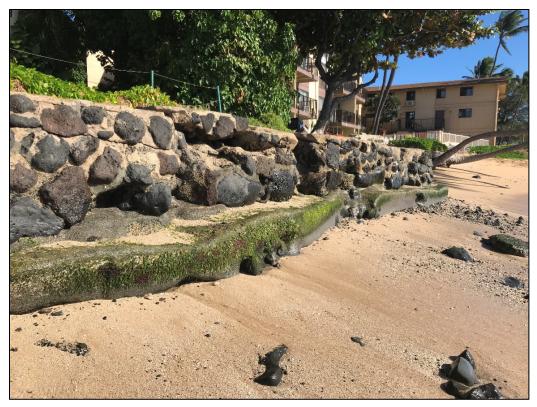
Figure 4-20 Cracking and dislodged stones on seawall face

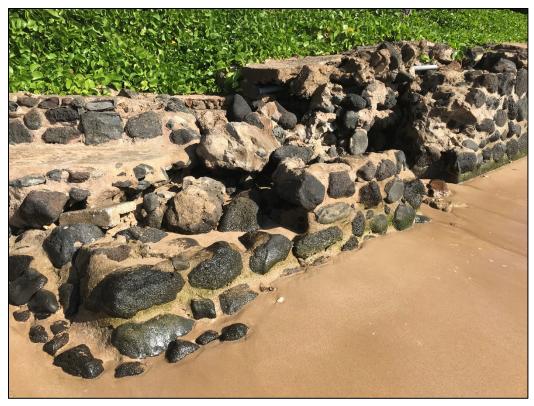
Figure 4-21 Damaged wall section east of CRM stair

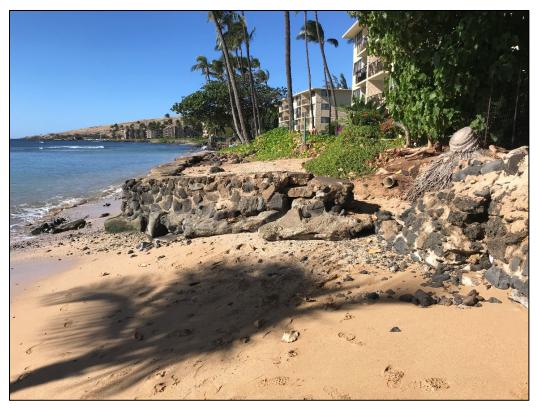
Figure 4-22 Damaged wall section at east end (adjacent seawall is also damaged)
