Recorded Owner/ Applicant	:	Howard Demello
Agent	:	Kathleen M. Douglas
Location	:	54-002 Haukoi Place, Hauula, Oahu
Tax Map Key	:	5-4-12: 16
Request	:	Shoreline Setback Variance
Proposal	:	Repairs to Existing Sea Wall
Determination	:	<u>A Negative Declaration Is Issued</u>

FINAL ENVIRONMENTAL ASSESSMENT

HOWARD AND MARTHA DEMELLO
54-002 HAUKOI PLACE
HAUULA, HAWAII 96717

TMK: 5-4-12:16

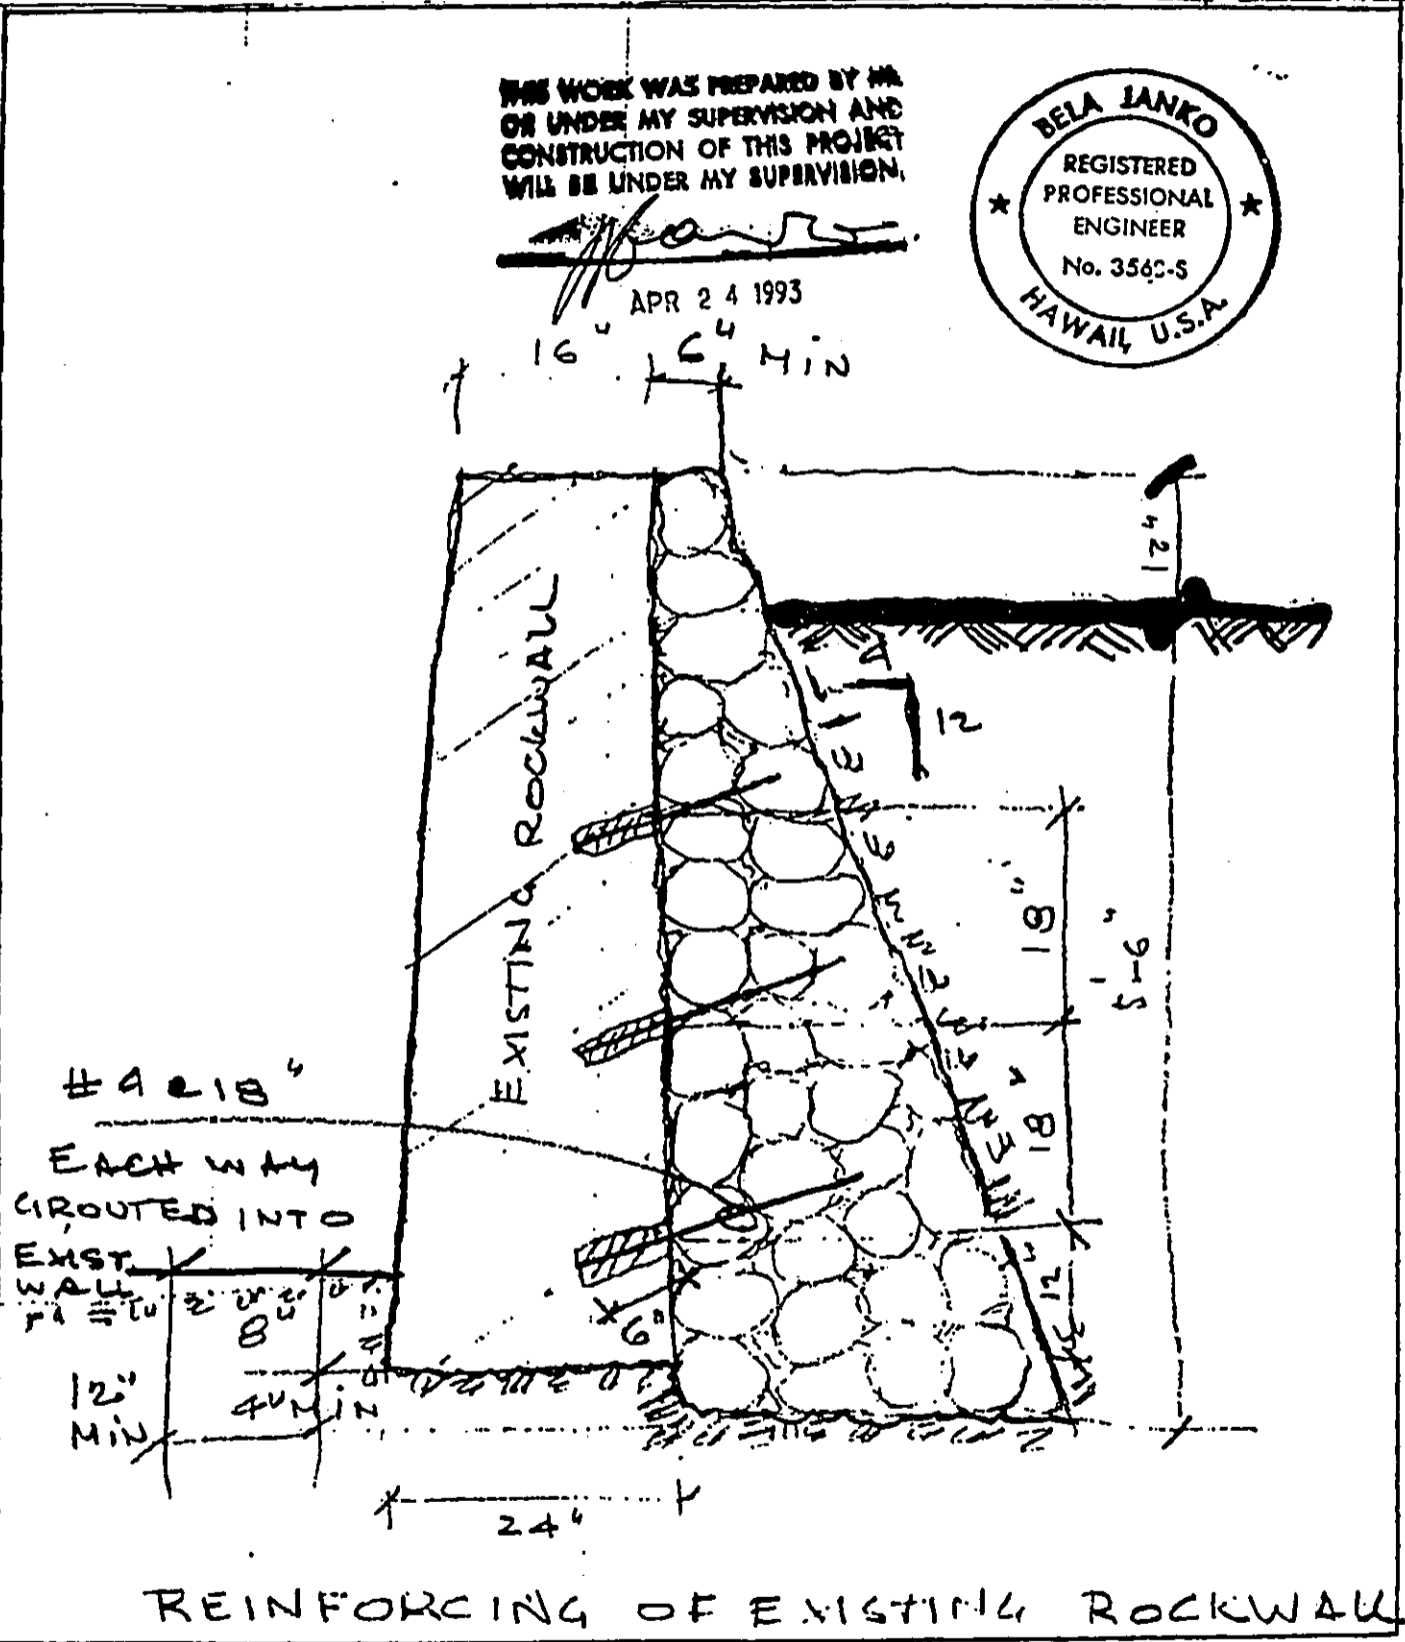
EXHIBIT "D"

The proposed repair of the existing wall will be effected by a reinforcing wall located mauka of the existing wall. (See, Exhibit "D", Plan for Reinforcing of Existing Rockwall.) The proposed reinforcement will provide structural stability to the existing wall yet will not interfere with access along the shoreline or the shoreline forces makai of the wall.

3. Proposed Alternative: The applicant proposes to leave the existing seawall in place and repair and reinforce the seawall from the mauka side of the existing wall. The proposal for the reinforcing wall has been prepared by a registered professional engineer. (See, Exhibit "D", Plan for Reinforcing the Existing Rockwall.)

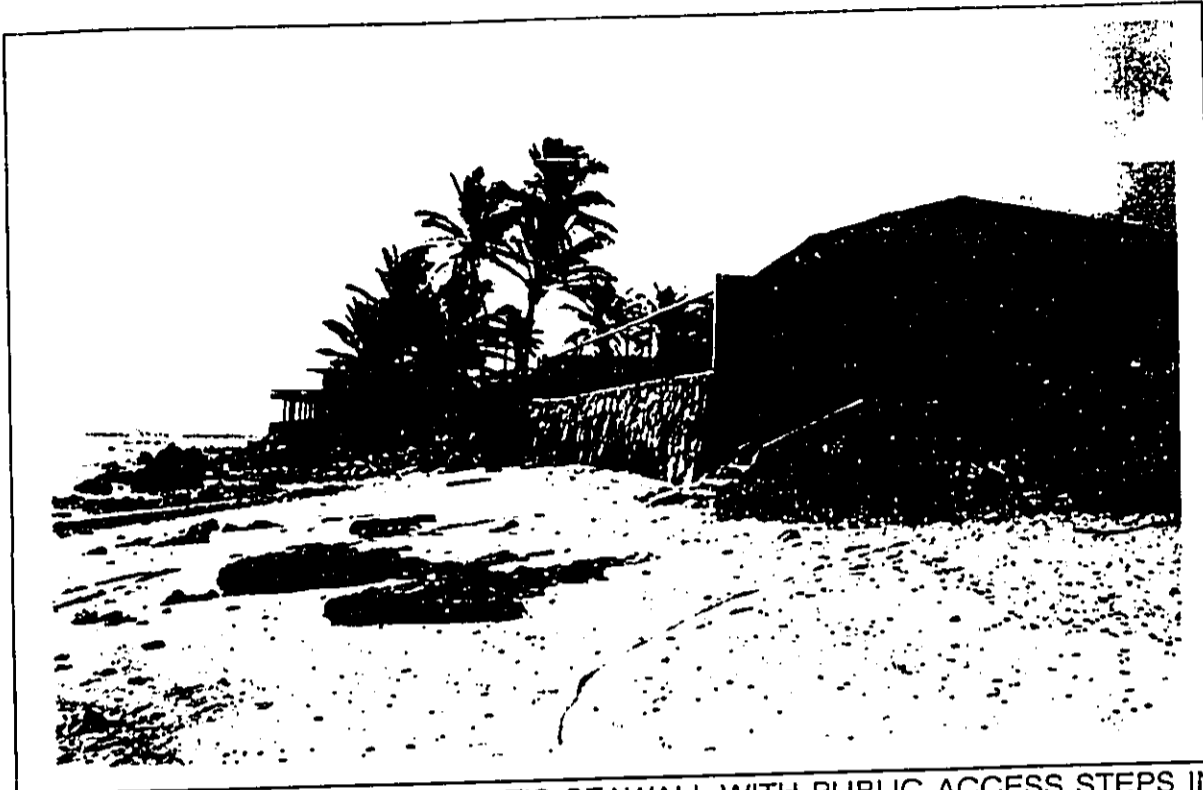
Photo 3 shows the steps maintained by the City and County for the public access, with the applicant's seawall in the immediate background. The southern end of the continuous sand beach extending south from Pali Kilo la can be seen in this photo. The alignment of all seawalls in this area is staggered, as shown in the photos. The north end of the applicant's wall is approximately 10 feet seaward of the wall to the north. Similarly, the wall for the property to the south protrudes approximately 6 feet seaward of the applicant's wall. These alignments result in a rough approximation of the natural shoreline as it curves toward Kaipapau Point.

PHOTO 3. VIEW OF APPLICANT'S SEAWALL WITH PUBLIC ACCESS STEPS IN FOREGROUND.

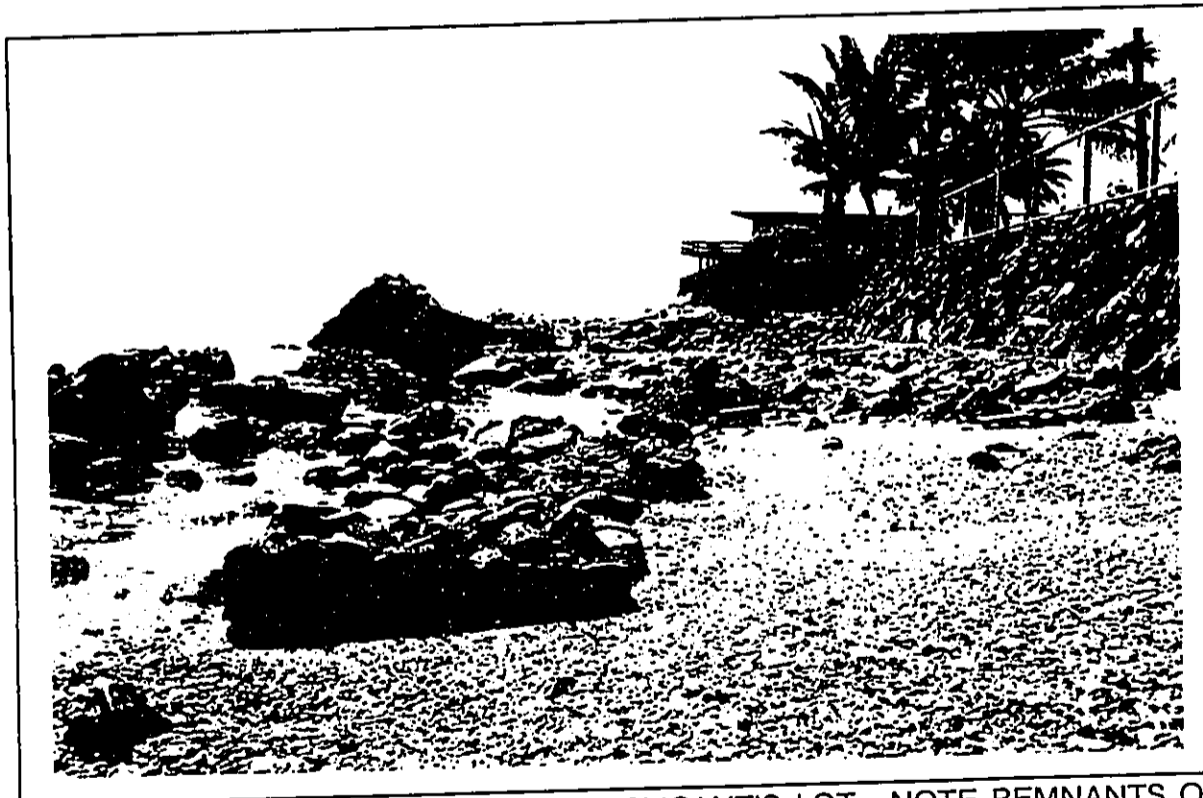
Photo 4 was taken from the south end of the applicant's property, looking to the south. The photo shows the next two seawalls in the sequence, as well as the coarse sand and basalt boulders which make up the shoreline. The square object in the foreground and the massive block in the background are the remnants of an old vertical seawall, which was on the adjacent property to the south. This wall was located 15 to 20 feet seaward of the present wall which protects the property.

PHOTO 4. SHORELINE SOUTH OF APPLICANT'S LOT. NOTE REMNANTS OF PREVIOUS SEAWALL.
