Recorded Owner : Mary Stewart Trust  
Applicant : Mary Stewart Trust  
Agent : Group 70 International, Inc.  
Location : 68-701 Crozier Drive, Mokuleia, Oahu  
Tax Map Key : 6-8-06: 18 and 19  
Request : Shoreline Setback Variance  
Proposal : Reconstruction of a Seawall (After-the-Fact)  
Determination : A Negative Declaration Is Issued

**APPLICATION FOR SHORELINE SETBACK VARIANCE  
AND  
FINAL ENVIRONMENTAL ASSESSMENT**

**After-the-Fact Approval of Seawall Reconstruction**  
68-701 Crozier Drive, Mokuleia, Oahu, HI  
TMK (1) 6-8-006:018 & 019

**EXHIBIT C**

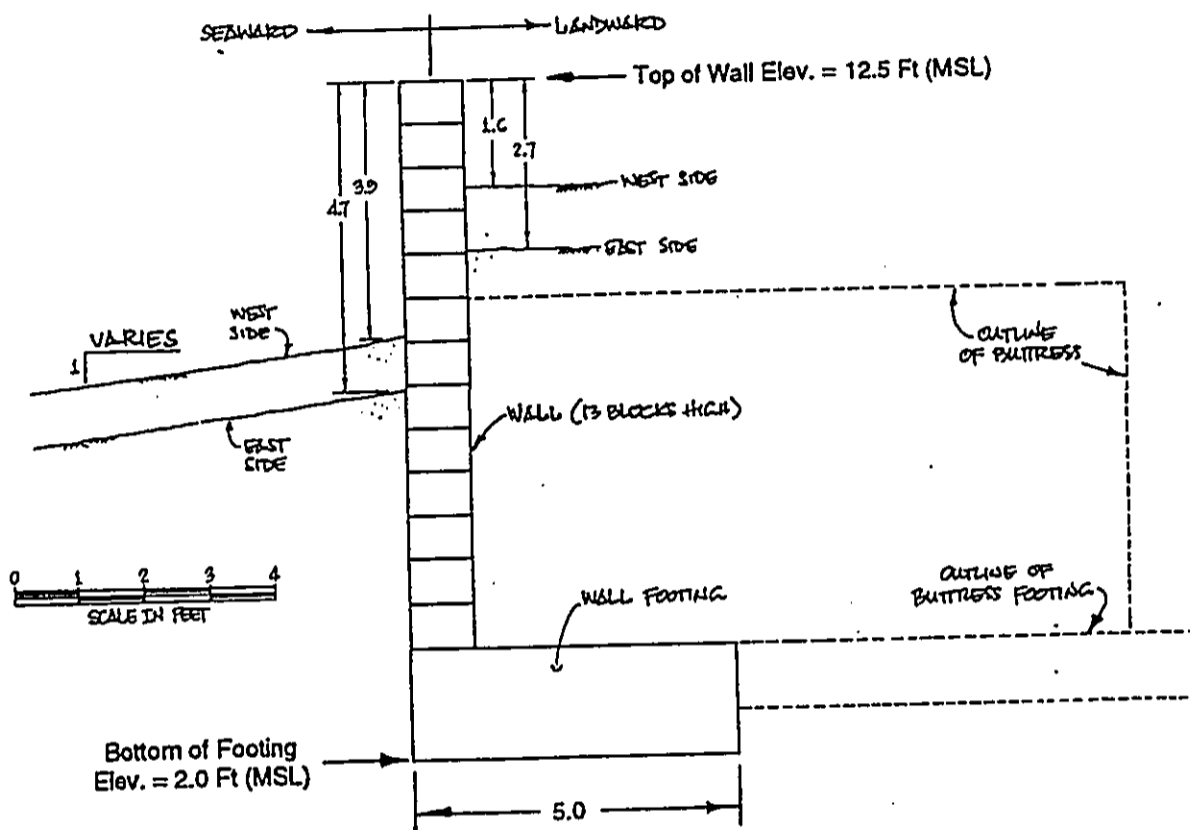
Figure 3  
 Cross Section of the Retaining Wall  
 Redrawn From Contractor-Furnished Plans

Figure 3 shows a cross section of the seawall. Its height ranges from 3.9 to 4.7 feet on the makai side, and 1.6 to 2.7 feet above grade on the mauka side. The new seawall aligns with the timber seawalls fronting each of the adjacent lots. Construction drawings furnished by the contractor, and a re-drawn cross-section of the seawall have been prepared. Twenty copies of the construction plans and re-drawn cross-section are included as Exhibit B.

As recommended by the DLU staff, the owners have agreed to modify the wall structure to remove the nine CMU columns (40 in. tall - five block courses) placed along the top of the wall. Plantings of naupaka bushes will be made along the inland side of the wall, to allow plant growth to eventually cover the top of the wall. This will re-create the pre-existing condition shown in photos from the late 1960's.

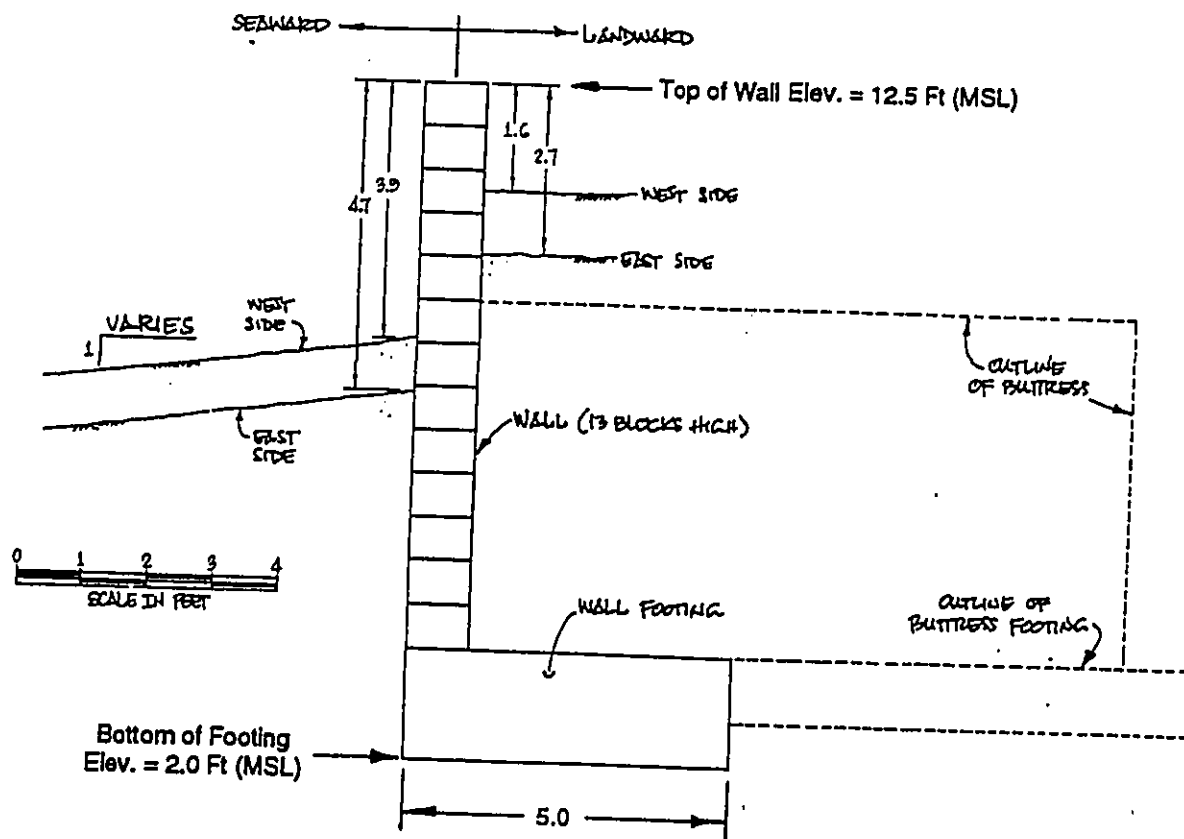
**Figure 3**  
**Cross Section of the Retaining Wall**  
**Redrawn From Contractor-Furnished Plans**

The top of the wall is 12.5 feet above mean sea level (msl) and the bottom of the footing is 2 feet above msl. According to Mr. Wasco, all excavation was in clean, coarse-grained, calcareous beach sand. Elevations of the top of sand on both sides of the wall shown on Figure 3 were measured on February 10, 1995. On the landward side, ground levels were 1.6 to 2.7 feet below the top of the wall. On the seaward side, the beach was 3.9 to 4.7 feet below the top of the wall.

SAG's structural computations can be found in Appendix C. Based on typical bearing strength and coefficient of sliding friction of calcareous sand, the wall's stability and strength is satisfactory. However, this conclusion becomes less confident if the beach sand on the seaward side of the wall were to be significantly eroded. An offsetting factor is that the buttresses do actually make some contribution to stability and strength and there may actually be six of them rather than five considered in the analysis.

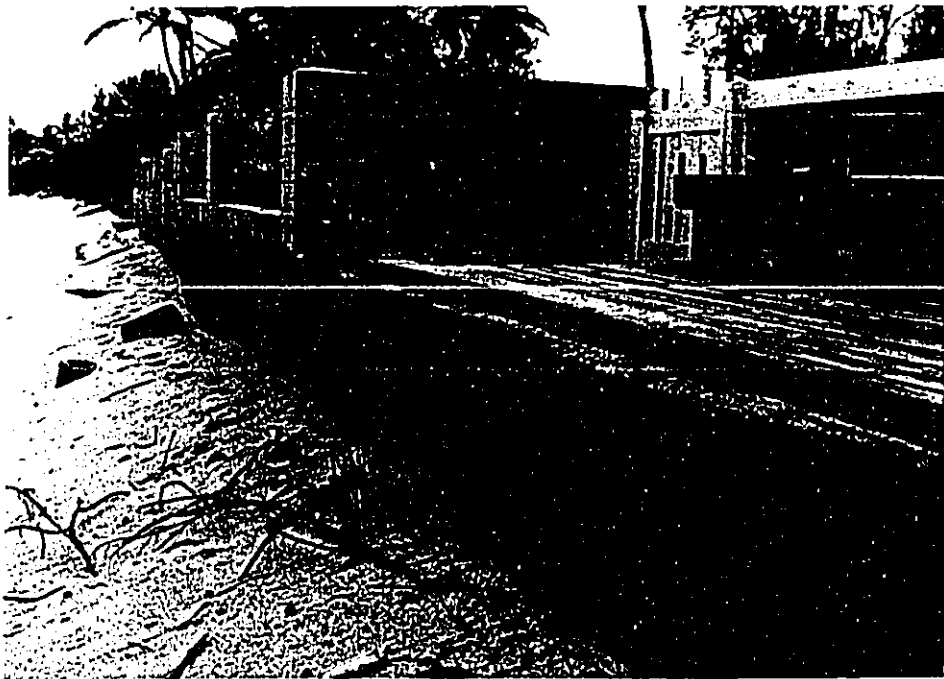
Photo No. 2

The retained portion of the old wall with one course of new blocks on top, is in the foreground.

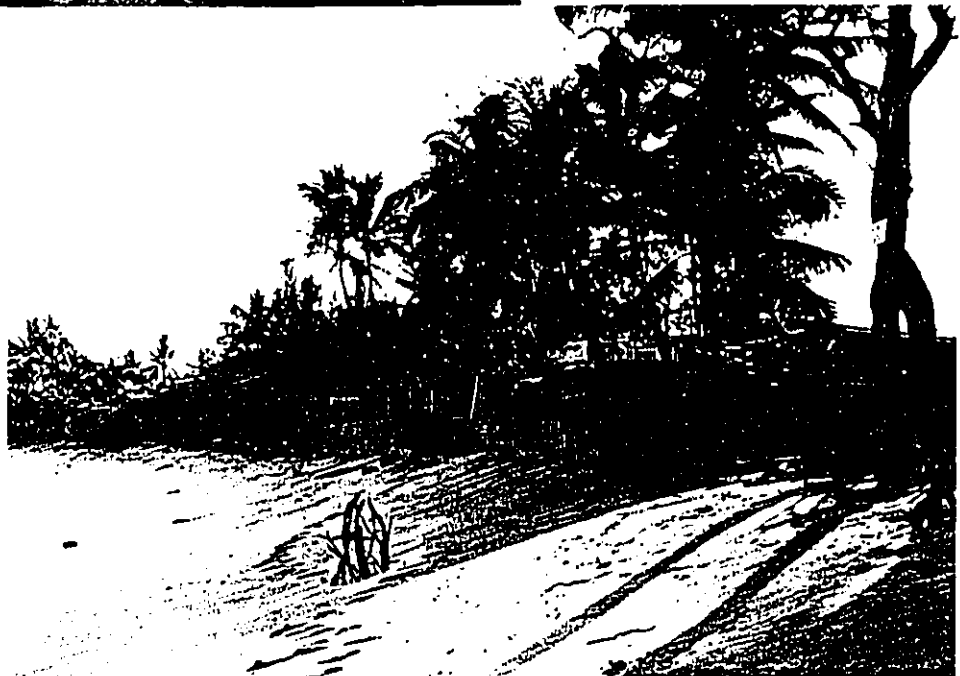
Photo No. 3

The new and old wall are aligned with timber pile seawalls in front of lots to the east and west.

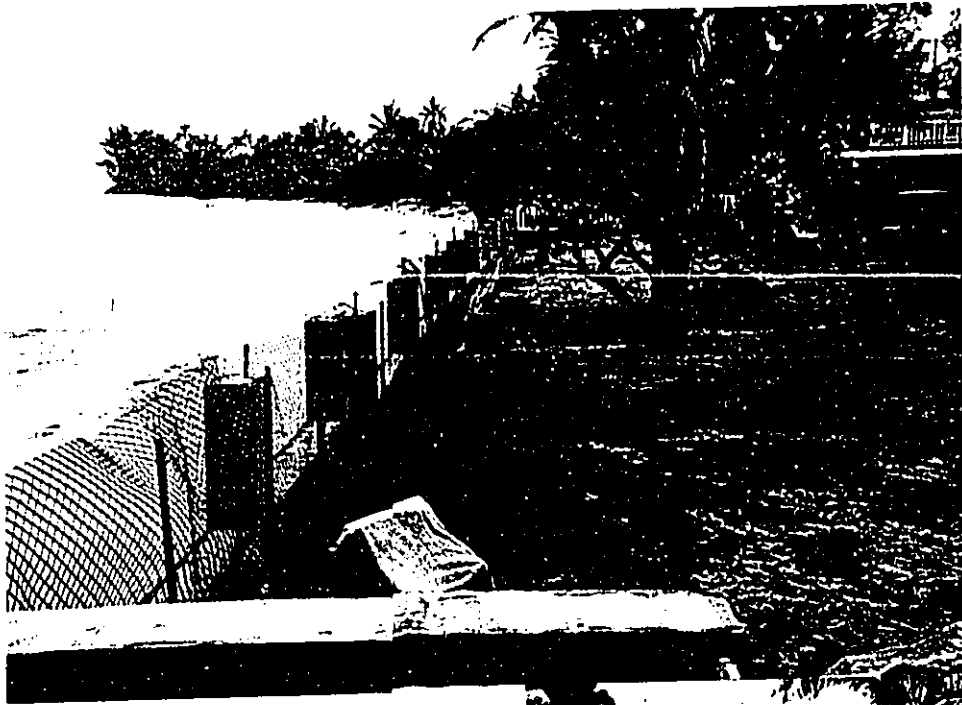
Photo No. 5

The depression in the ground between the trees and wall is apparently where overtopping of the old wall was most severe.
