CHAPTER 343, HRS Environmental Assessment (EA)/Determination Finding of No Significant Impact

Request : Shoreline Setback Variance

Proposal : Replacement of an existing unauthorized

Reconstruction of Seawall at 68-701 Farrington Highway, Mokuleia

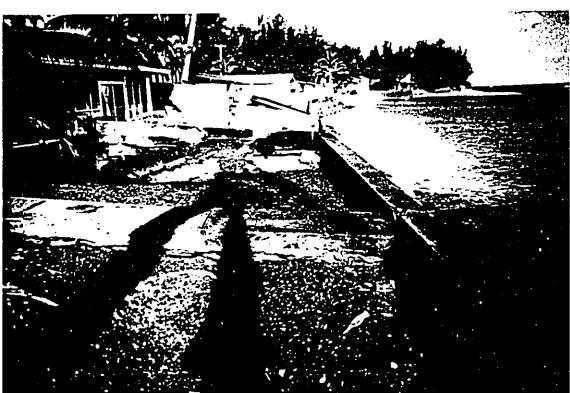
The seawall fronting TMK 6-8-10:23 has a large vertical crack at mid-length and another at its joint with the wall for TMK 6-8-10:24. Undermining is most obvious at the west end (right-hand side of Photo No. 2). Photo Nos. 1 & 2.

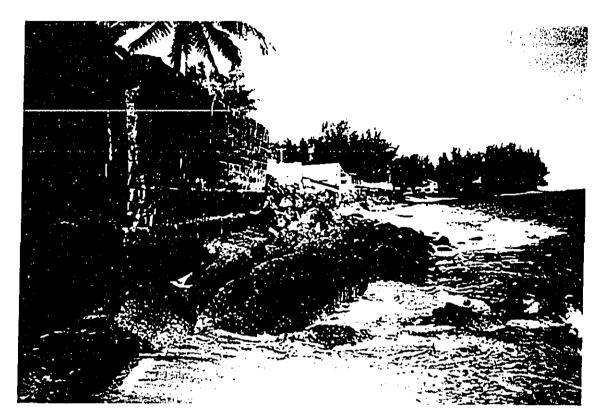
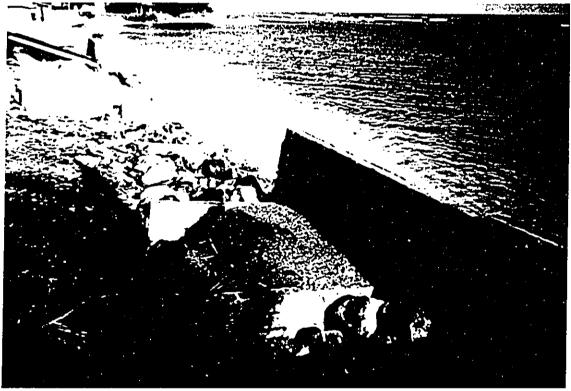
The west side of the wall at TMK 6-8-10:24 is completely gone and an assortment of loose boulders has been placed as an emergency measure (bottom photo). The hollow tile wall remaining on the east end is leaning outward and ready to fall on the beach (top photo). Photo Nos. 5 & 6.

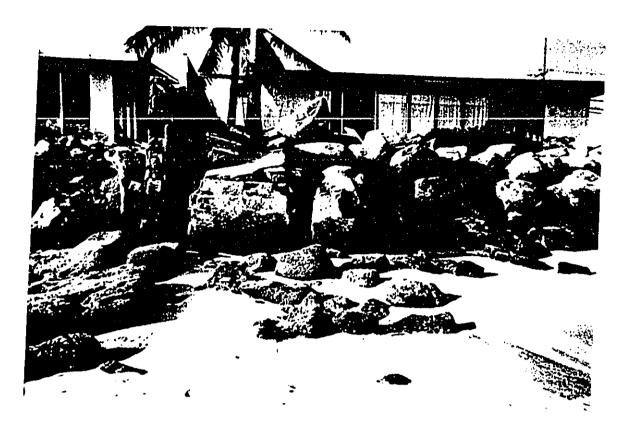
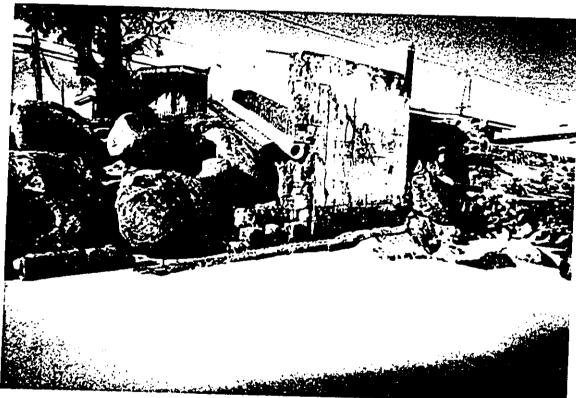
Only small remnants of the hollow tile seawall at TMK 6-8-10:25 remain (top left and bottom right). The remainder of the lots frontage has been temporarily stabilized with boulders as an emergency measure.

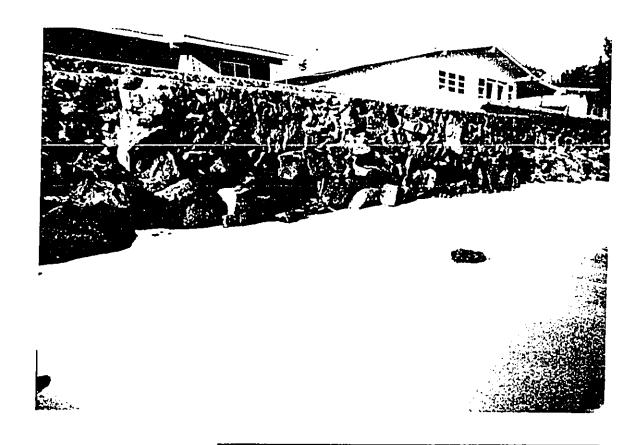
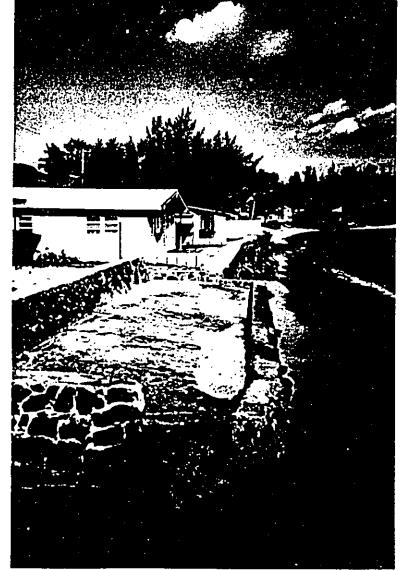
Photo Nos. 15 & 16.

The top photo shows the extent of undermining of the rubble-rock seawall at TMK 6-8-10:26. Concrete has been poured on the landward side to avoid undermining there (photo at right). A second wall set 14 feet behind the seawall has been constructed to contain overtopping waves.
