Shoreline Setback Variance 2004/SV-13
Final Environmental Assessment (Final EA)

**FINAL ENVIRONMENTAL ASSESSMENT FOR A
SHORELINE SETBACK VARIANCE APPLICATION**

EXISTING SEAWALL

68-001 Laau Paina Place, Waialua, Hawaii

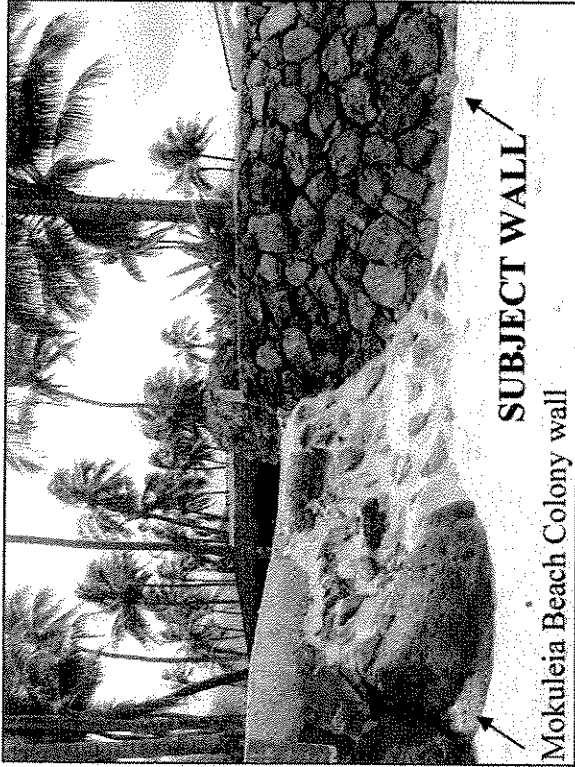
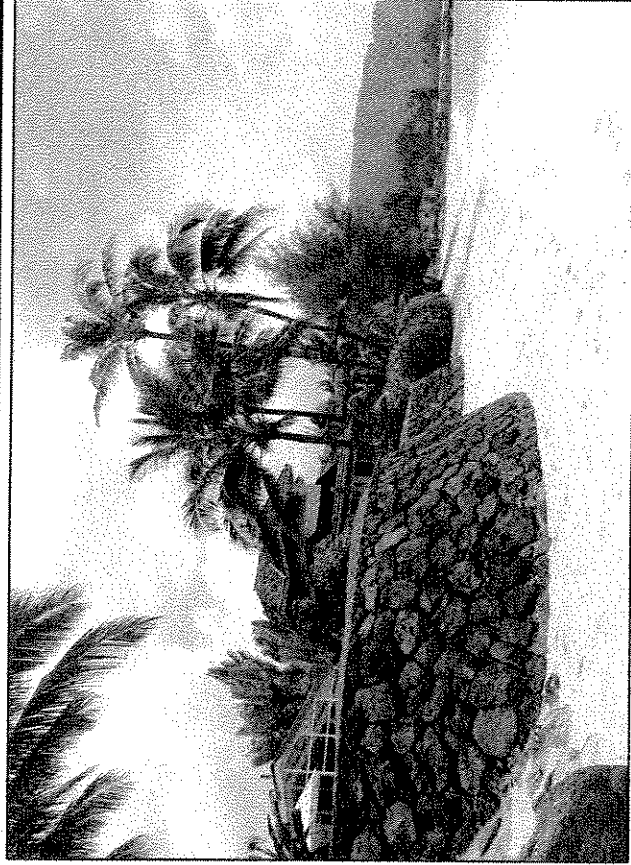
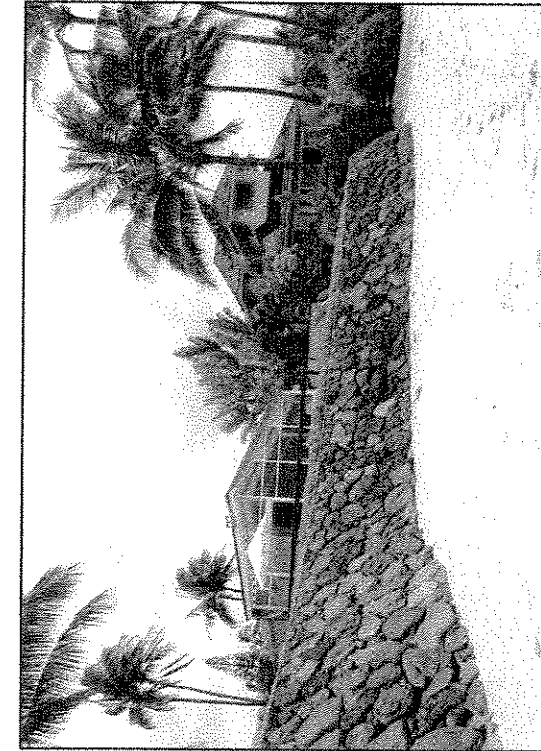
Figure 3
VIEWS OF SEAWALL FROM BEACH (April 17, 2004)
 68-001 Laau Paina Place, Waiialua, Oahu, Hawaii

Applicant's wall on the right. Adjacent to Mokuleia Beach Colony wall.

View of subject property from the beach.

Stairs are located on subject property.

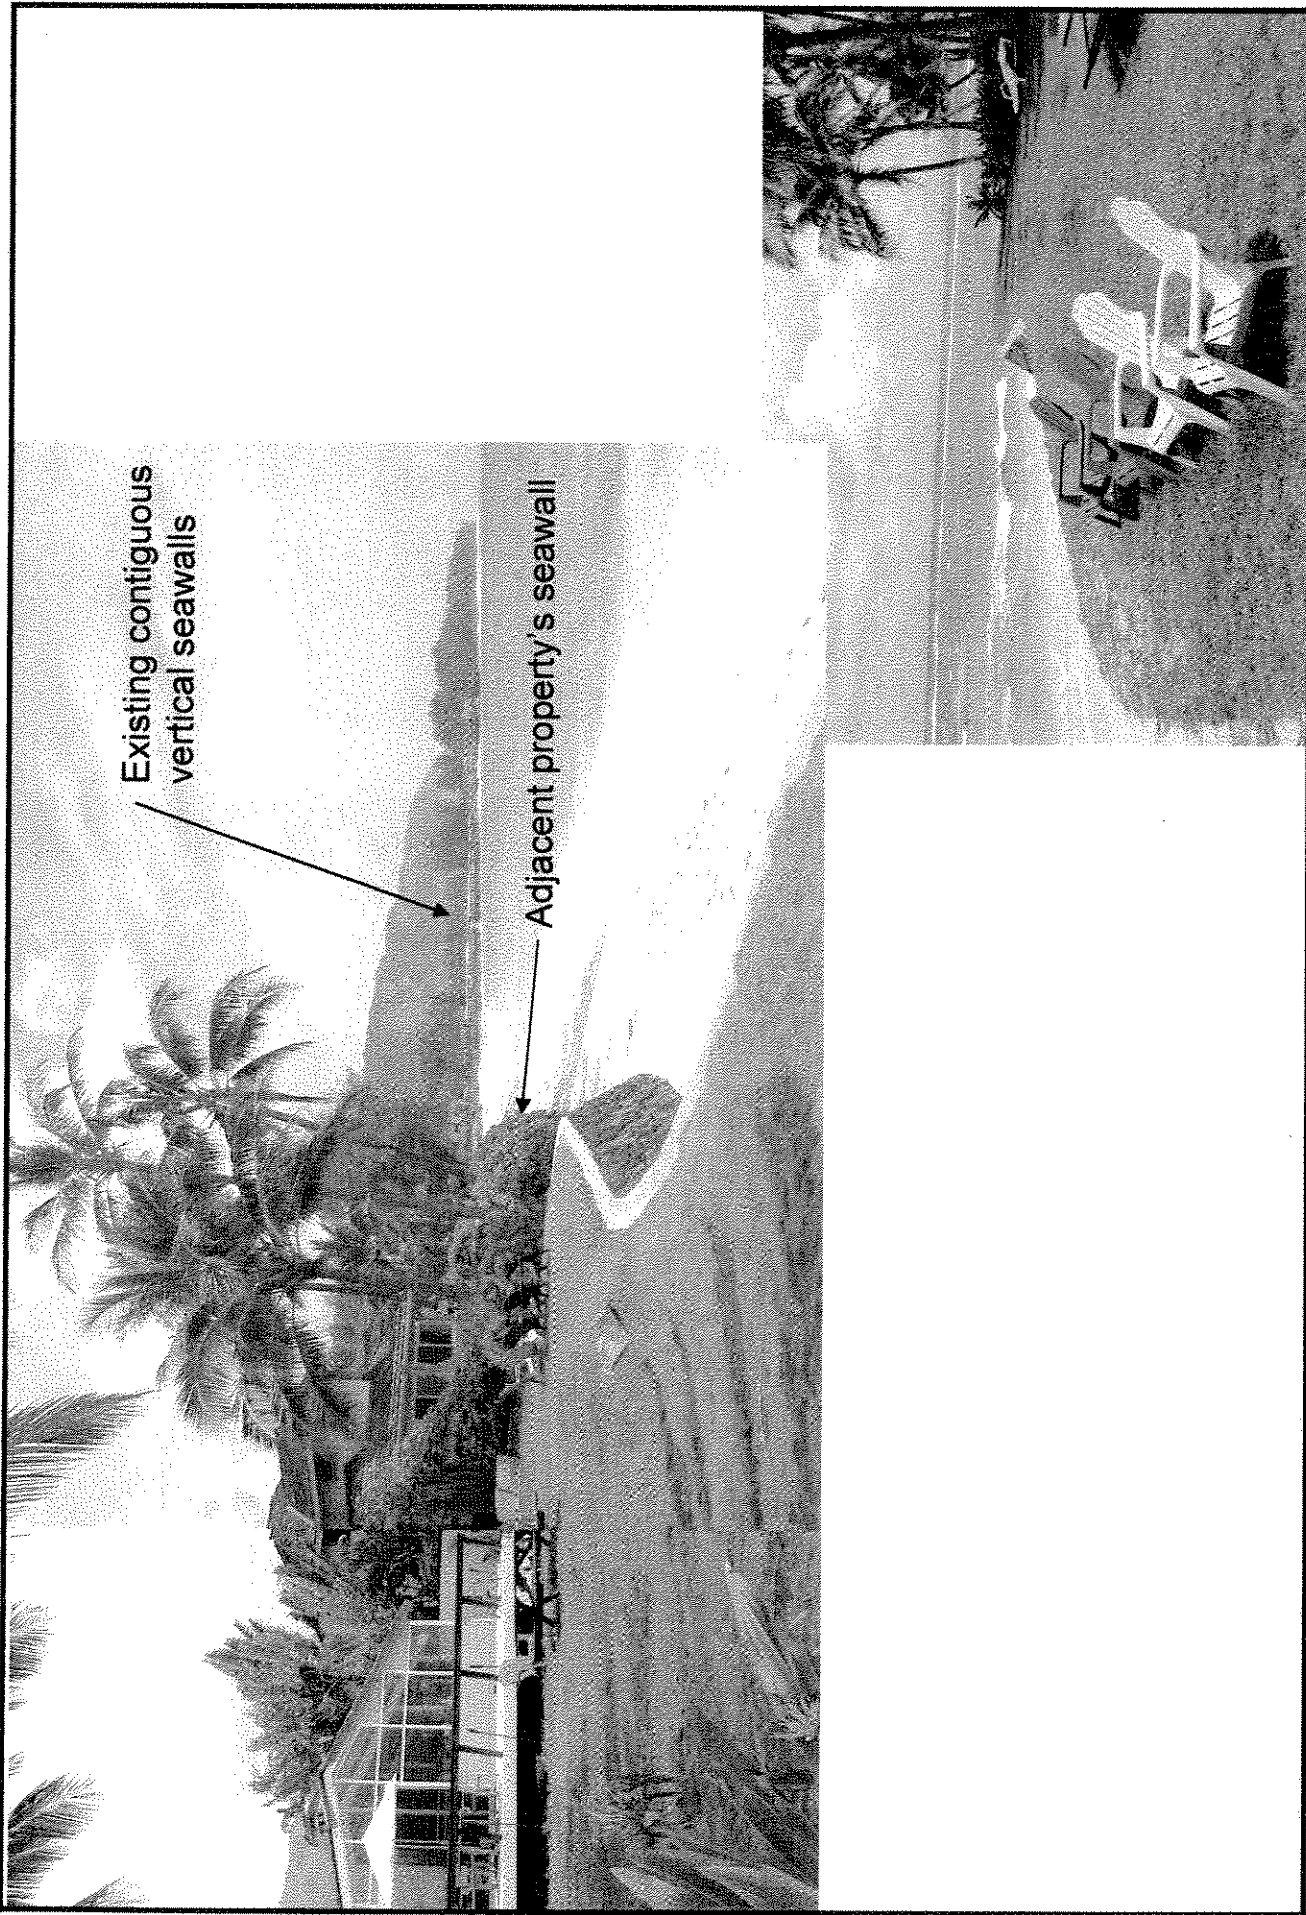
Figure 4

VIEW OF SEAWALL FROM SUBJECT PROPERTY'S YARD (April 17, 2004)

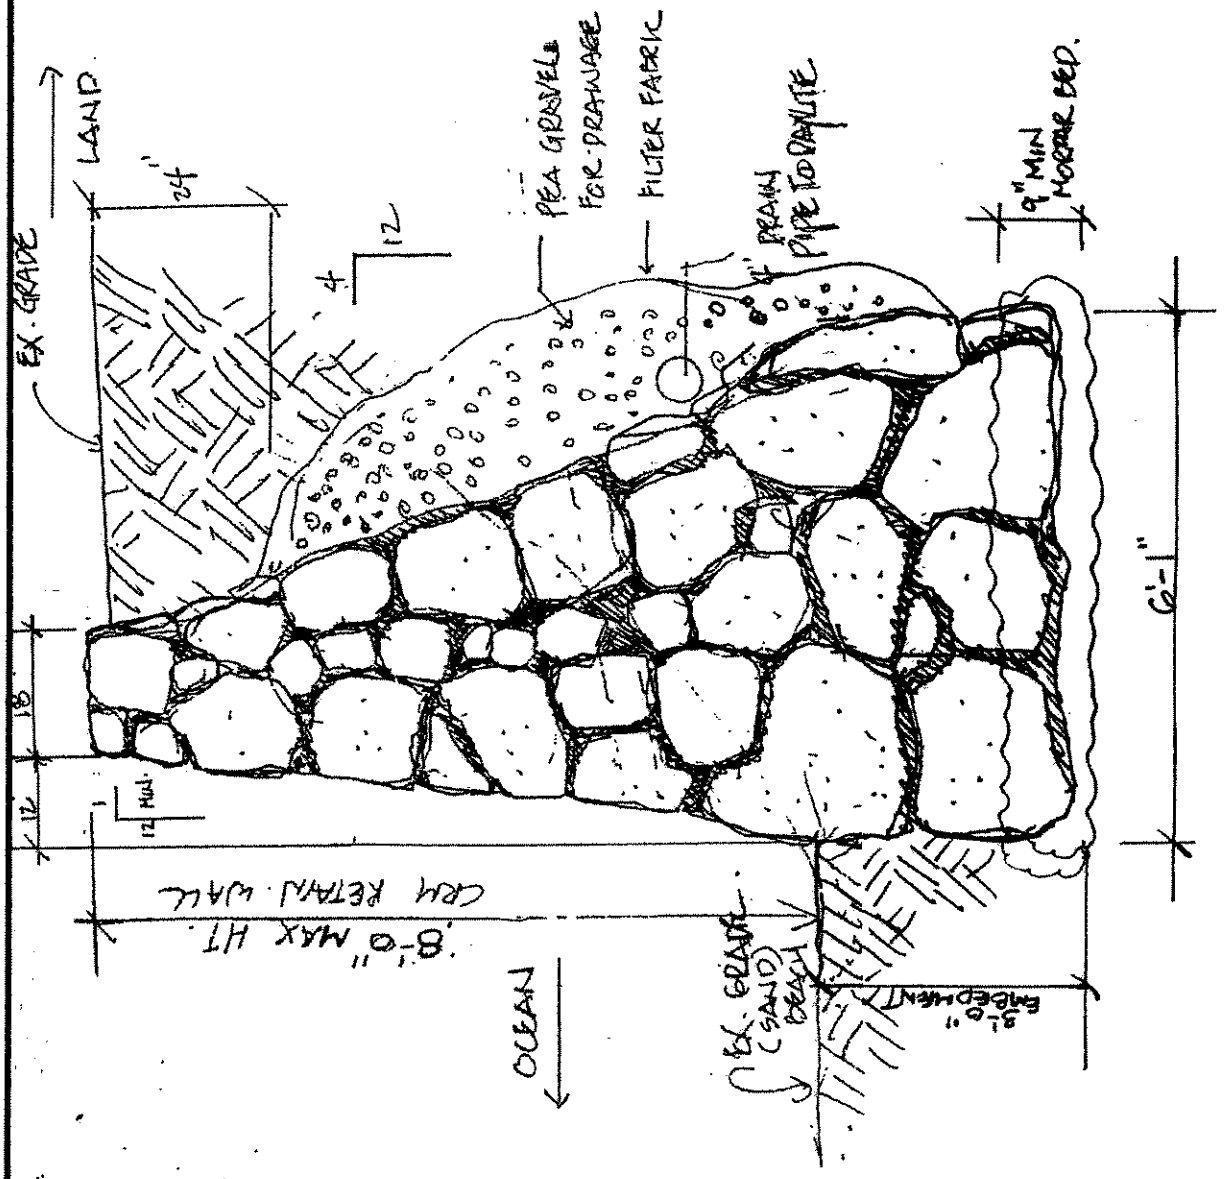
Figure 6 shows a cross section of the existing vertical CRM seawall which consists of large rocks grouted in place. The seawall is approximately 6 feet 1 inch wide at the base tapering to 18 inches wide at the top. The base of the wall is buried about 3 feet below existing grade (sand beach). The property's rear yard, which is landscaped with yard grass, plant materials and coconut trees, is almost level with the top of the seawall. The seaward face of the wall is exposed about 8 feet high above the existing sand beach. Earth fill has been placed behind (landward of) the seawall. Built into the wall are 4-inch tile drains set in crushed rock wrapped in filter fabric. The seawall's design parameters and engineering calculations are provided in **Appendix B**.

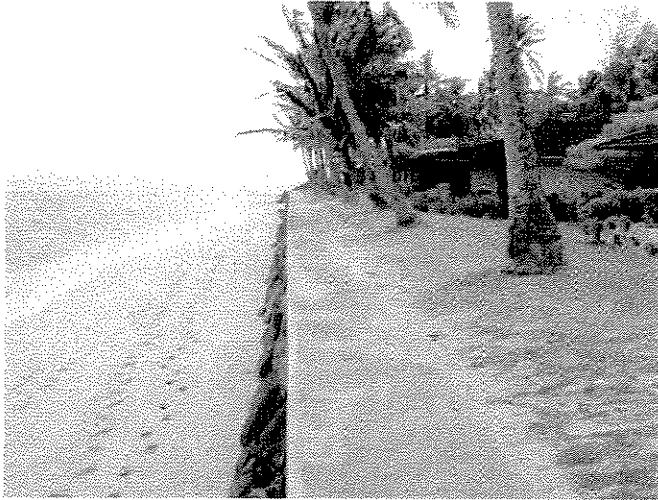
View eastward along the top of the seawall fronting the Mokuleia Beach Colony. Note the narrow beach.

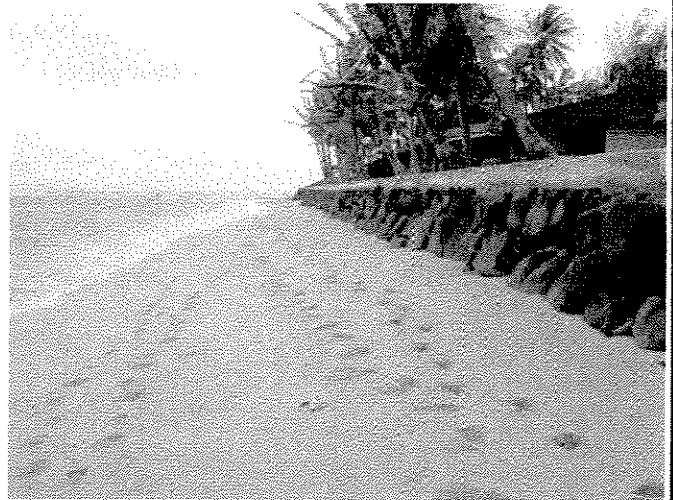
View eastward along the beach fronting the Mokuleia Beach Colony seawall. Note the narrow and steep beach profile.

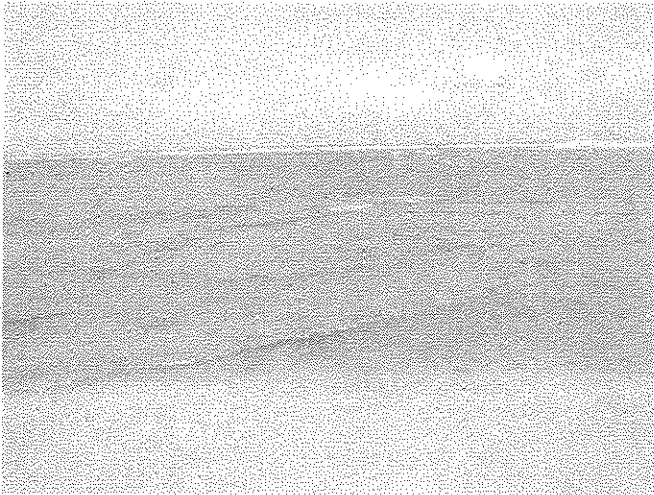
View offshore Parcel 10. Note the shallow reef and wave angle at the shoreline indicating eastward longshore transport.

Winter North Pacific swell were causing breaking waves across entire embayment.

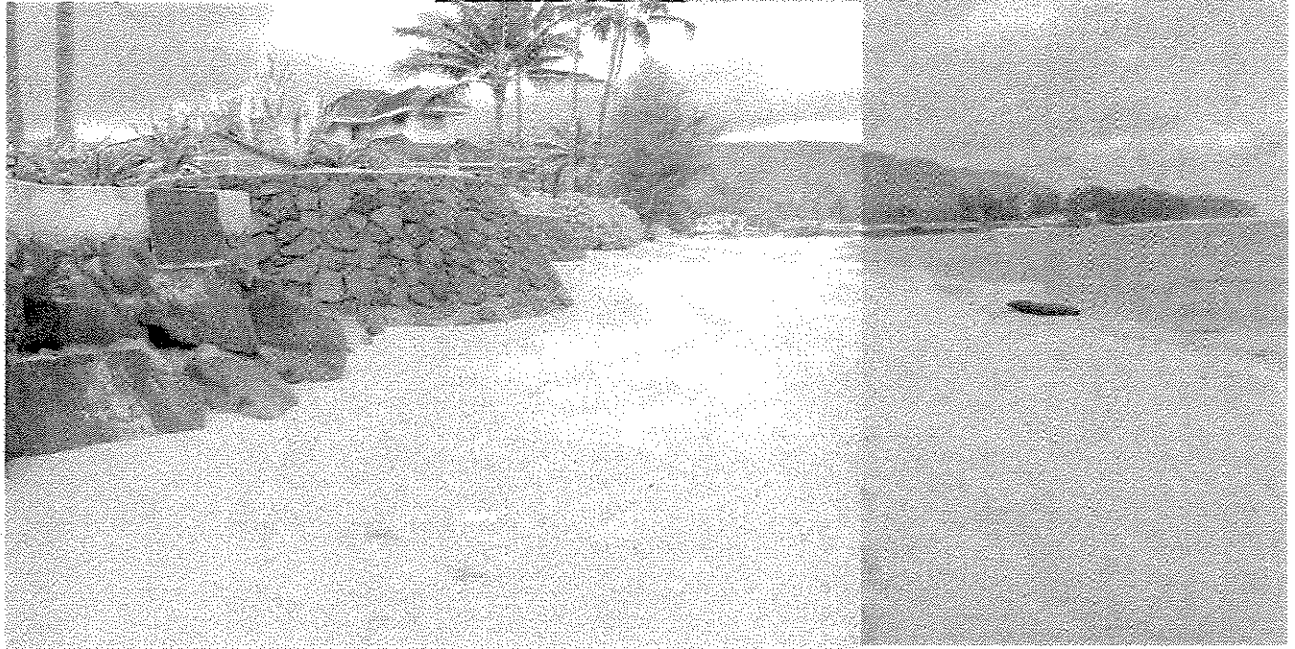
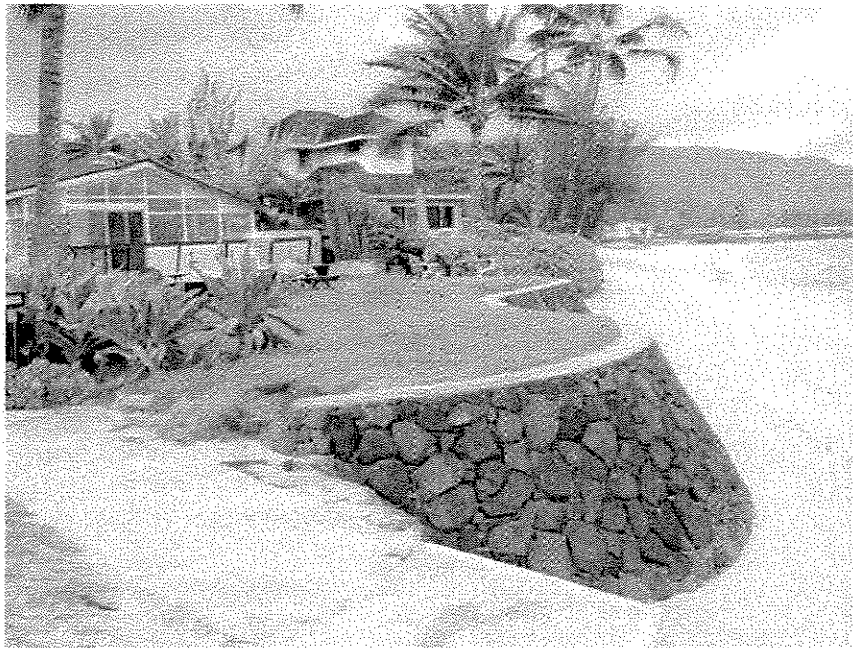
Figure 9
PHOTOS OF PROJECT SITE – PARCEL 10

Views westward from west end of Mokuleia Beach Colony seawall. Parcel 10 is in the foreground. Parcel 11 is next to Parcel 10. (Sign is on the west end of the Mokuleia Beach Colony seawall. The sign permits the public to walk on the top of the seawall.)

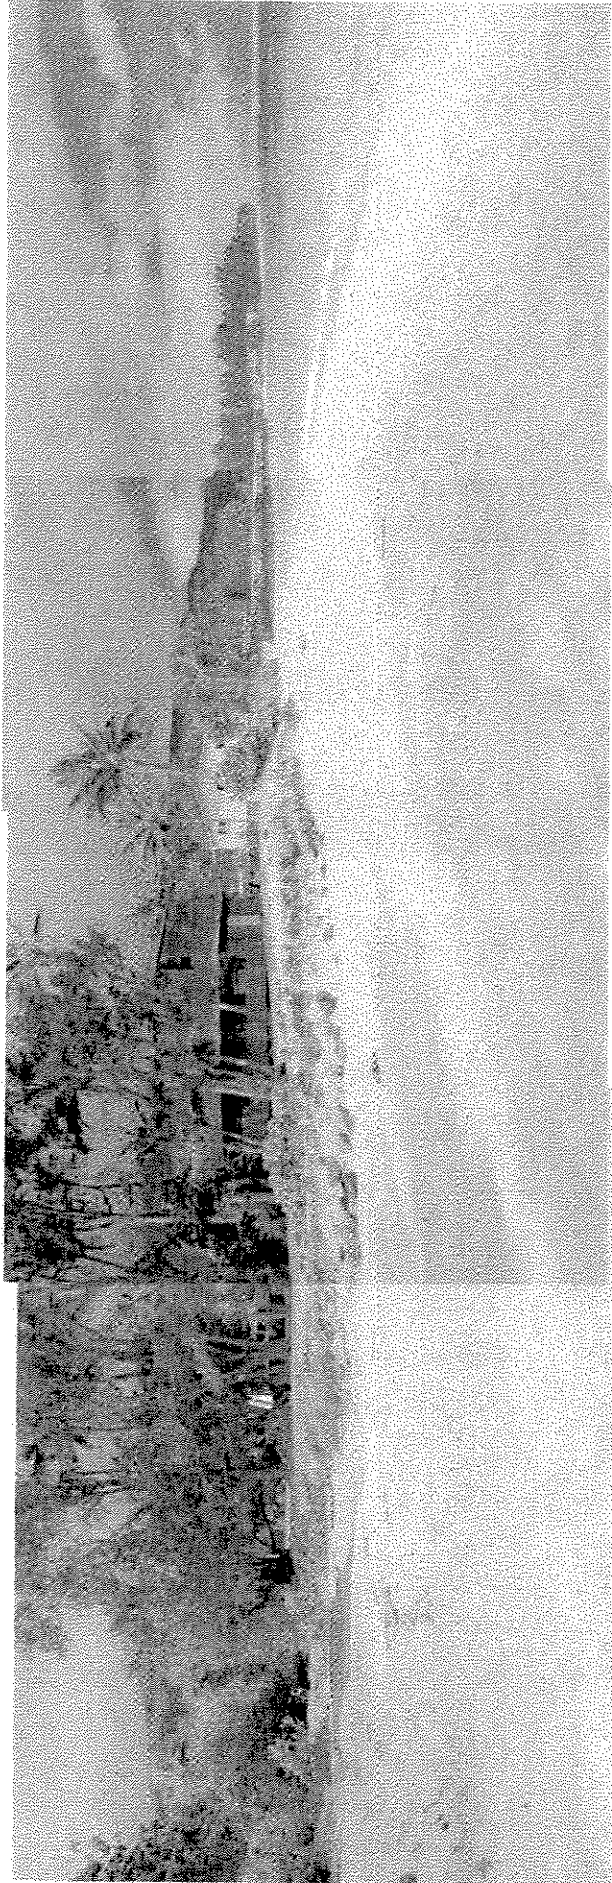
View westward from stream mouth. Note eroded condition of embankment on west side of the stream. Continuous line of seawalls protect entire central shore frontage within the embayment.

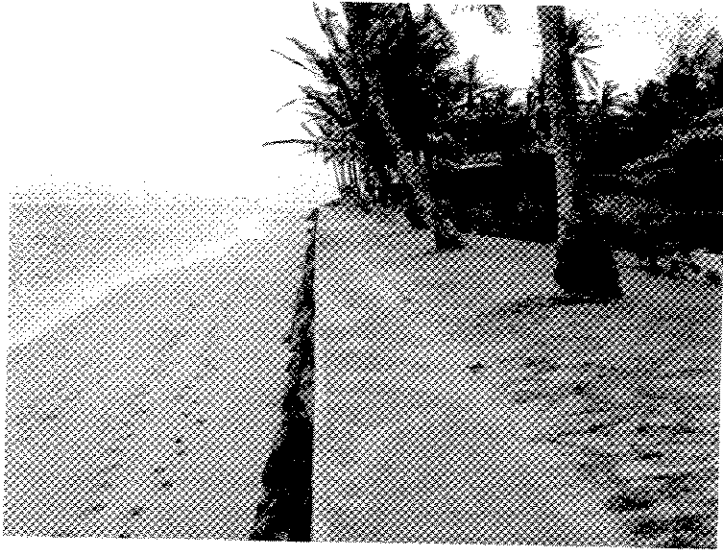
View eastward along the top of the seawall fronting the Mokuleia Beach Colony. Note the narrow beach.

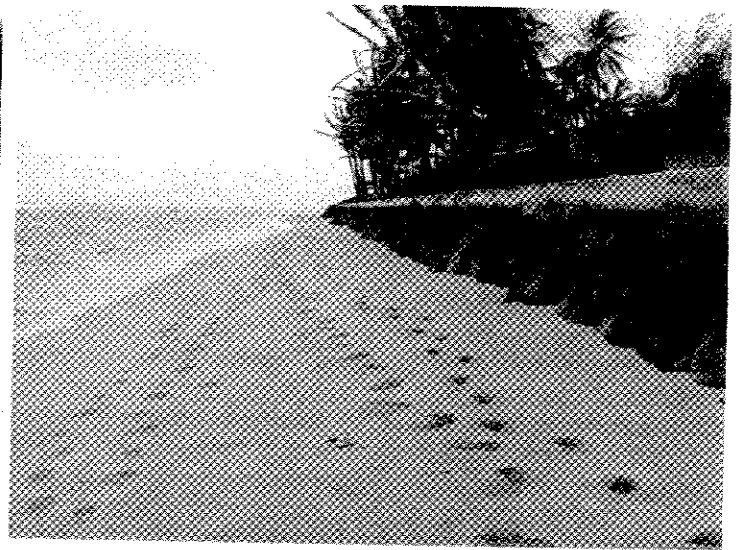
View eastward along the beach fronting the Mokuleia Beach Colony seawall. Note the narrow and steep beach profile.

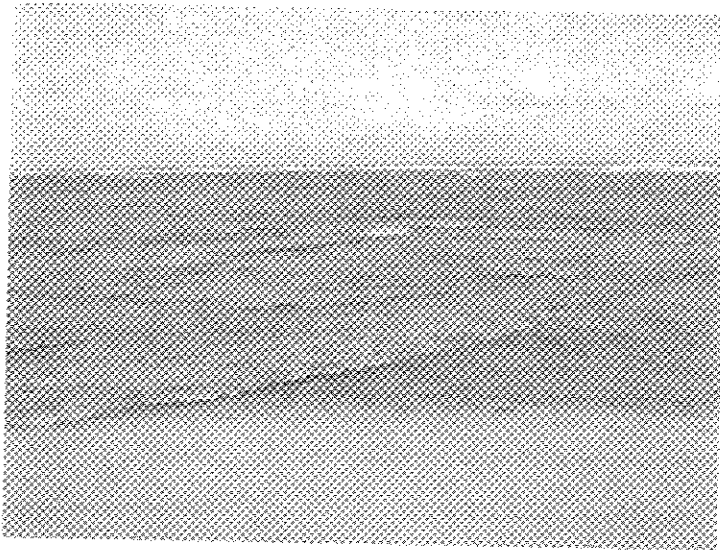
PHOTO page-1

View offshore Parcel 10. Note the shallow reef and wave angle at the shoreline indicating eastward longshore transport.

Winter North Pacific swell were causing breaking waves across entire embayment.

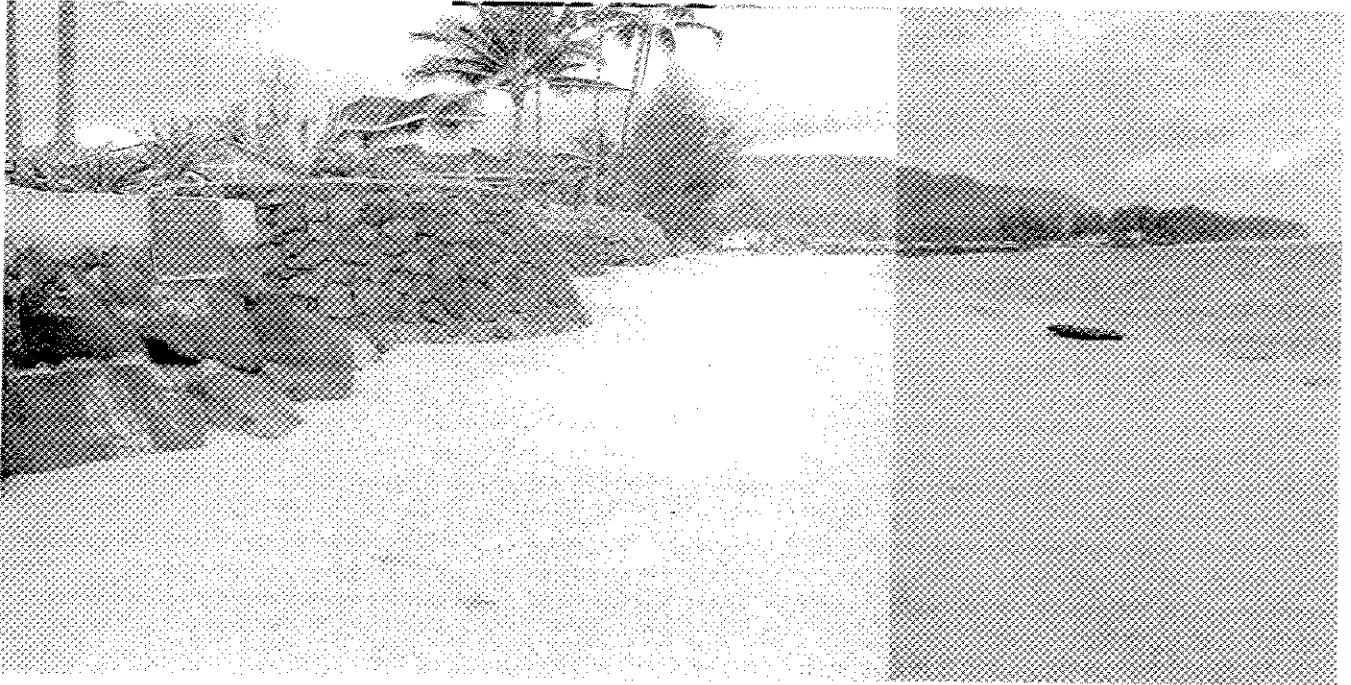
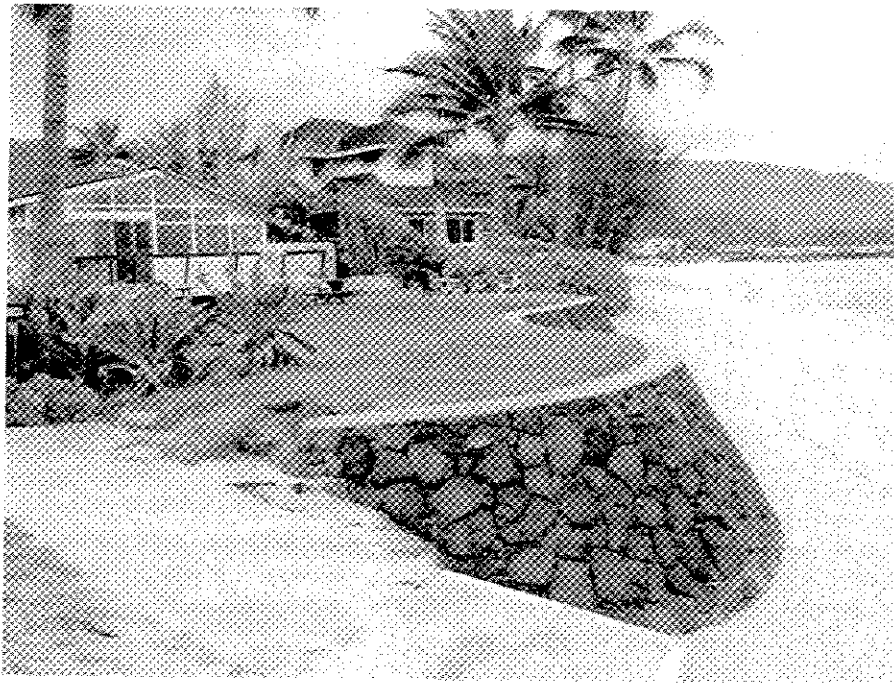
PHOTO page-2

Views westward from west end of Mokuleia Beach Colony seawall. Parcel 10 is in the foreground. Parcel 11 is next to Parcel 10. (Sign is on the west end of the Mokuleia Beach Colony seawall. The sign permits the public to walk on the top of the seawall.)

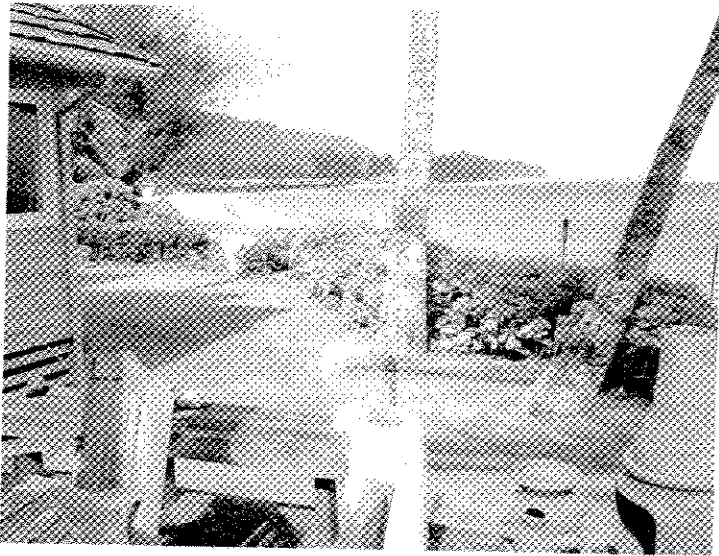
View westward from porch on Parcel 11.

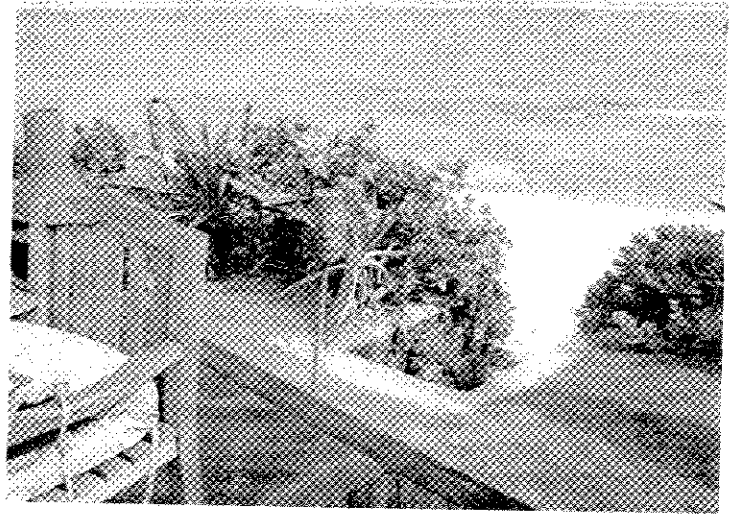
View offshore from porch on Parcel 11.
Steps in seawall lead down to the beach.

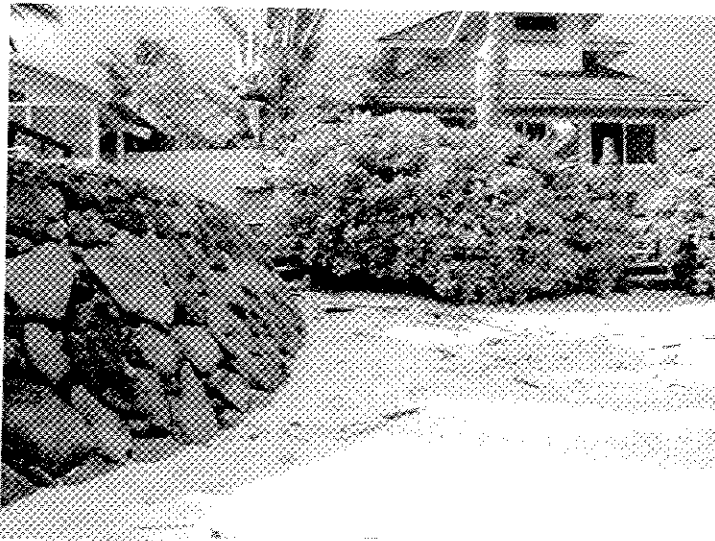
View of Parcel 11 seaward frontage. Seawall is hidden by naupaka vegetation. Curved seawall on left fronts Parcel 10.

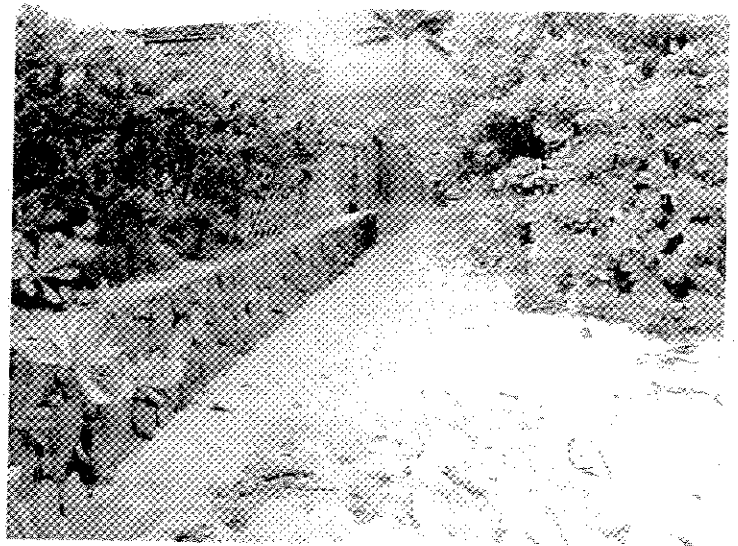
PHOTO page-3

View mauka along private right-of-way. The CRM wall on left is Parcel 11's return wall.

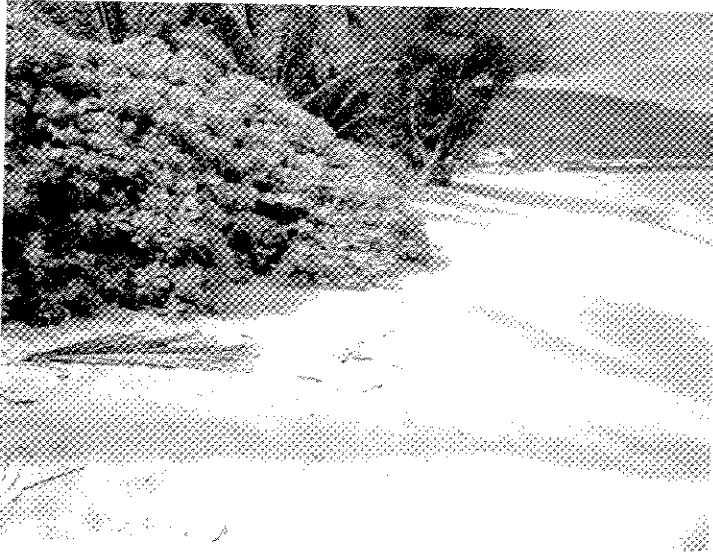
View westward from private right-of-way.
Naupaka vegetation fronts Parcel 12.

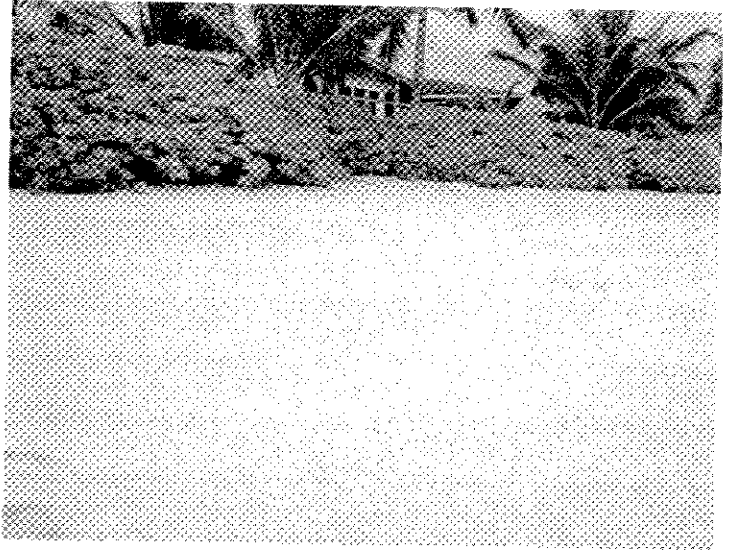
Naupaka vegetation fronting Parcel 12 on
west side of private right-of-way.

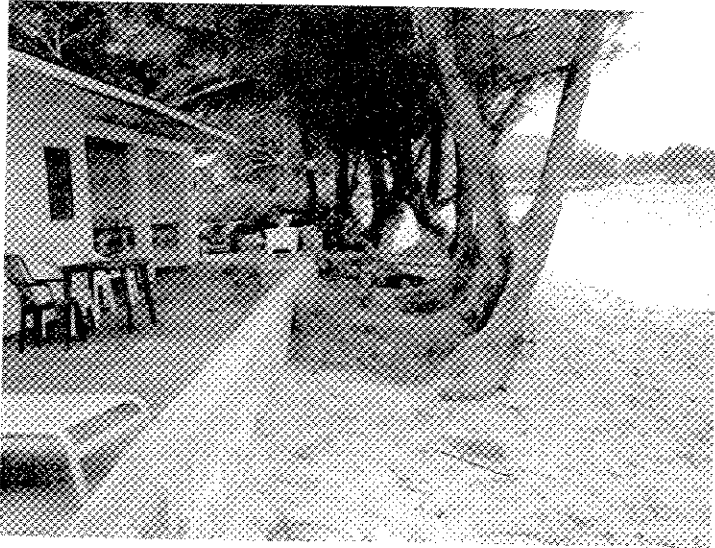
CMU wall fronts Parcel 13 .

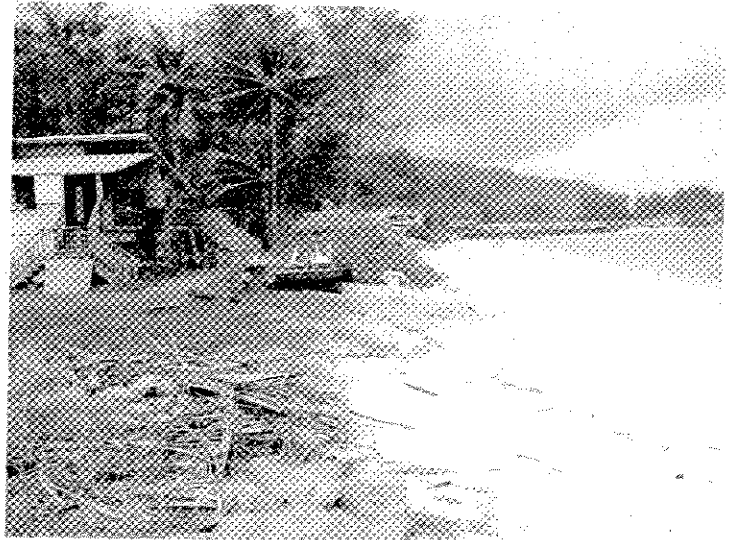
PHOTO page-4

Photo page-4 shows the parcels westward to the stream. The parcel on the west side of the right-of-way (Parcel 12) is obscured by naupaka vegetation, and the adjacent parcel (Parcel 13) is fronted by a CMU wall. The large parcel on the east side of the stream (Parcel 20) is unprotected. Photo page-5 shows the stream and adjacent shoreline reach to the west. The parcel on the west side of the stream mouth shows obvious erosion damage, and a nearly continuous line of seawalls protect the remaining shoreline within the embayment.

Shoreline fronting Parcel 20 on east side
of stream. Note debris line at edge of
vegetation.

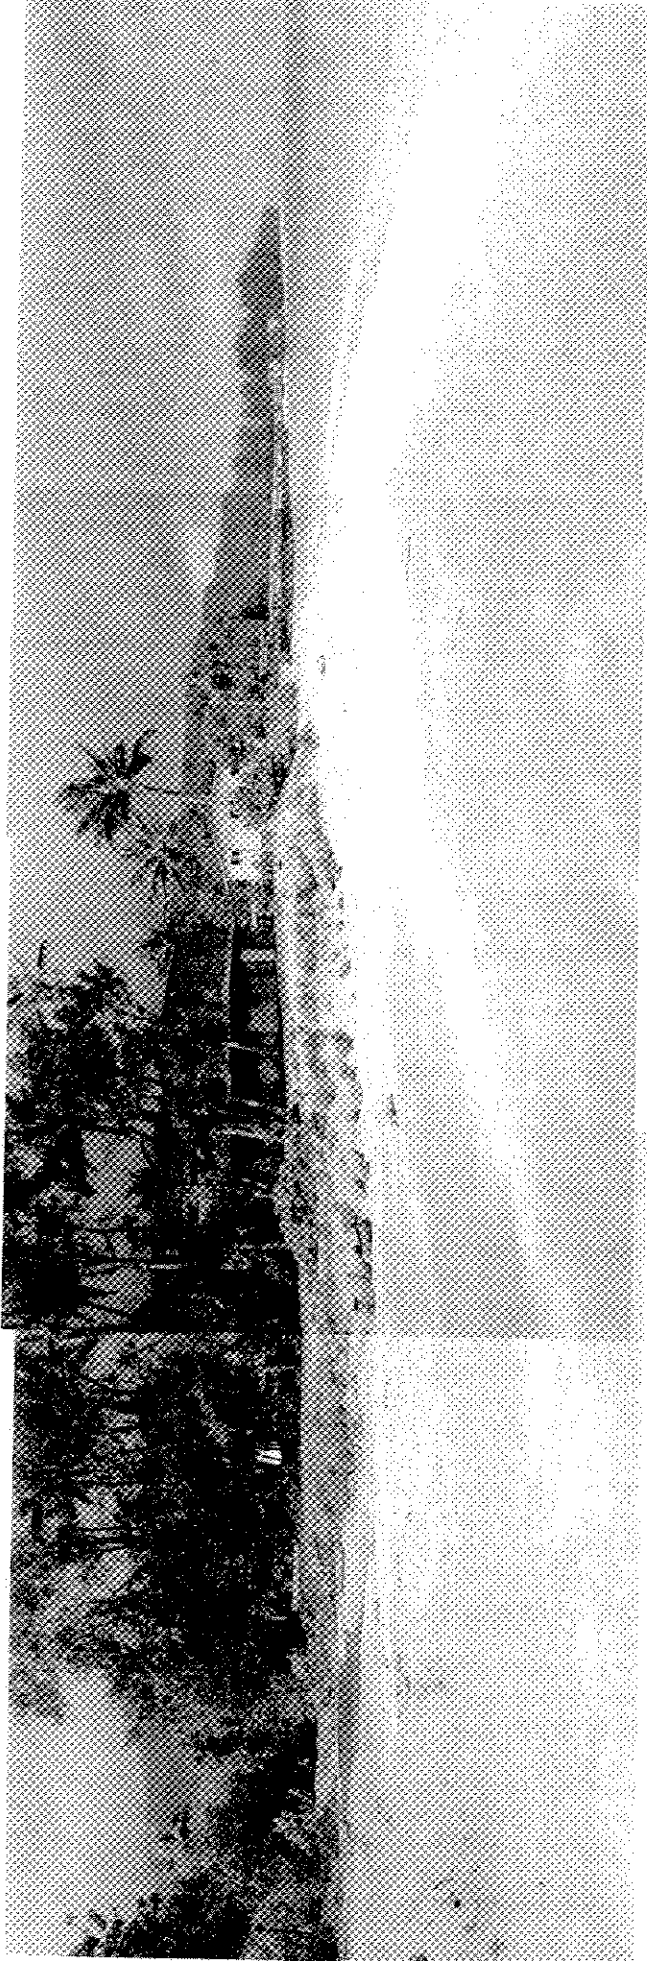
View westward from stream mouth. Note eroded condition of embankment on west side of the stream. Continuous line of seawalls protect entire central shore frontage within the embayment.
