Subject: Chapter 343, Hawaii Revised Statutes  
Draft Environmental Assessment (EA)

Applicant/  
Landowner: William and Margaret O'Connell  
Agent: Thomas C. Zizzi, Esq.  
Location: 84-709 Upena Street - Waianae  
Tax Map Key: 8-4-7: 1  
Request: Shoreline Setback Variance  
Proposal: To retain a modified vertical seawall structure and other structures within the shoreline setback.

# Draft Environmental Assessment

**TMK:(1) 8-4-007-001; 84-709 Upena Street, Waianae, Oahu**

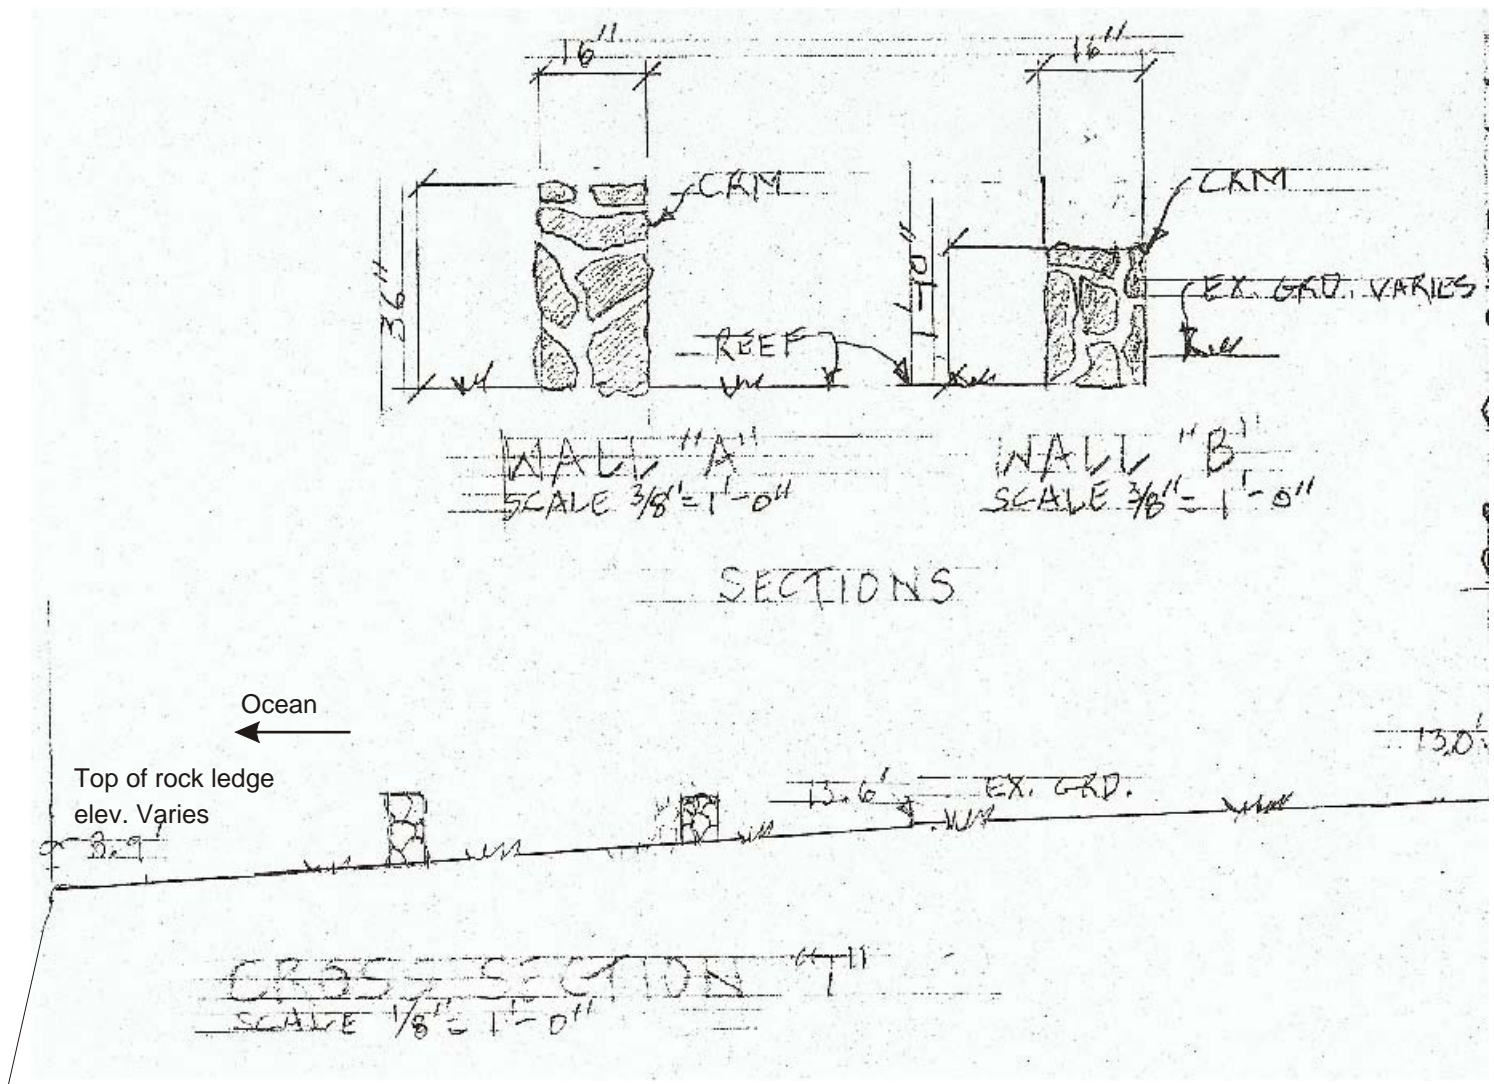
EXISTING SEAWALL AND SHORELINE TYPICAL SECTION

The ground elevation along the base of the wall is about +12 feet MSL, and the wall height is about 3 feet. Therefore, the crest elevation of the seawall is about +15 feet MSL. A metal fence about 2 feet high runs along the top of the seawall. There is a secondary rock wall on the mauka side of the seawall that is about 1.8 feet high. The ground elevation on the mauka side of this secondary wall is about +13 feet MSL. This secondary wall forms a containment for water from wave overtopping of the seawall. This dual wall system is apparently very effective in mitigating wave erosion damage to the property. The scouring of the cobbles and rocks within the containment area is an indication of the force of the overtopping waves (see Photo page-1). Brown spots in the lawn area just landward of the wall system indicates that wave overtopping

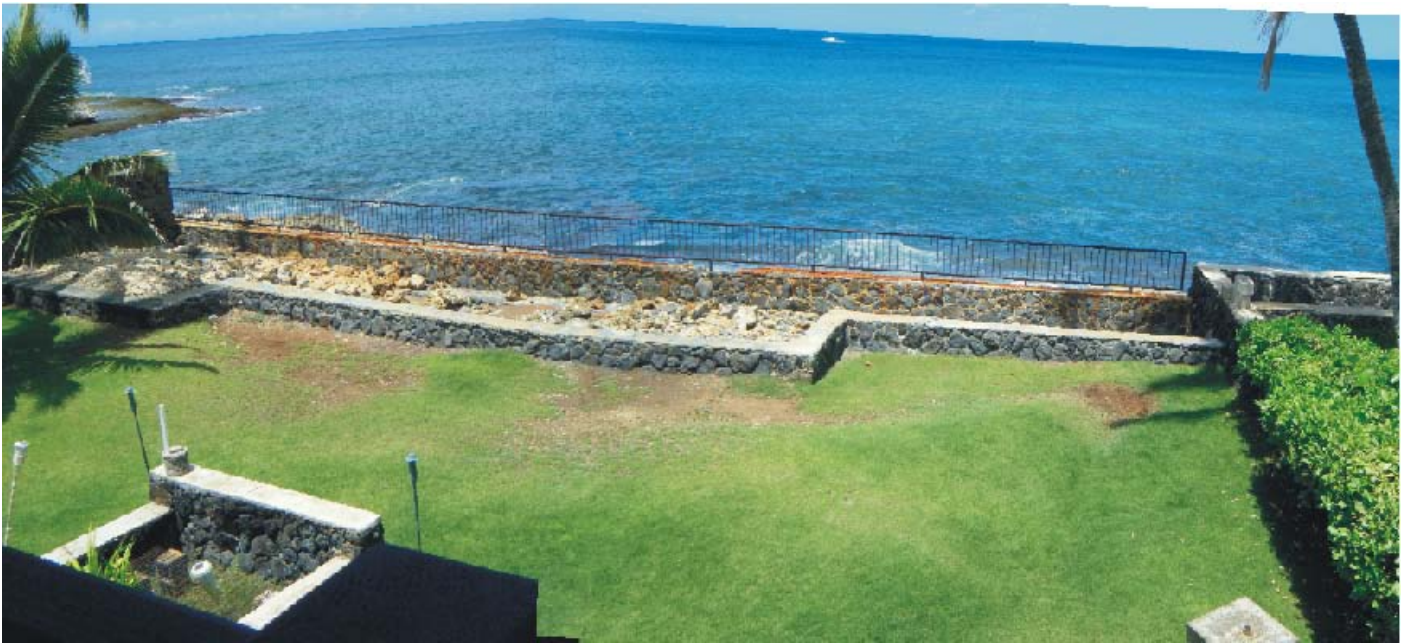
View of shoreline from observation tower on the property. Brown areas mauka of the secondary wall indicate scouring damage from wave overtopping.

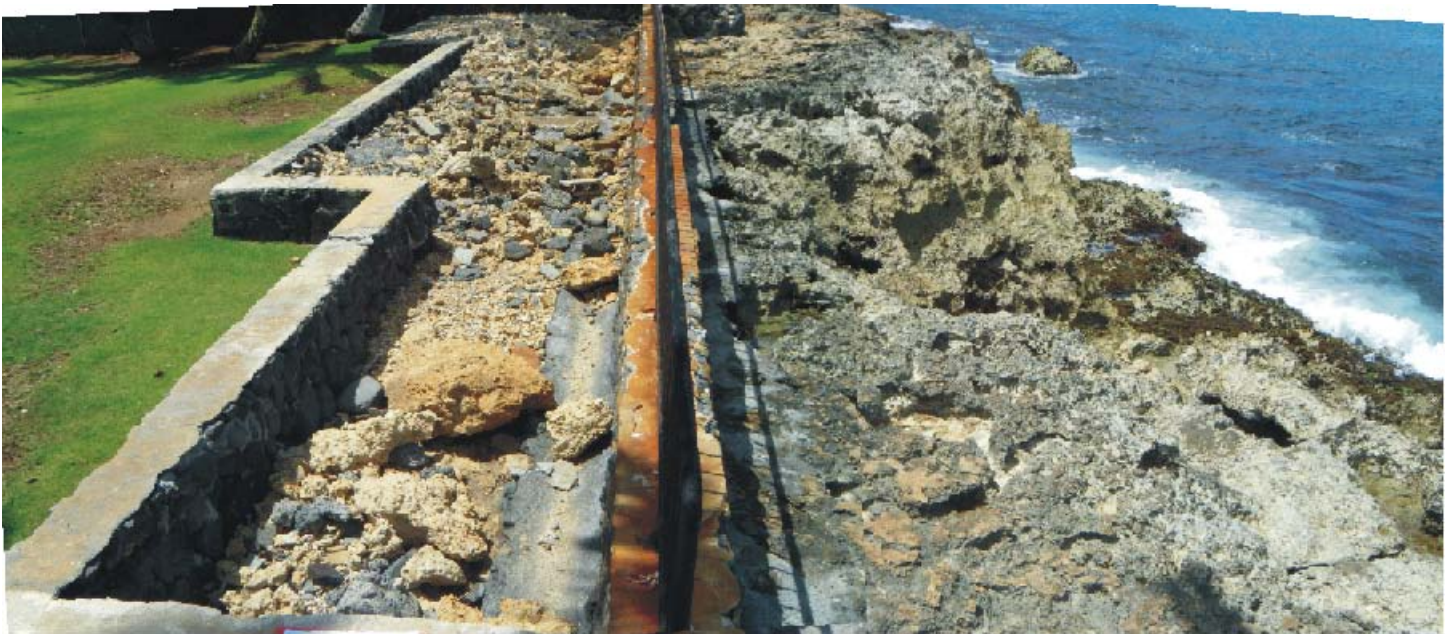
View southward along the top of the seawall. The seaward wall is topped with a metal fence (brown stains are from rusting of the fence). The landward wall contains the water from wave overtopping of the seaward wall. Brown spots in the lawn area just landward of this wall indicates that wave overtopping damage can still continue to occur during high wave events.

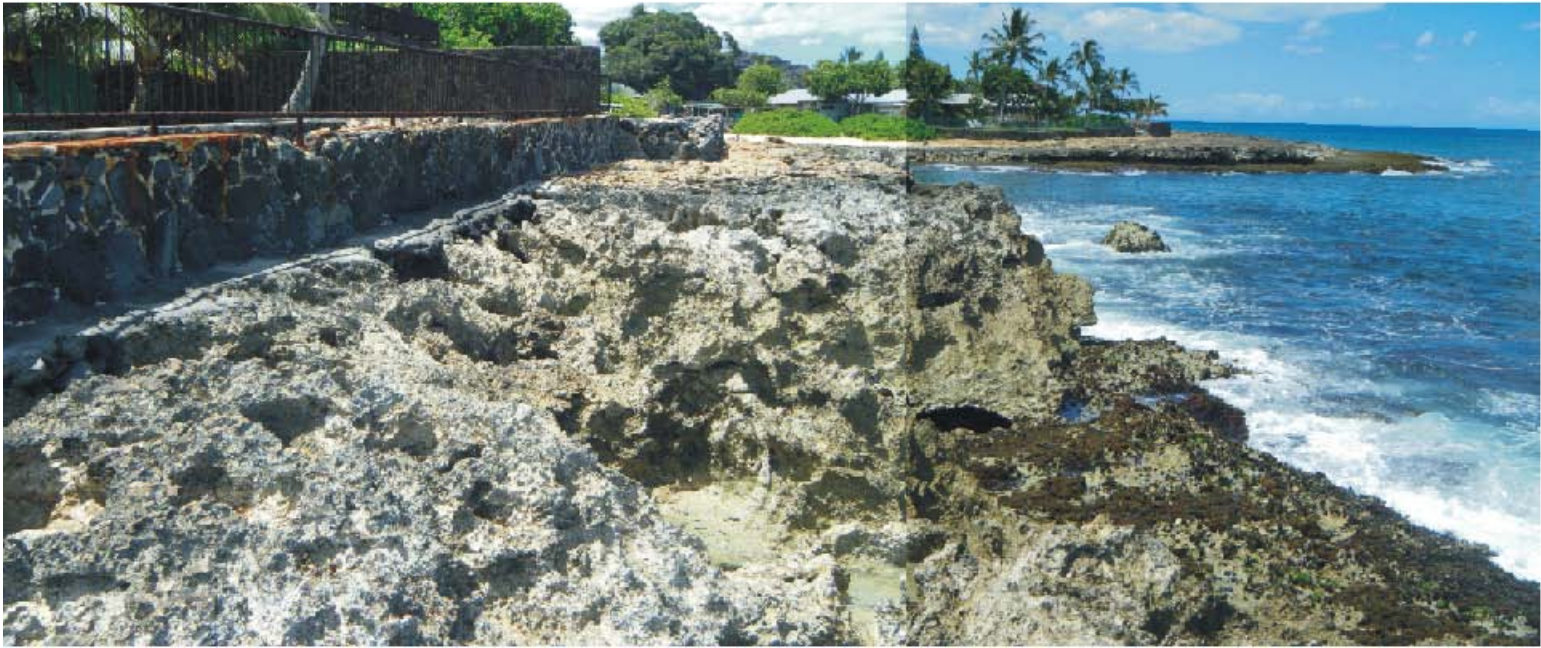
View southward of shoreline fronting the subject property seawall. The shoreline is an eroded limestone cliff face with very sharp dissolution cavities.
