# AERIAL PHOTOGRAPHY ANALYSIS OF COASTAL EROSION ON THE ISLANDS OF KAUAI, MOLOKAI, LANAI, MAUI AND HAWAII

JUNE, 1991

**PREPARED BY:**  
**MAKAI OCEAN ENGINEERING, INC**  
**and**  
**SEA ENGINEERING, INC.**  
**Honolulu, Hawaii**

**PREPARED FOR:**  
**STATE OF HAWAII**  
**OFFICE OF STATE PLANNING**  
**COASTAL ZONE MANAGEMENT**  
**PROGRAM**

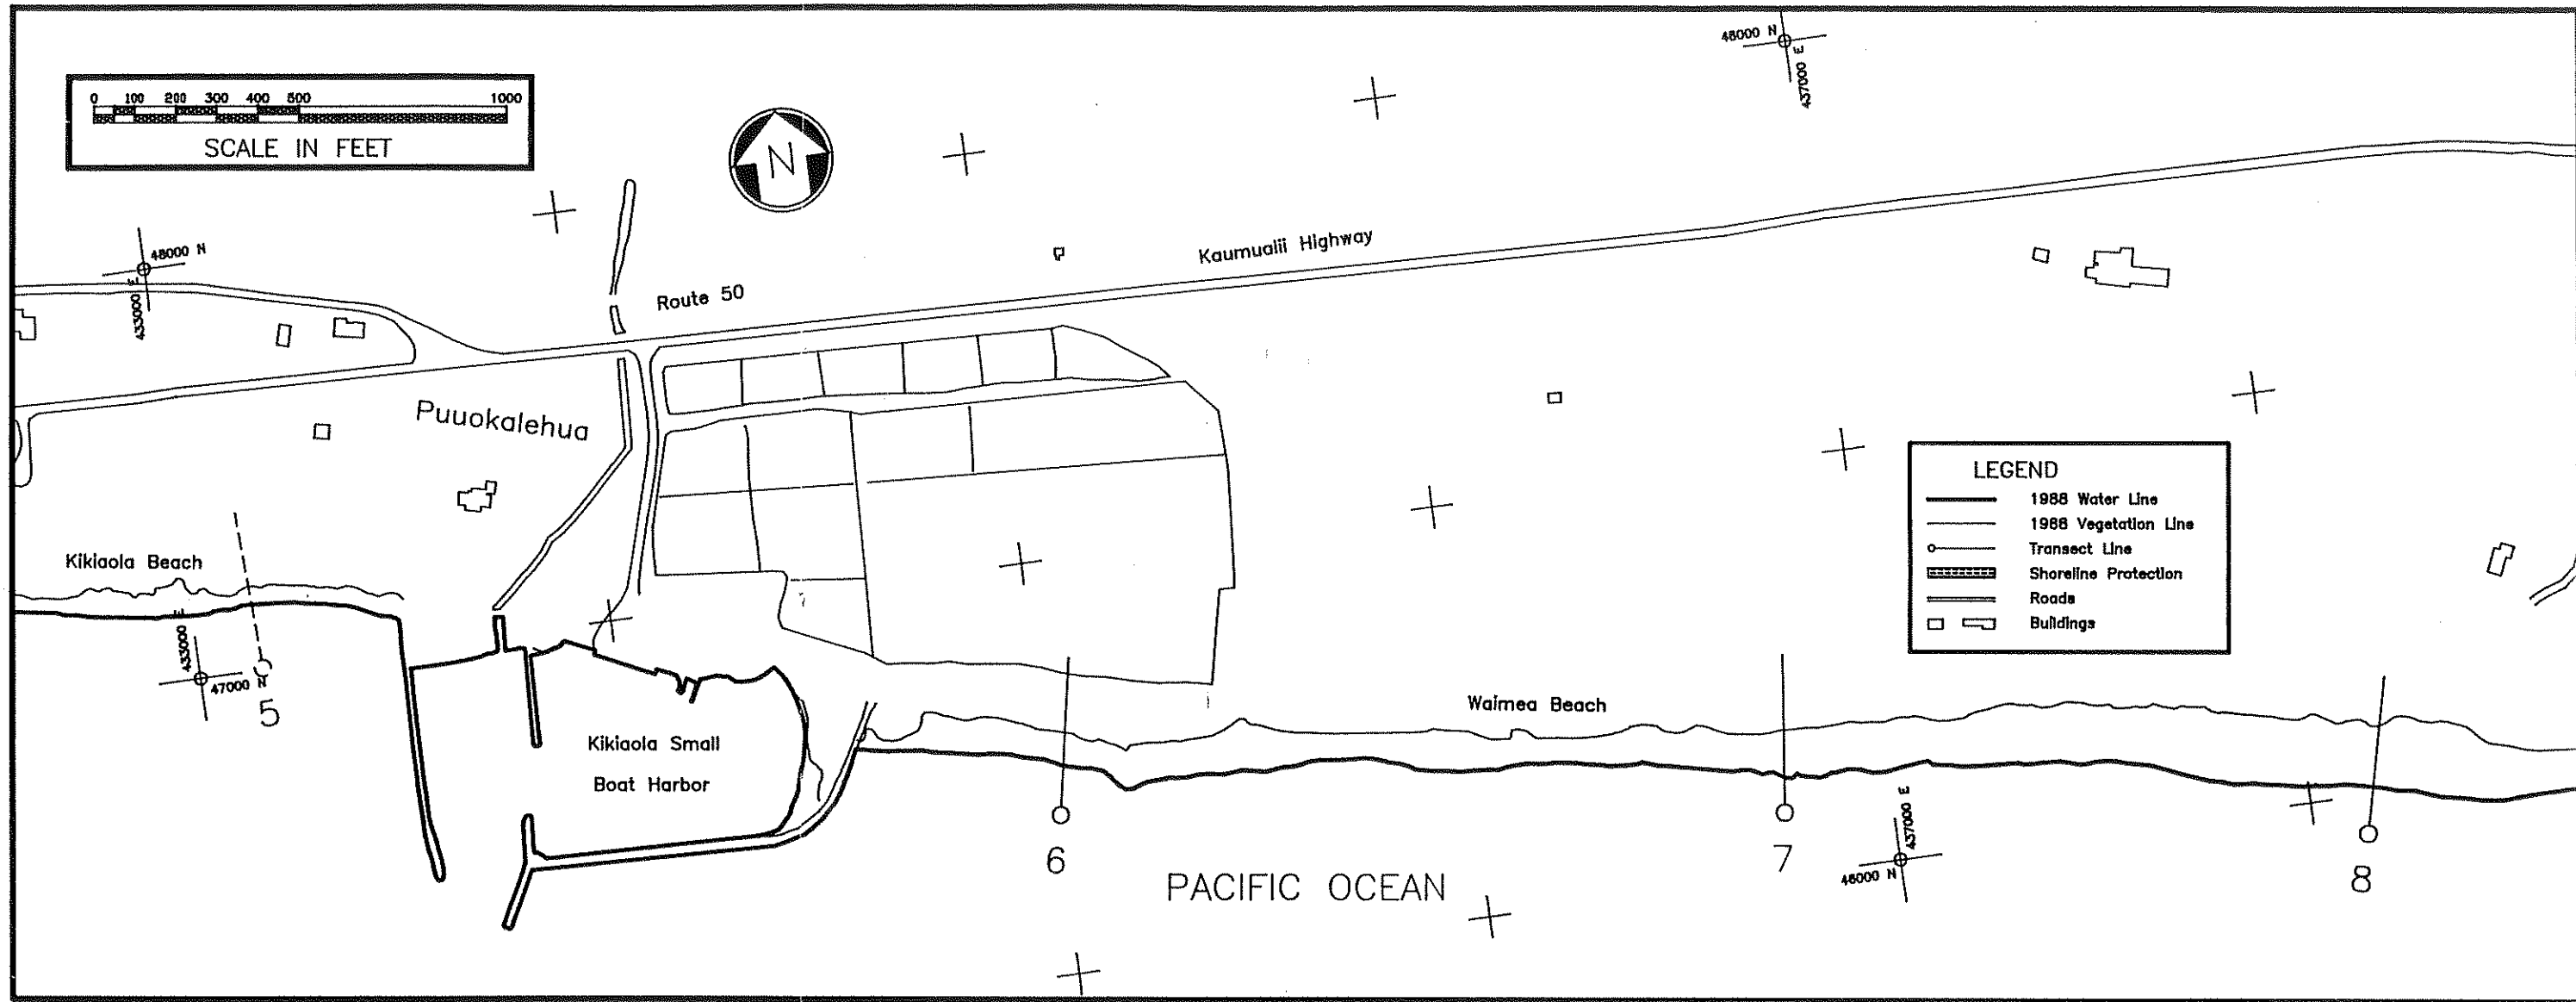
**FIGURE KA-2**

- The accretion in this subsector is due to the same mechanism that caused the erosion in subsector KA-1, the blockage of the westward littoral drift by the harbor. In addition to the erosion and accretion of the adjacent downdrift and updrift shorelines, the littoral transport has resulted in chronic shoaling problems in the entrance channel of the harbor.

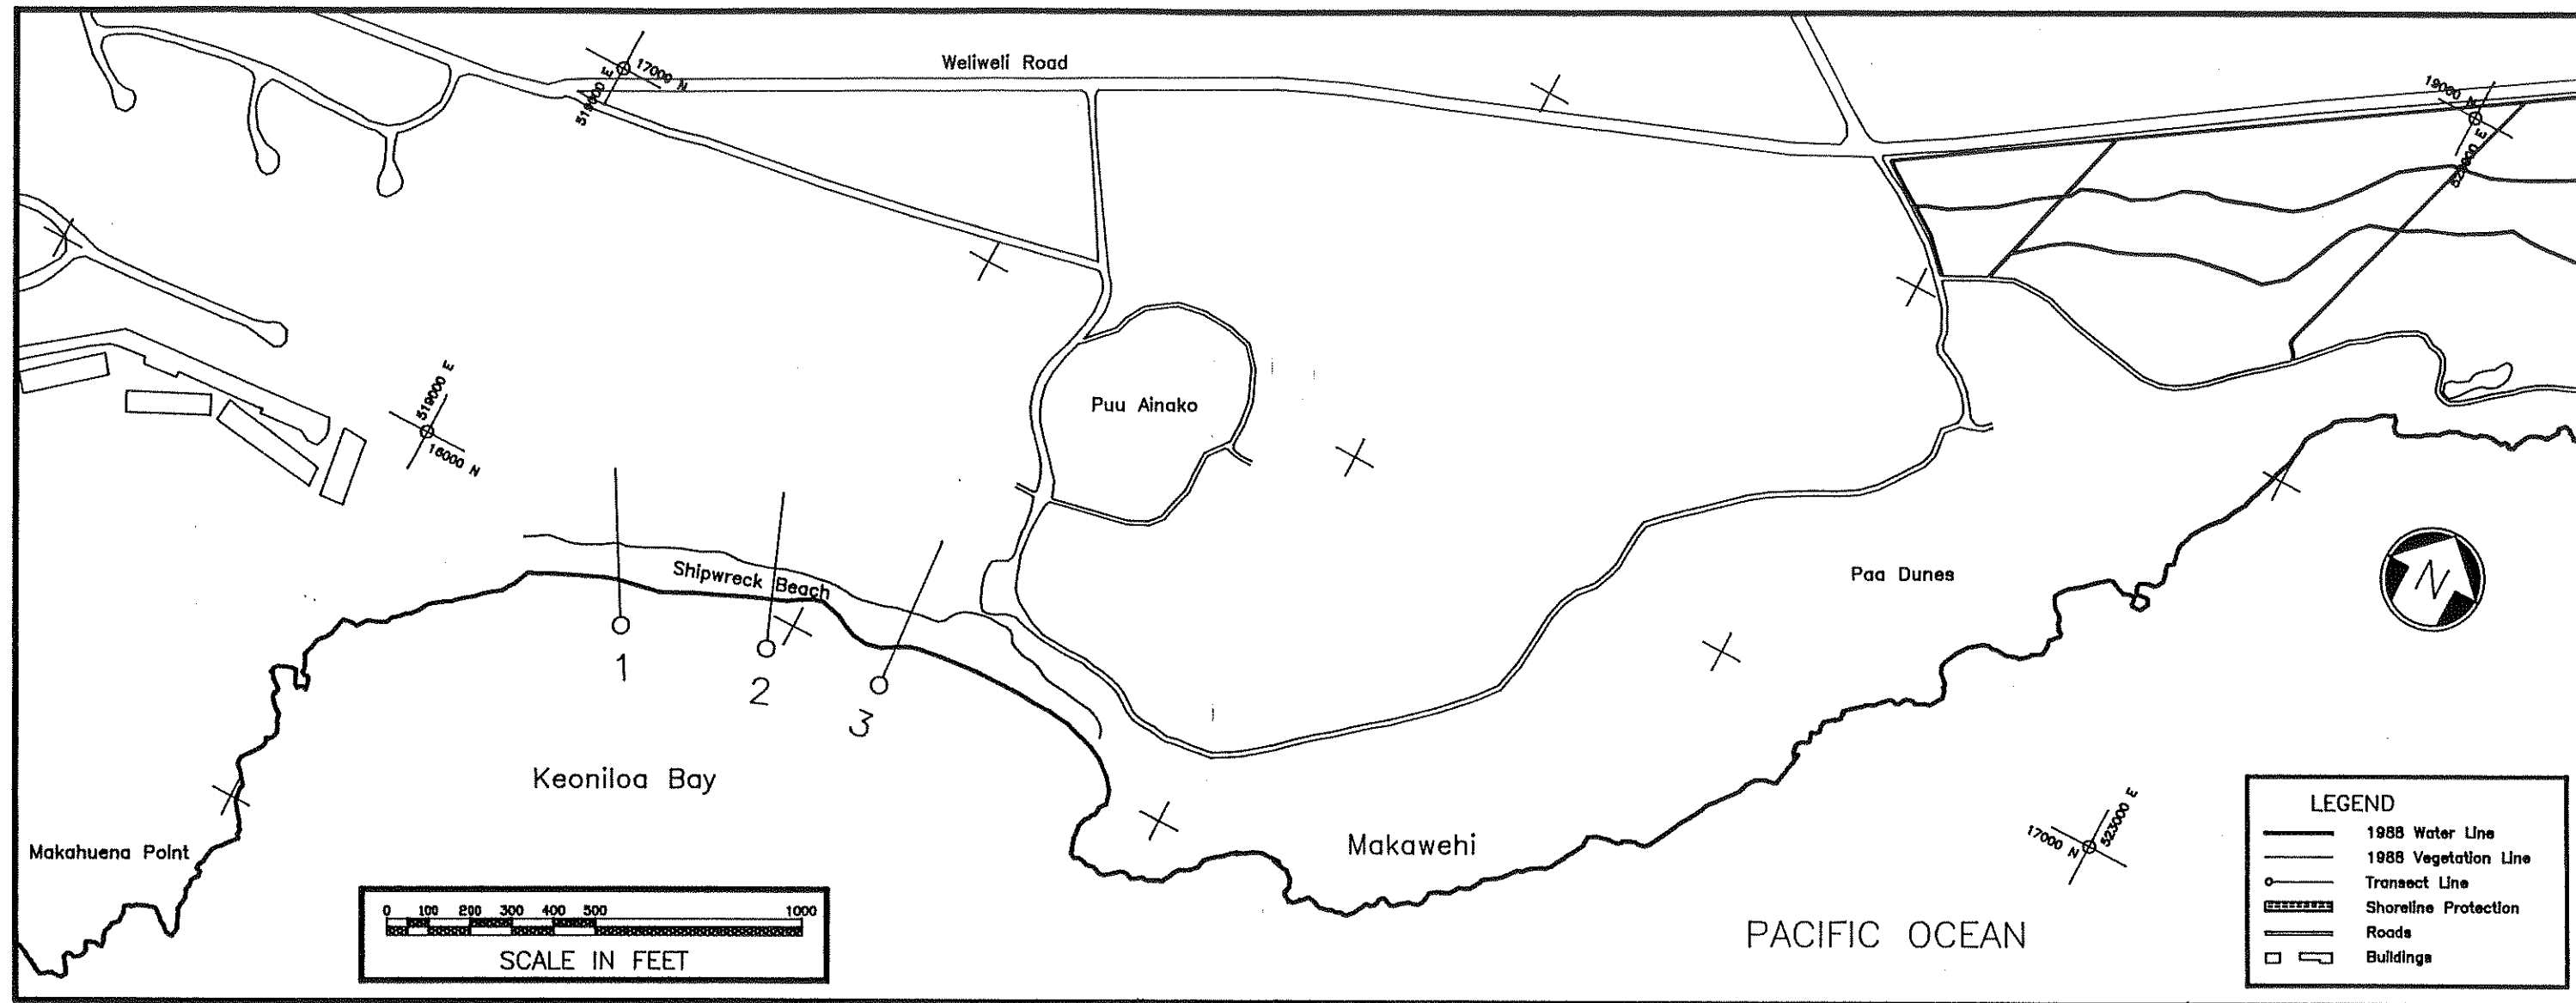
**FIGURE KB-1**

- The aerial photographs indicate that the overall trend for this beach is erosion of the vegetation line (Regions 1, 2 and 3).
- During the site visit for this study, no evidence of ongoing erosion was noted. The apparent erosion over past years may have been at least partially due to off-road vehicles affecting the vegetation or the onshore transport of wind-blown sand.

- The data for this beach are questionable due to possible changes in the vegetation line due to recreational use and onshore transport of wind-blown sand. However, from all indications, including the observed behavior of the beach over the years, it is a dynamic beach that is subject to relatively large changes, particularly during Kona storms.

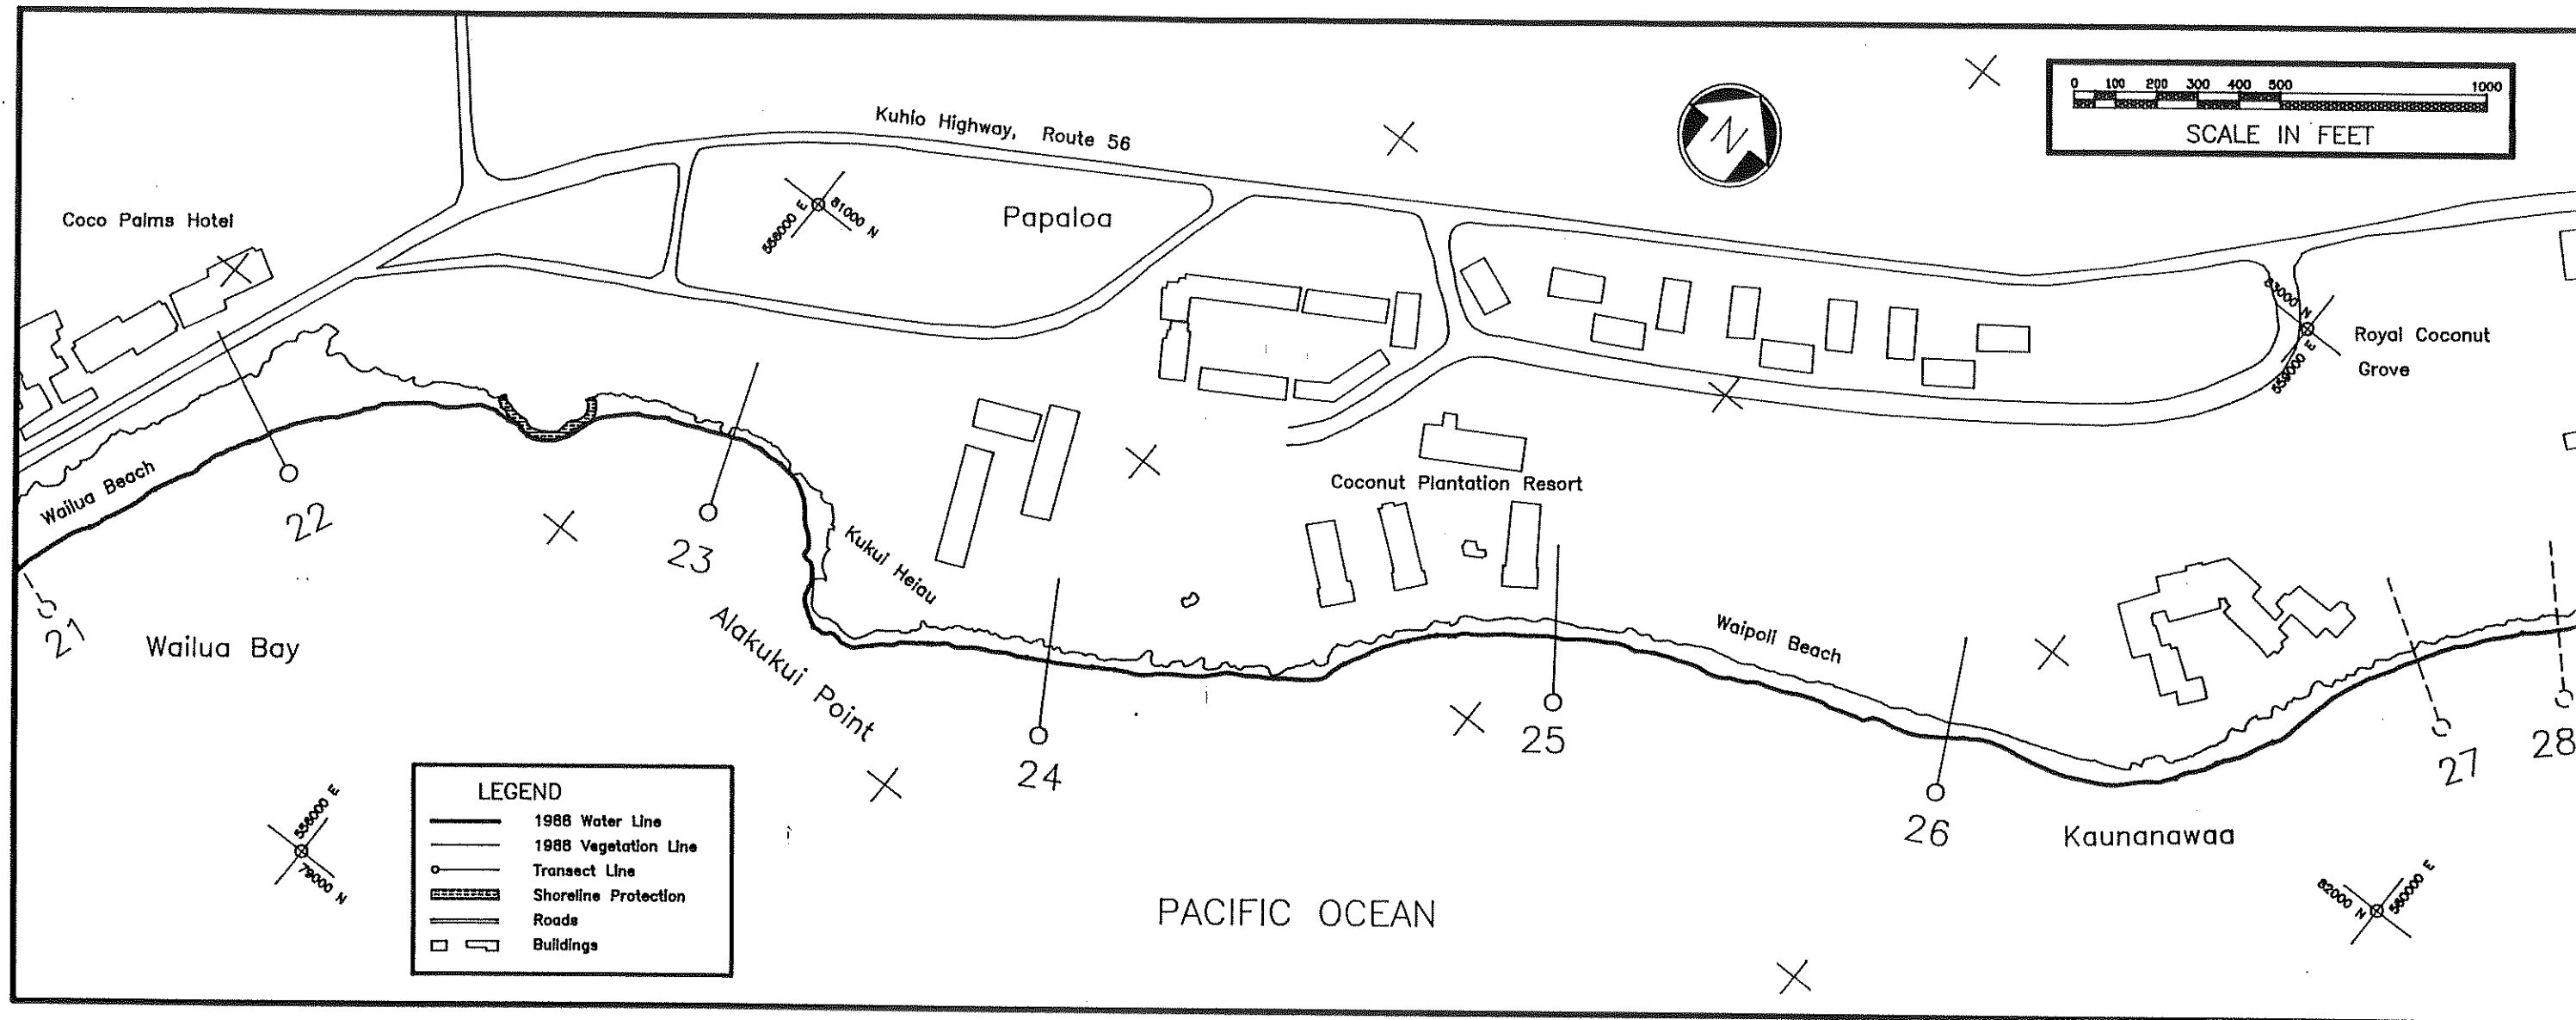
**FIGURE KC-5**

- Regions 21 (shown in Subsector KC-4) and 22 show that Wailua Beach has accreted since 1950.
- The area near the river mouth is unstable and river flooding at times causes erosion of the south end of the beach.
- The beach south of Alakukui Point (Region 23) is stable, with only minor vegetation line changes.

- Wailua Beach is accreting, except for the south end, which is affected by the river discharge. The other beach areas are relatively stable, but may undergo periods of erosion.

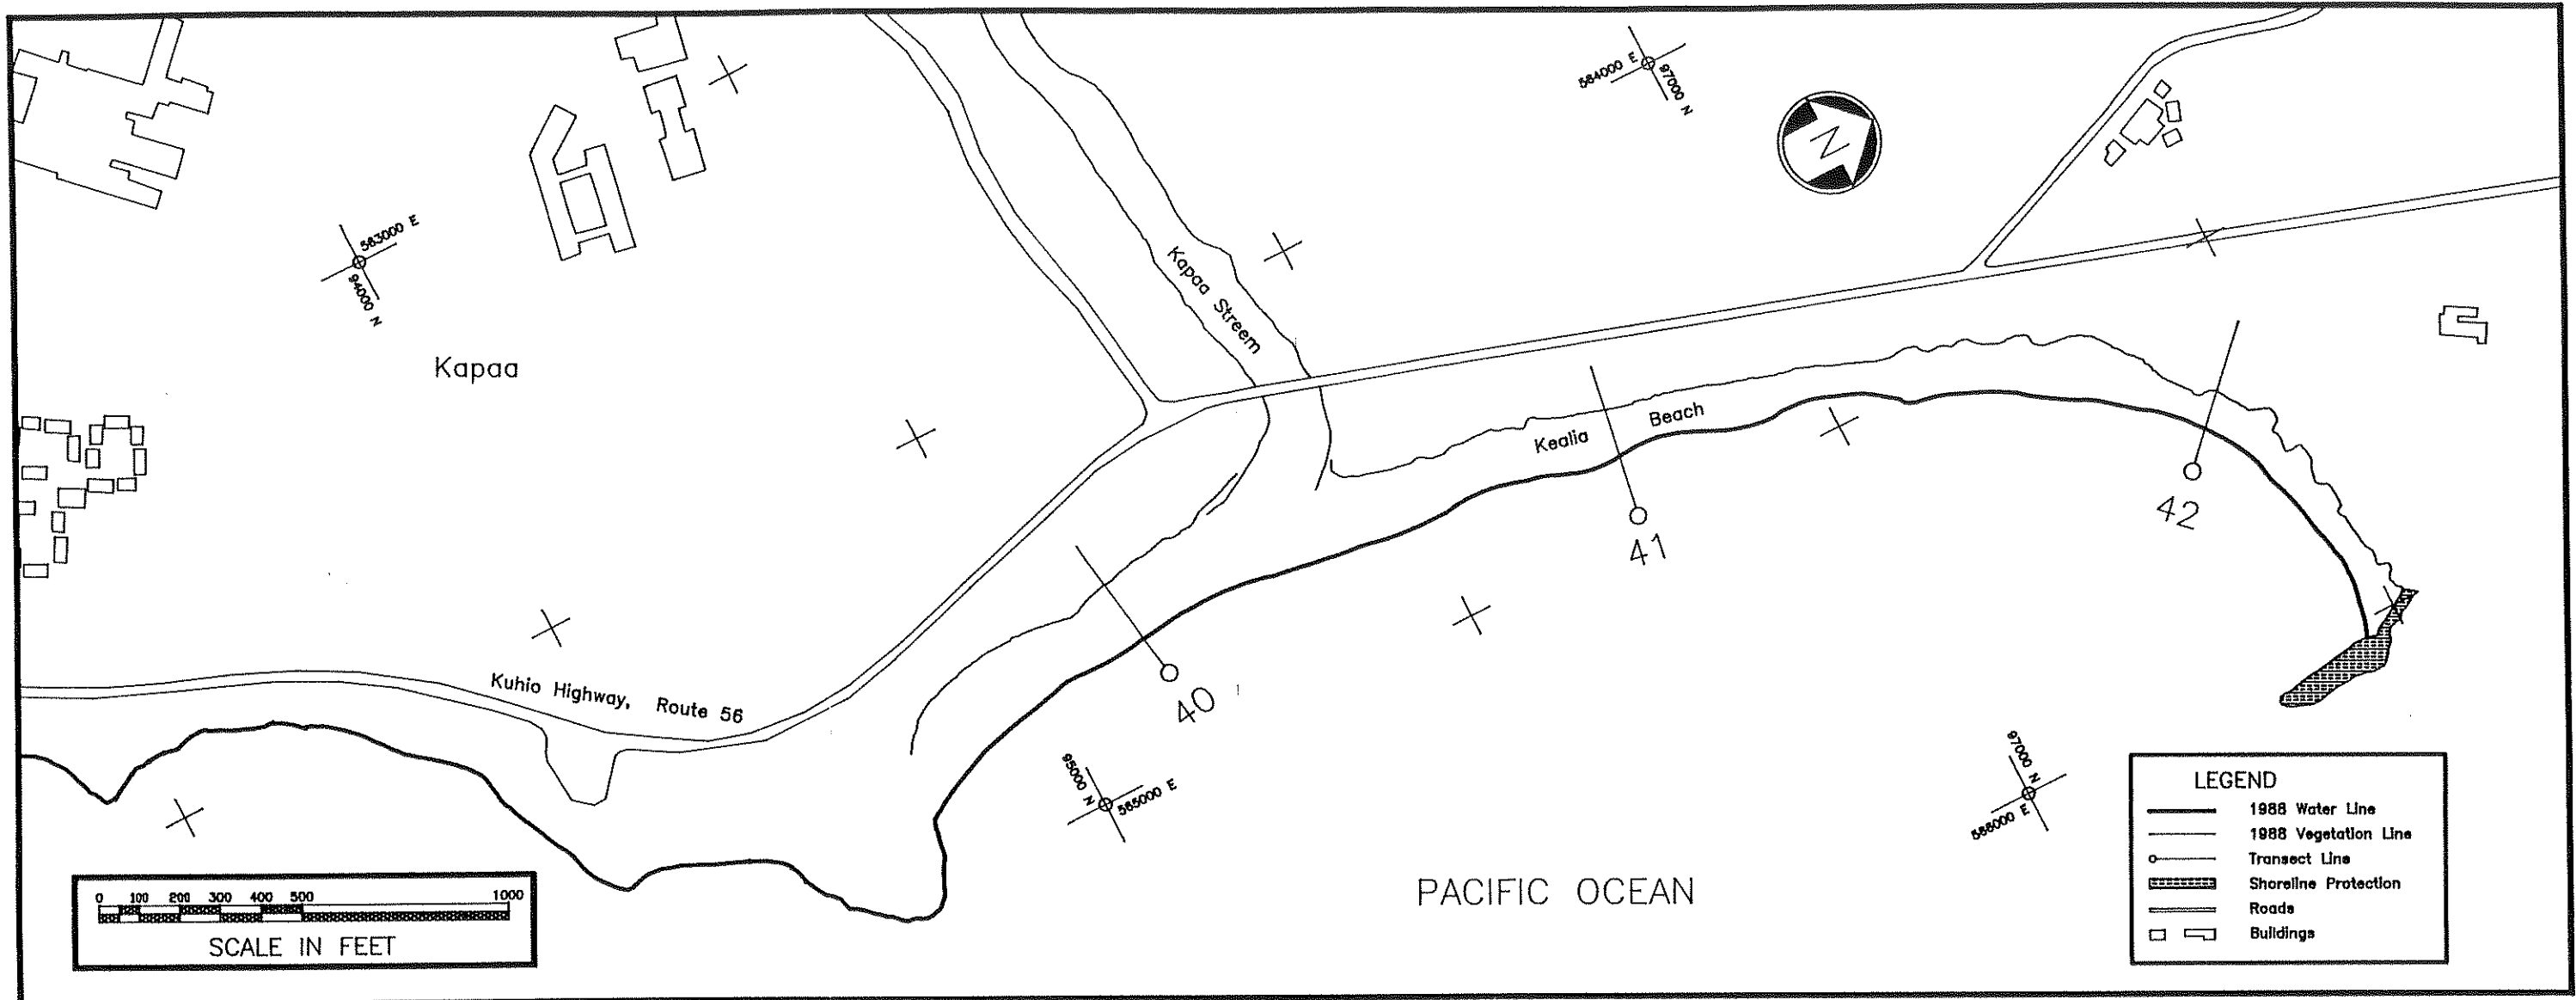
FIGURE KC-8

- Regions 40, 41 and 42 indicate a significant recession of the vegetation line at Kealia Beach. Most of the change occurred between 1950 and 1975. Net erosion along the beach ranges from 21 to 45 feet.
- There were no signs of ongoing or chronic erosion observed during the site visit.
- The 1960 data for this subsector were not used because the photographs were blurry and the vegetation lines were difficult to define.

- The cause of the erosion at Kealia Beach is not readily apparent. The beach is a discrete littoral cell, and there are no obvious onshore changes that would have affected the cell. The jetty at the north end of the beach is at the end of the sandy area, and should have little or no impact.
- There is a large sand channel in the nearshore area off the beach. Typically, beaches similar to Kealia, with exposure to significant waves and a large offshore sand channel, are dynamic, but relatively stable over the long term. This is not the case at Kealia. Any development seaward of the highway should be avoided.

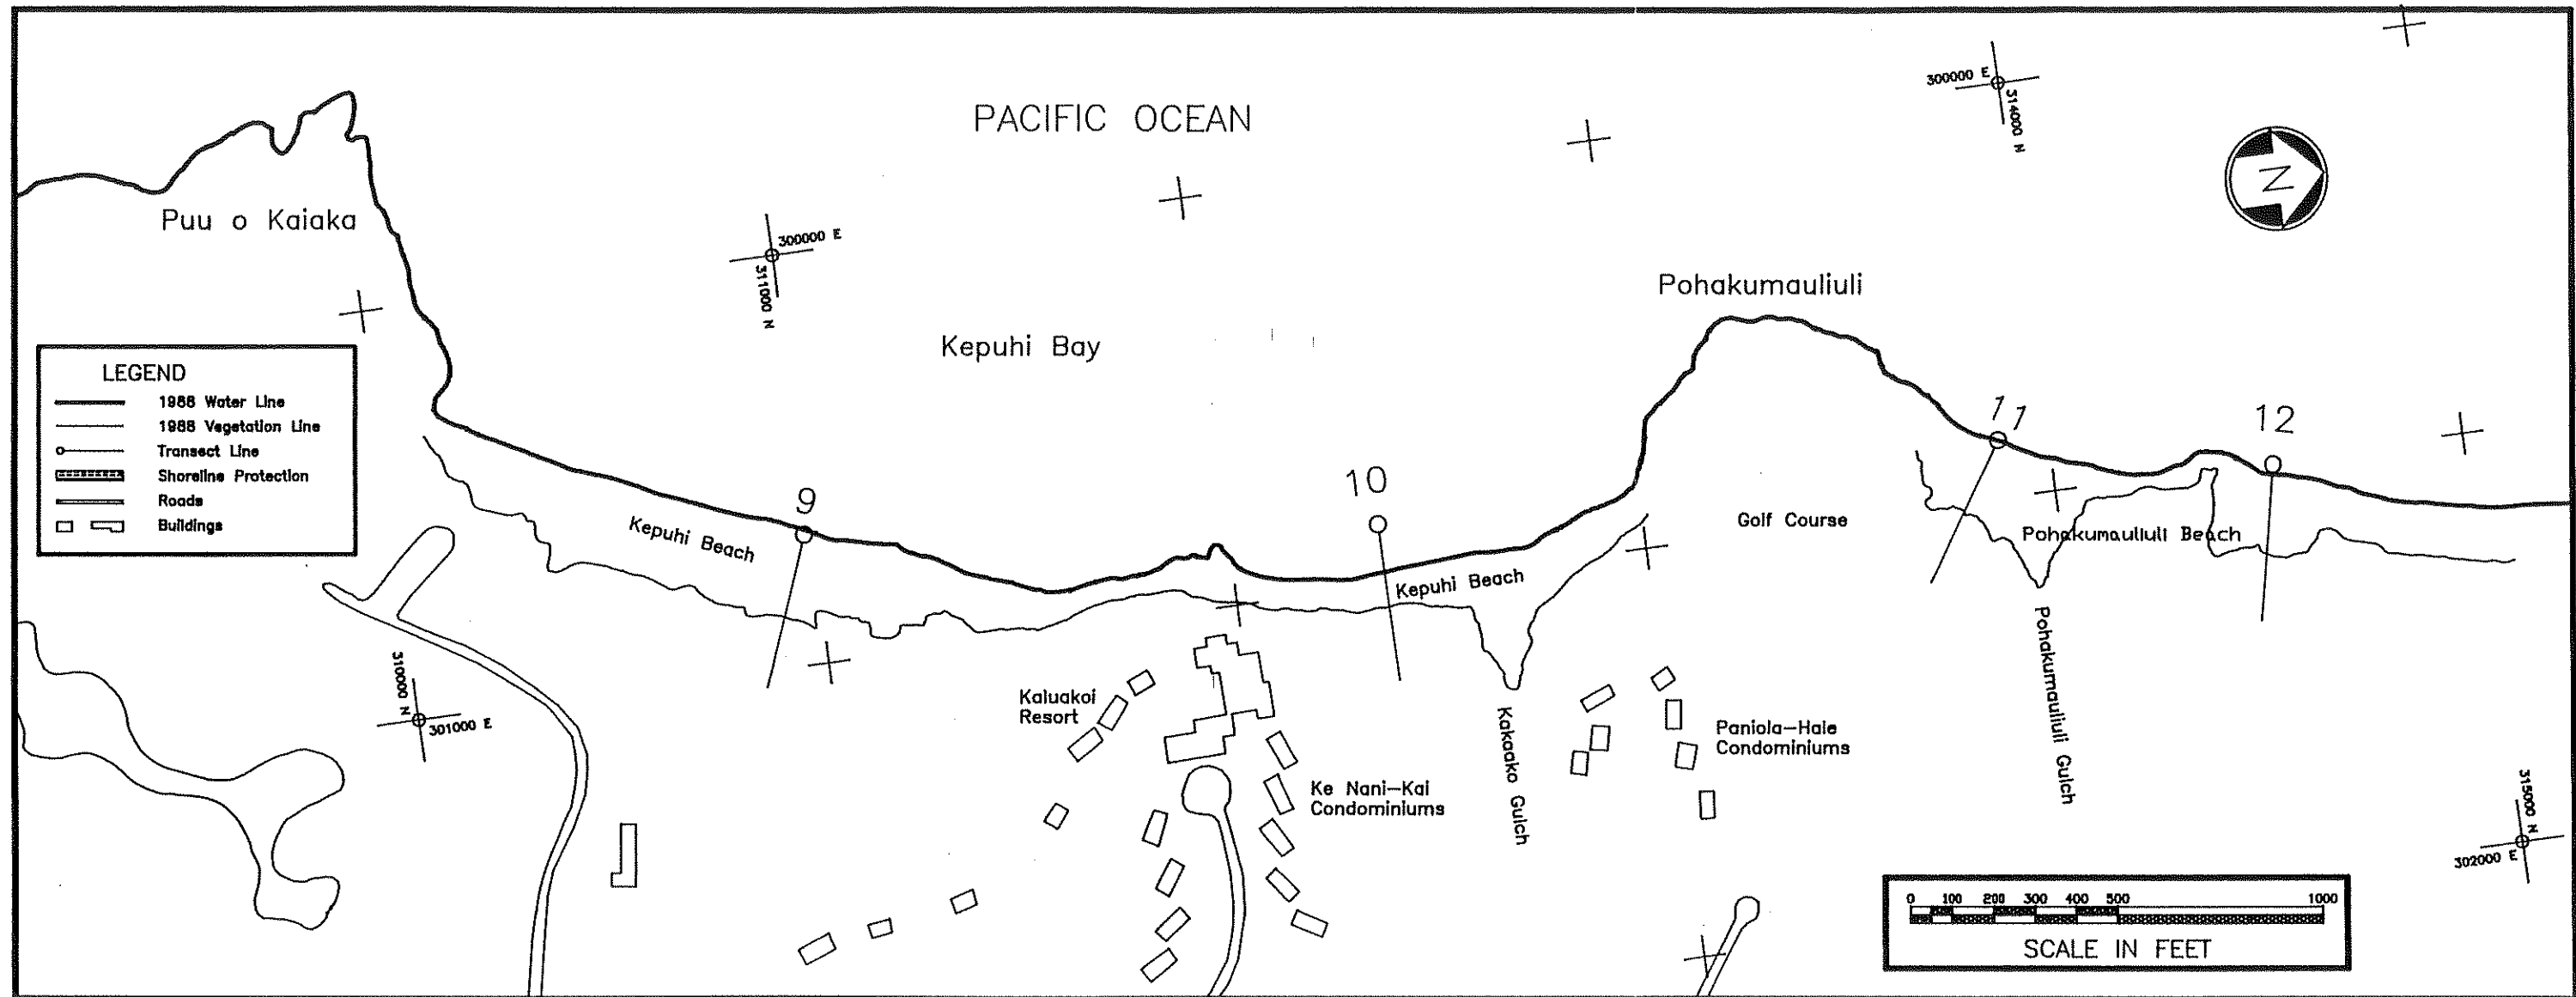
**FIGURE OA-3**

- Kepuhi Beach is a 2900 foot long sand beach located just north of Puu O Kaiaka. The beach is broken into two subsectors by a naturally occurring outcrop of basalt boulders and ledges in the center of the beach.
- Beachrock is frequently exposed at the toe of the beach, particularly along the southern half.
- Pohakumauliuli Beach is separated from Kepuhi Beach by part of an old cinder cone, which forms a headland between the two. Another part of the cinder cone overhangs the center of the beach, and essentially splits it in two.
- Both beaches are directly exposed to the north Pacific swell, and subsequent erosion and accretion. Beachrock and boulders are commonly exposed along these beaches during the winter months.

- As at Papohaku Beach to the south, both these beaches had lost most or all of their sand at the time of the 1968 aerial photograph. The reason is not known, but it could have been due to an exceptionally large occurrence of north Pacific swell or a severe Kona storm.
- Both beaches are subject to significant winter/summer changes. Large waves in the winter months cause loss of sand from the beach, and beachrock ledges and boulders are exposed.

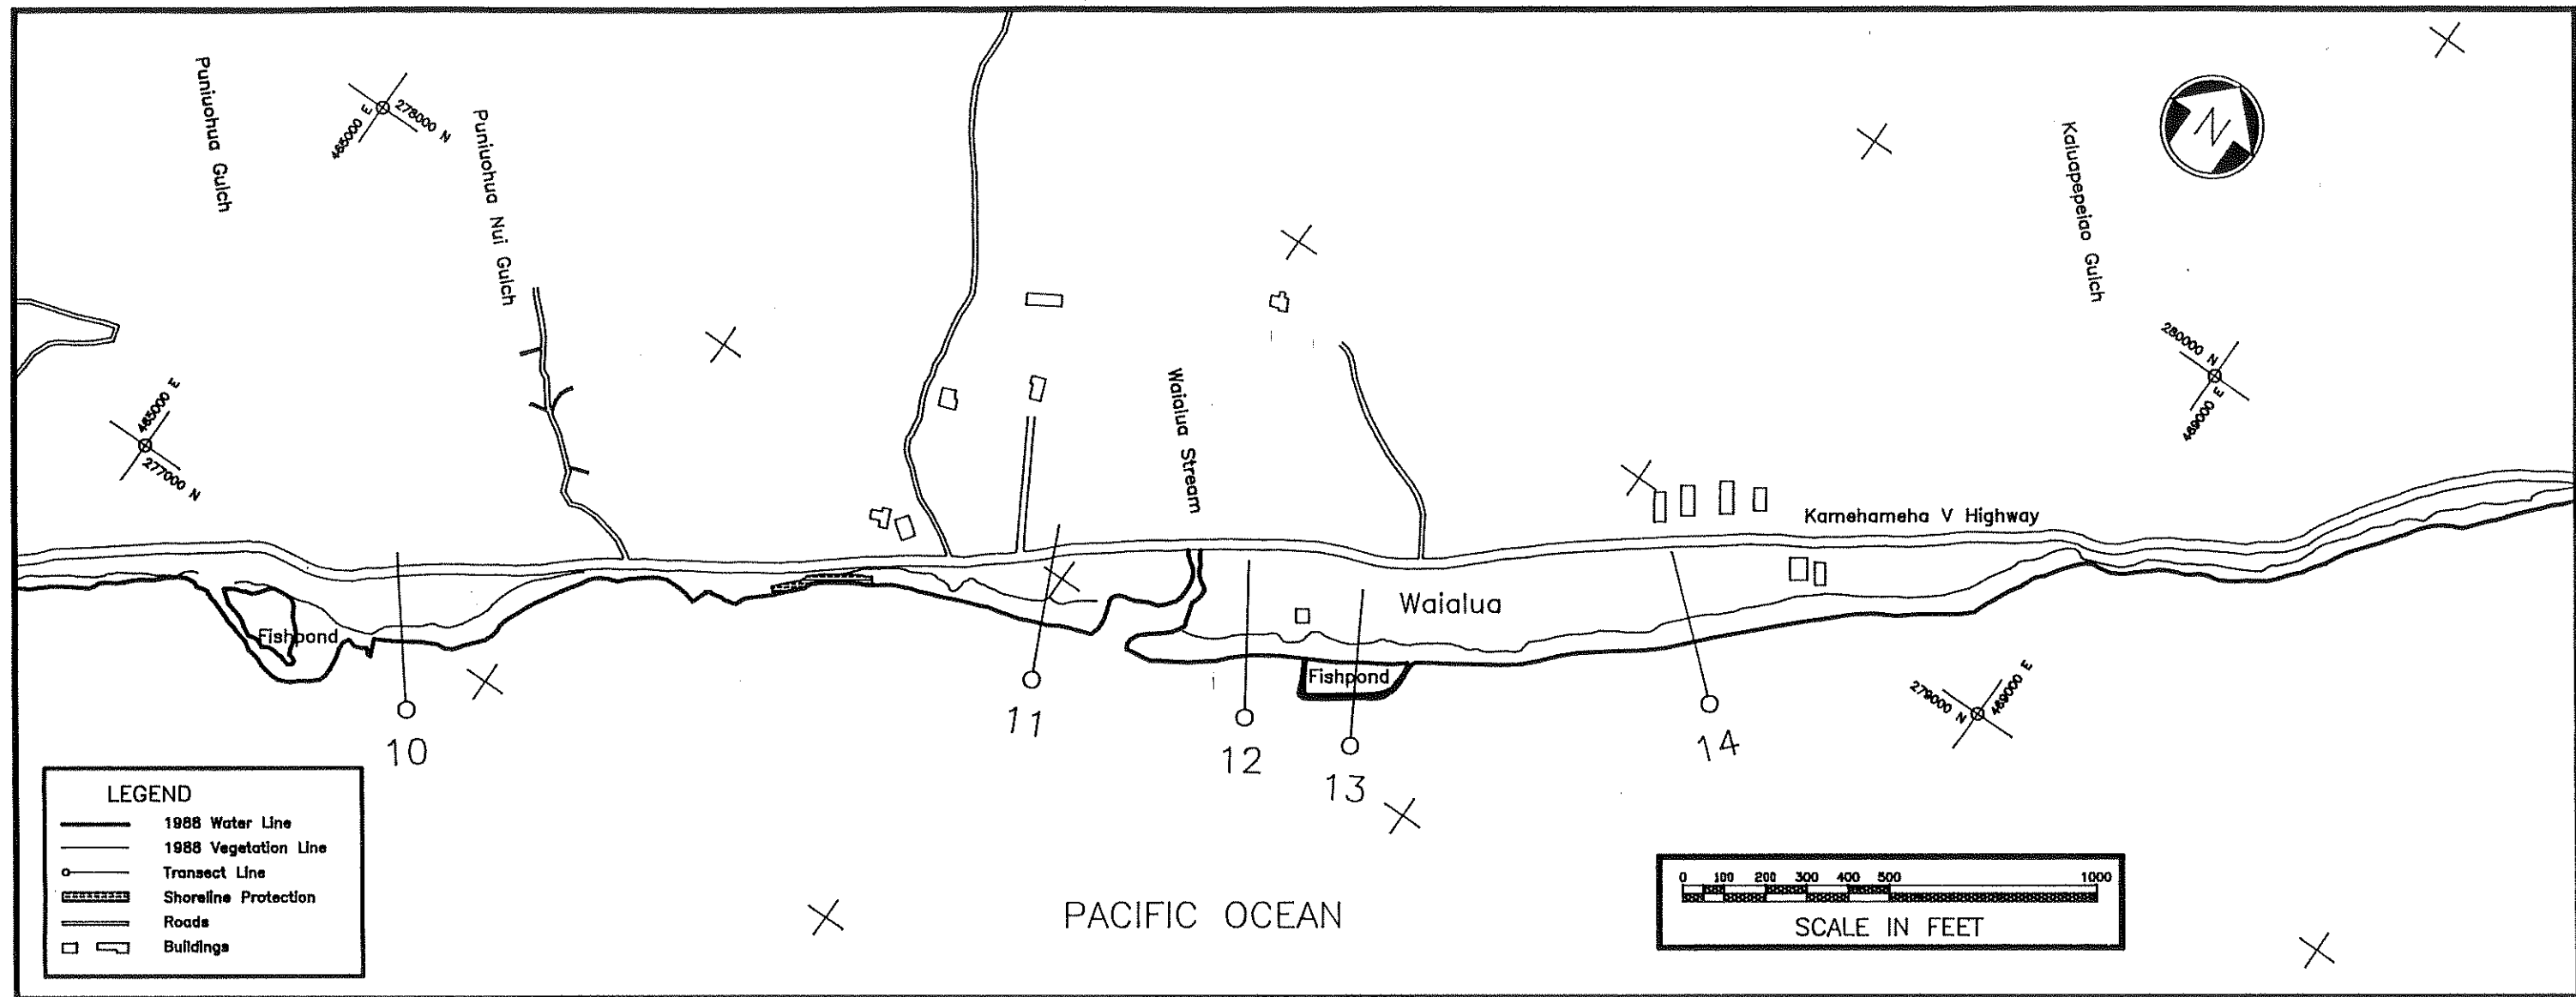
**FIGURE OB-3**

- Region 10, the small beach area at the south end of the subsector indicated steady, although minor, erosion over the measurement period. Evidence of erosion was found during the site visit. The toe of the dirt embankment was undercut just north of Region 10. One palm tree had been undercut and had fallen, and the roots were exposed on another because of embankment erosion.

- The small beaches in this subsector were relatively stable, except for the area north of the Waialua Stream.
- The 1975 aerial photographs showed a bulldozer on the beach in front of Waialua Stream, apparently engaged in removing sand from the beach. The extent of the sand mining operation is not known, but this may have been the cause of the erosion north of the stream.

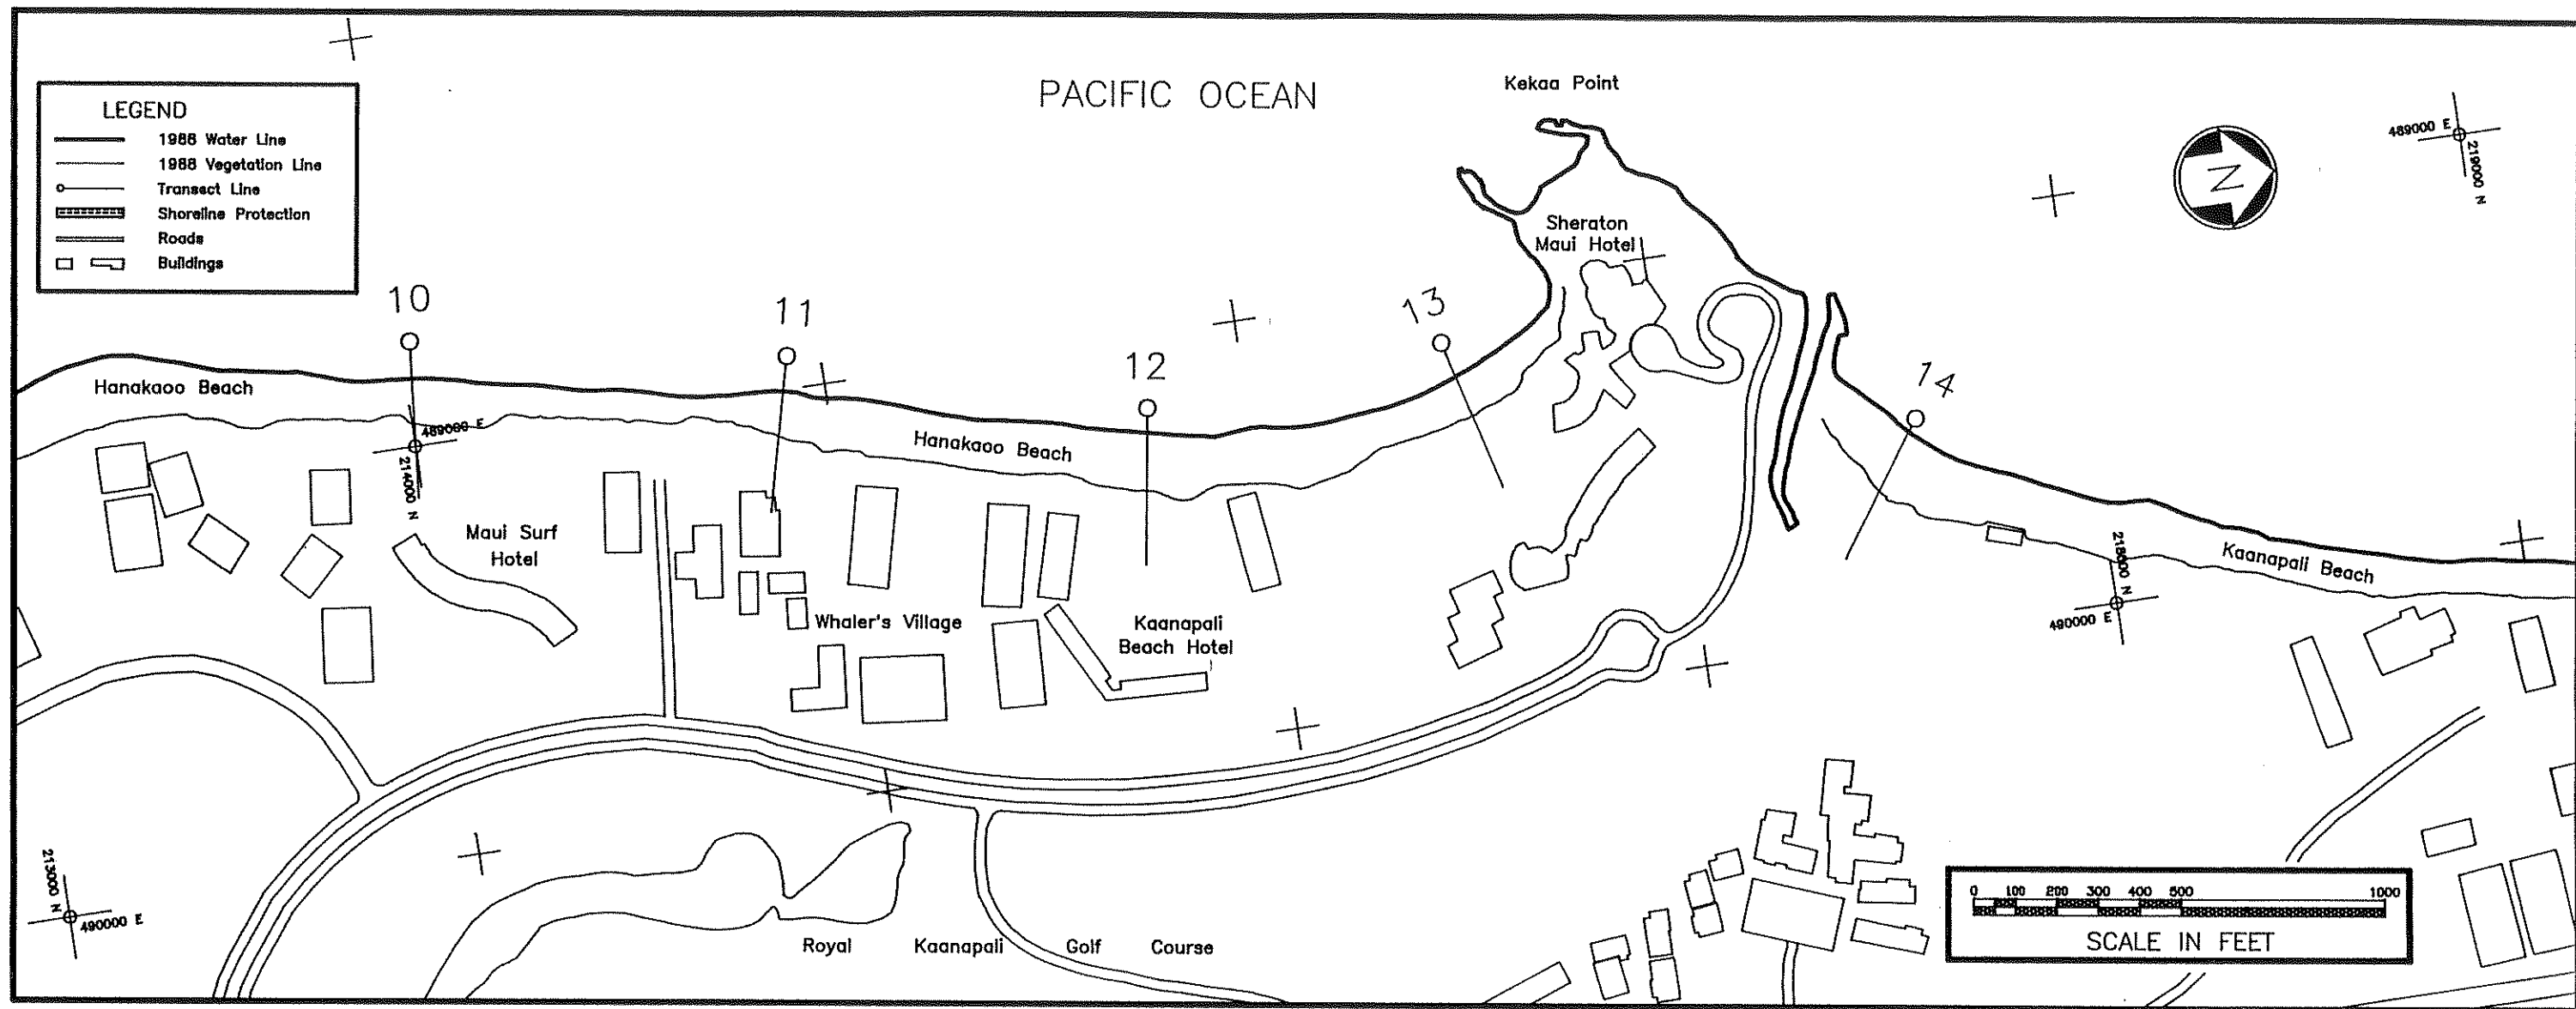
**FIGURE MA-5**

- As in subsector MA-4, some of the hotels and related facilities have been built very close to the vegetation line. It appears that the beach is stable during typical conditions, but has a history of erosion during severe Kona storms. After the January 1980 Kona storms, at least some of the hotels considered building protective revetments. This is a potential problem area, due to proximity of the structures to the vegetation line.

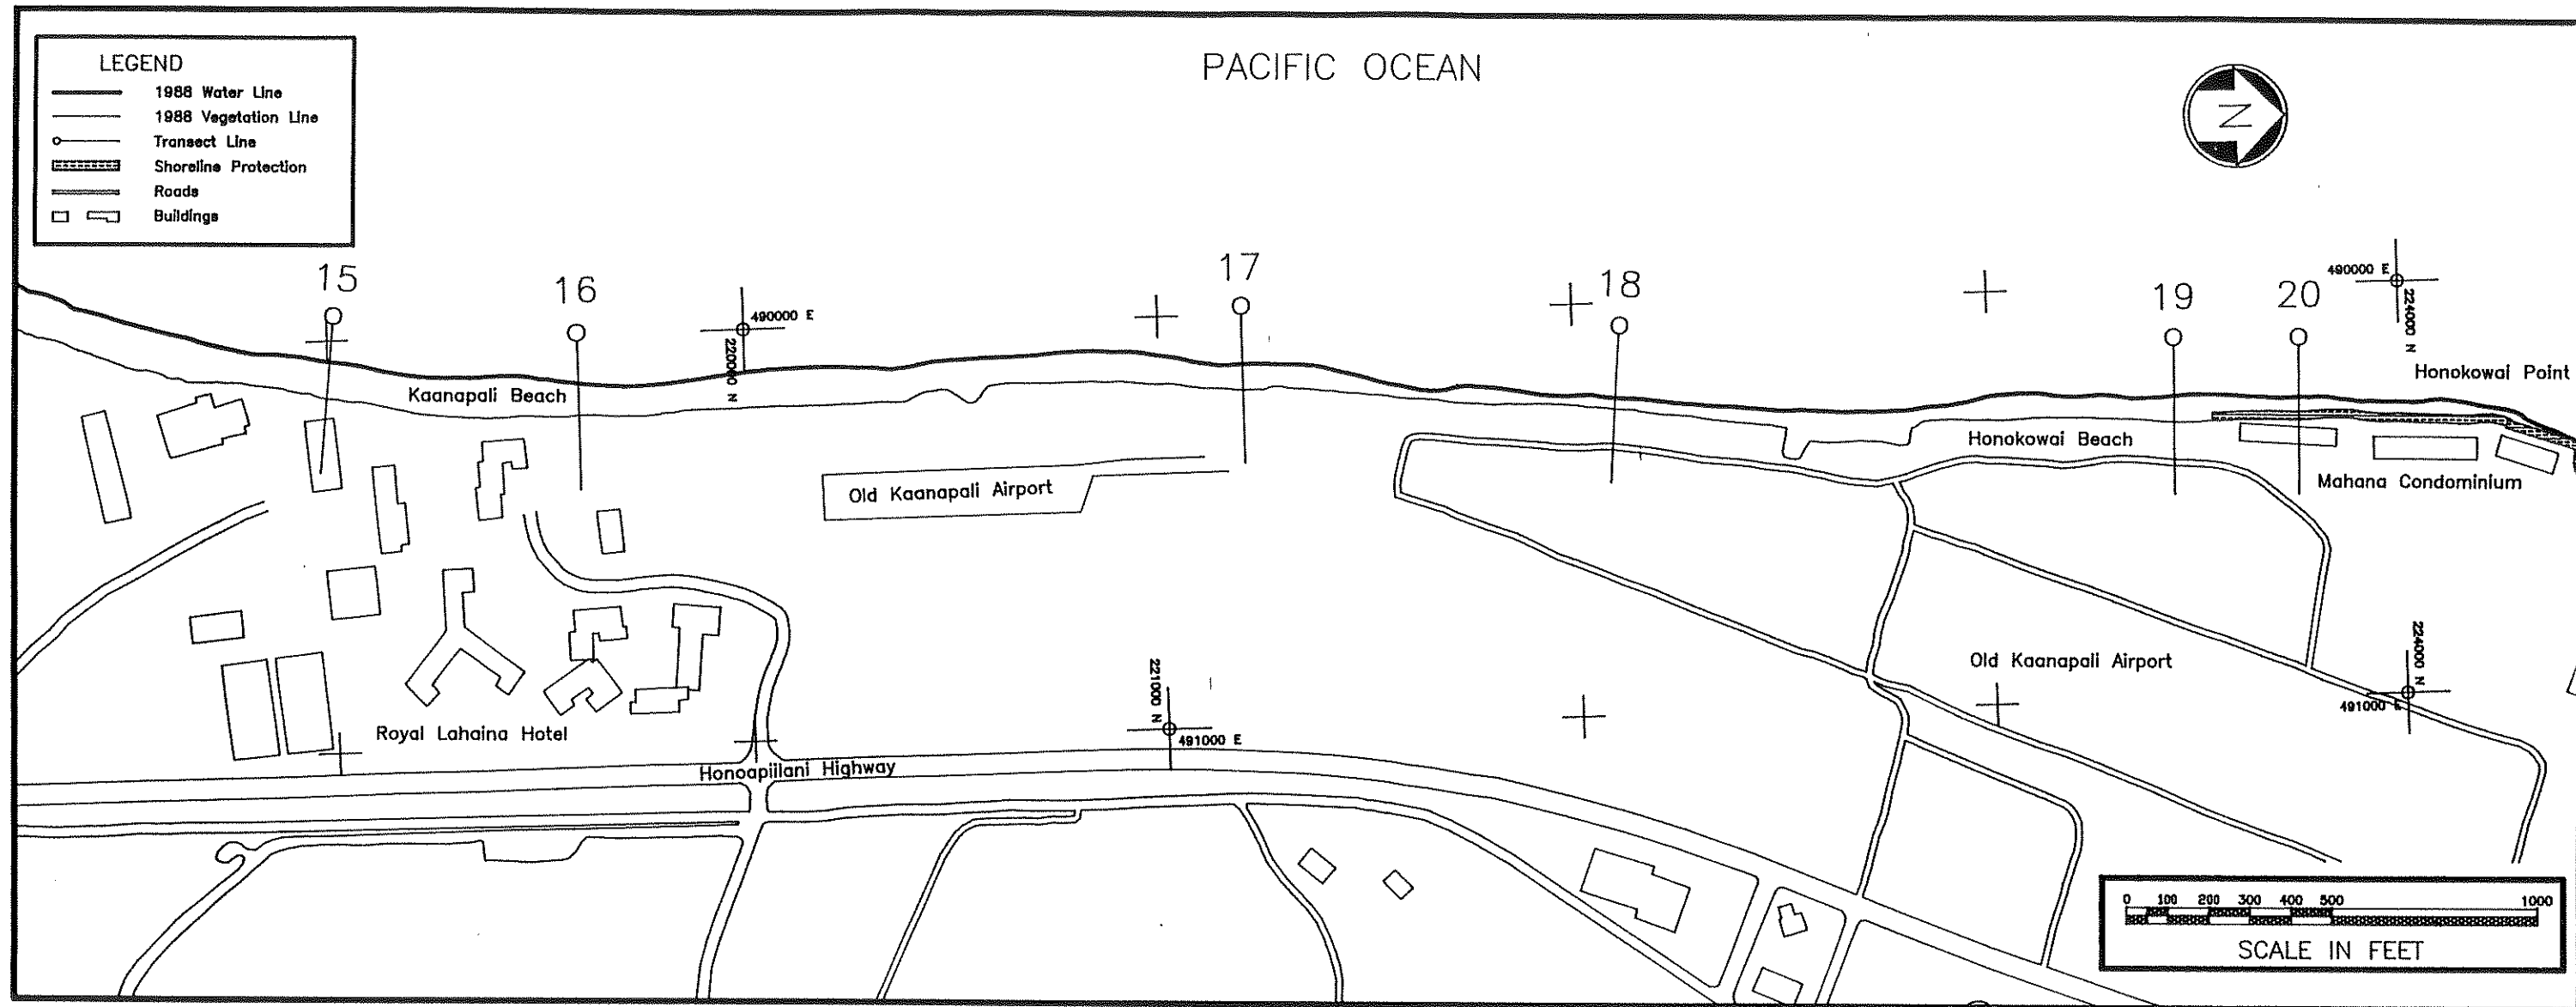
**FIGURE MA-6**

- Vegetation line changes are most pronounced at the two ends of the subsector.
- The relatively narrow beach is exposed to varying seasonal waves, and probably does not provide a large amount of buffer before the vegetation line is affected.
