# AERIAL PHOTOGRAPHY ANALYSIS OF COASTAL EROSION ON THE ISLANDS OF KAUAI, MOLOKAI, LANAI, MAUI AND HAWAII

JUNE, 1991

**PREPARED BY:**  
**MAKAI OCEAN ENGINEERING, INC**  
**and**  
**SEA ENGINEERING, INC.**  
**Honolulu, Hawaii**

**PREPARED FOR:**  
**STATE OF HAWAII**  
**OFFICE OF STATE PLANNING**  
**COASTAL ZONE MANAGEMENT**  
**PROGRAM**

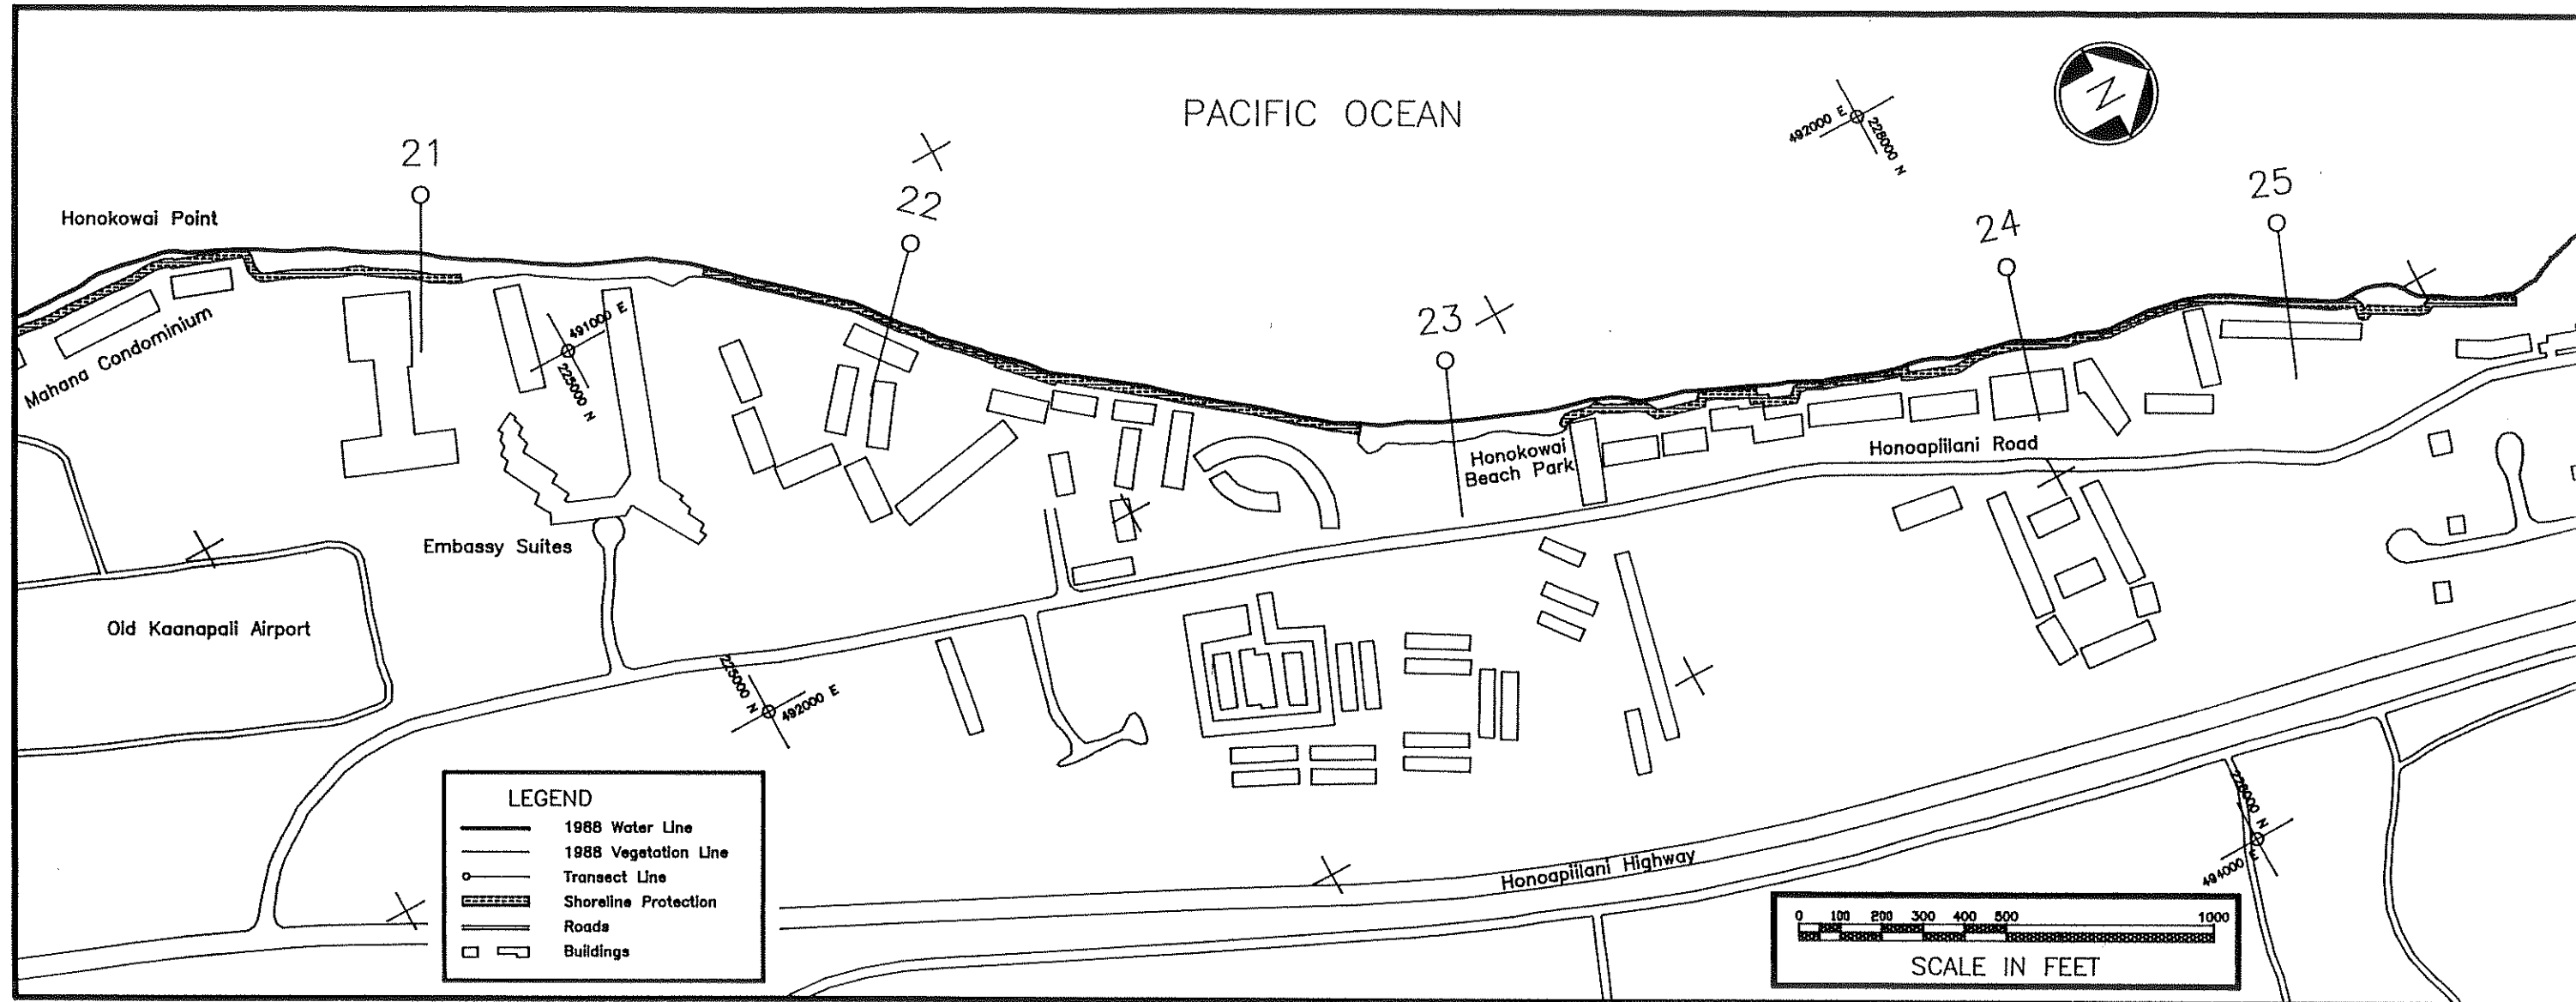
FIGURE MA-7

- There are limited management options for this subsector, due to the extensive development and associated shore protection.
- The problems in this subsector stem not so much from erosion as from placing structures too close to a temporarily accreted vegetation line.

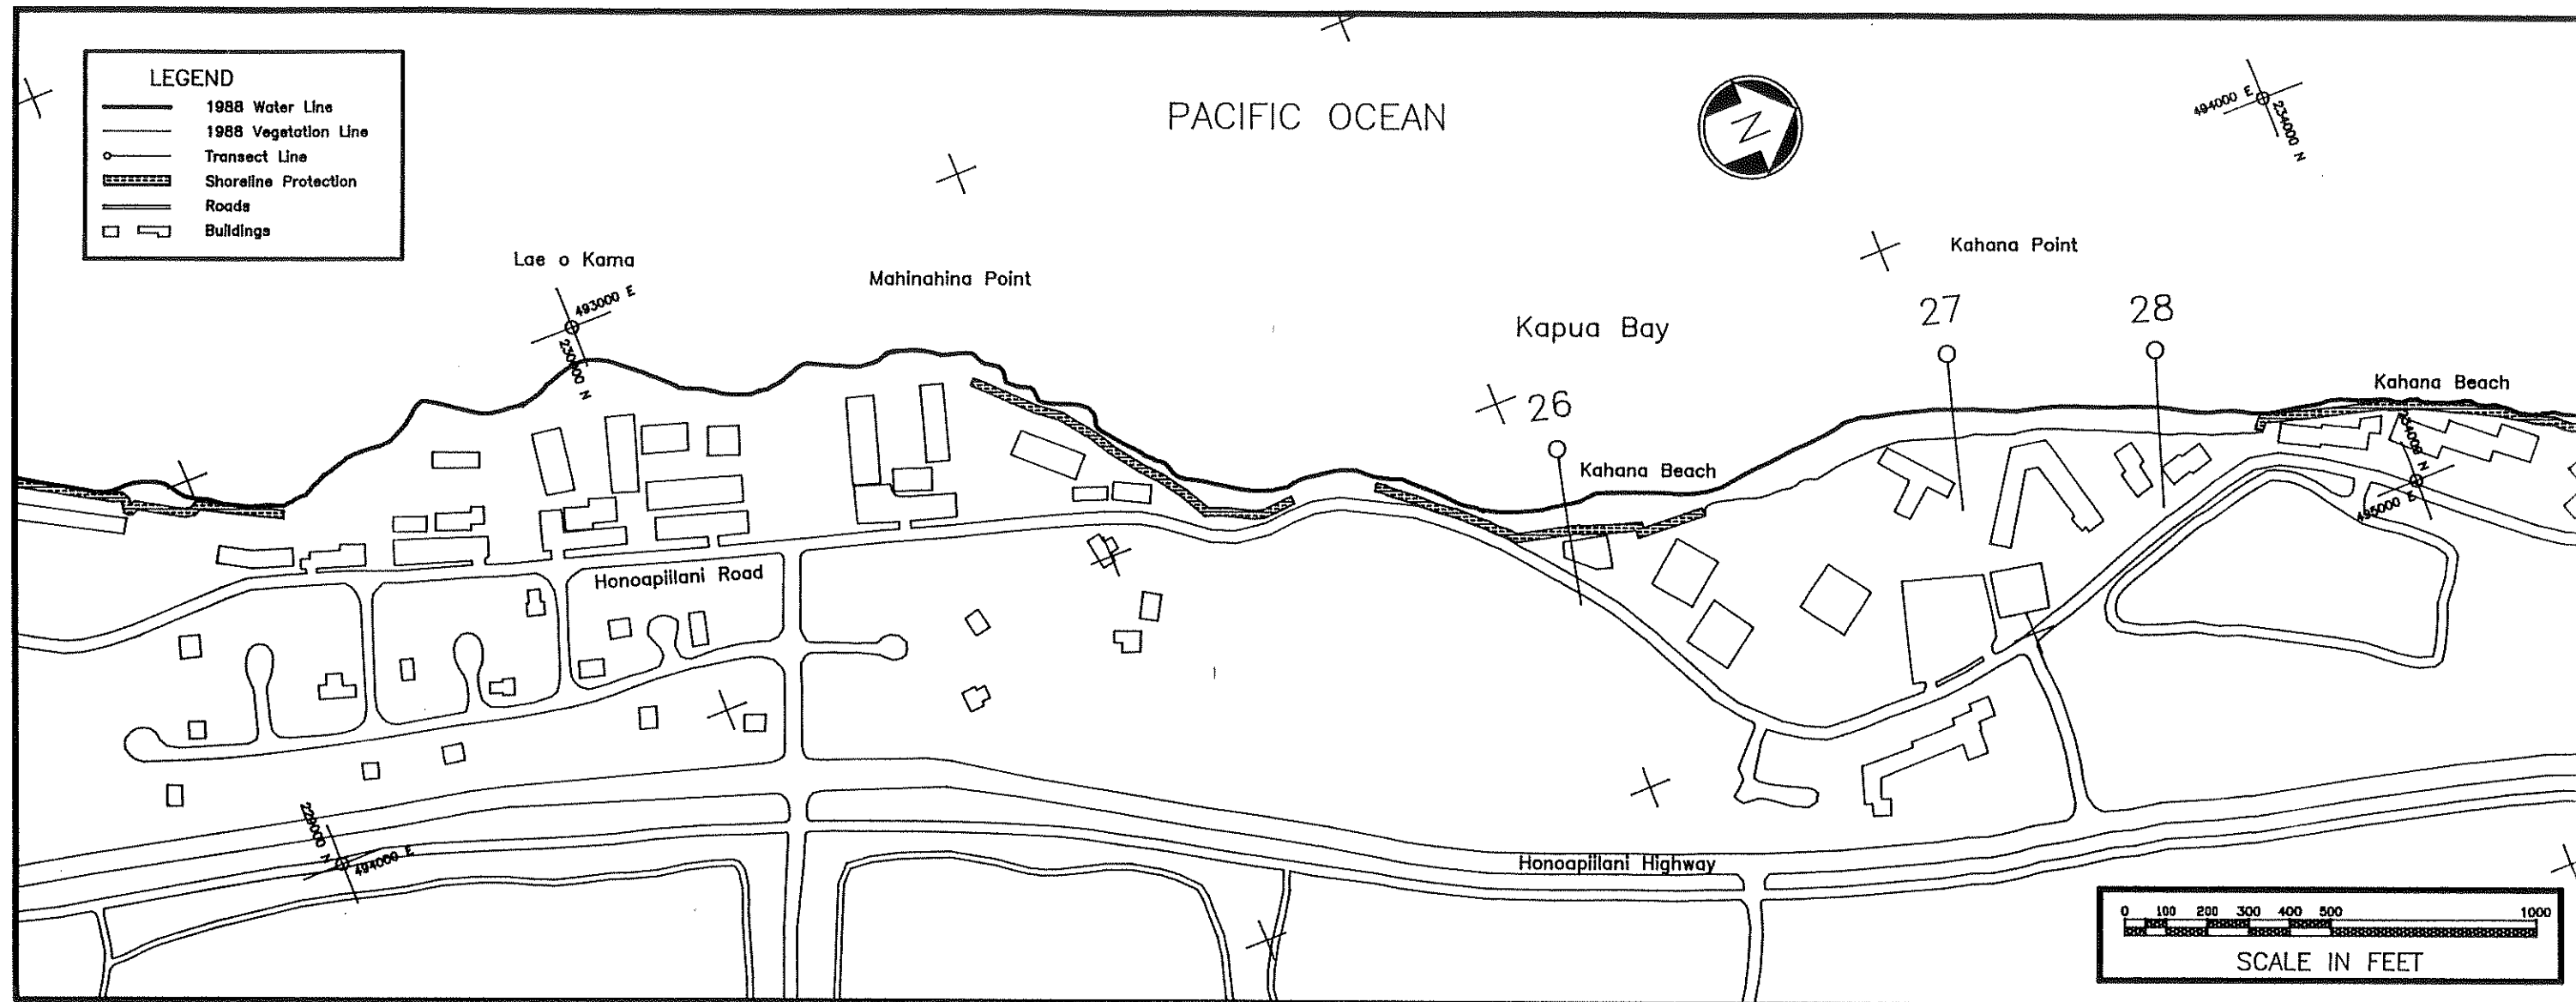
FIGURE MA-8

- Kahana Beach is a dynamic beach, similar to Honokowai Beach to the south. Some of the buildings were placed too close to the shoreline to allow the natural vegetation line fluctuations to occur. Unfortunately, most of the development occurred between 1961 and 1975, when the beach was at or near its maximum seaward position. Shore protection is now common through this subsector.

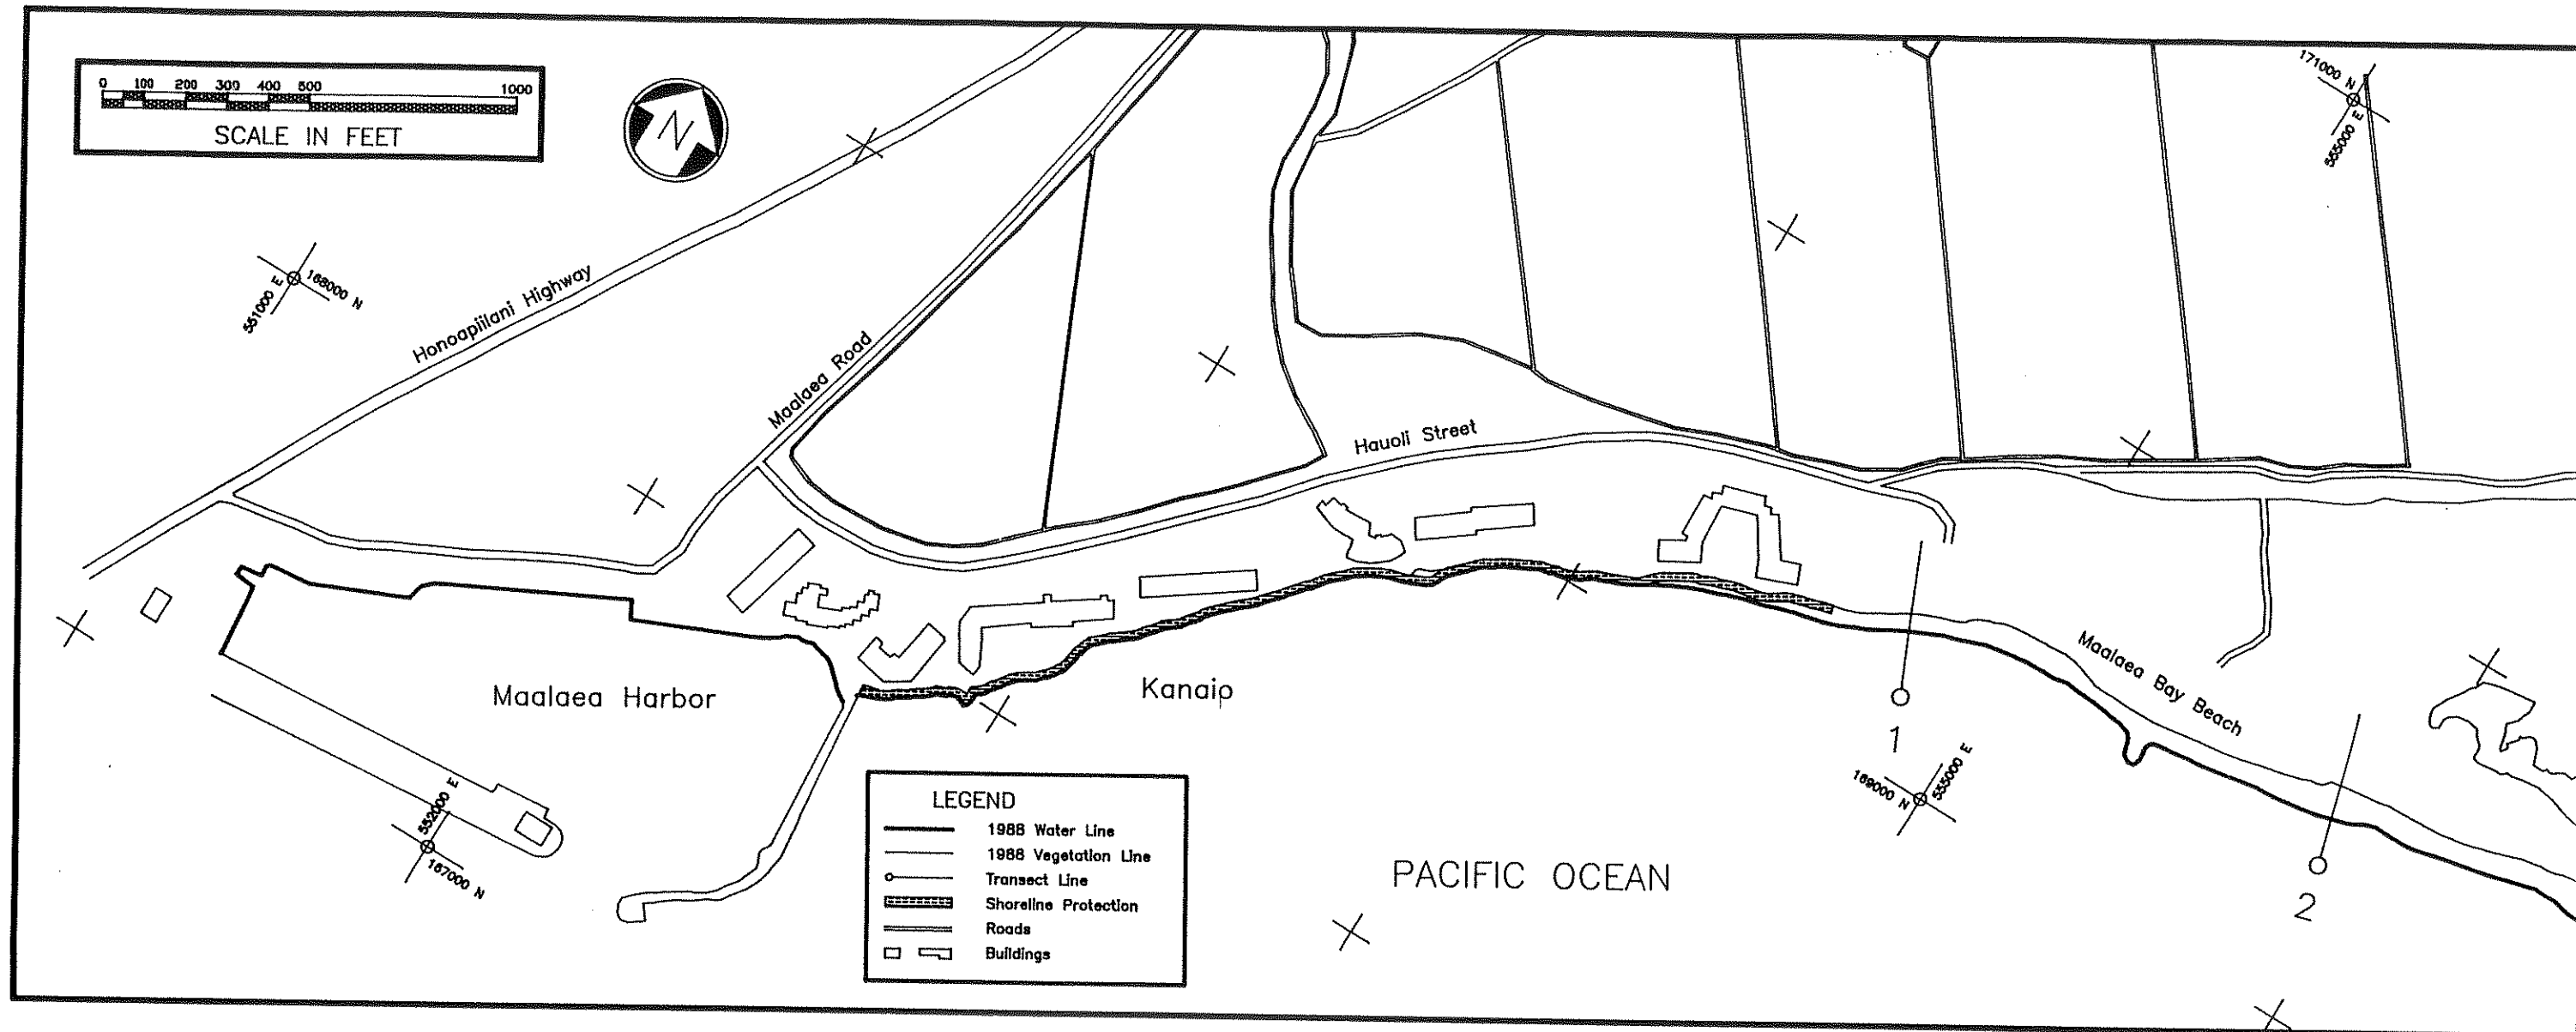
**FIGURE MB-1**

- Construction of the Maalaea Harbor in 1952 resulted in the loss of 1500 feet of narrow beach to the east of the harbor. Shore protection now extends 2400 feet to the east of the harbor.
- The beach in the eastern part of the subsector has been stable. Maximum net change in the vegetation lines since 1975 in Regions 1 and 2 was 4 feet.

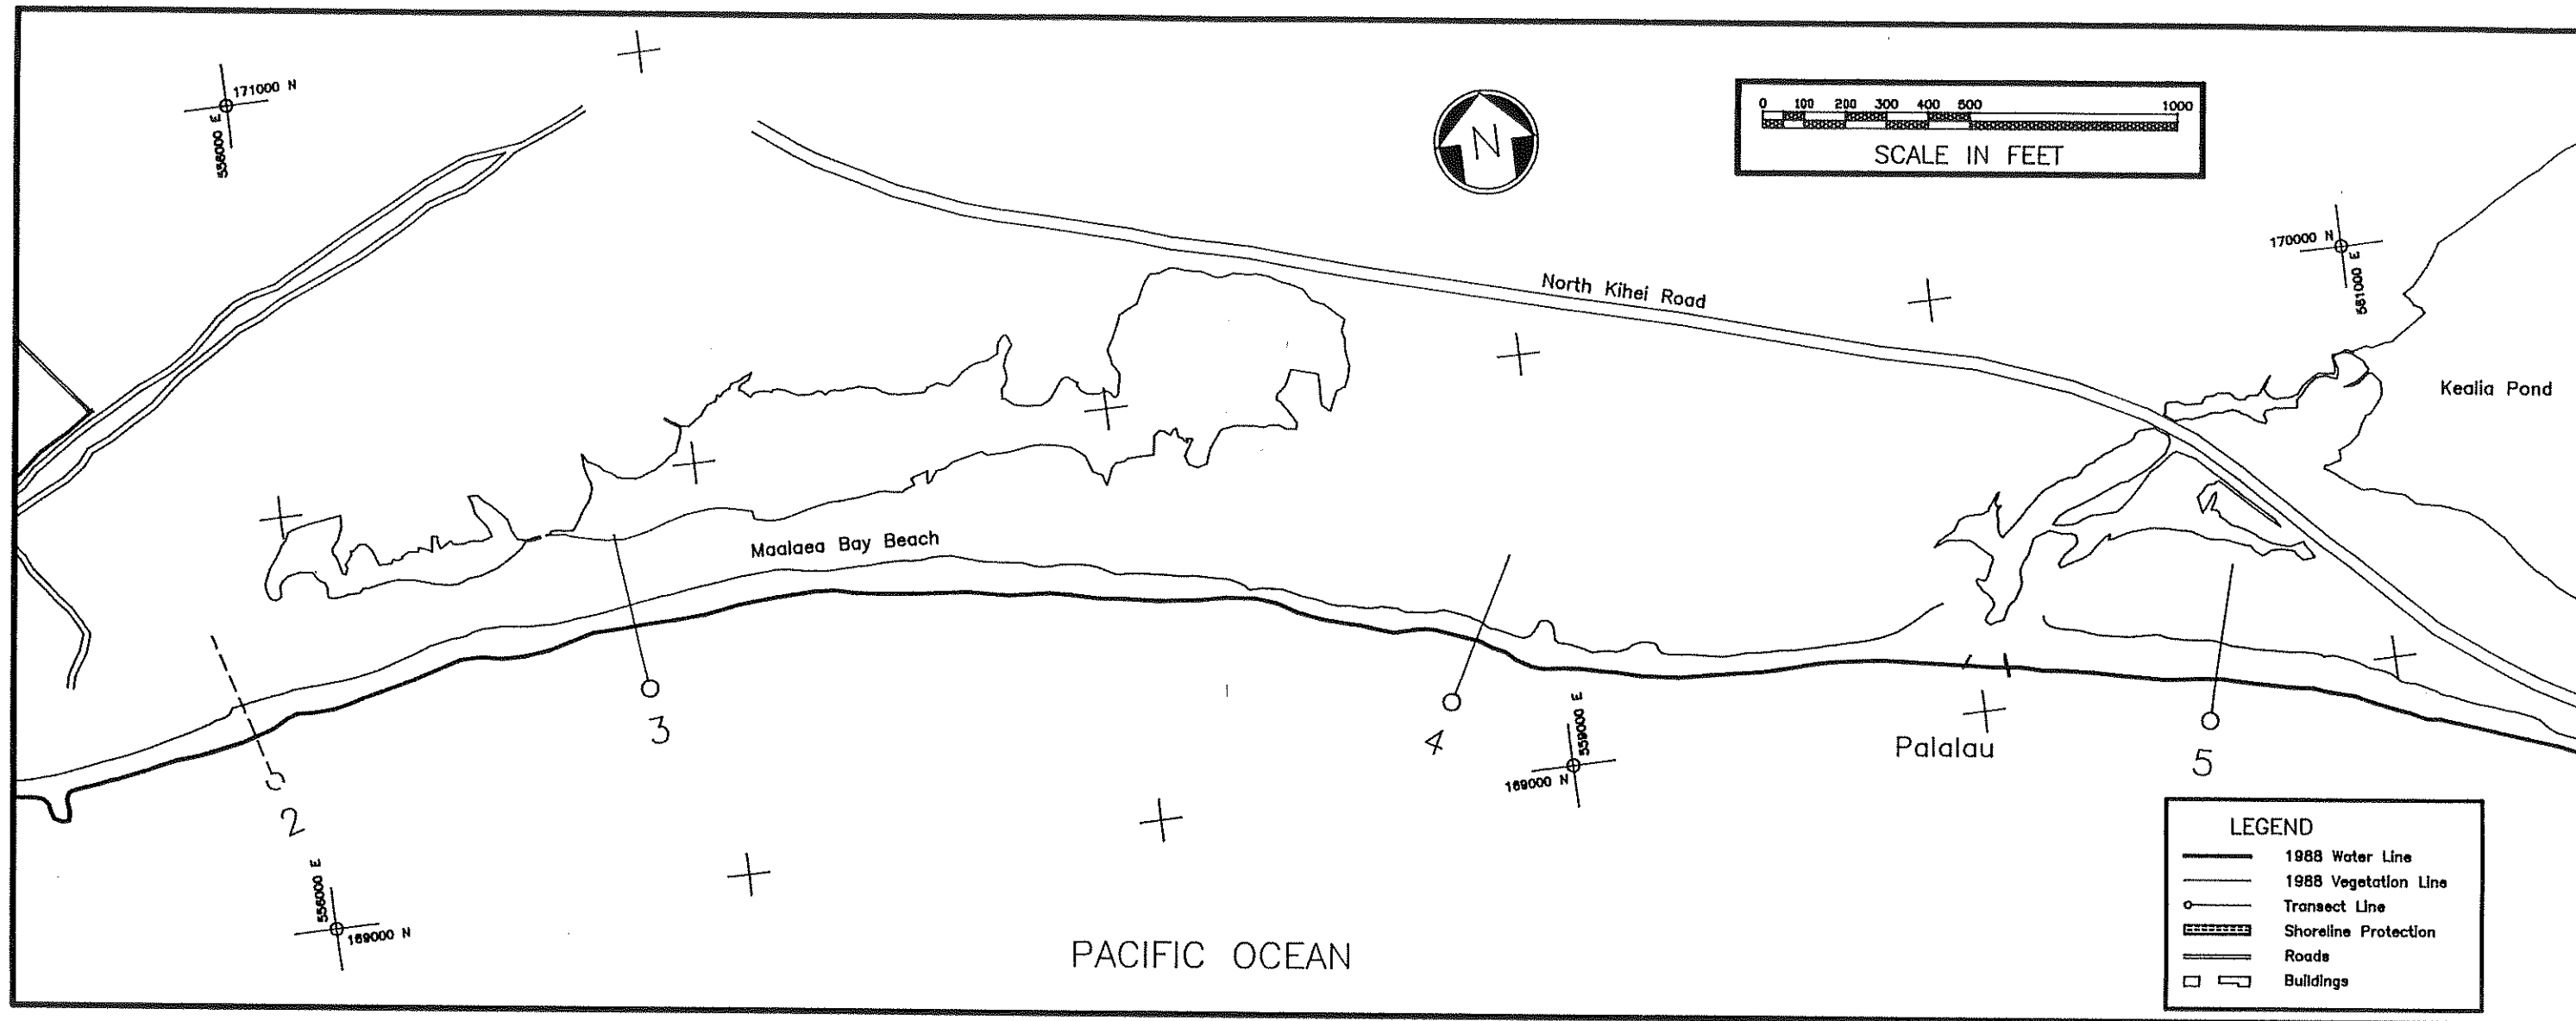
**FIGURE MB-2**

- The beach west of Palalau has been stable.
- East of Palalau, the beach has eroded steadily.
- There is no backshore development in this subsector.

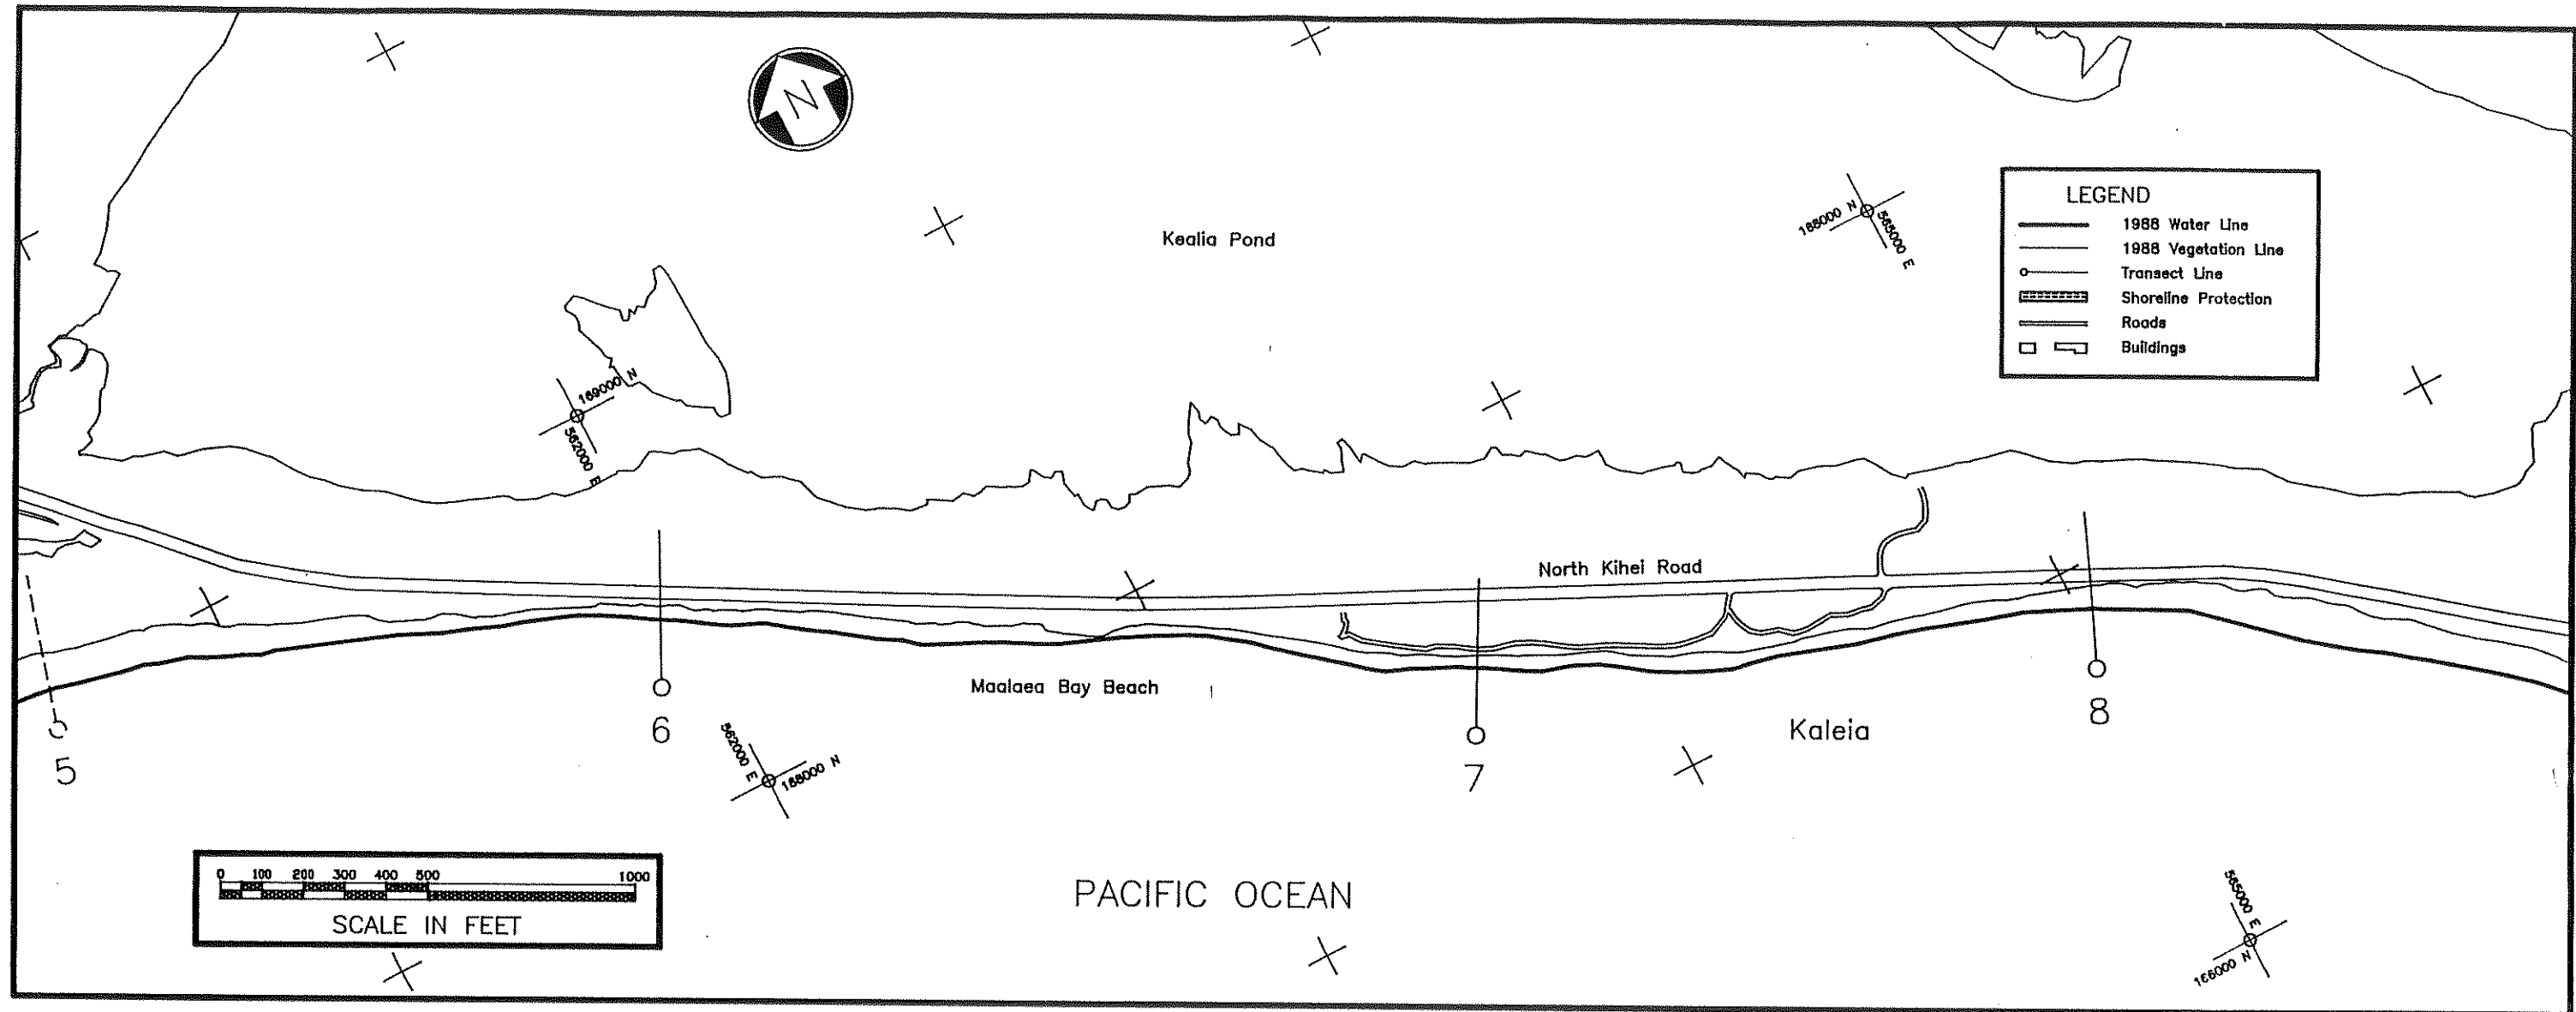
**FIGURE MB-3**

- The entire length of Maalaea Beach along Kealia Pond has eroded.
- Net erosion between 1949 and 1988 ranged from 25 to 55 feet.
- Continued erosion could damage North Kihei Road near Region 6, where trees lining the road are already being undercut by waves.

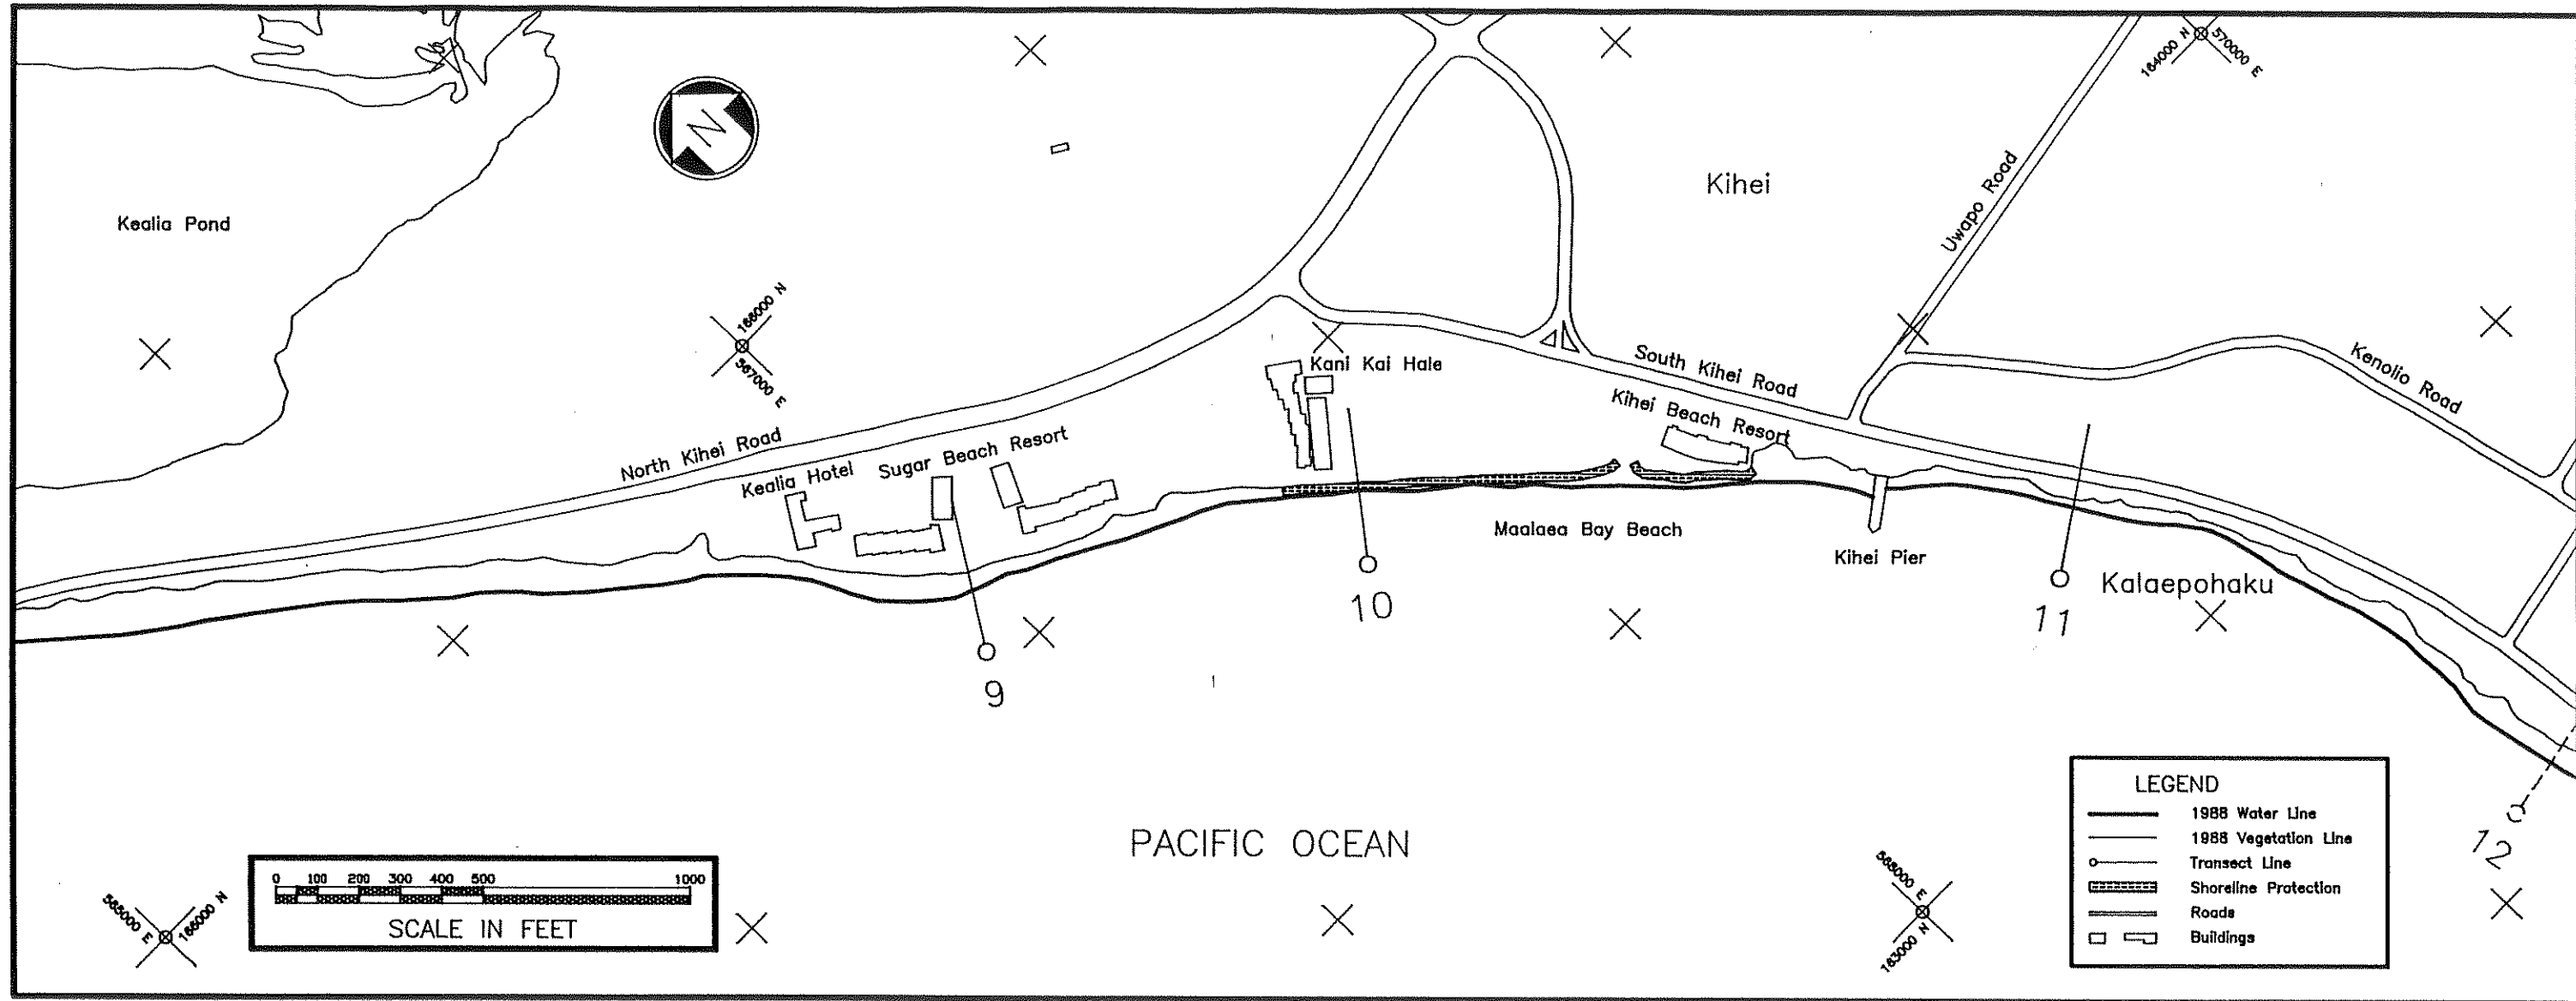
FIGURE MB-4

- Beach history has not been consistent throughout this subsector.
- Region 9 has been dynamic; the beach was eroded 45 feet in 1964, but has since accreted. Net erosion between 1949 and 1988 was 17 feet.
- Net accretion of 37 feet has occurred in Region 10. Despite the accretionary trend, shore protection structures have been constructed. This is because the resort hotels were constructed in the dynamic zone of the beach, seaward of the 1949 vegetation line. They are, therefore, subject to erosion damage.
- Region 11 has been relatively stable. The vegetation line accreted 8 feet between 1949 and 1975, and was unchanged between 1975 and 1988.
- Extensive accretion of sand was reported in the early 1900's around Kihei Pier. Evidence of this accretion was not visible in the aerial photos used in this study. Conversely, along the 60 feet of coast

- This subsector contains dynamic, accreting and stable regions.
- Region 9 is dynamic, with net erosion of 17 feet. The vegetation line in Region 10 accreted 37 feet between 1949 and 1988. Region 11 has been stable, with net accretion of 8 feet, and no net change since 1975.
- Many of the resort hotels north of Kihei Pier, and the road south of the pier are within 50 feet of the vegetation line. This subsector, therefore, is a potential problem area.
- Erosion is severe just south of Kihei Pier and could threaten the road.

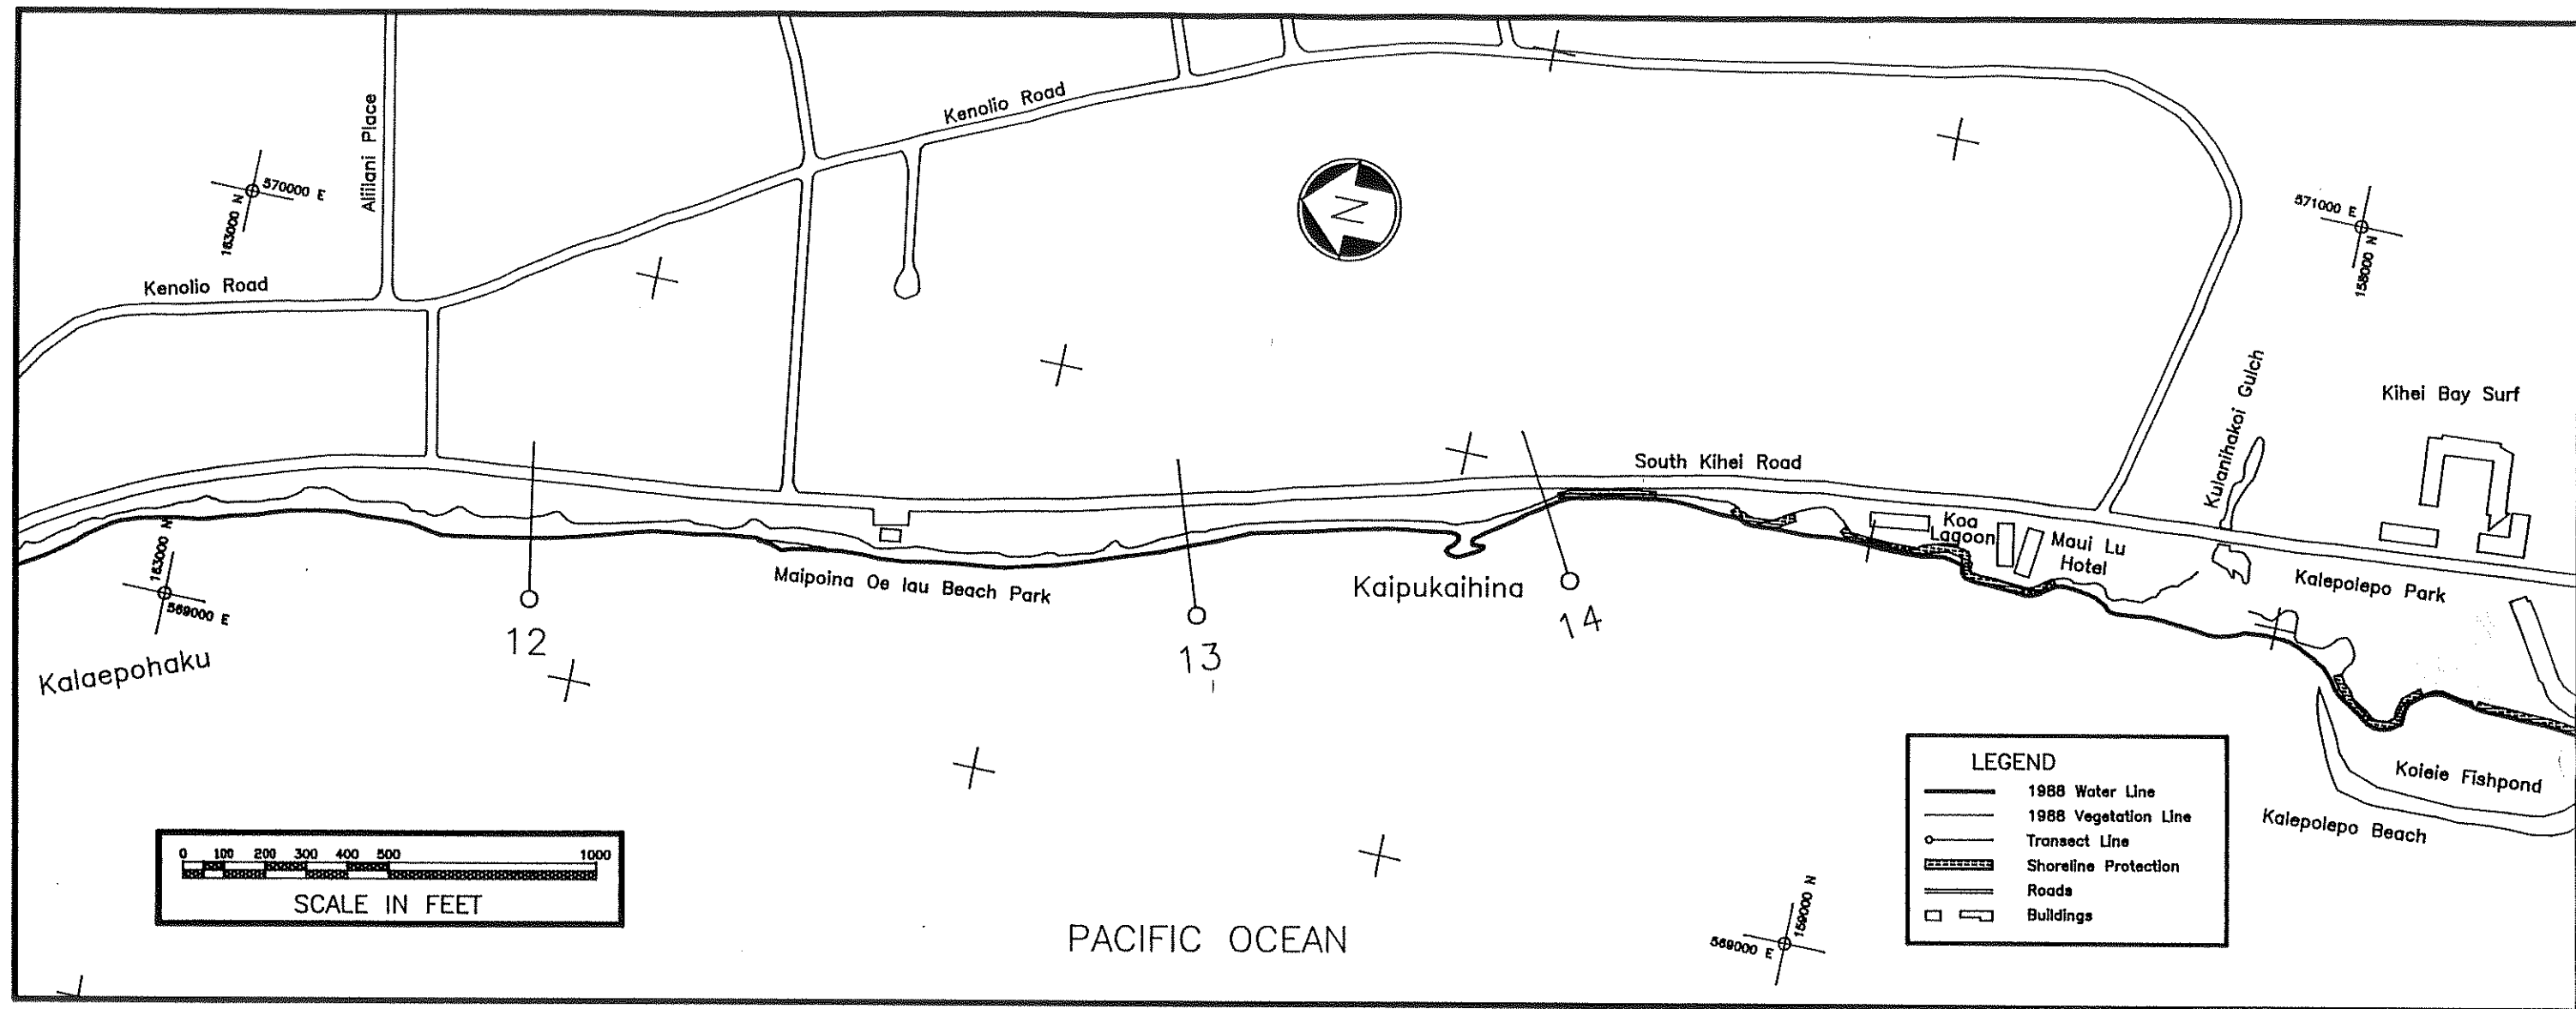
FIGURE MB-5

- Although a protective, fringing reef is present offshore, the road and buildings have been subject to erosion damage because they were constructed too close to the water.
- The oblique aerial photos show that erosion is continuing north of Kulanihakoi Gulch, south of the revetment. A scarp has been cut into the vegetation line exposing roots and causing trees to fall into the beach.

- The beach in this subsector has undergone steady erosion. Net erosion between 1949 and 1988 ranged from 25 to 30 feet.
- South Kihei Road and buildings constructed seaward of the road are often within 30 feet of the waterline and, therefore, threatened by erosion.

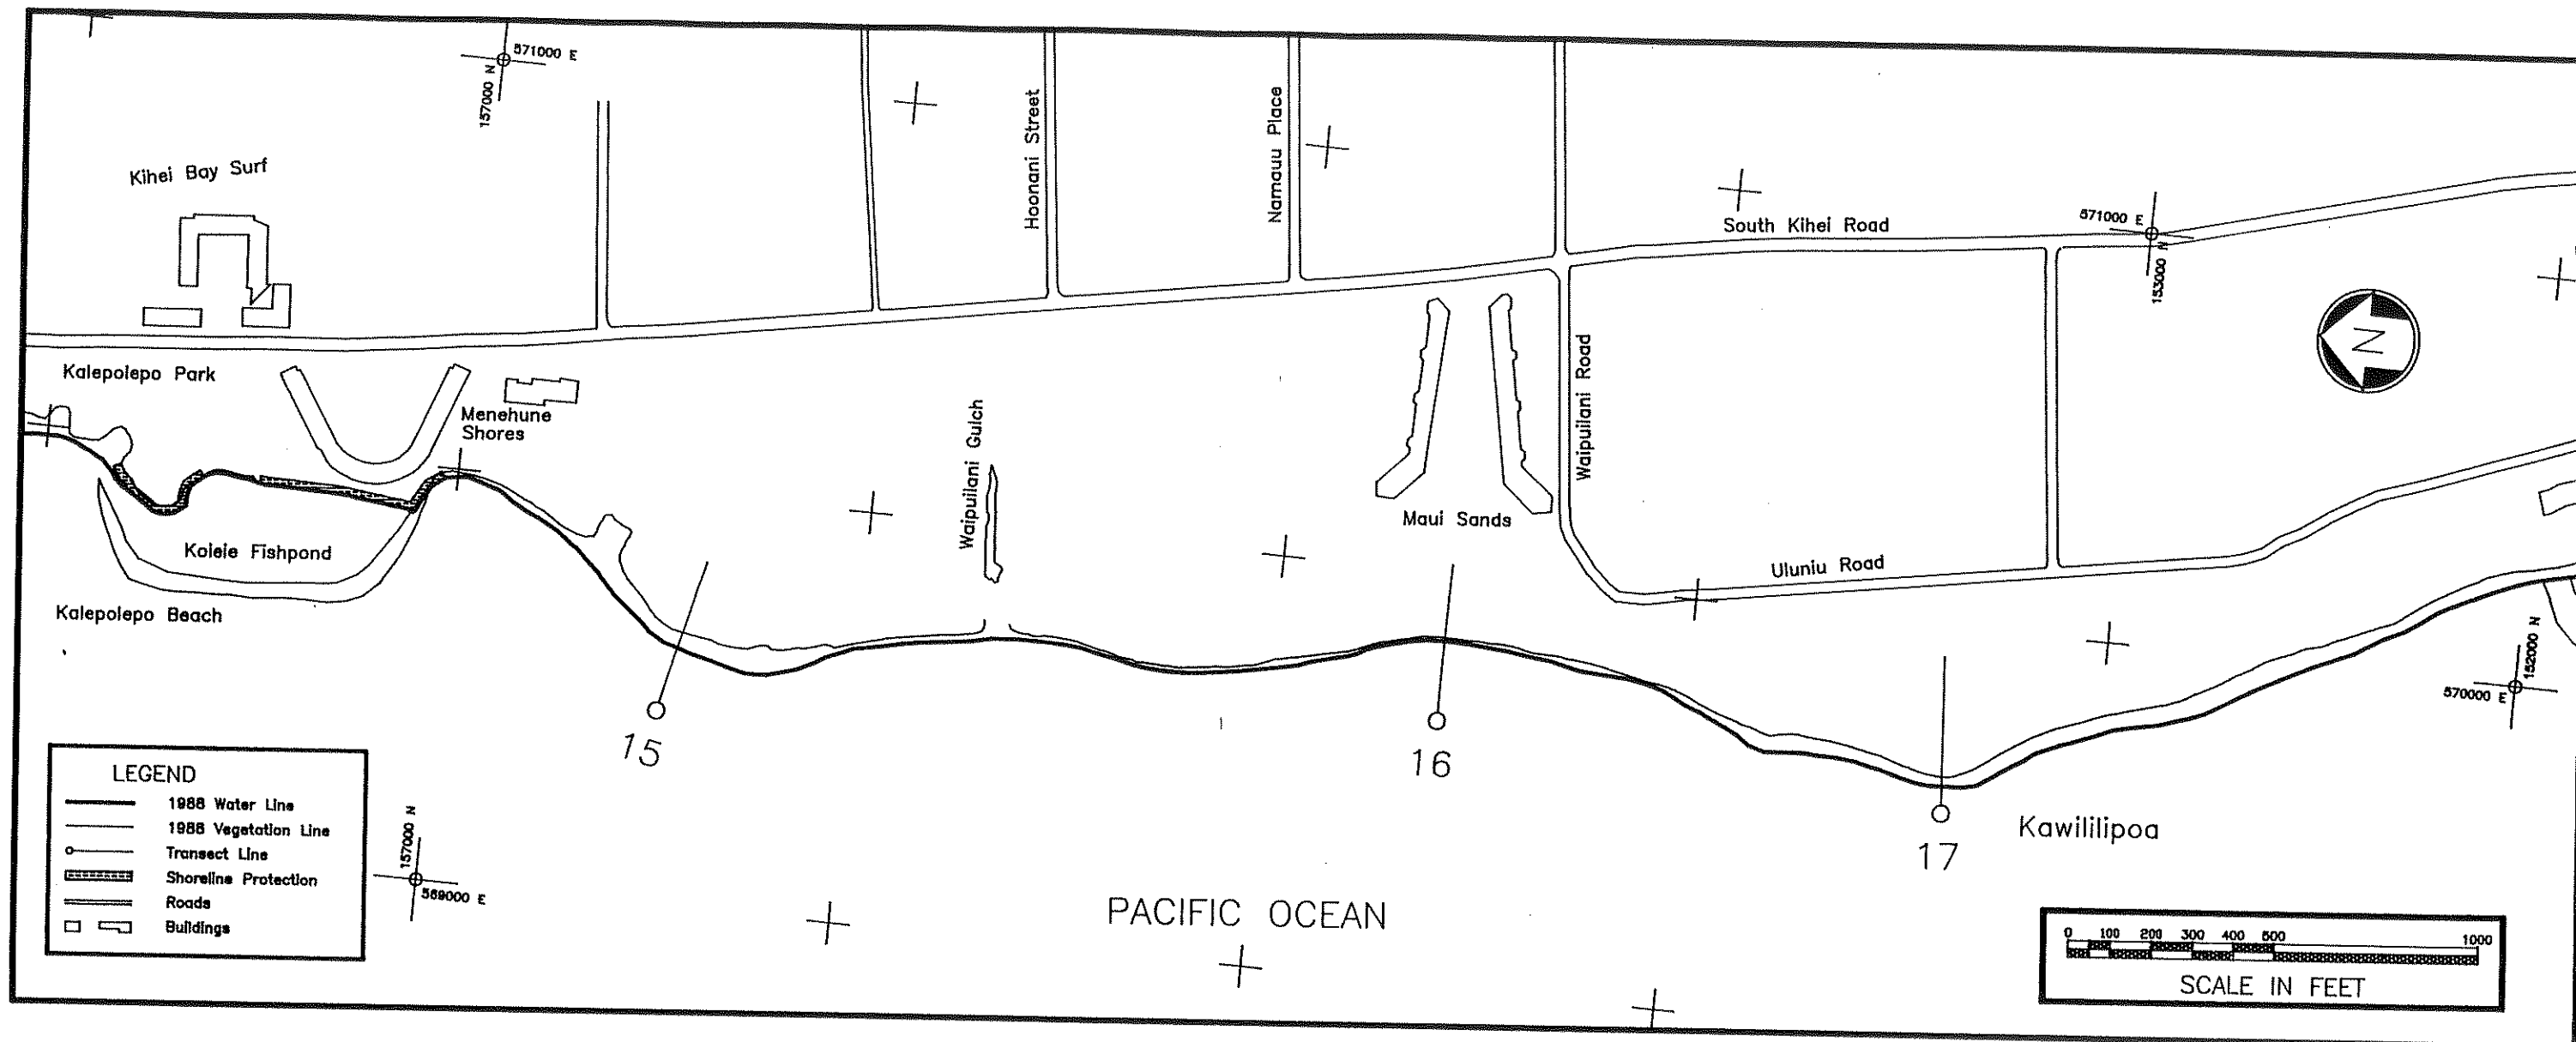
FIGURE MB-6

- The beach in this subsector has experienced dramatic changes since 1949. From 1949 to 1988, the beach has accreted 115 feet, eroded 92 feet, and accreted 284 feet in Regions 15, 16 and 17 respectively.
- These changes are likely due to a regional shift in longshore currents that has caused currents from the south and from the north to converge and deposit sand around Region 17.
- Erosion in Region 16 has cut a scarp into the vegetation, exposing roots and undercutting trees. The erosion, however, is not causing problems because the backshore is a grassy lawn of the state beach preserve.

- The beach in this subsector has changed dramatically since 1949. In Regions 15 to 17 it has accreted 115 feet, eroded 92 feet, and accreted 284 feet.
- The large resort hotels are located over 300 feet from the beach, and thus are not threatened by the erosion in Region 16.
