# AERIAL PHOTOGRAPHY ANALYSIS OF COASTAL EROSION ON THE ISLANDS OF KAUAI, MOLOKAI, LANAI, MAUI AND HAWAII

JUNE, 1991

**PREPARED BY:**  
**MAKAI OCEAN ENGINEERING, INC**  
**and**  
**SEA ENGINEERING, INC.**  
**Honolulu, Hawaii**

**PREPARED FOR:**  
**STATE OF HAWAII**  
**OFFICE OF STATE PLANNING**  
**COASTAL ZONE MANAGEMENT**  
**PROGRAM**

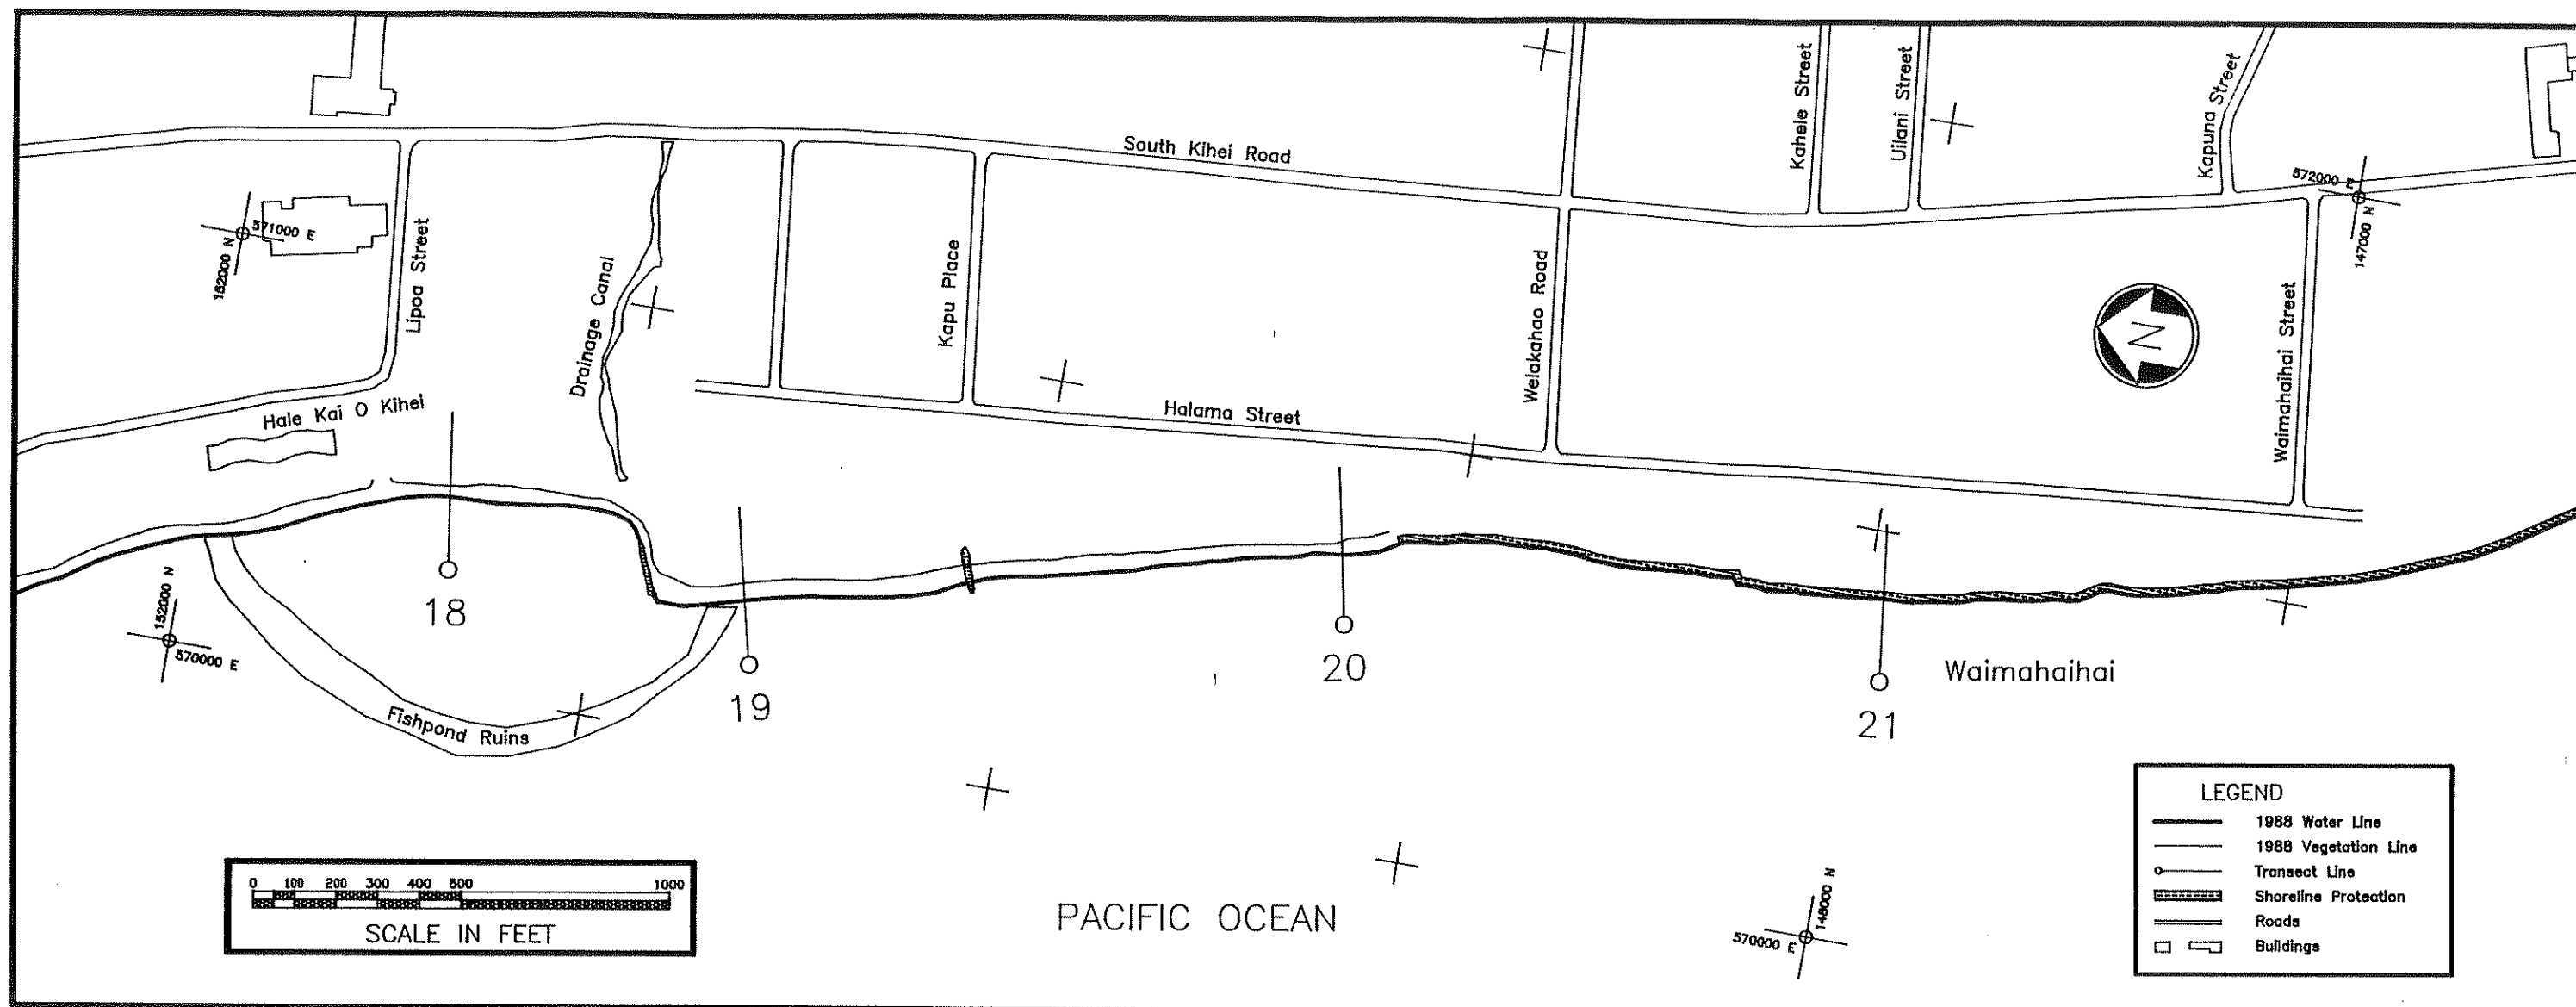
FIGURE MB-7

- The beach changes in this subsector are the direct result of man-made coastal structures.
- The construction of a groin within the fishpond ruins has caused beach accretion in Region 19, and beach erosion in Region 18.
- Seawalls and revetments protecting property in the southern half of the subsector have resulted in loss of the beach in this area, and severe erosion along the shore to the north of the structures.
- More recently, a groin has been constructed to halt the erosion around Region 20, north of the shore protection.

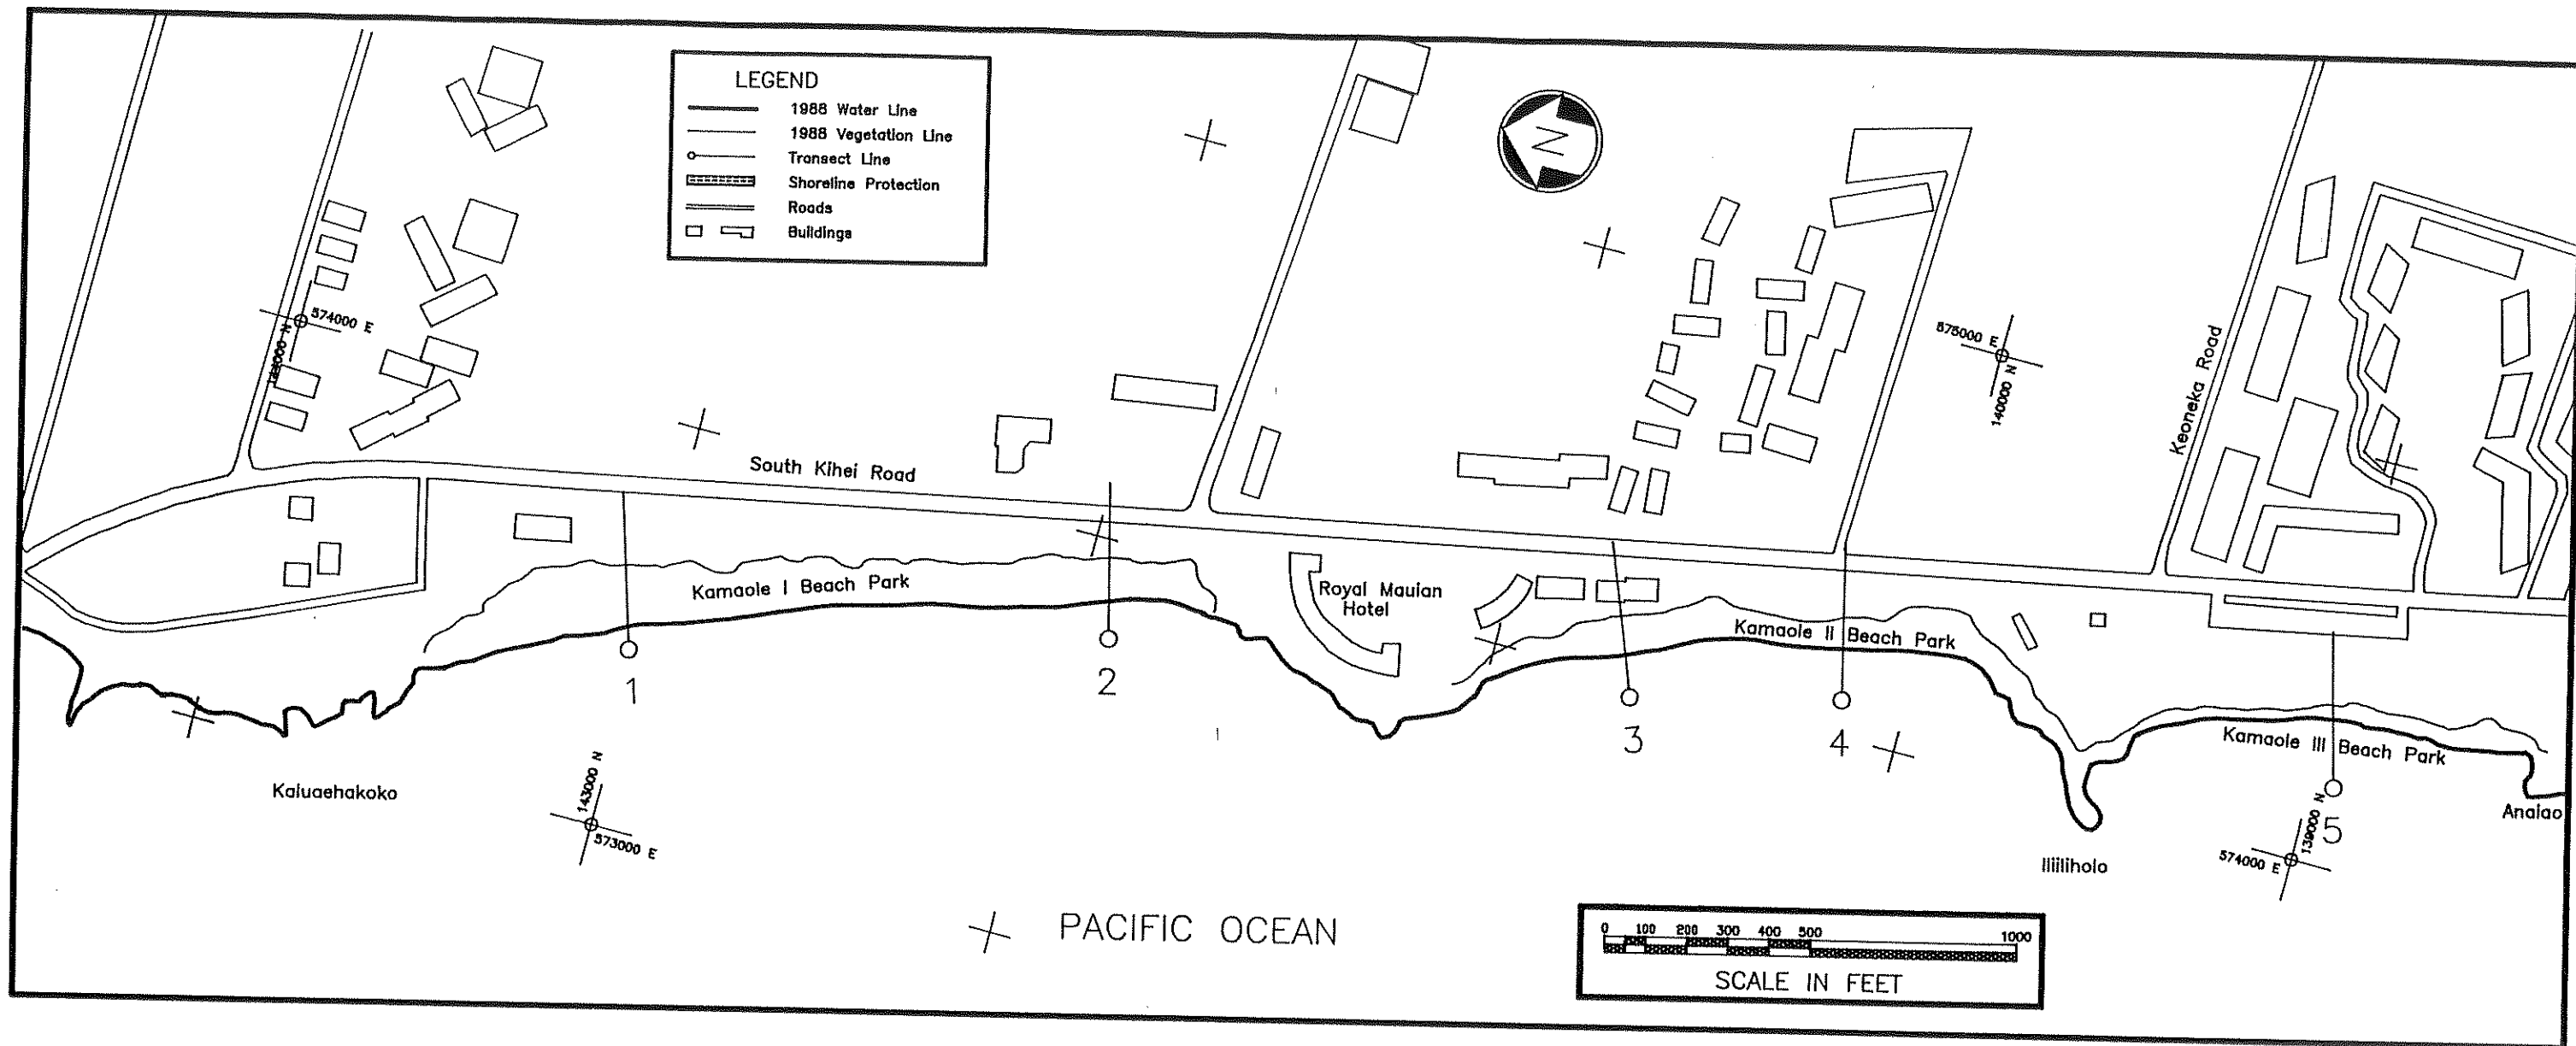
FIGURE MC-1

- The beaches in this subsector are dynamic, and have undergone periods of significant erosion and accretion since 1949. This is due to the lack of a protecting fringing reef and full exposure to Kona Storms.
- Periodically, storms severely erode these beaches.

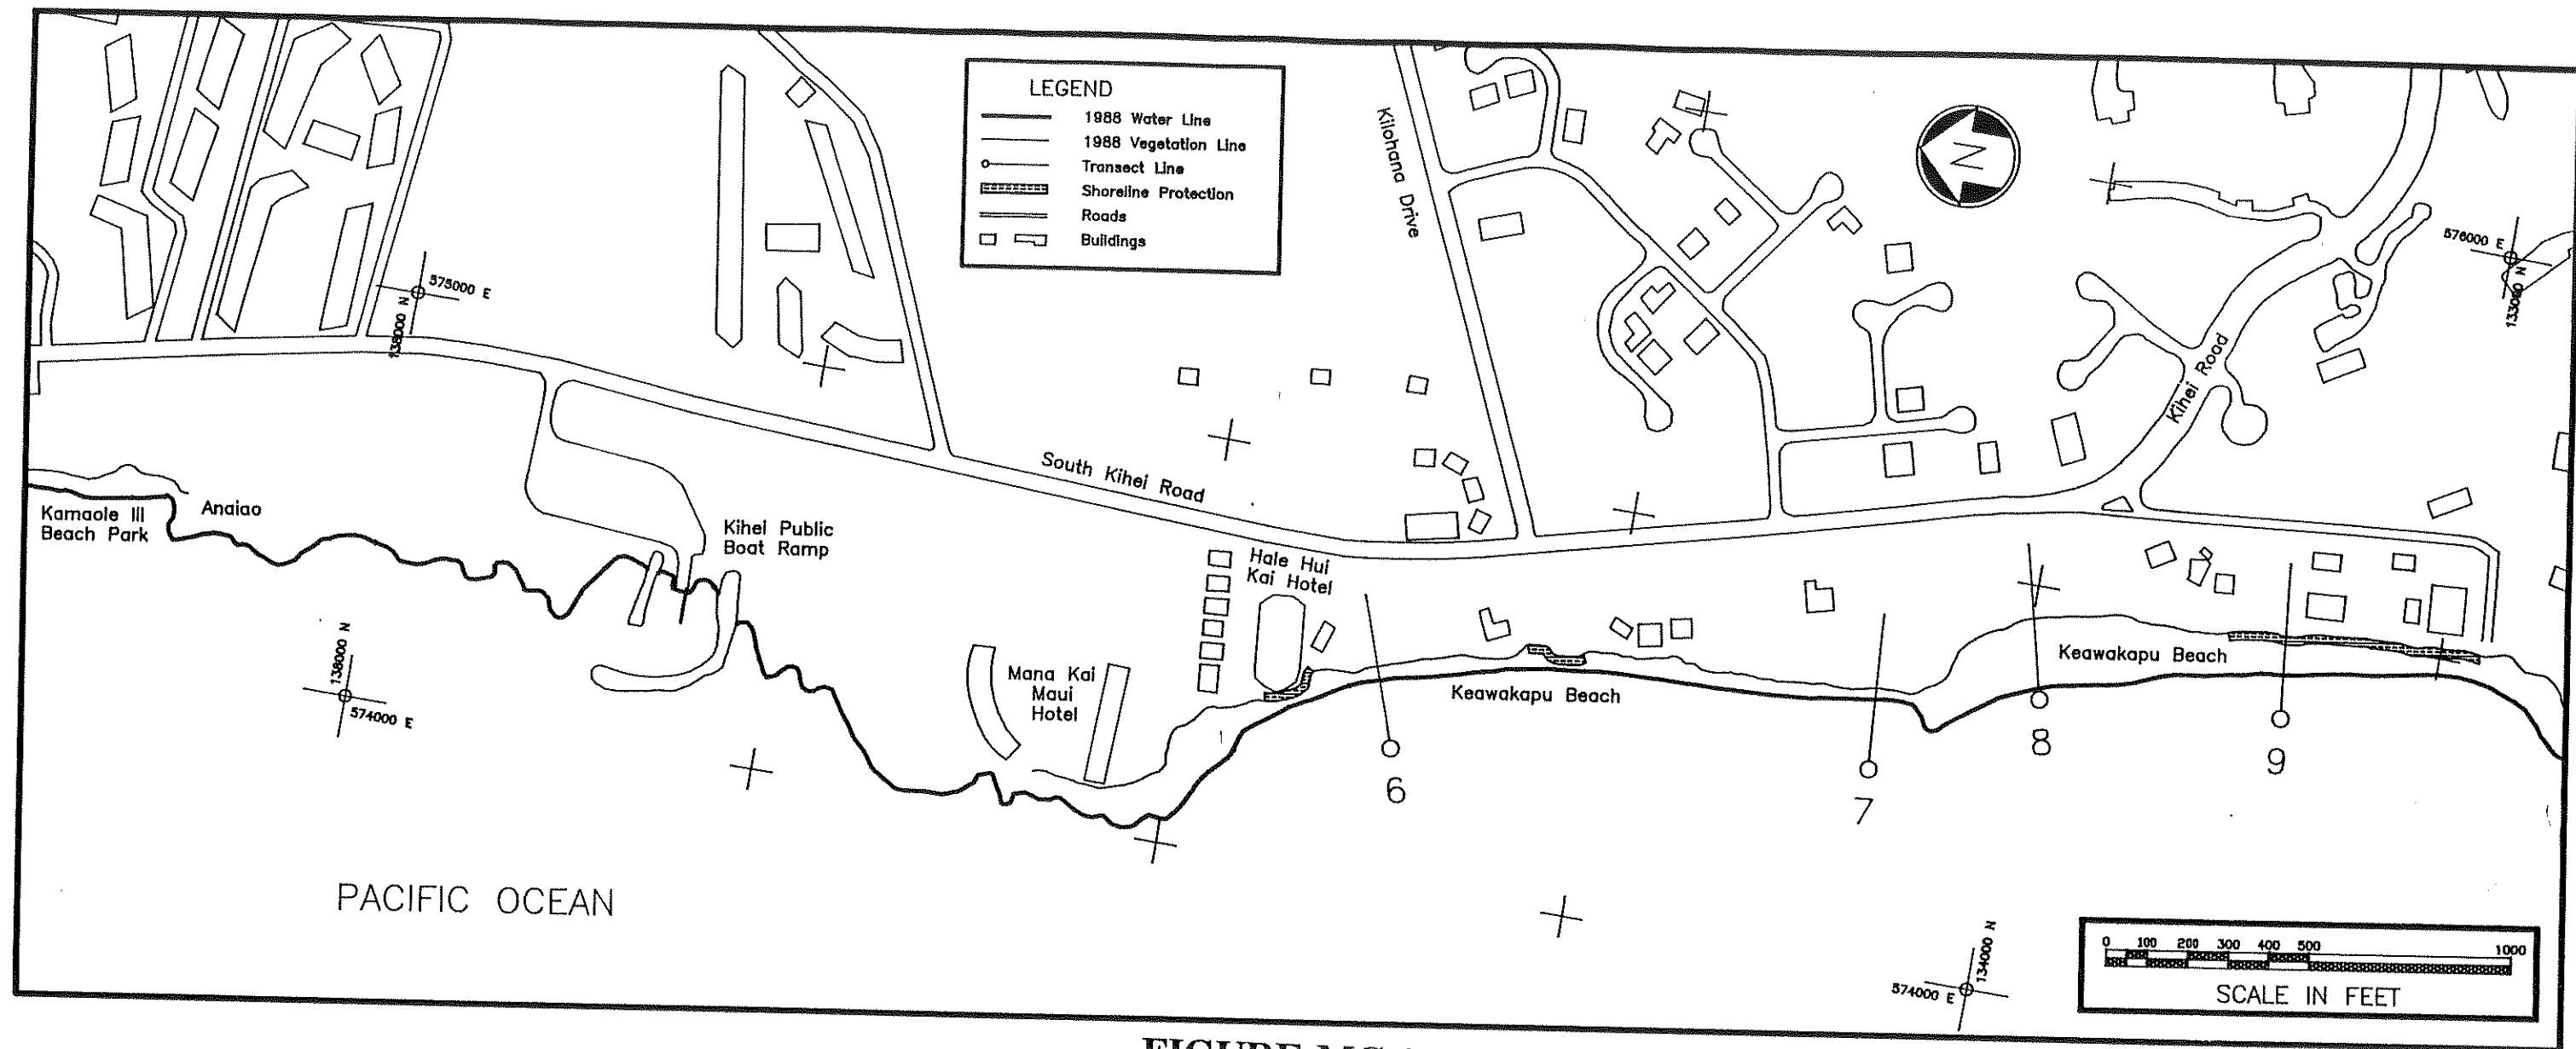
FIGURE MC-2

- Keawakapu Beach is an unprotected, dynamic beach subject to severe storm erosion.
- Storms in 1959 and the winter of 1963 caused severe erosion, and left beach rock exposed along the entire length of beach.
- The beach then accreted through 1975.
- Storms in 1980 and 1982 again caused severe erosion along the beach, as is shown by the 1988 vegetation line.

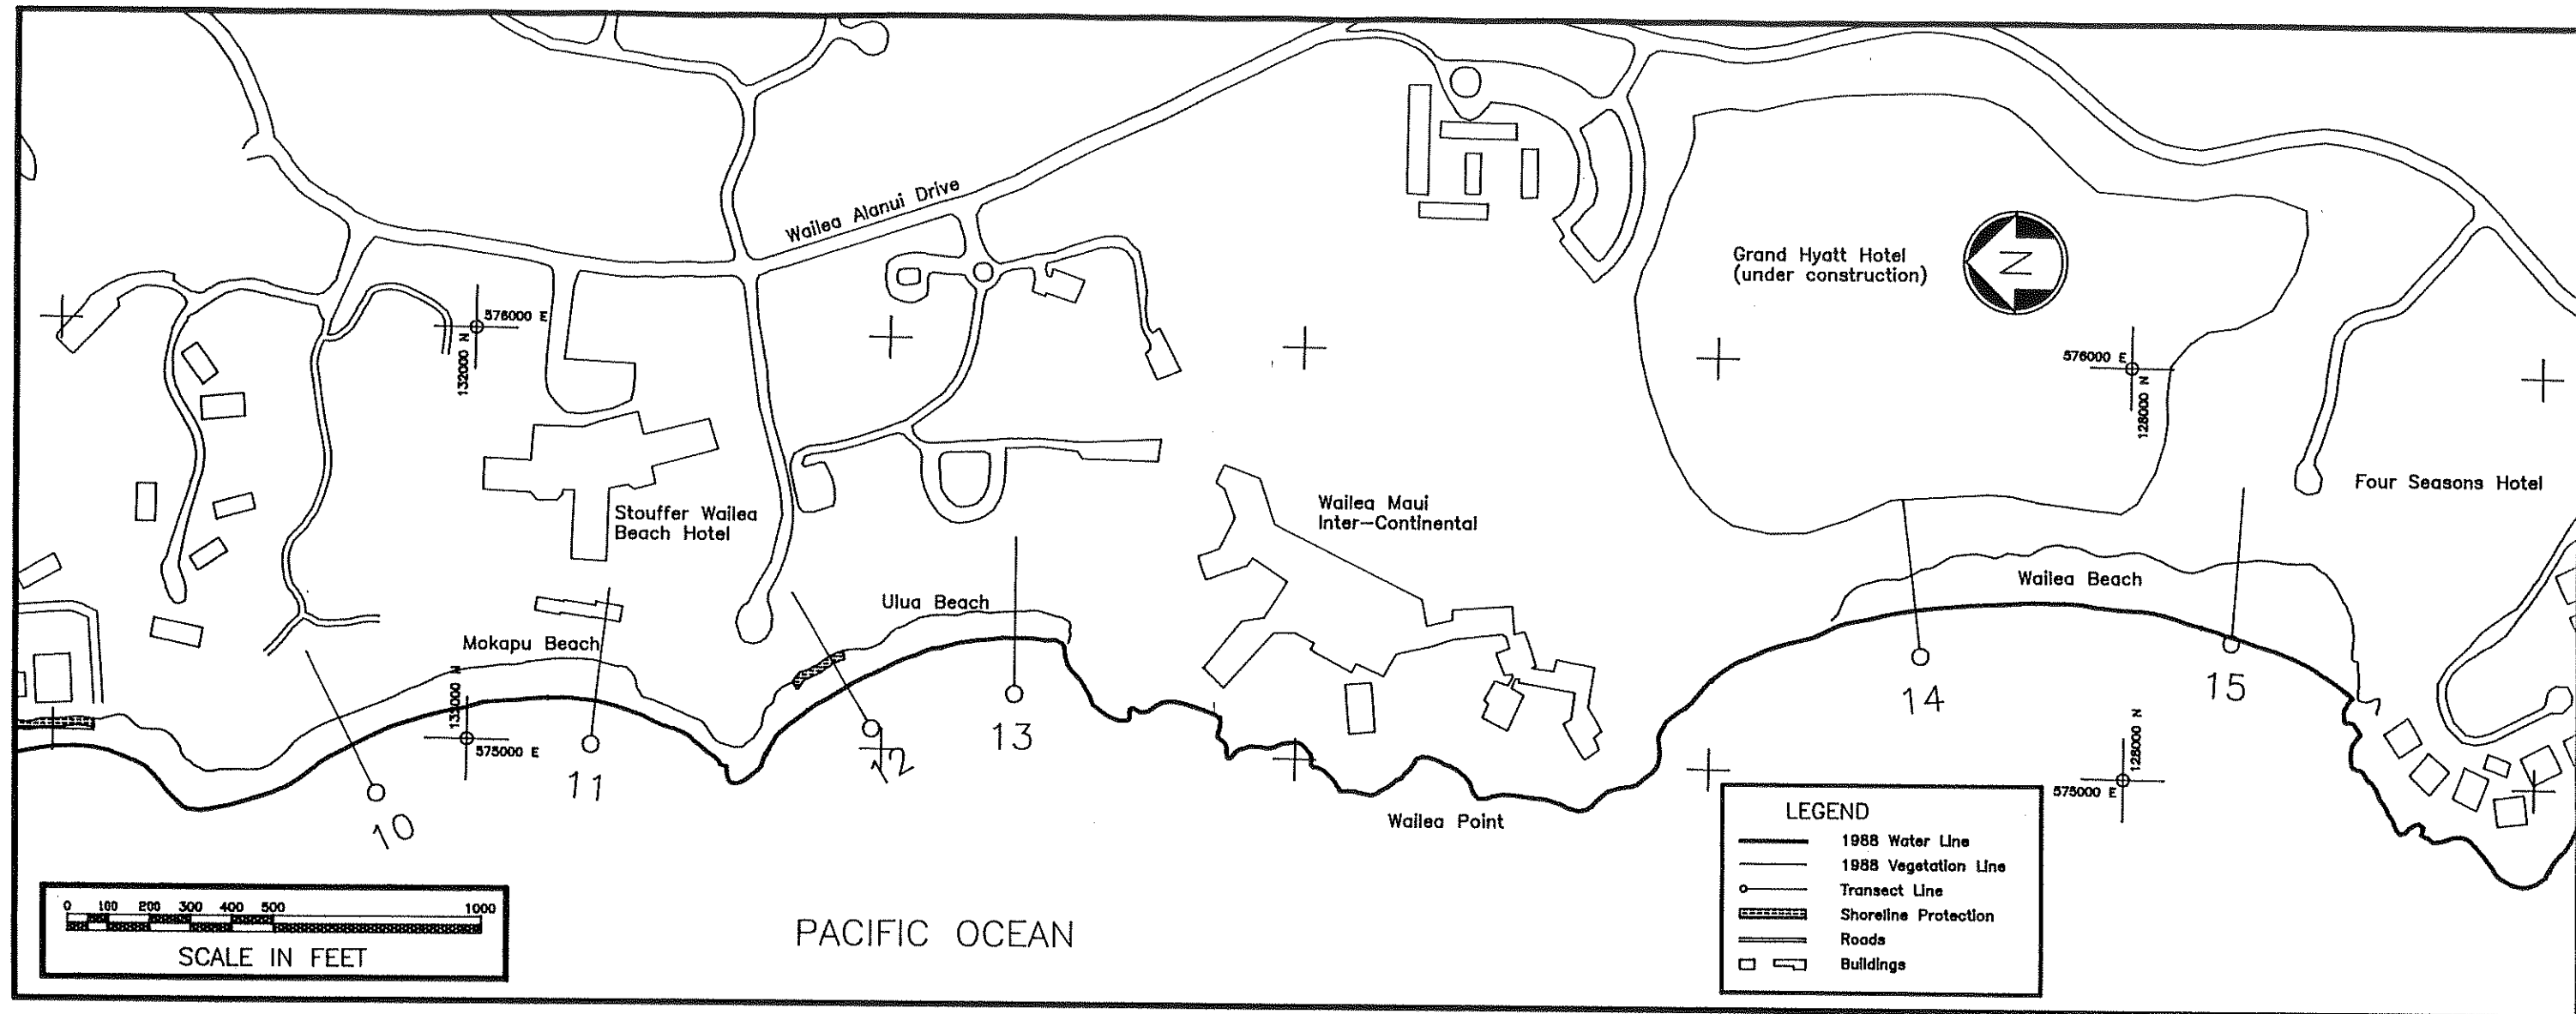
FIGURE MC-3

- Mokapu and Ulua Beaches are eroding. Net erosion at Mokapu and Ulua Beach ranged from 25 to 85 feet.
- Wailea Beach is dynamic. It has undergone net accretion in its northern reach, and slight erosion in the southern reach.

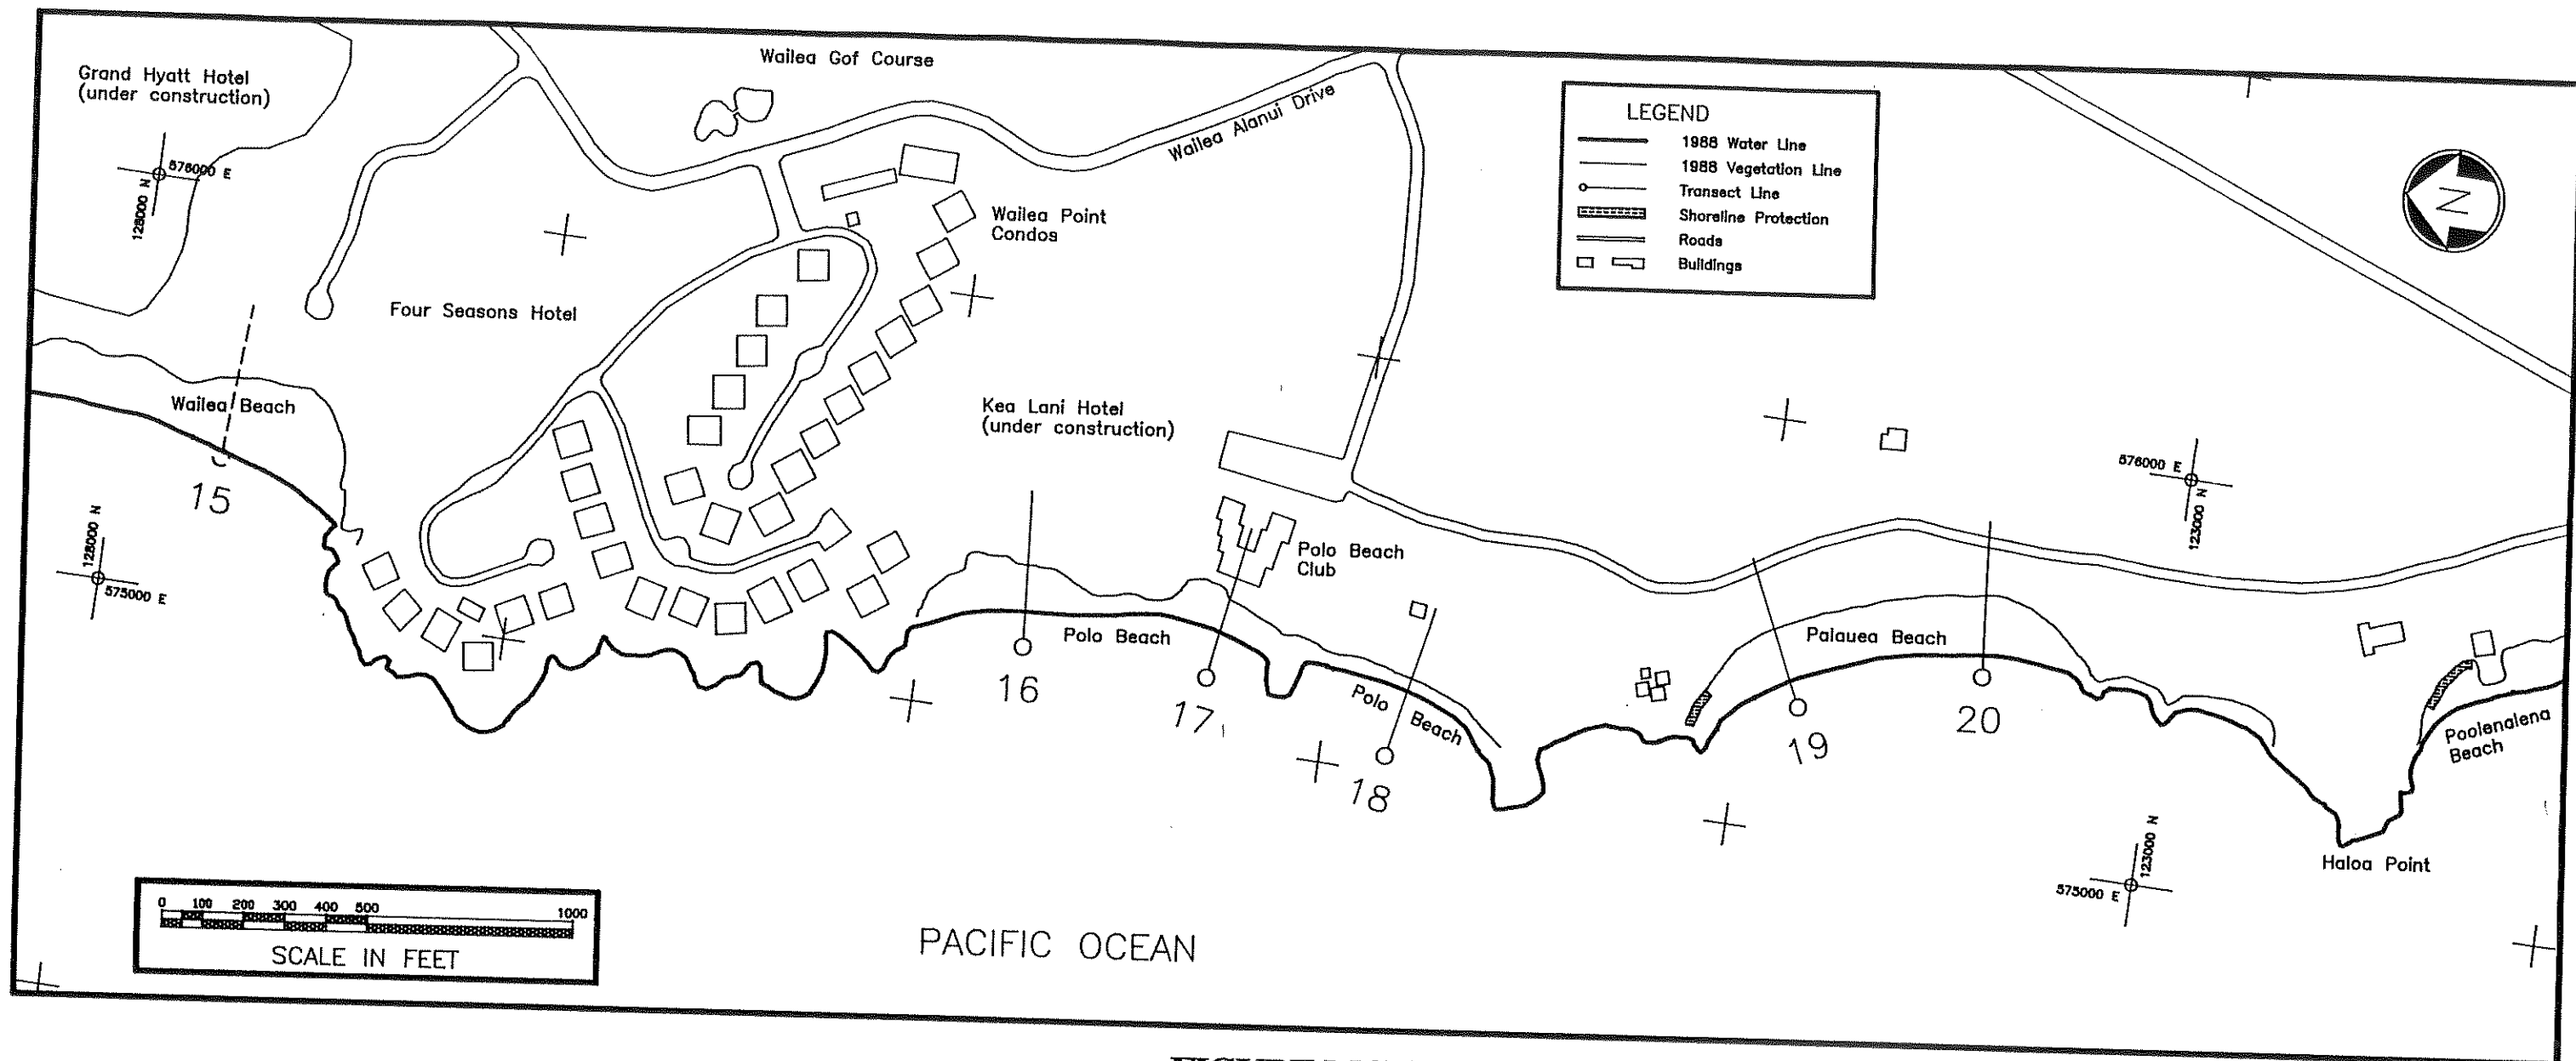
**FIGURE MC-4**

- Similar to the other beaches in this sector, Polo and Palauea Beaches are dynamic. These beaches are subject to occasional severe erosion by storms, followed by gradual beach recovery.
- In Regions 16, 17, 19 and 20 net erosion between 1949 and 1988 ranged from 22 to 52 feet.

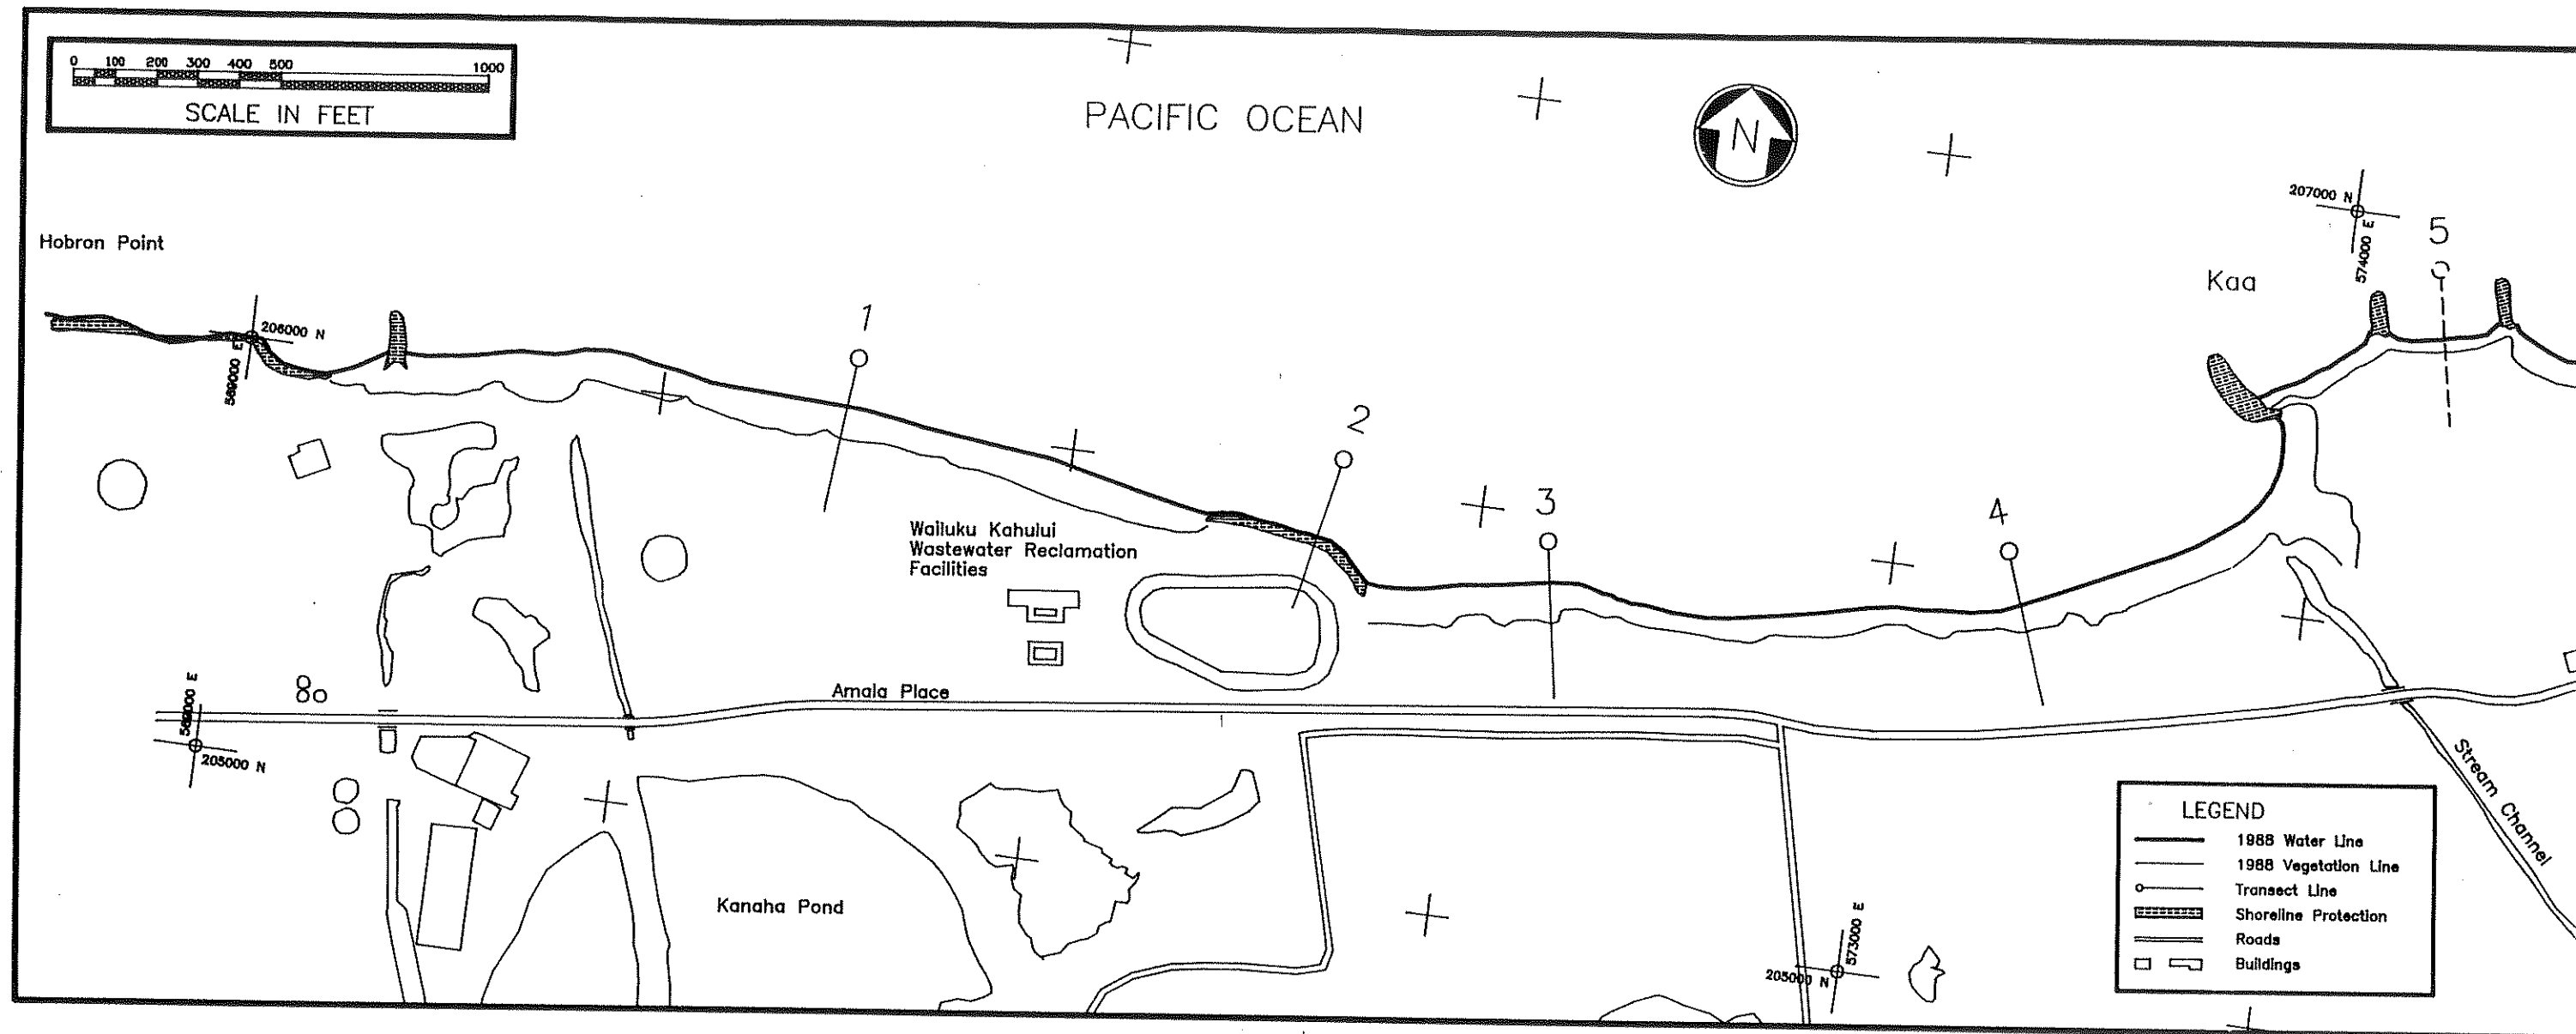
**FIGURE MD-1**

- Severe erosion is evident along the entire subsector.
- The beach morphology around the rock groins located at the ends of the subsector exhibits no evidence of alongshore sediment transport.
- Sand is probably transported offshore during large wave climates. The offshore reef also may not be as productive as it was in the past, causing a decrease in the coralline sand washed onshore.

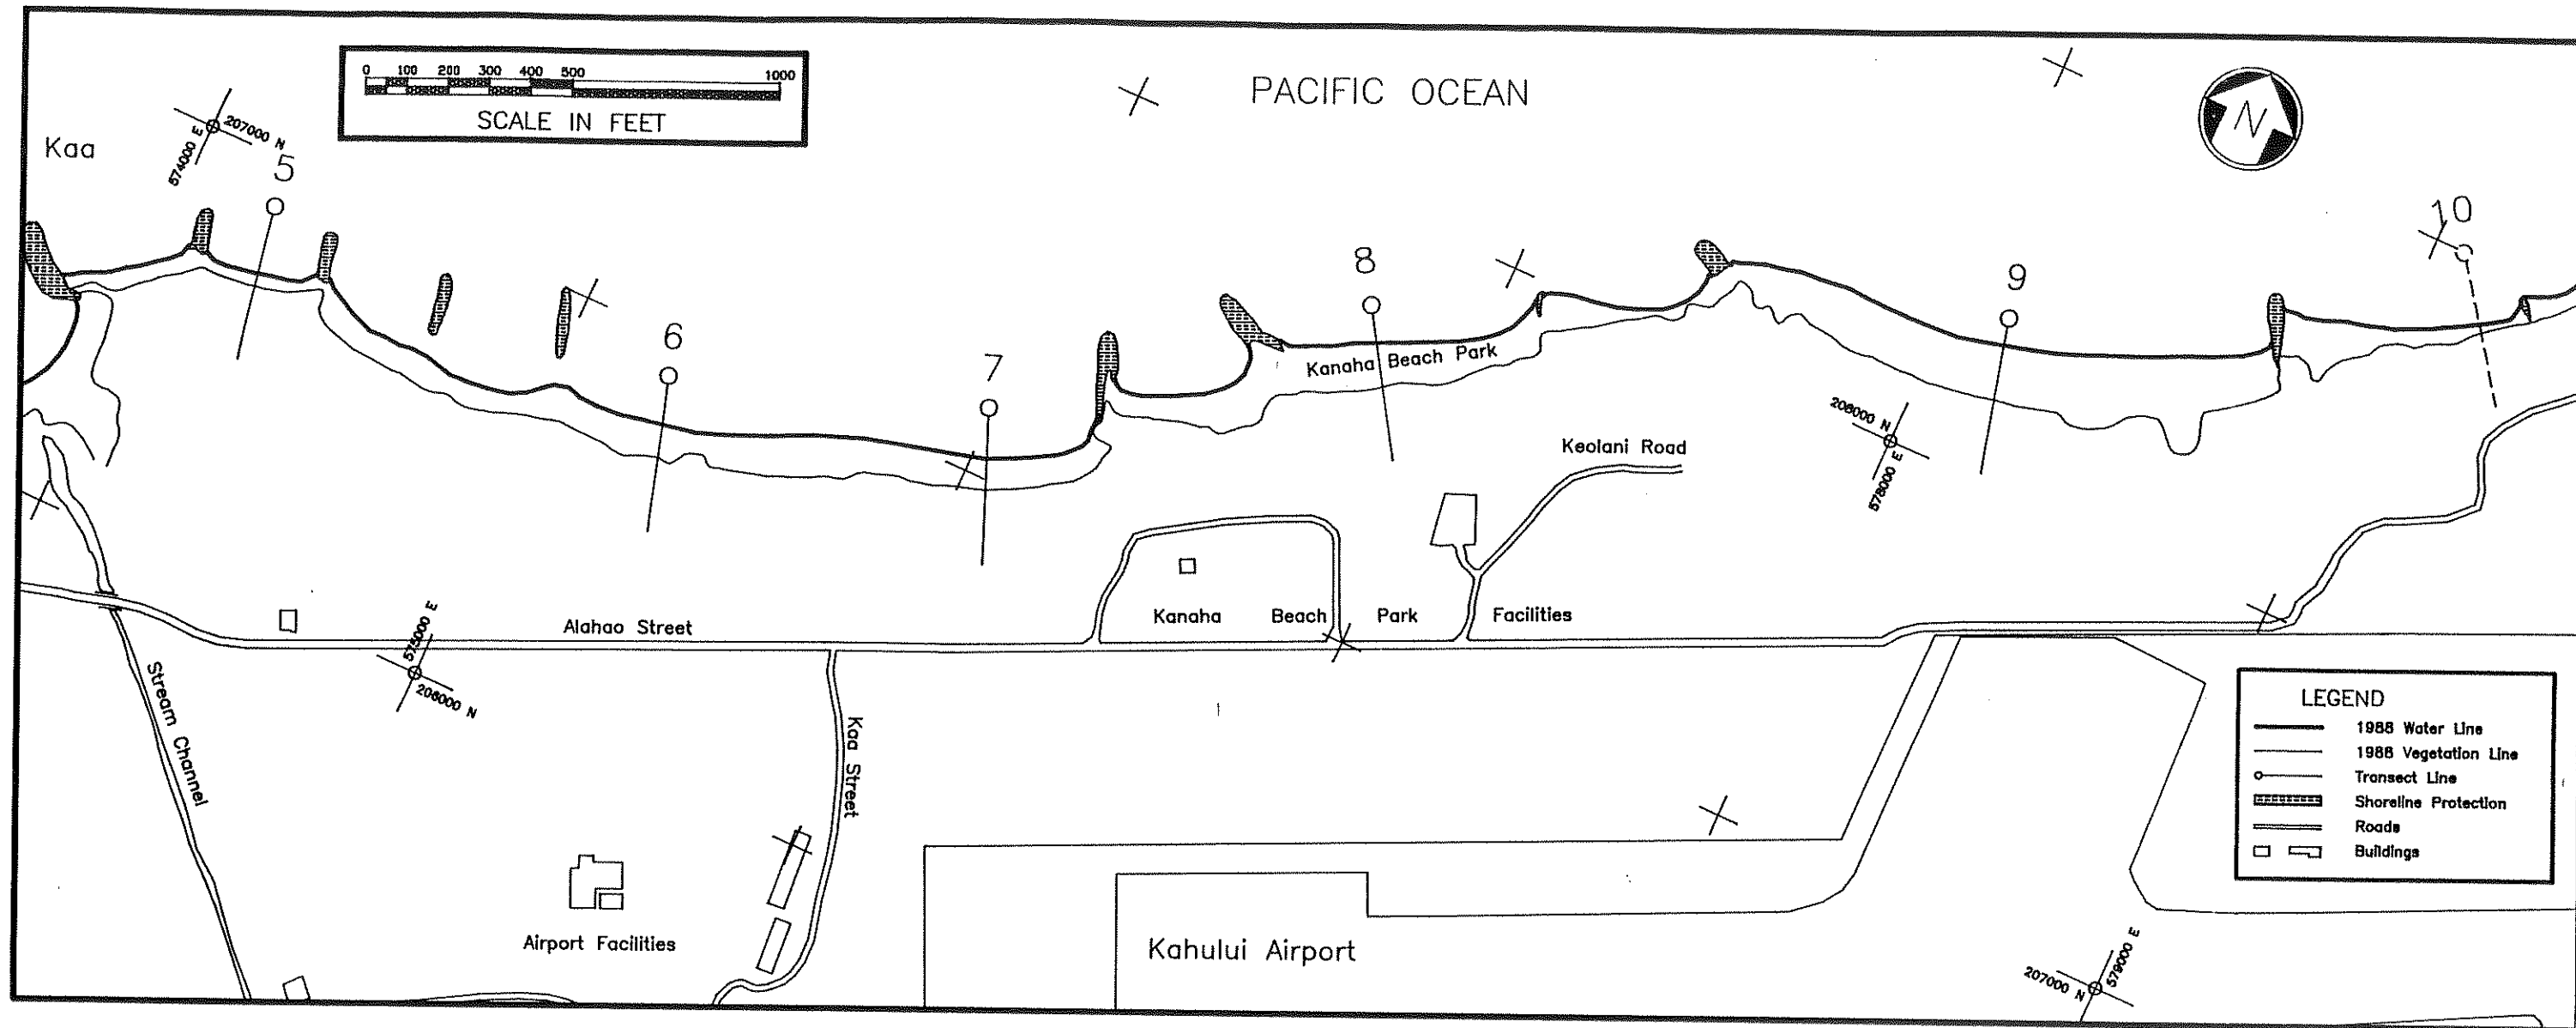
**FIGURE MD-2**

- The localized accretion and erosion along this subsector has been accelerated by the 200 foot long groins present in front of Kanaha Beach Park. Sand by-passes these groins at the tip and by overtopping the structure.
- Eleven groins are located along this subsector. Most are not less than 100 feet in length, and some are absent at the waterline. These groins slow the alongshore sediment transport.

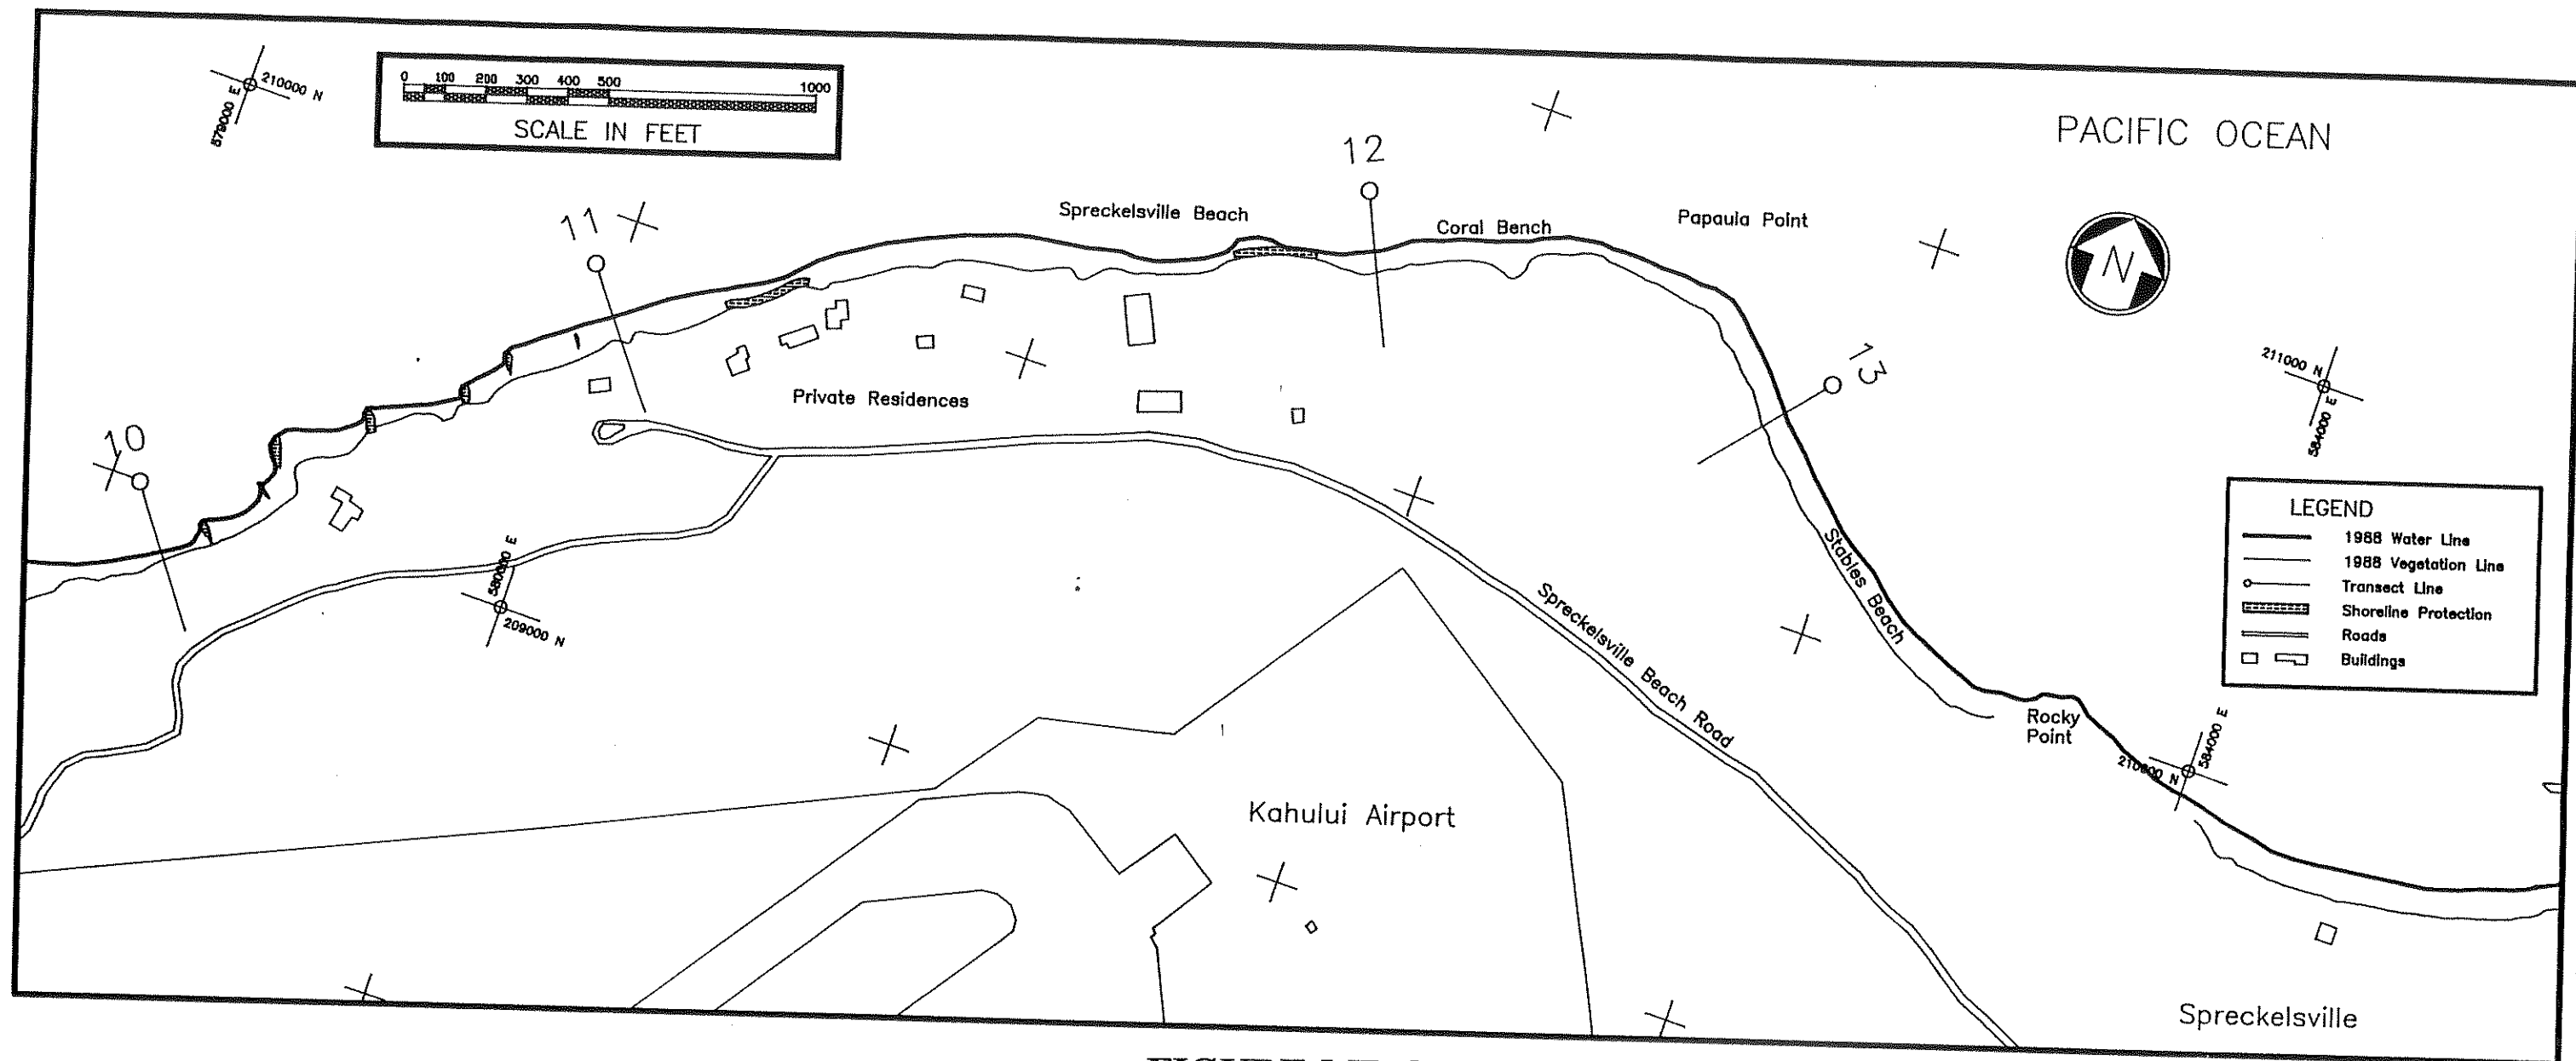
**FIGURE MD-3**

- The west end of the subsector is generally accreting and probably influenced by the groins.
- The reach east of Papaula Point is stable with only minor changes (Region 13).
