# AERIAL PHOTOGRAPHY ANALYSIS OF COASTAL EROSION ON THE ISLANDS OF KAUAI, MOLOKAI, LANAI, MAUI AND HAWAII

JUNE, 1991

**PREPARED BY:**  
**MAKAI OCEAN ENGINEERING, INC**  
**and**  
**SEA ENGINEERING, INC.**  
**Honolulu, Hawaii**

**PREPARED FOR:**  
**STATE OF HAWAII**  
**OFFICE OF STATE PLANNING**  
**COASTAL ZONE MANAGEMENT**  
**PROGRAM**

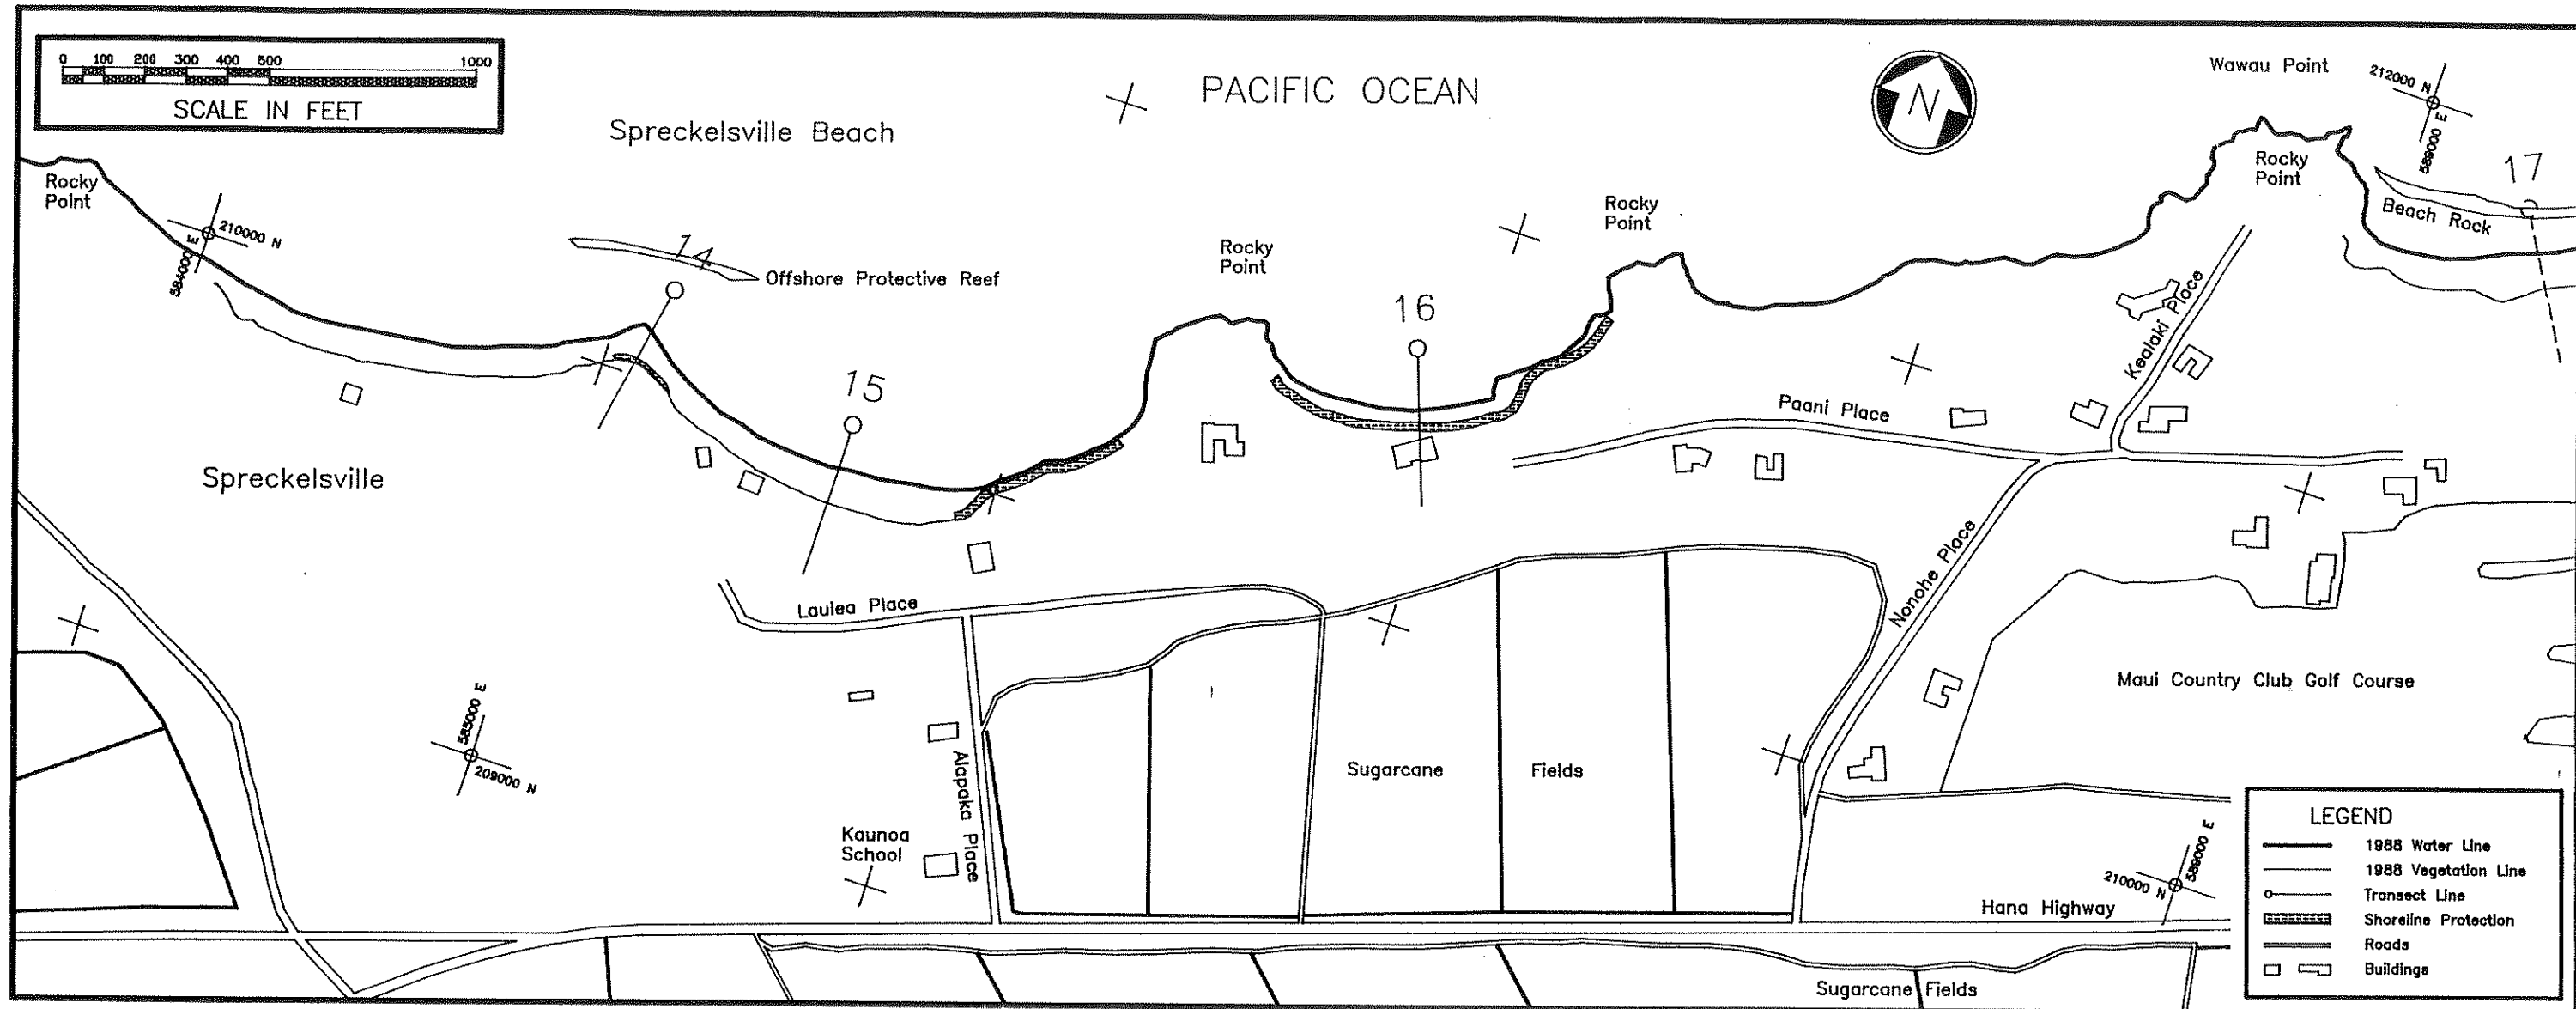
FIGURE MD-4

- The beaches in this subsector are generally eroding. Shore protection structures have been built to help stabilize the vegetation line.

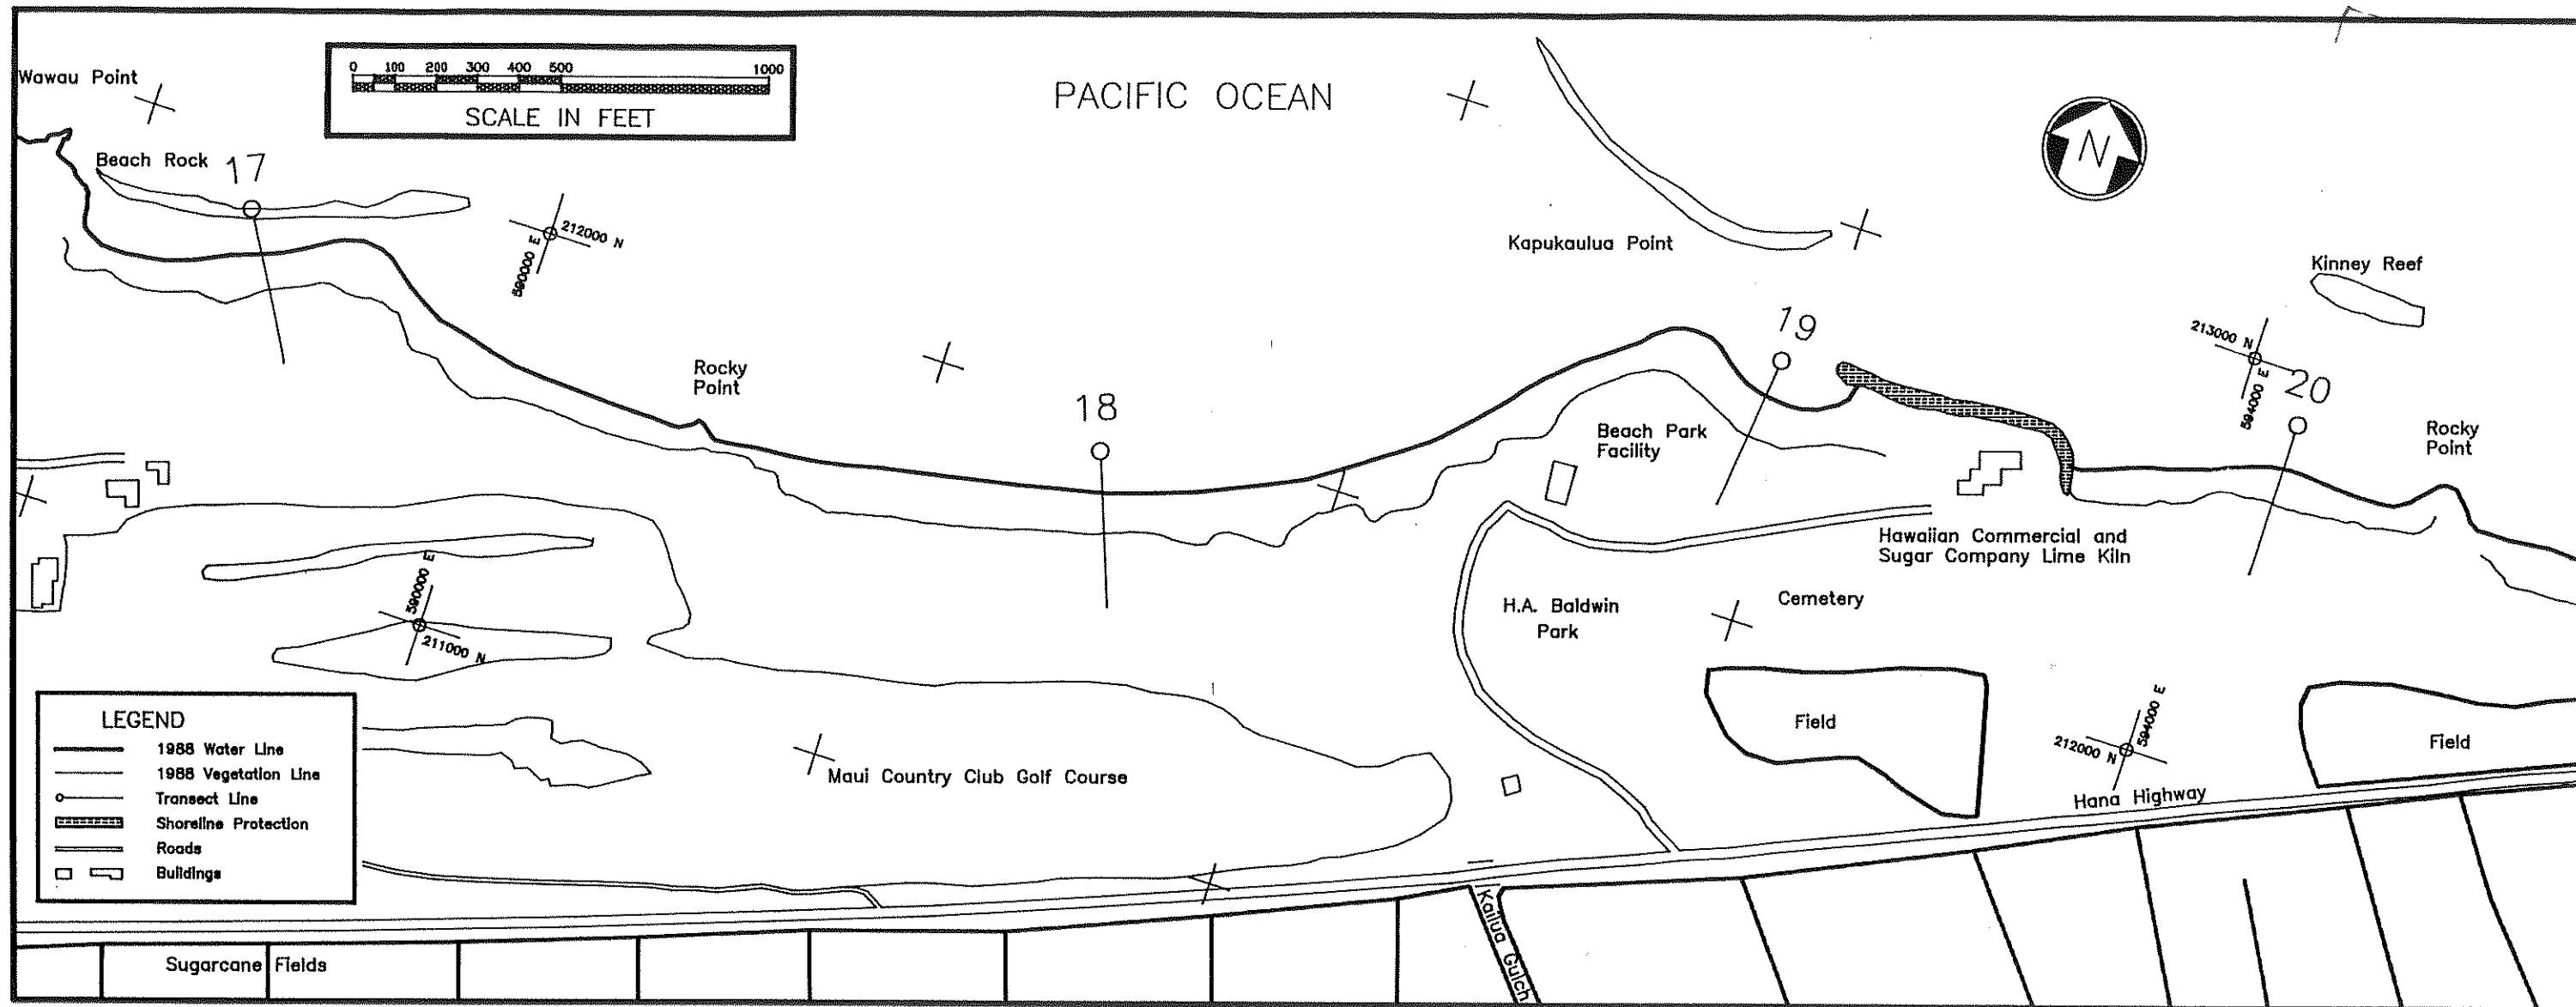
FIGURE MD-5

- There is a net westerly alongshore sediment transport in this subsector.
- The beach is, in general, eroding except for some minor accretion landward of the beach rock at the west end of the subsector.
- Region 20, located updrift of the lime kiln revetment, also shows minor erosion, though less than Region 19 by a factor of five.

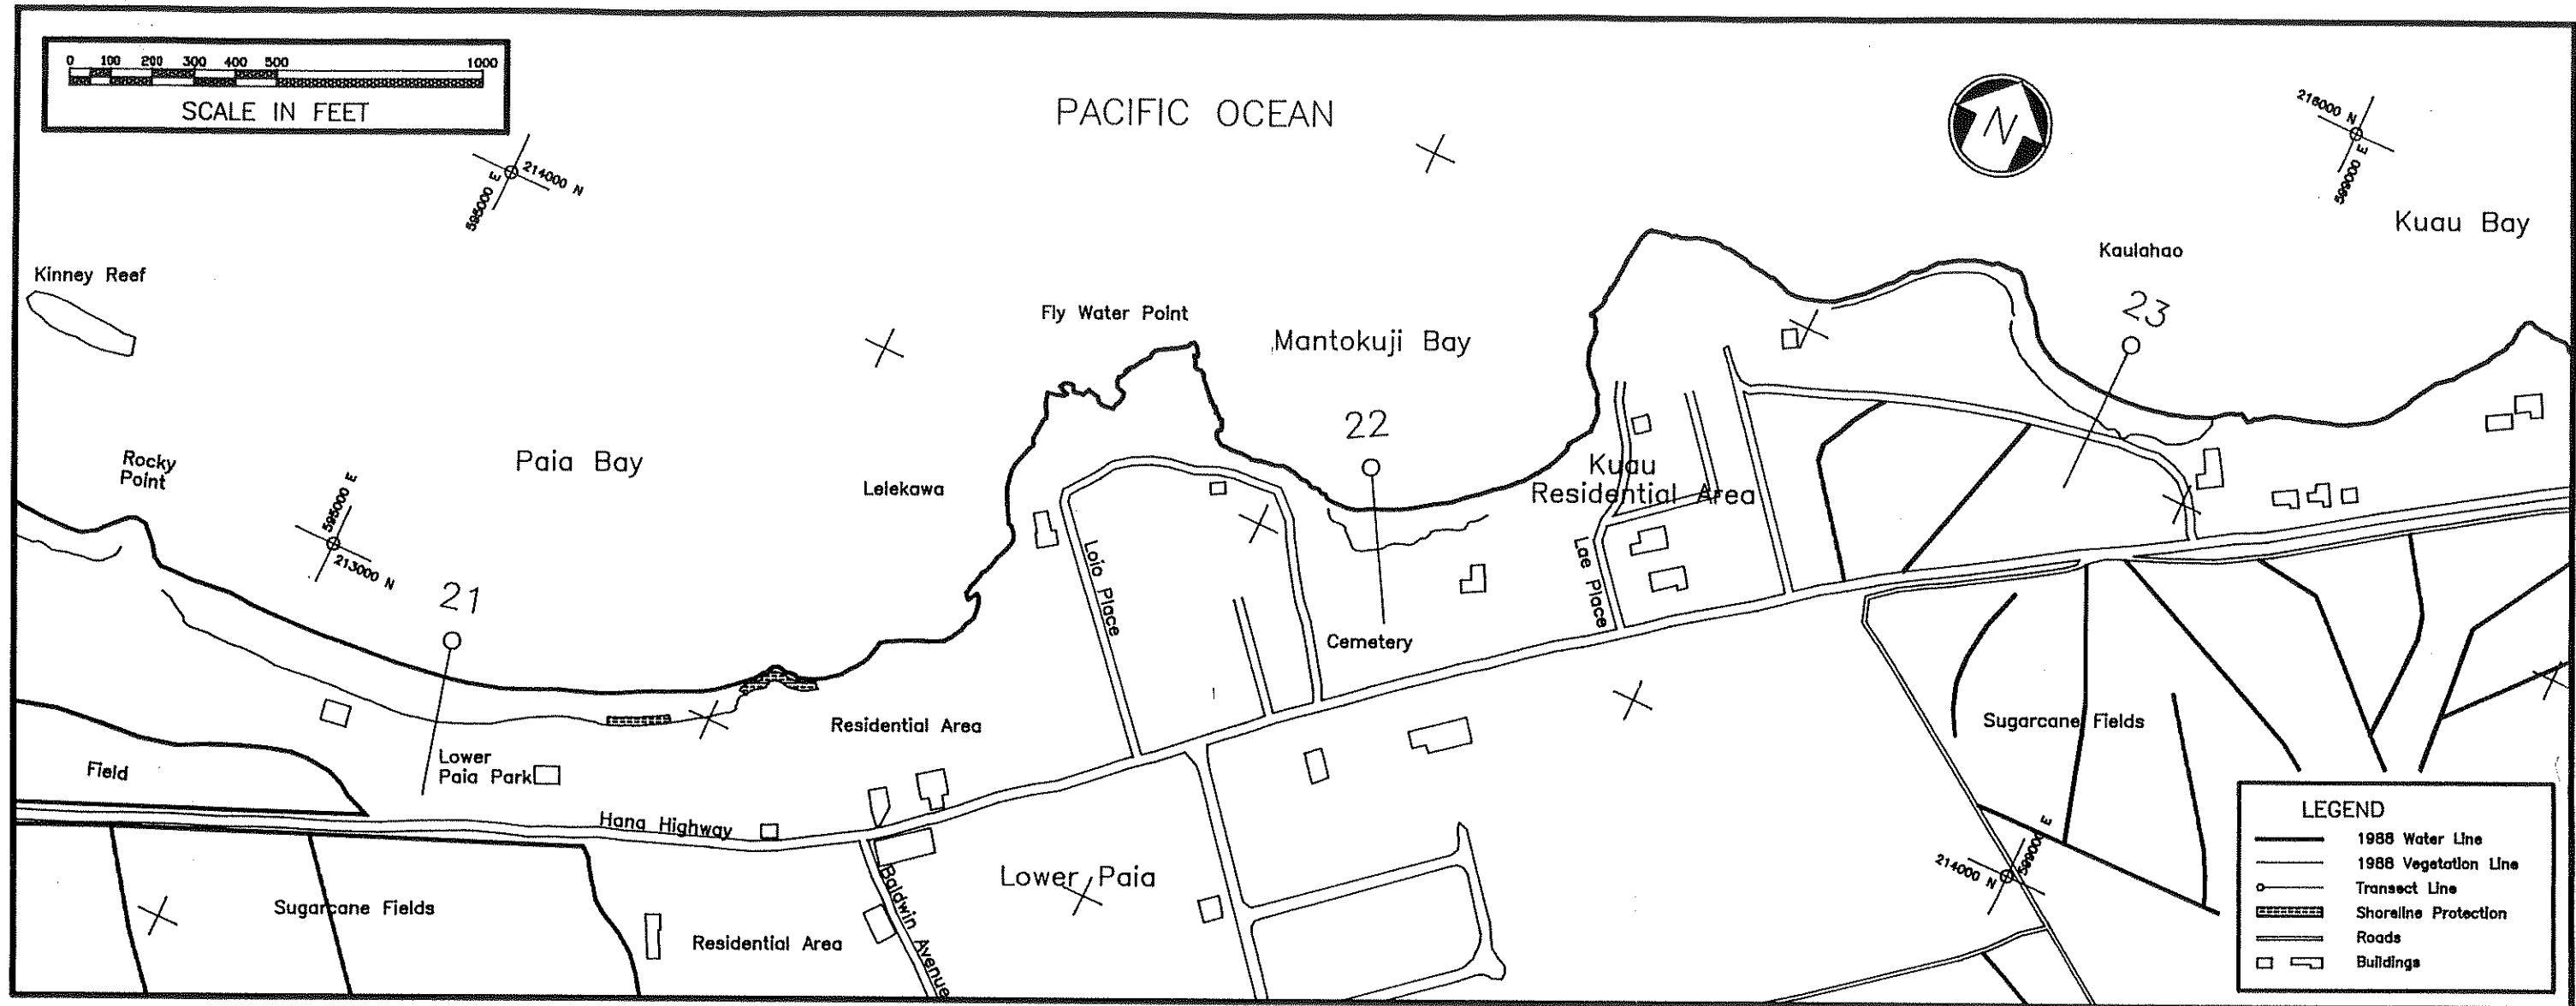
**FIGURE MD-6**

- The beaches in this subsector are stable.
- The beach at Mantokuji Bay is a closed littoral system bounded by two rocky points.
- There are signs of erosion of the dirt embankment at the rocky points.
