KAHANA STREAM RESTORATION PROJECT

Ahupu'a 'O Kahana State Park, Kahana, O'ahu

Final Report to the Hawaii Fish Habitat Partnership
Commission on Water Resource Management
Department of Land and Natural Resources, State of Hawai'i

Project Period: August 26, 2013 – September 30, 2017

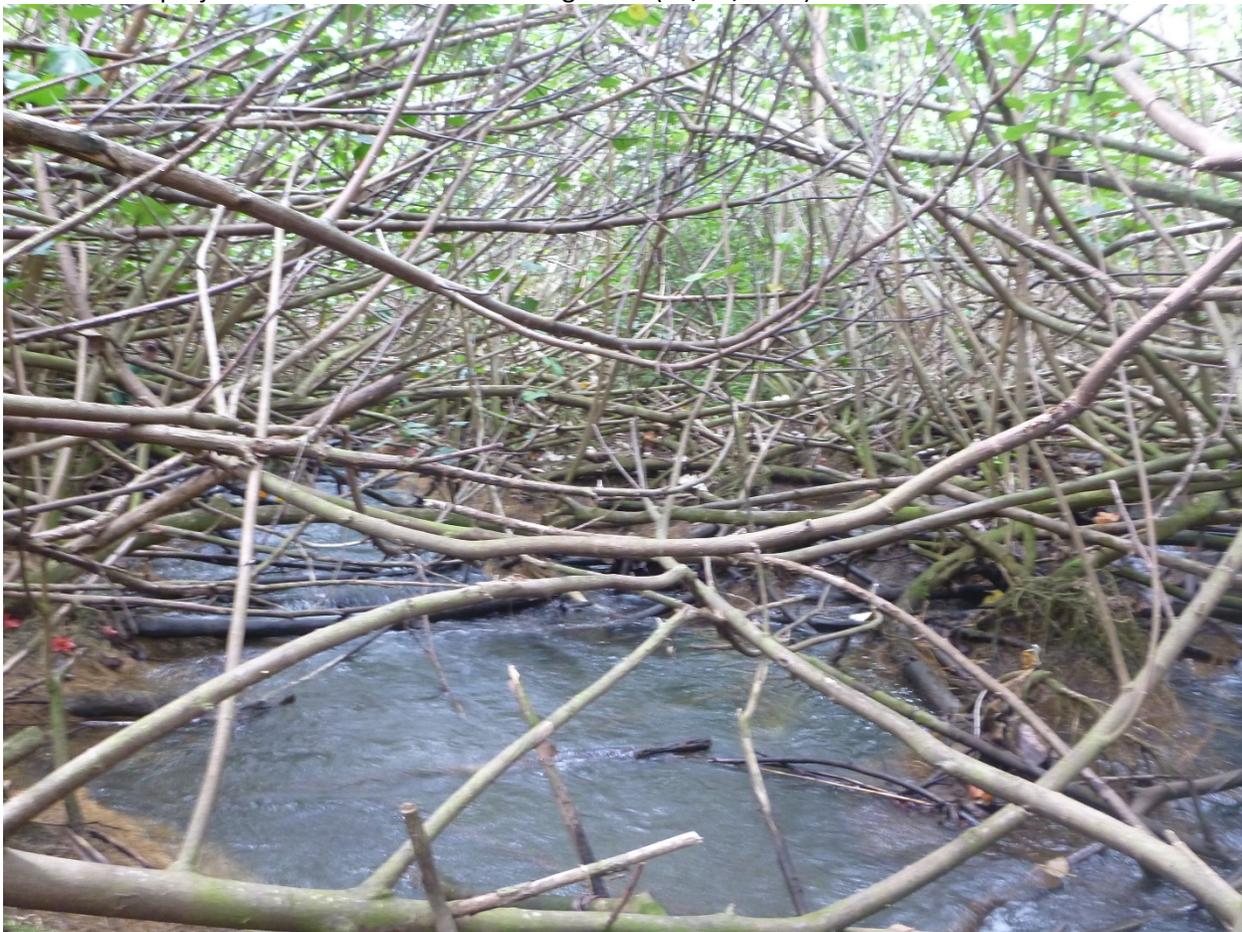
Photo 1. Pre-project stream condition and hau growth (08/01/2014).

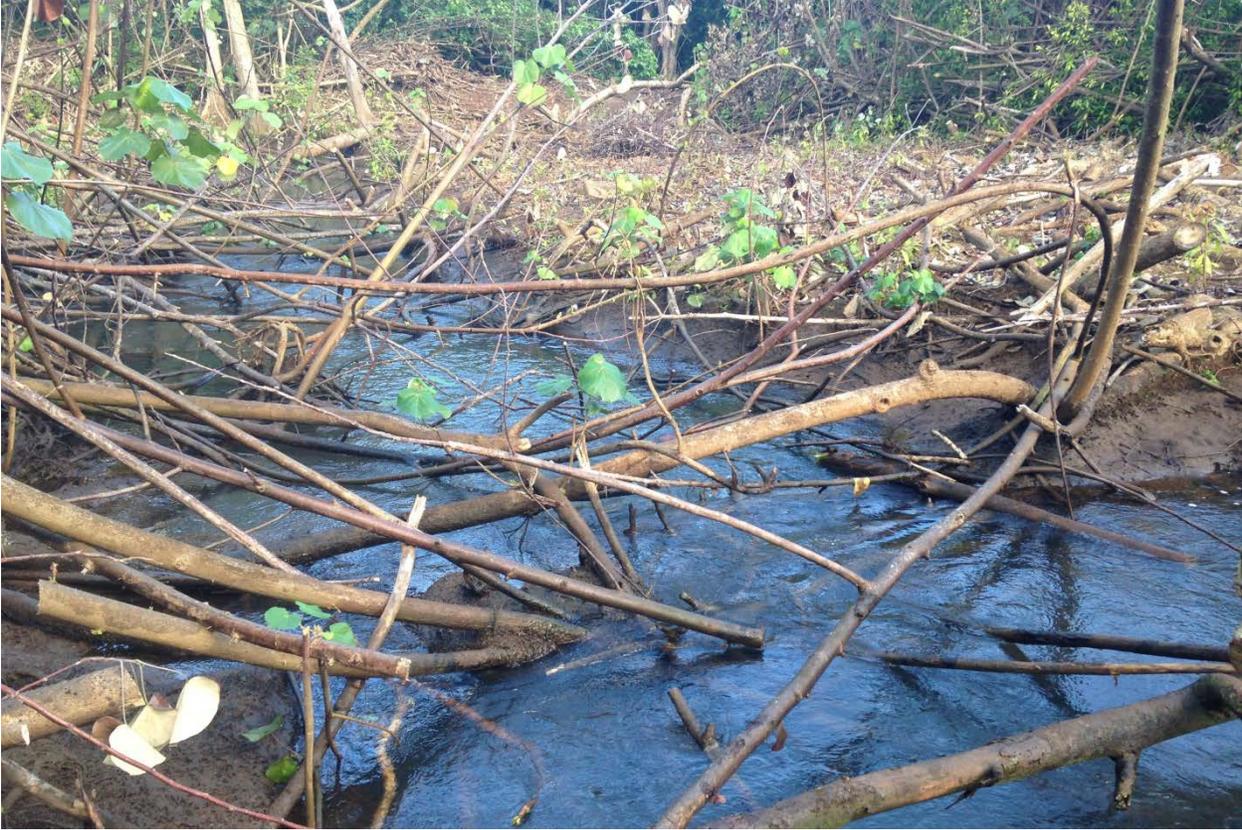
Photo 6. Contracted work on hau clearing (October 2016 – April 2017).

The formal contract was executed in July 2016 for the removal of approximately 1 acre of *H. tiliaceus* and other non-native trees in the wetland along the stream corridor (See Photos 7 to 10). Work began in October 2016 and was completed in April 2017. The contractor cut *H. tiliaceus* down to the ground level by chainsaw and hand removed each limb out of the stream to the staging area. All *H. tiliaceus* limbs were chipped and the mulch spread around the staging area and made available to the community. The contractor applied Garlon 4™, an herbicide approved for wetland application, using a single point (point and spray or paint) method (i.e., not broad spray) to kill the *H. tiliaceus* stumps. Approximately 500 linear feet of the main stream channel was cleared of *H. tiliaceus* as well as approximately 200 linear feet of tributary channels by the contractor.

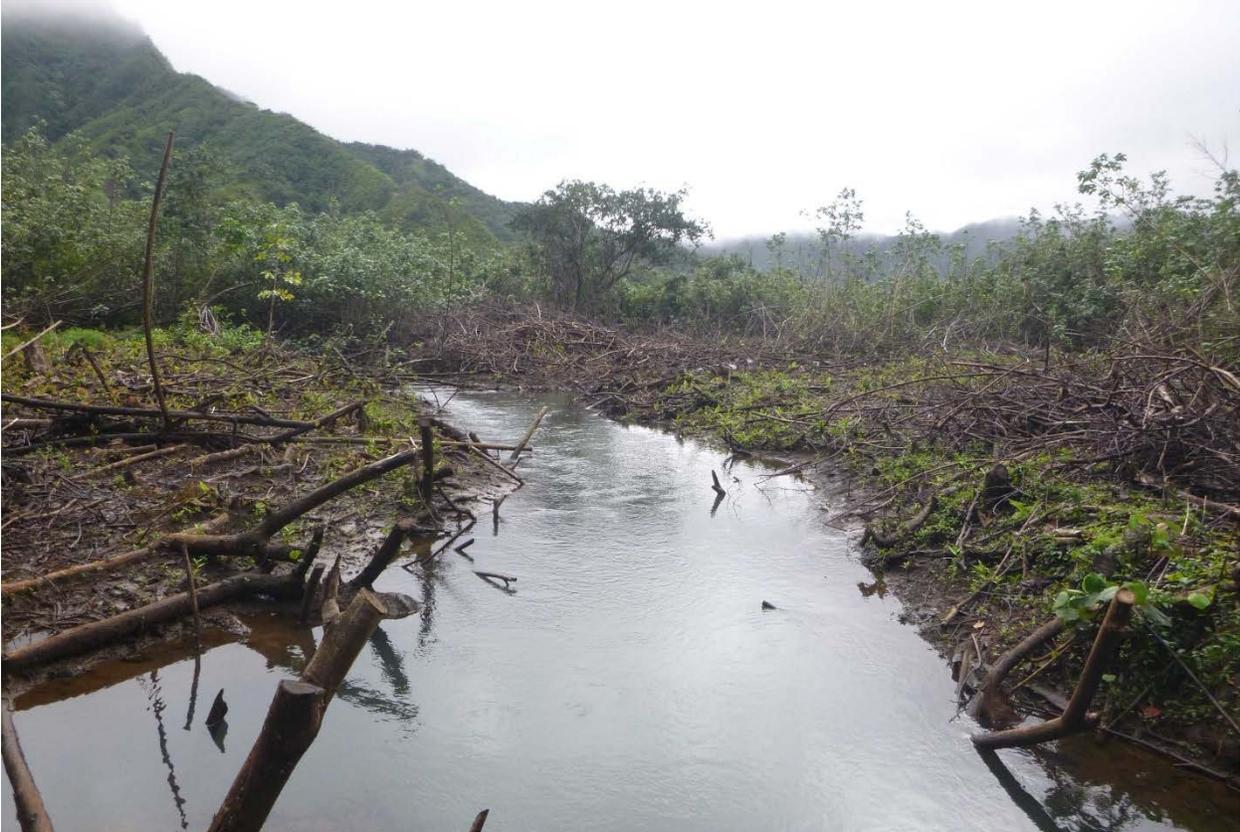
Photo 7. Contracted work on hau clearing (12/23/2016).

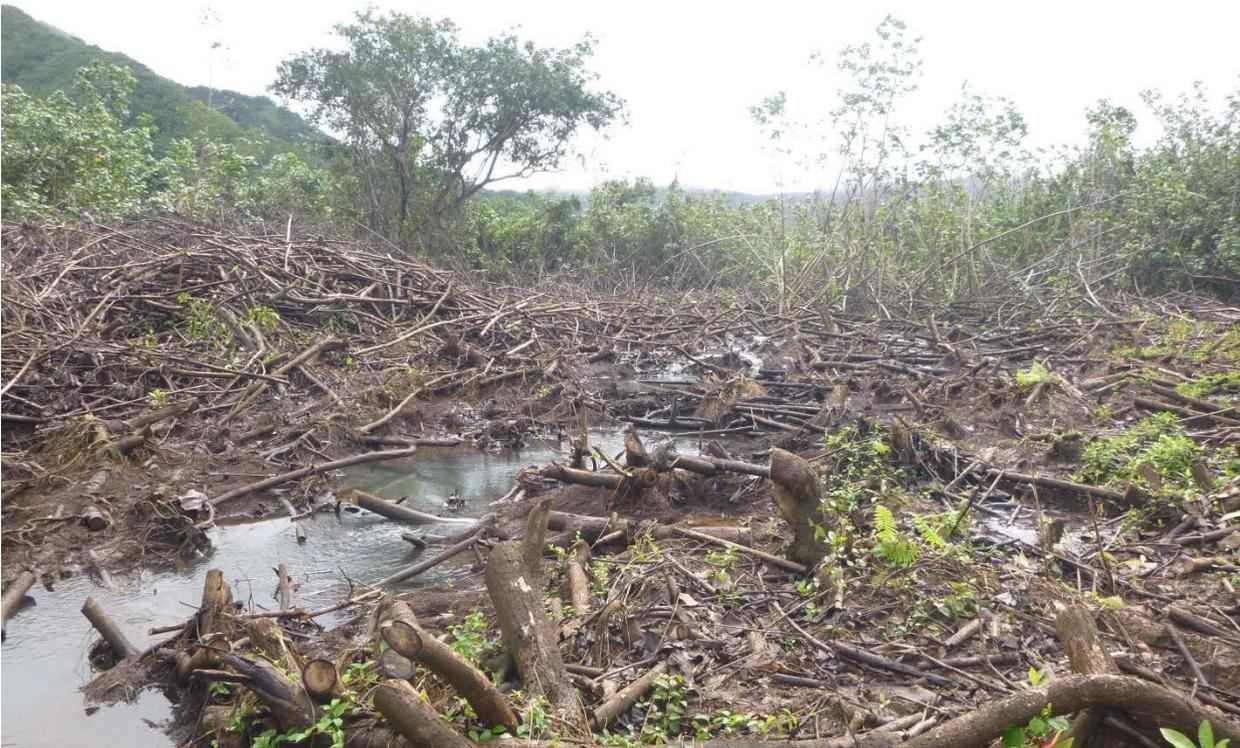
Photo 8. Contracted work on hau clearing (12/23/2016).

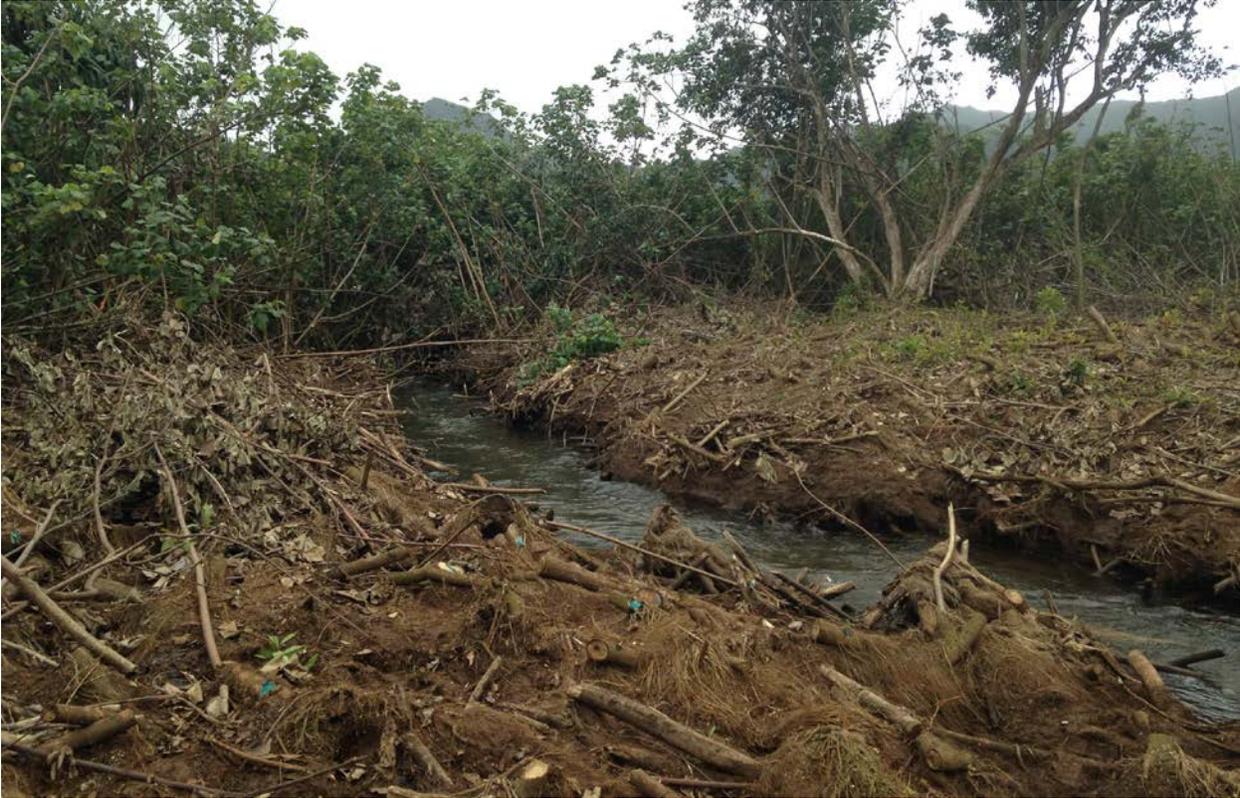
Photo 9. Contracted work on hau clearing (01/31/2017).

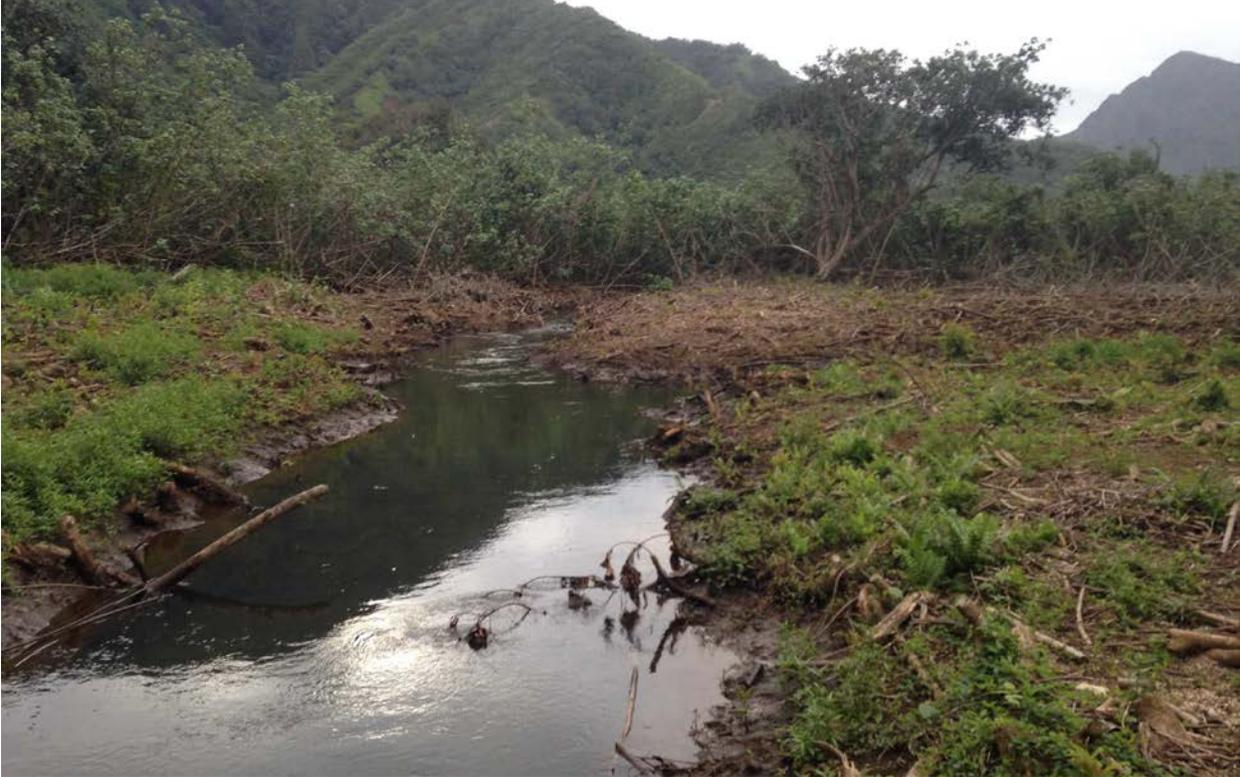
Photo 10. Contracted work on hau clearing (01/31/2017).

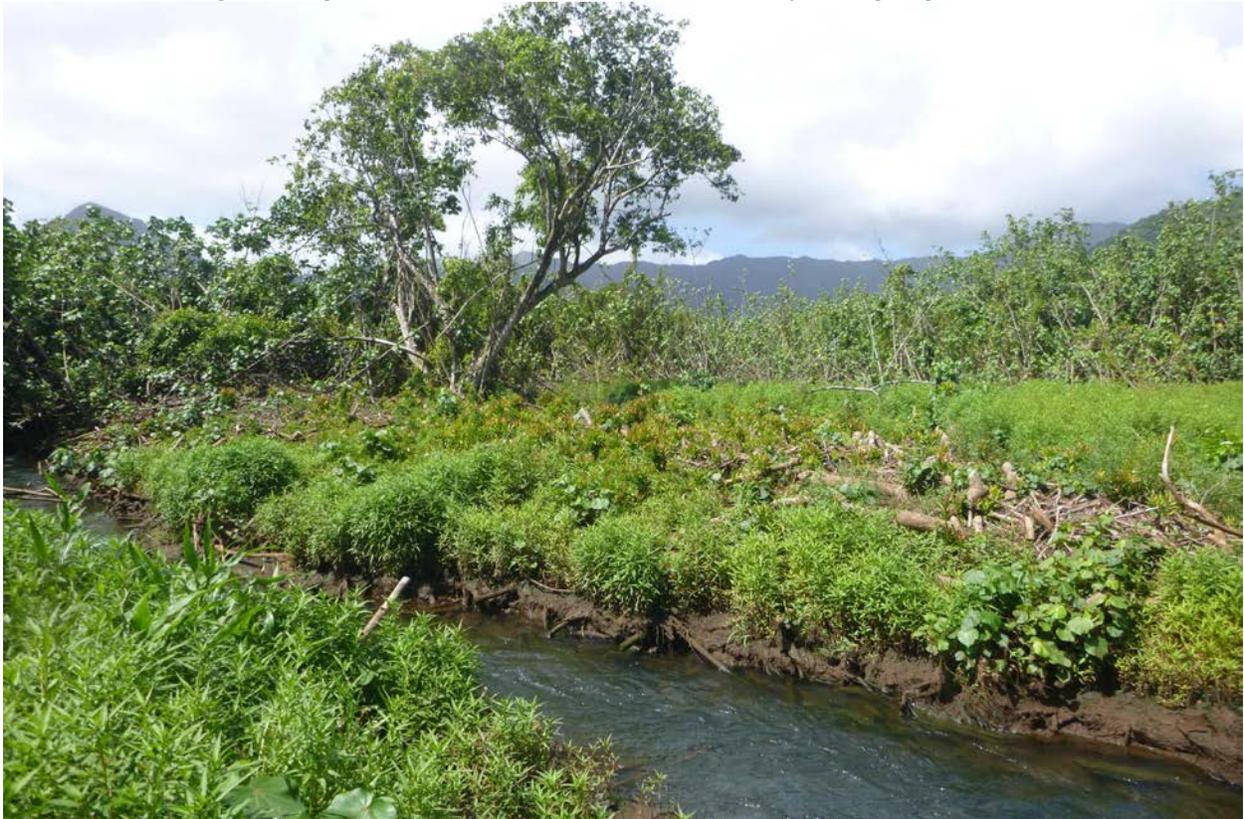
Photo 11. New vegetation growth on Kahana Stream as native outplanting begins (05/15/2017).

Following the completion of the contracted work, DLNR staff used coconut fiber as ground cover and planted a variety of native trees, sedges, grasses and groundcover (Table 1) along the riparian corridor. During 14 different work days in 2017, DLNR staff, USFWS staff, and volunteers continued to weed and trim back the growth of non-native species to provide an opportunity for the native species to thrive (See Photos 11 to 18; Plate 1).

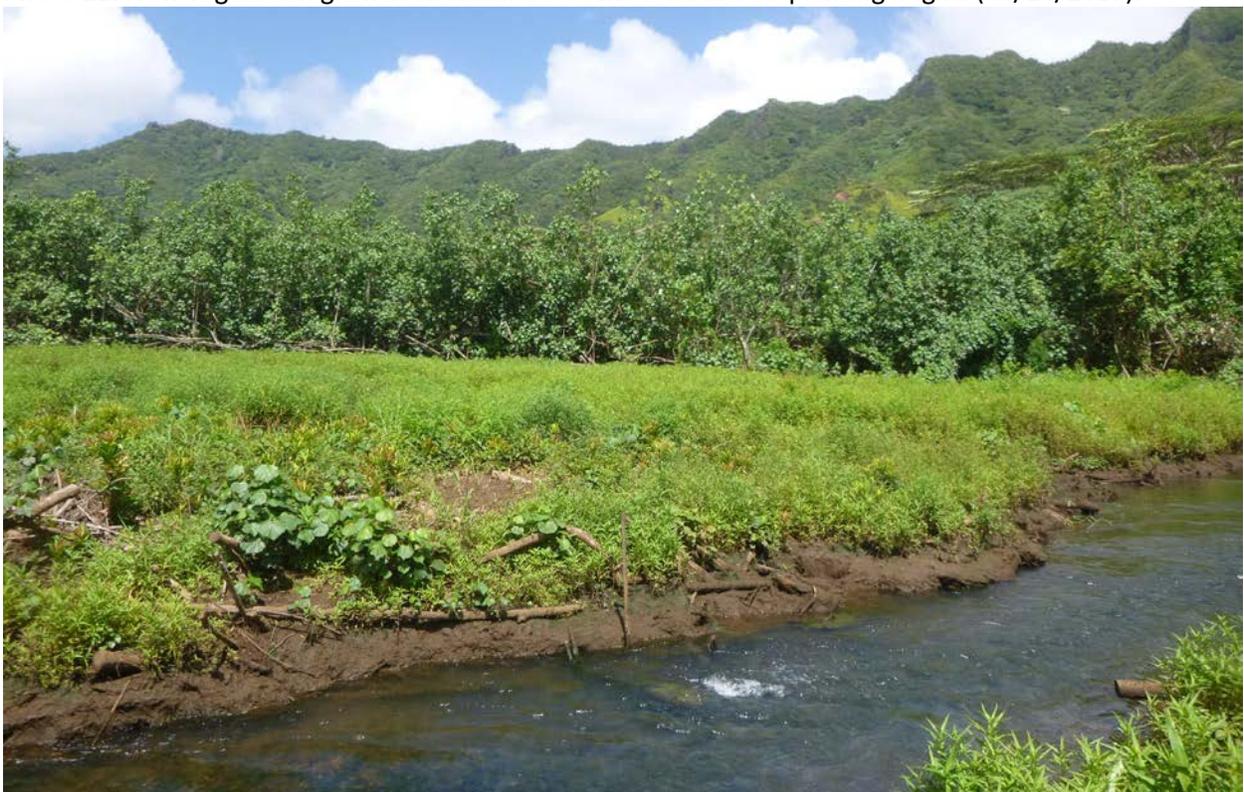
Photo 12. New vegetation growth on Kahana Stream as native outplanting begins (05/15/2017).

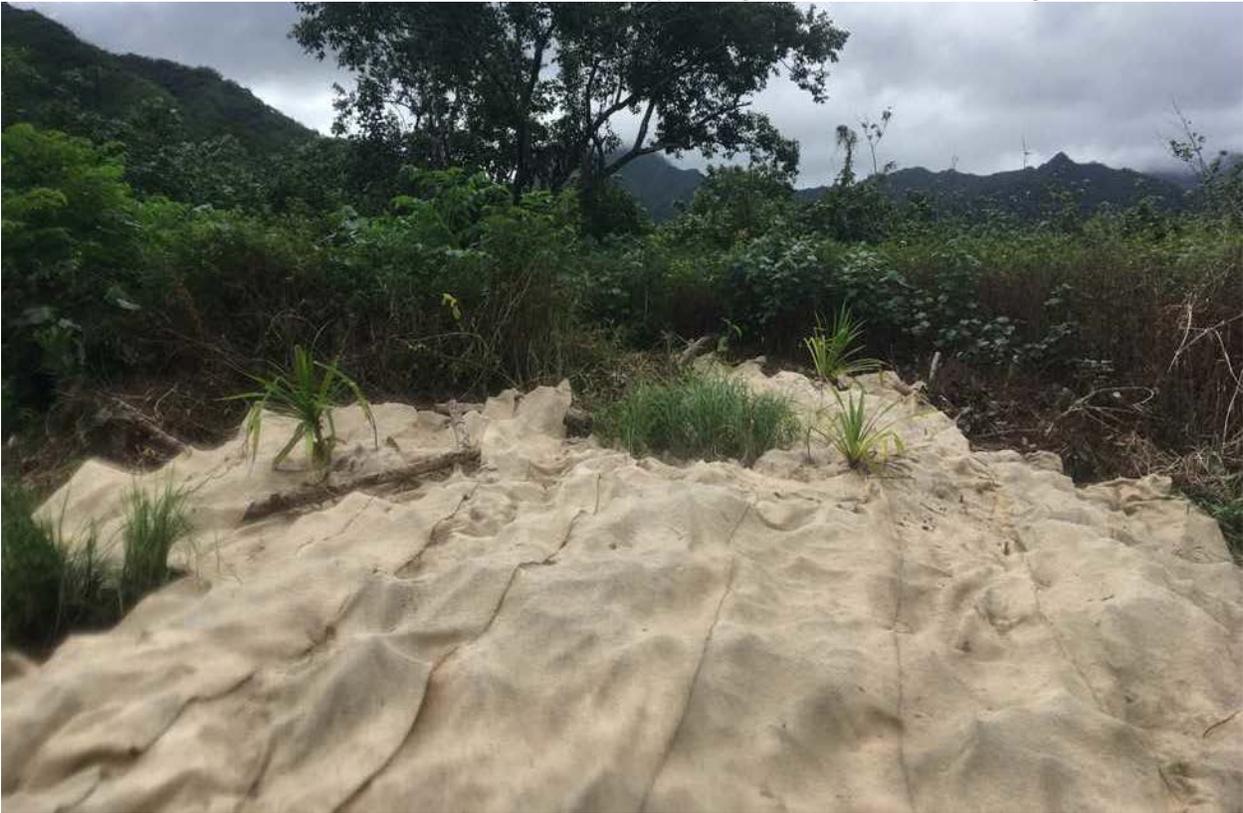
Photo 13. CWRM and DOFAW staff continue native outplanting and install fiber matting (09/22/2017).

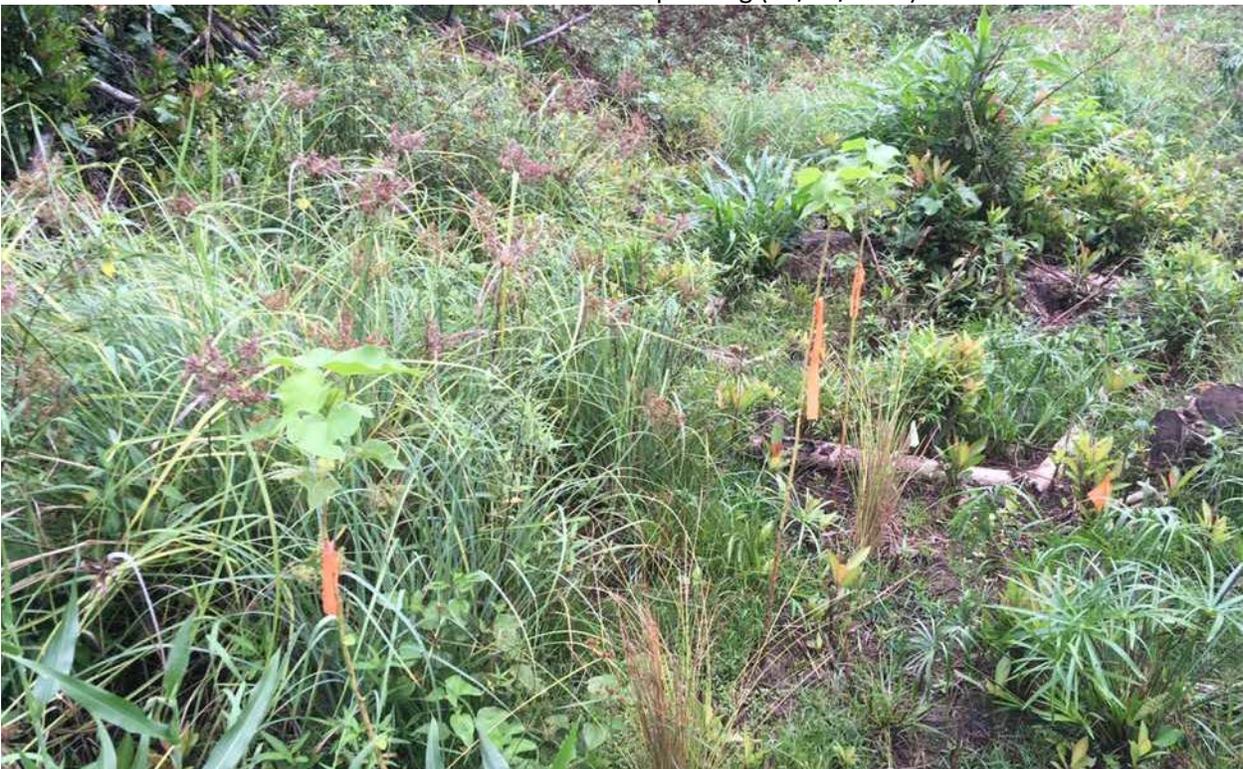
Photo 13. CWRM and DOFAW staff continue native outplanting (09/22/2017).

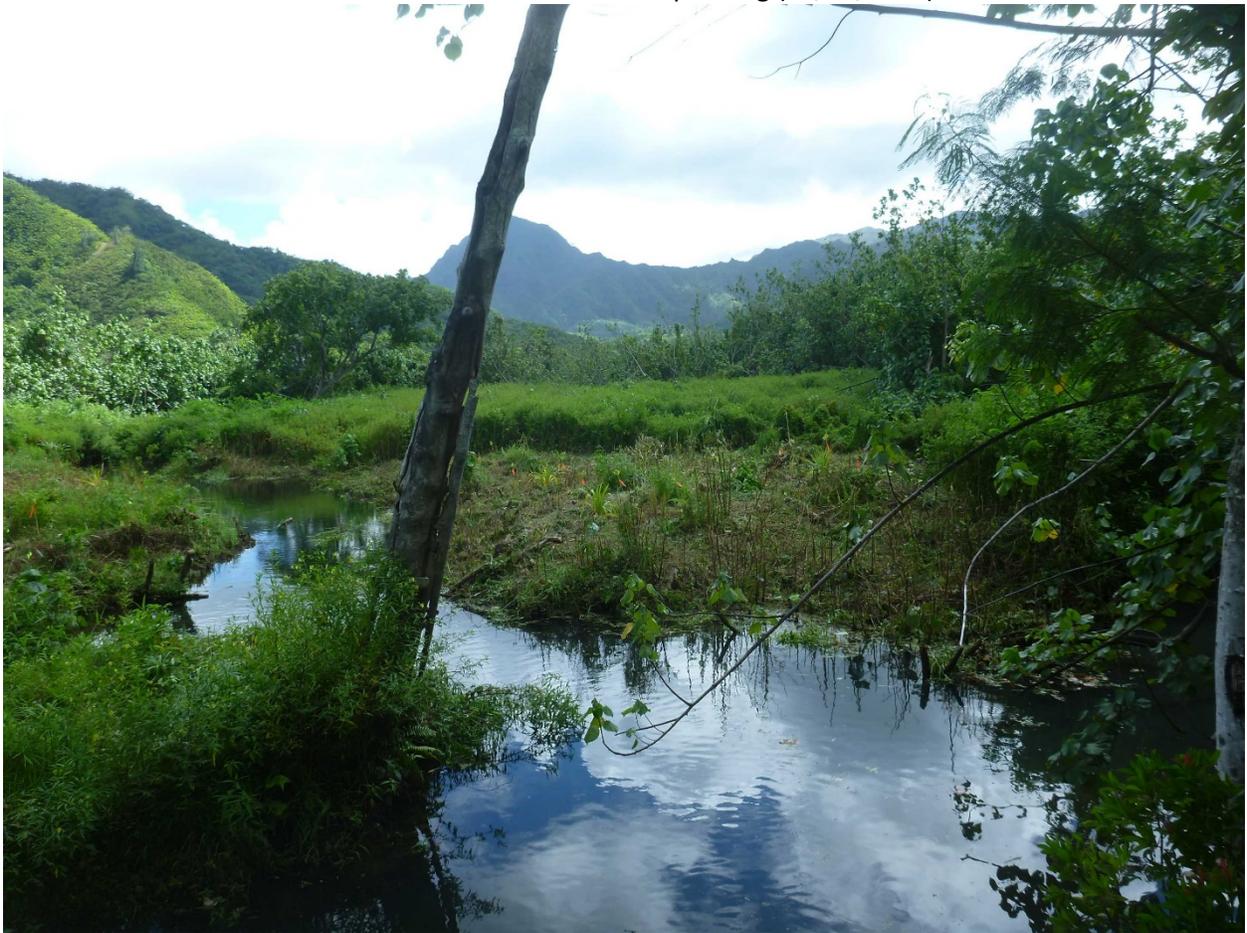
Photo 18. CWRM and DOFAW staff continued native outplanting (09/22/2017).
