**Final
Addendum to an
Archaeological Inventory Survey
of Approximately 1339-Acres of Castle and Cooke Lands
Waipi‘o and Waiawa Ahupua‘a,
‘Ewa District, O‘ahu Island**

**TMK: [1] 9-4-006:001 por., 002 por., 029 por.;
9-5-003: 001 por.; and 9-6-004:021 por.**

**Cultural Surveys Hawai‘i, Inc.
Kailua, Hawai‘i
(Job Code: WAPIO 9)**

September 2009

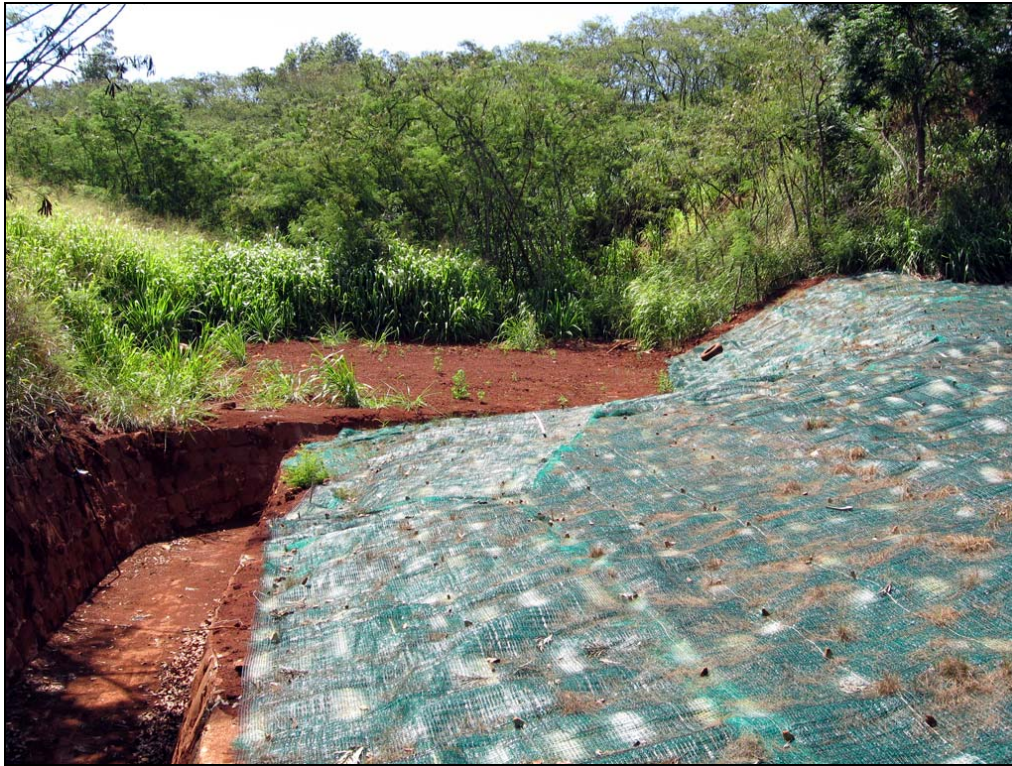
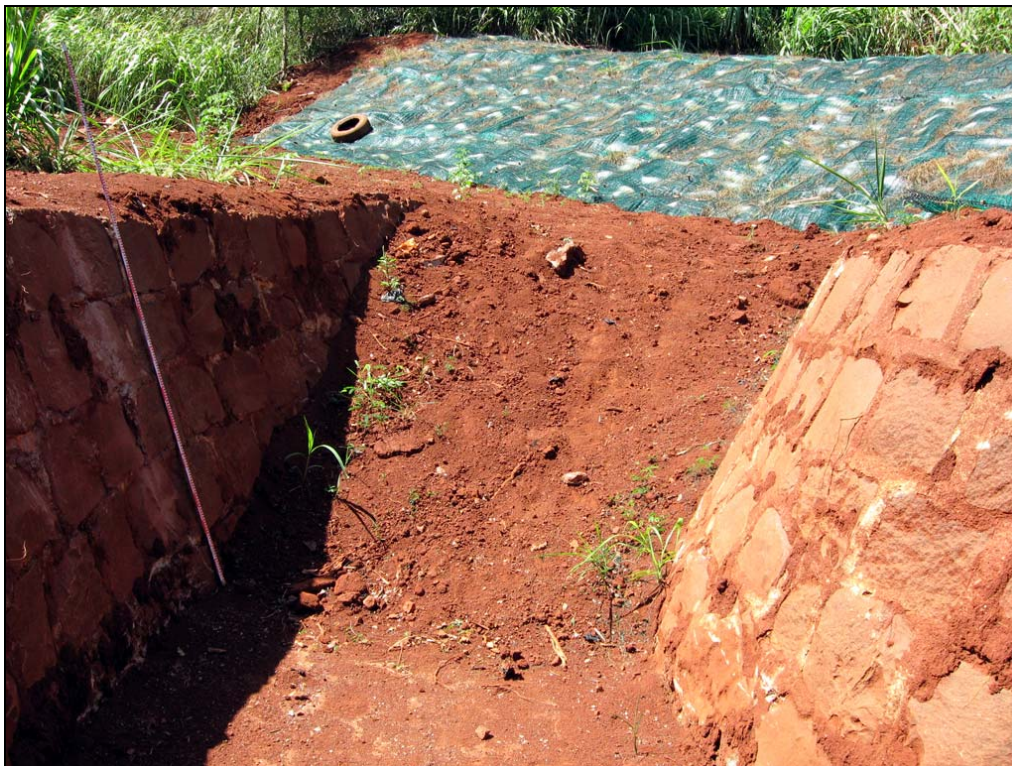
Portions of the Feature A ditch in the northern portion of Survey Area A, north of the northern natural drainage gully, have been recently modified in association with flood mitigation efforts. From the northern gully to the ditch outlet at the northern end of Survey Area A, the Feature A ditch has been modified to function as a drainage ditch (see Figure 22). In the area where the ditch crosses the northern drainage gully, a large earthen berm has been constructed over the ditch (Figure 8). The earthen berm, measuring approximately 2 m in height above the top of the Feature A ditch, is constructed adjacent to the south edge of the gully and functions in diverting storm water from the gully into the Feature A ditch. From the earthen berm north to the ditch outlet, all sediment from the interior of the Feature A ditch has been removed, allowing storm water to flow through the ditch and into Kīpapa Gulch. Other modifications to the ditch in this area include the addition of stone and mortar lining above the cut basalt block and mortar ditch lining (Figure 9) to reinforce a portion of the downslope ditch wall, and modification of the sluice gate and ditch outlet (Figure 10) to widen the outlet. In addition to the modifications to the Feature A ditch, a recently constructed earthen drainage ditch (Figure 11) runs along the top edge of the tablelands, upslope of the Feature A ditch, beginning at the southern natural drainage gully and terminating at the northern natural drainage gully. This drainage ditch, measuring approximately 2.5 m wide and 1.0 m deep, functions in diverting storm water from the southern drainage gully and areas upslope of the Feature A ditch between the gullies, into the northern gully and through the modified portions of the Feature A ditch.

Figure 8. SIHP # 50-80-09-9530 Feature A irrigation ditch, showing earthen berm recently constructed over the ditch (views to southeast, south)

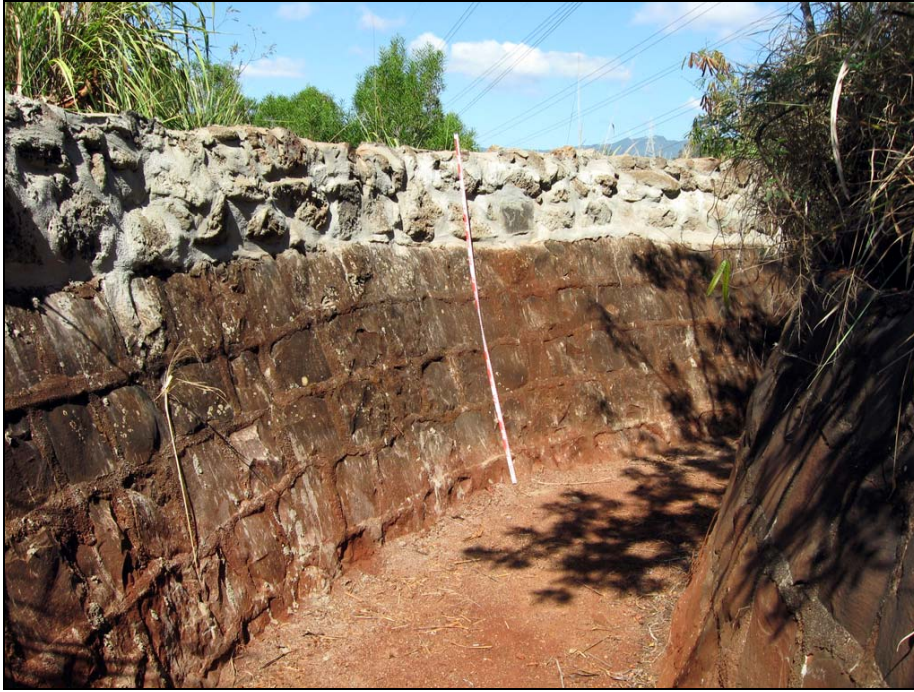
Figure 9. SIHP # 50-80-09-9530 Feature A irrigation ditch, showing recently constructed stone and mortar lining above the cut basalt block and mortar ditch lining (view to southwest)

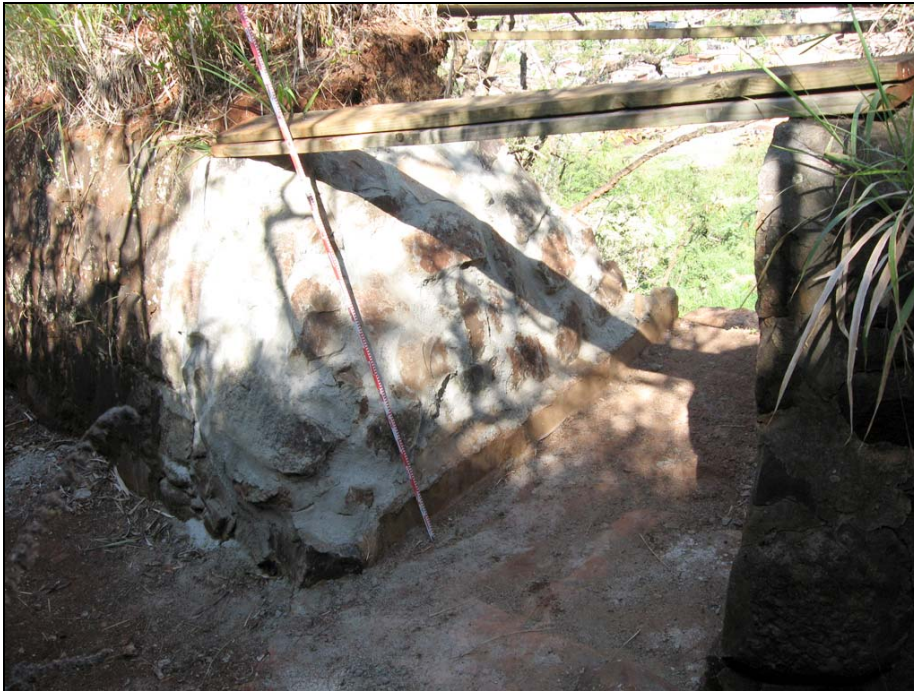
Figure 10. SIHP # 50-80-09-9530 Feature A irrigation ditch, showing recent modifications to the sluice gate and ditch outlet at the edge of Kīpapa Gulch (view to southwest)

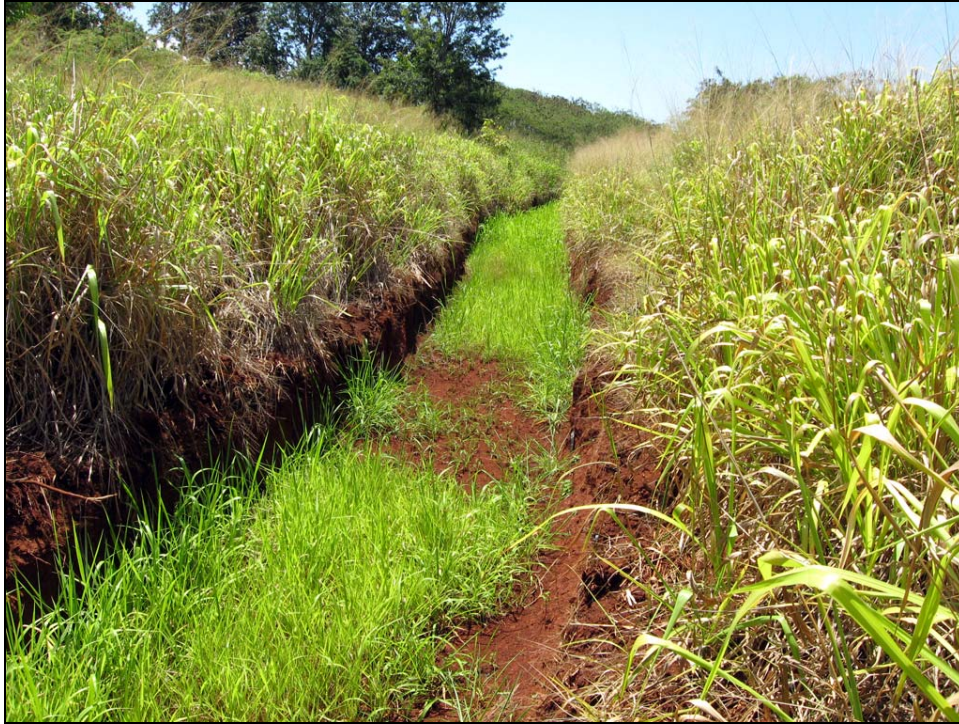
Figure 11. Recently constructed drainage ditch along the edge of the tablelands, upslope of the SIHP # 50-80-09-9530 Feature A irrigation ditch

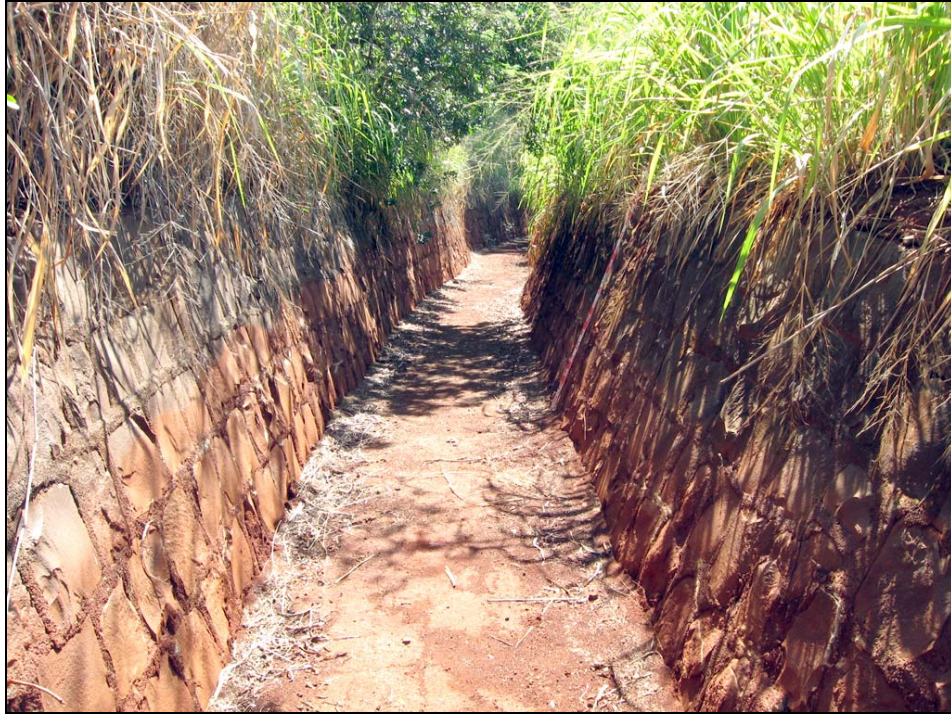
Figure 23. SIHP # 50-80-09-9530 Feature A irrigation ditch, showing portion of the ditch where interior sediment has been recently removed (view to northeast)

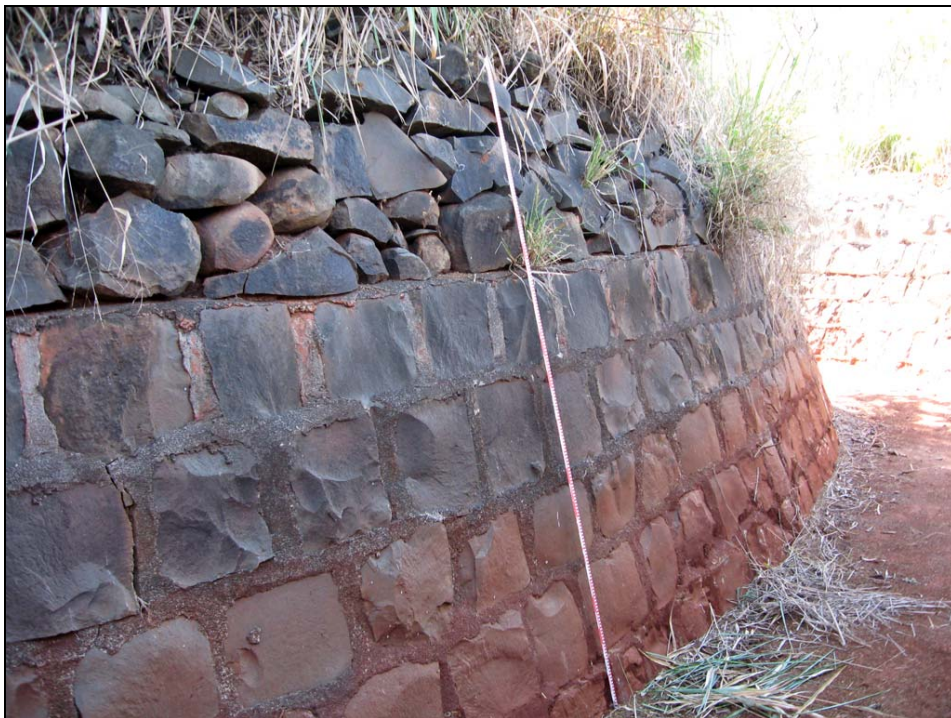
Figure 24. SIHP # 50-80-09-9530 Feature A irrigation ditch, showing additional stacked-stone lining above the cut basalt block and mortar ditch lining (view to east)

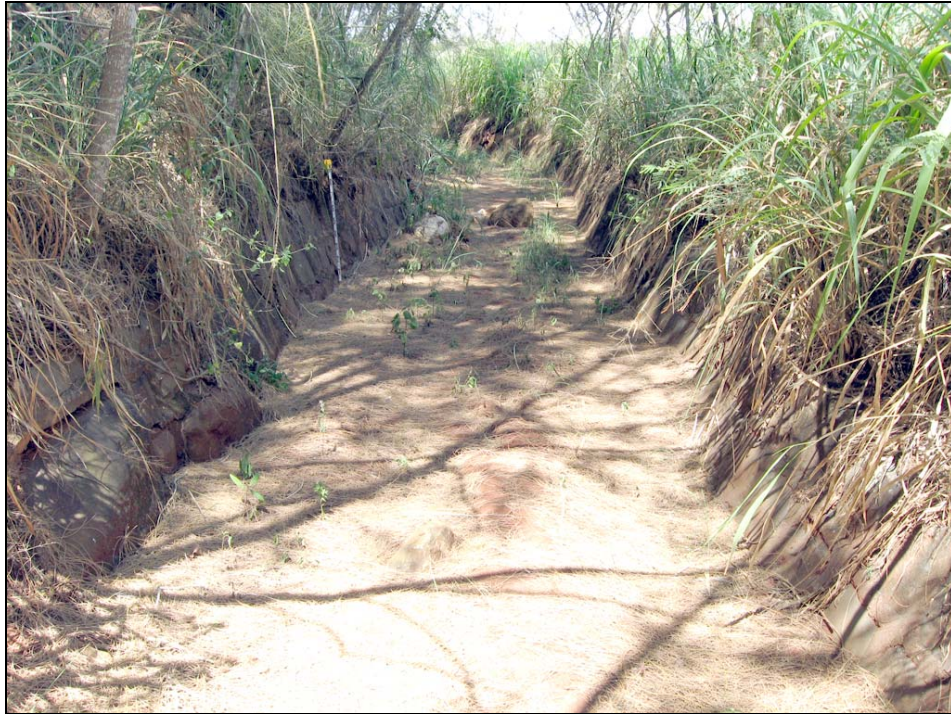
Much of the Feature A ditch is partially filled with sediment eroding from upslope areas (Figure 27). Portions of the ditch, where the ditch crosses natural drainage gullies, are completely covered by erosional sediment. Two portions of the downslope wall of the ditch have been damaged by flooding (Figure 28). The Feature A ditch apparently collects storm water draining from upslope areas and the two natural gullies within Survey Area A, and was breached in these two locations during periods of particularly heavy rainfall. The flood damaged portions of the ditch are located immediately upslope of the Kīpapa Gulch Estates residential complex.

Figure 27. SIHP # 50-80-09-9530 Feature A irrigation ditch, showing portion of the ditch partially filled with sediment (view to southwest)

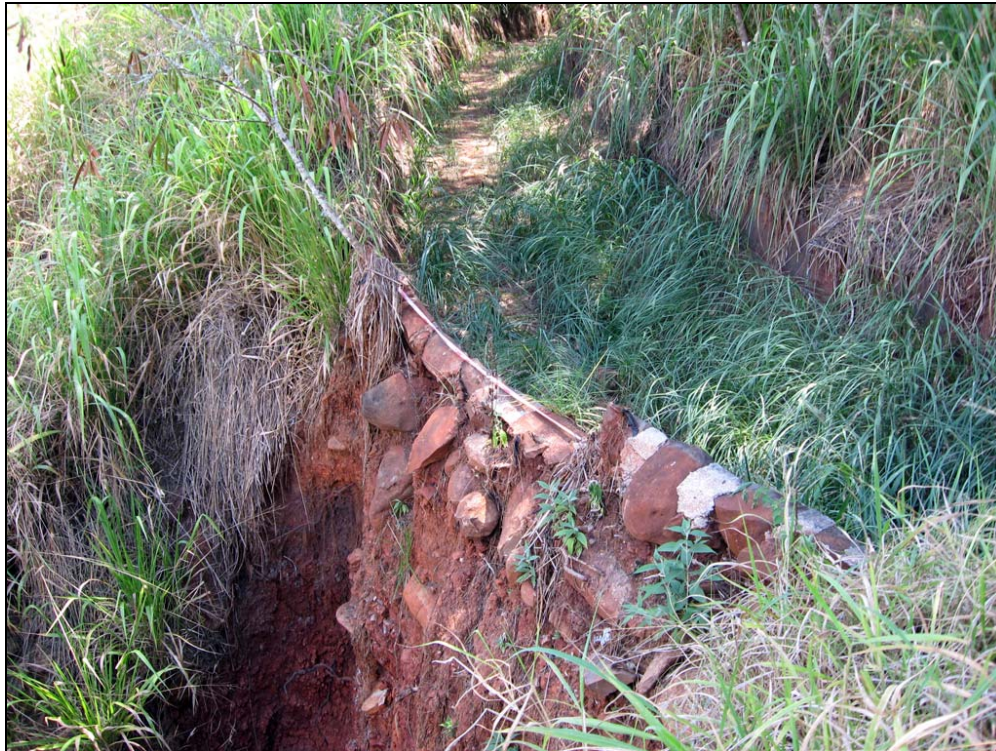
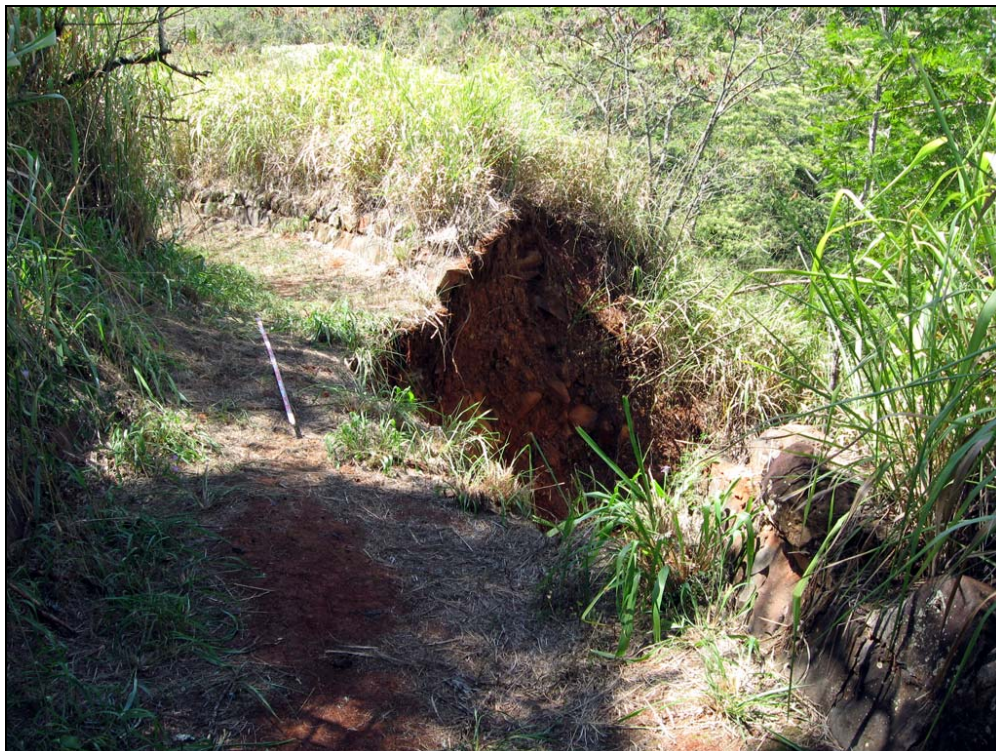
Figure 28. SIHP # 50-80-09-9530 Feature A irrigation ditch, showing portions of the ditch damaged by flooding

If SIHP # 50-80-09-9530 Feature A will be impacted by the proposed project, it is recommended that a Preservation Plan be prepared for the project, in accordance with Hawai'i Administrative Rules (HAR) 13-277-3, to address buffer zones and protective measures for SIHP # 50-80-09-9530 Feature A. This preservation plan should detail the short- and long-term preservation measures that will safeguard the historic property during project construction and subsequent use of the project area. The preservation plan should also address any breaches or potential burial of portions of the SIHP # 50-80-09-9530 Feature A irrigation ditch.

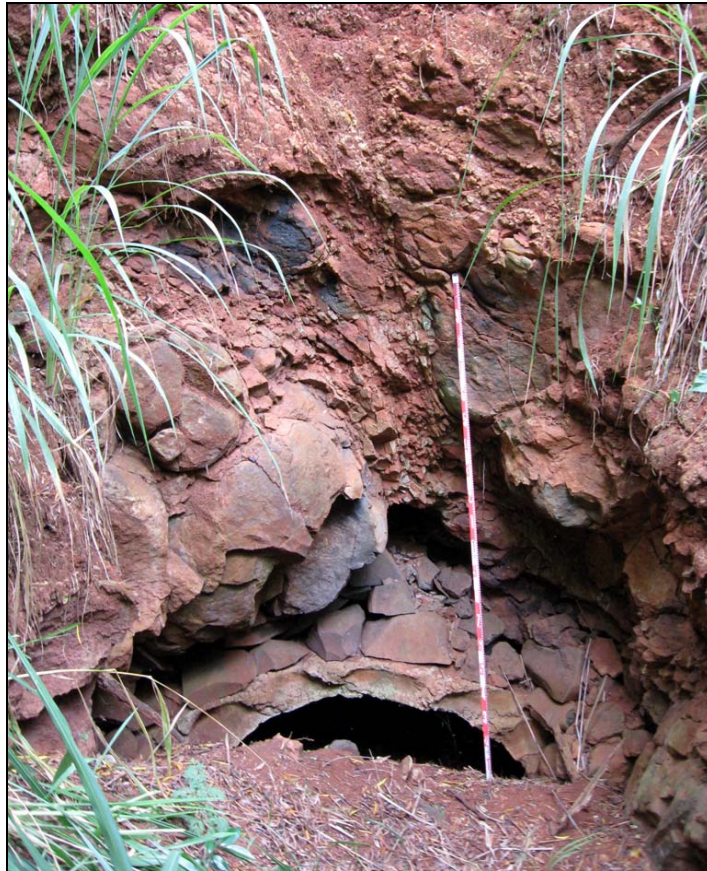
Figure 32. Photograph of a collapsed portion of the SIHP # # 50-80-09-9530 Feature A ditch tunnel

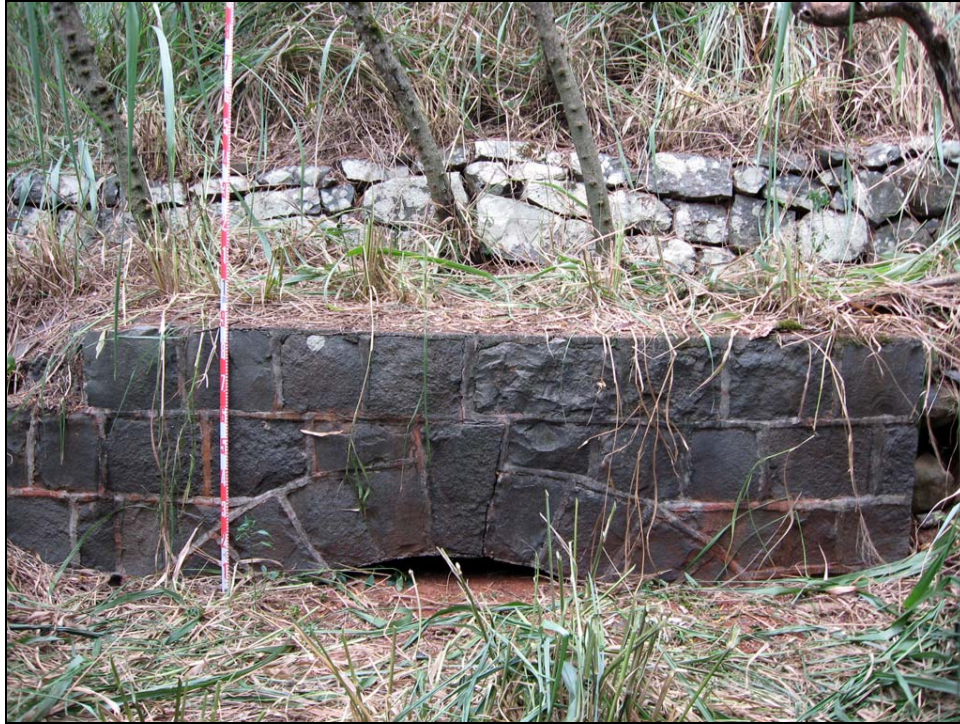
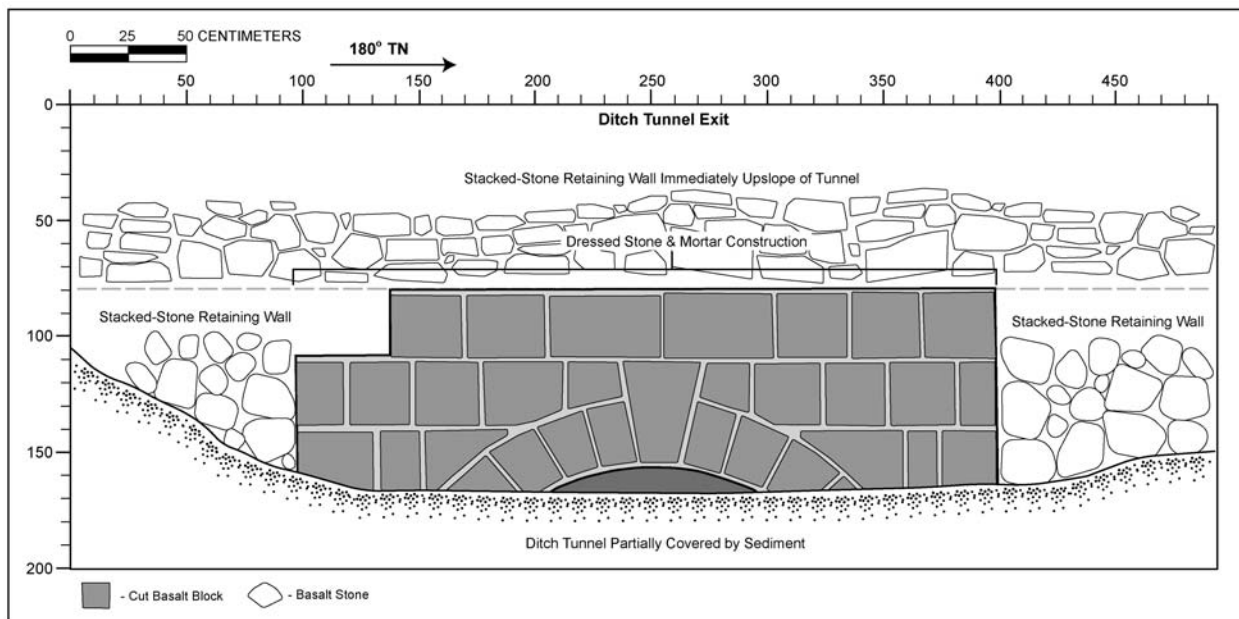
Figure 40. Photograph (above, view to east) and profile diagram (below) of the SIHP # 50-80-09-9530 Feature J ditch tunnel exit

50-80-09-9530 Features A, B, H, and I are in good condition. Feature J is in poor condition. Portions of the SIHP # 50-80-09-9530 ditch system have been disturbed by erosion and flooding. Portions of the Feature A ditch have also been modified for adaptive reuse of the feature as a drainage ditch. SIHP # 50-80-09-9530 was previously assessed by Tulchin et al. (2009) as significant under Criterion A (associated with events that have made an important contribution to the broad patterns of our history), Criterion C (embody the distinctive characteristics of a type period or method of construction), and Criterion D (have yielded, or may be likely to yield information important in prehistory or history) of the Hawai'i Registers of Historic Places evaluation criteria.

No further work is recommended for SIHP # 50-80-09-9530 Features B, H, I, and J. Sufficient information regarding the location, function, age, and construction methods of the features has been generated by the current inventory survey investigation to mitigate any adverse effect caused by proposed development activities.

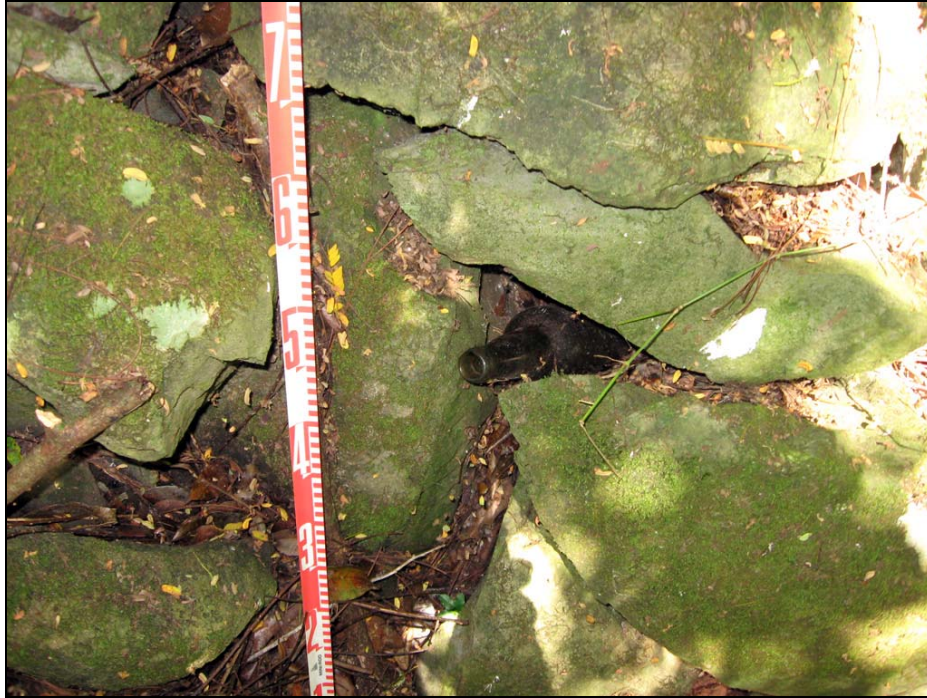
Figure 43. Photograph of SIHP # 50-80-09-7080 mound, showing historic bottle wedged into crevice
