COASTAL DATA EXCHANGE

HISTORICAL SHORELINE CHANGE DATA FOR HAWAII

Brad Romine

Coastal Erosion Studies

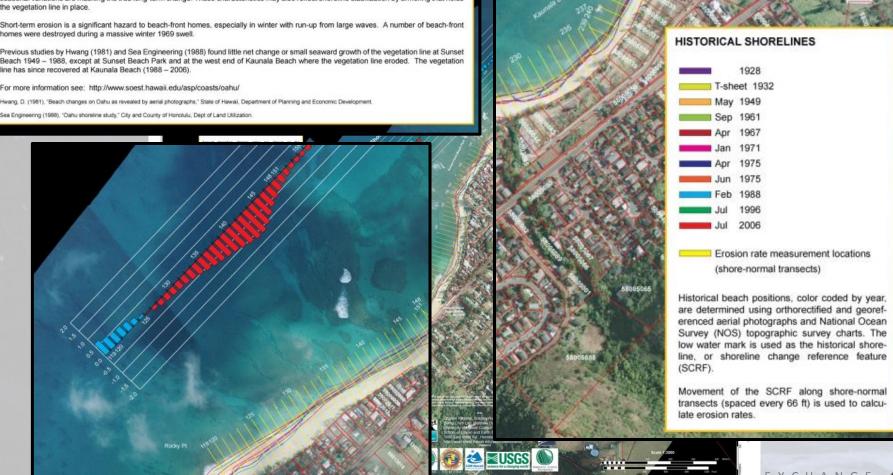
Erosion Maps

The shoreline fronting the community of Sunset Beach (transects 119 - 269) on the north shore of Oahu is the site of world famous big wave surf breaks including Sunset and Velzyland. The area is exposed to swells from the north Pacific in winter months and easterly tradewind waves year-round. Sunset Beach is the central portion of a continuous (4 mi long) beach composed of carbonate sand, and characterized by occasional outcrops of limestone that may be intermittently buried or exposed by shifting sand.

Shoreline change rates at Sunset Beach (1928 - 2006) are mostly low (< 1 ft/yr). Large winter swell causes dramatic changes in shoreline position that largely recover the following season. Because of this, shoreline change rates at Sunset Beach have high uncertainty due to shortterm variations in shoreline position. Despite wide variations in beach width, the vegetation line has remained approximately stable since 1928. The high rate uncertainty and stable vegetation line suggest that the shoreline has remained approximately stable over the long-term or that seasonal variations are masking the true long-term change. These characteristics may also reflect shoreline stabilization by armoring that holds the vegetation line in place.

homes were destroyed during a massive winter 1969 swell.

Beach 1949 - 1988, except at Sunset Beach Park and at the west end of Kaunala Beach where the vegetation line eroded. The vegetation line has since recovered at Kaunala Beach (1988 - 2006).

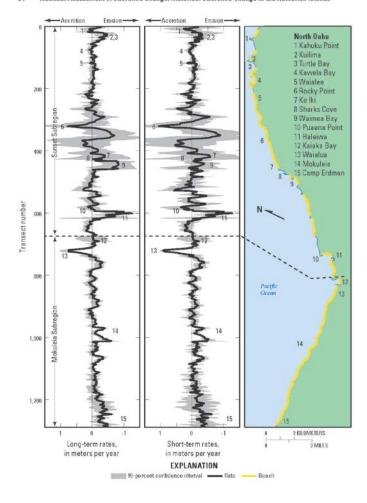
Figure 24. Long-term (all available years) and short-term (1940s to present) shoreline change rates, North Dahu (Location shown in figure 22)

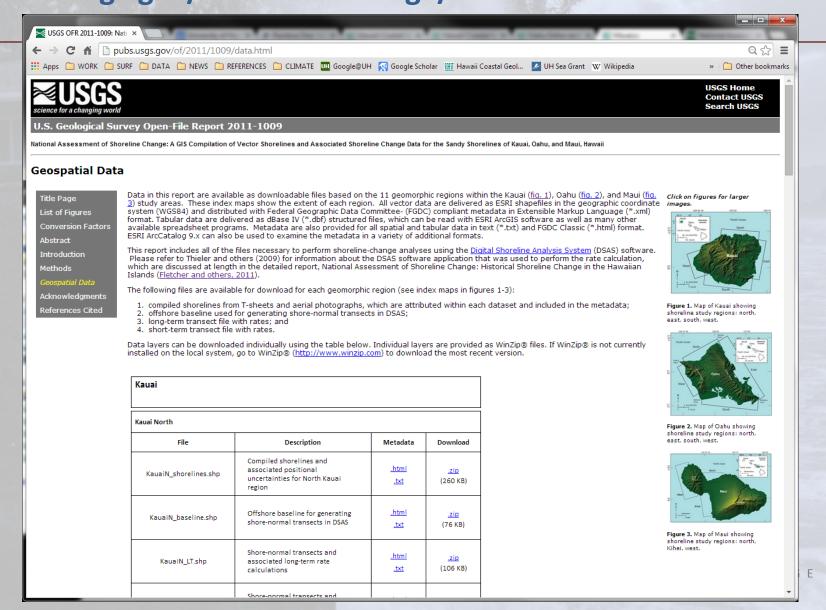
Historical Shoreline GIS Layers at the NATIONAL ASSESSMENT OF SHORELINE CHANGE, HAWAII coastal.er.usgs.gov/shoreline-change/

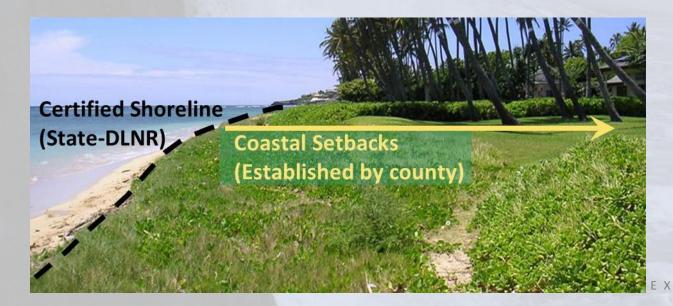
Coastal Building Setbacks

- Maui:
 erosion rate (ft/yr) x 50 yrs + 25 ft
- Kauai, DLNR:
 erosion rate (ft/yr) x 70 yrs + 40 ft
