**COASTAL DATA EXCHANGE**

**MAUI ISLAND SHORELINE  
STRUCTURE INVENTORY**

**Tara Owens, Coastal Processes Specialist**  
**University of Hawaii Sea Grant**

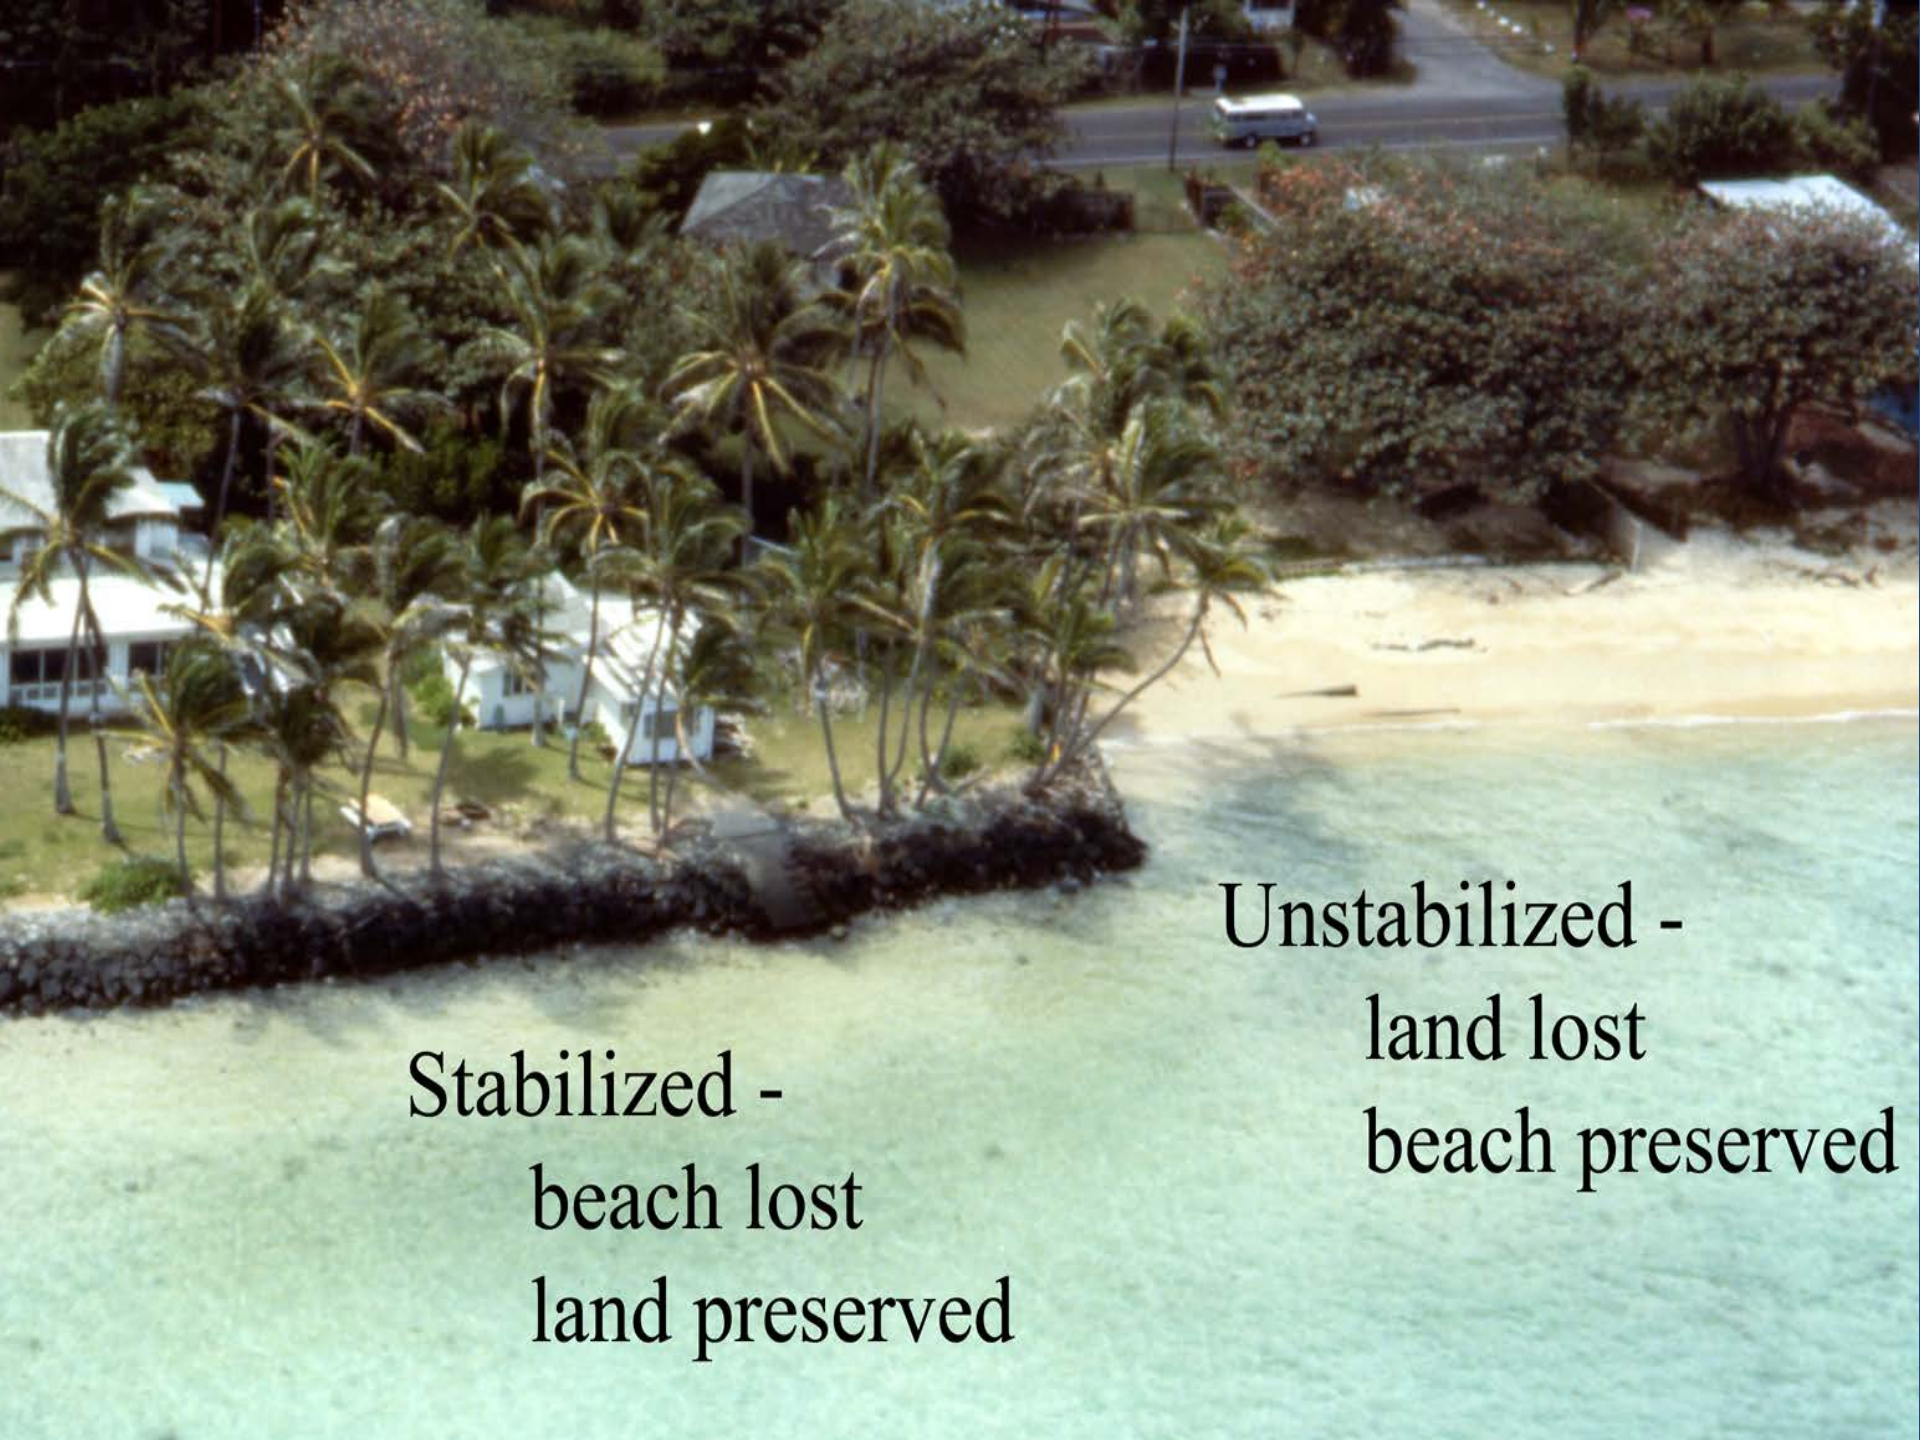
Stabilized -  
beach lost  
land preserved

Unstabilized -  
land lost  
beach preserved

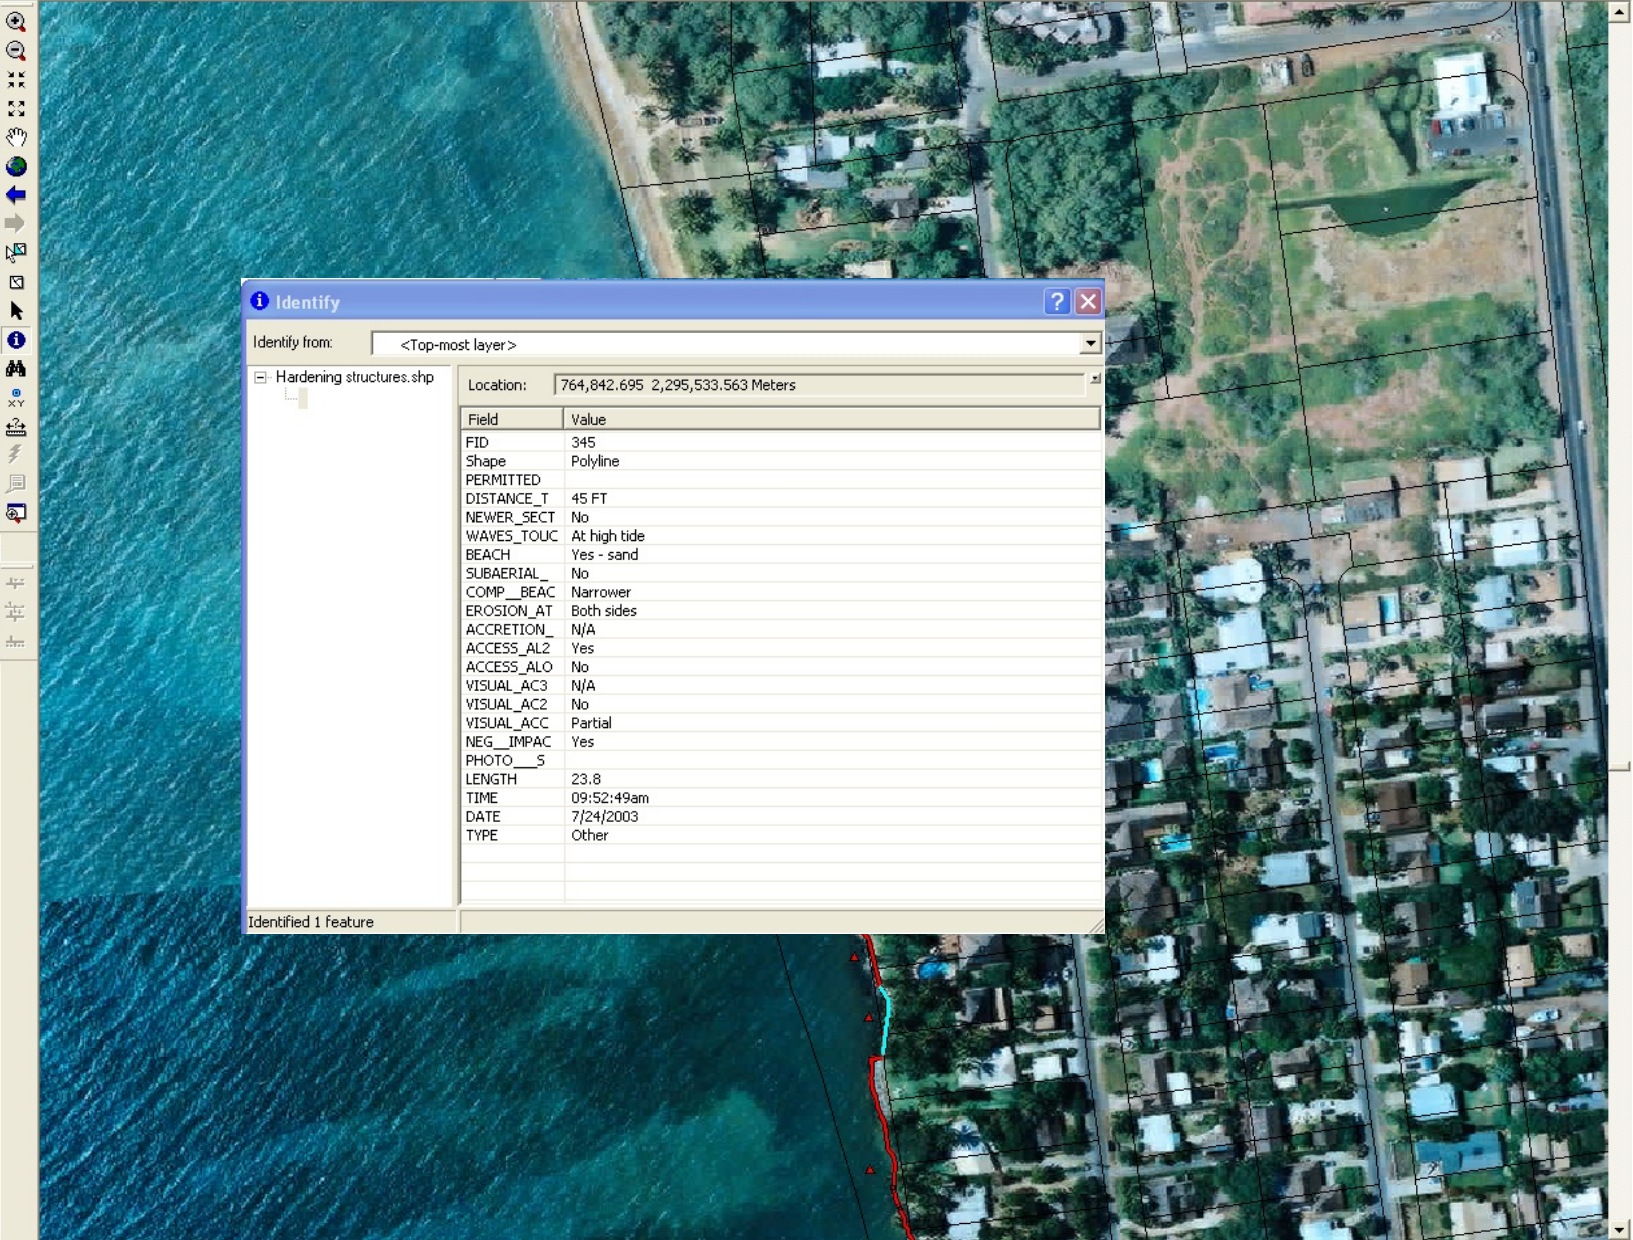
Location: 764,842.695 2,295,533.563 Meters

Field	Value
FID	345
Shape	Polyline
PERMITTED	
DISTANCE_T	45 FT
NEWER_SECT	No
WAVES_TOUC	At high tide
BEACH	Yes - sand
SUBAERIAL_	No
COMP_BEAC	Narrower
EROSION_AT	Both sides
ACCRETION_	N/A
ACCESS_AL2	Yes
ACCESS_ALO	No
VISUAL_AC3	N/A
VISUAL_AC2	No
VISUAL_ACC	Partial
NEG_IMPAC	Yes
PHOTO__S	
LENGTH	23.8
TIME	09:52:49am
DATE	7/24/2003
TYPE	Other

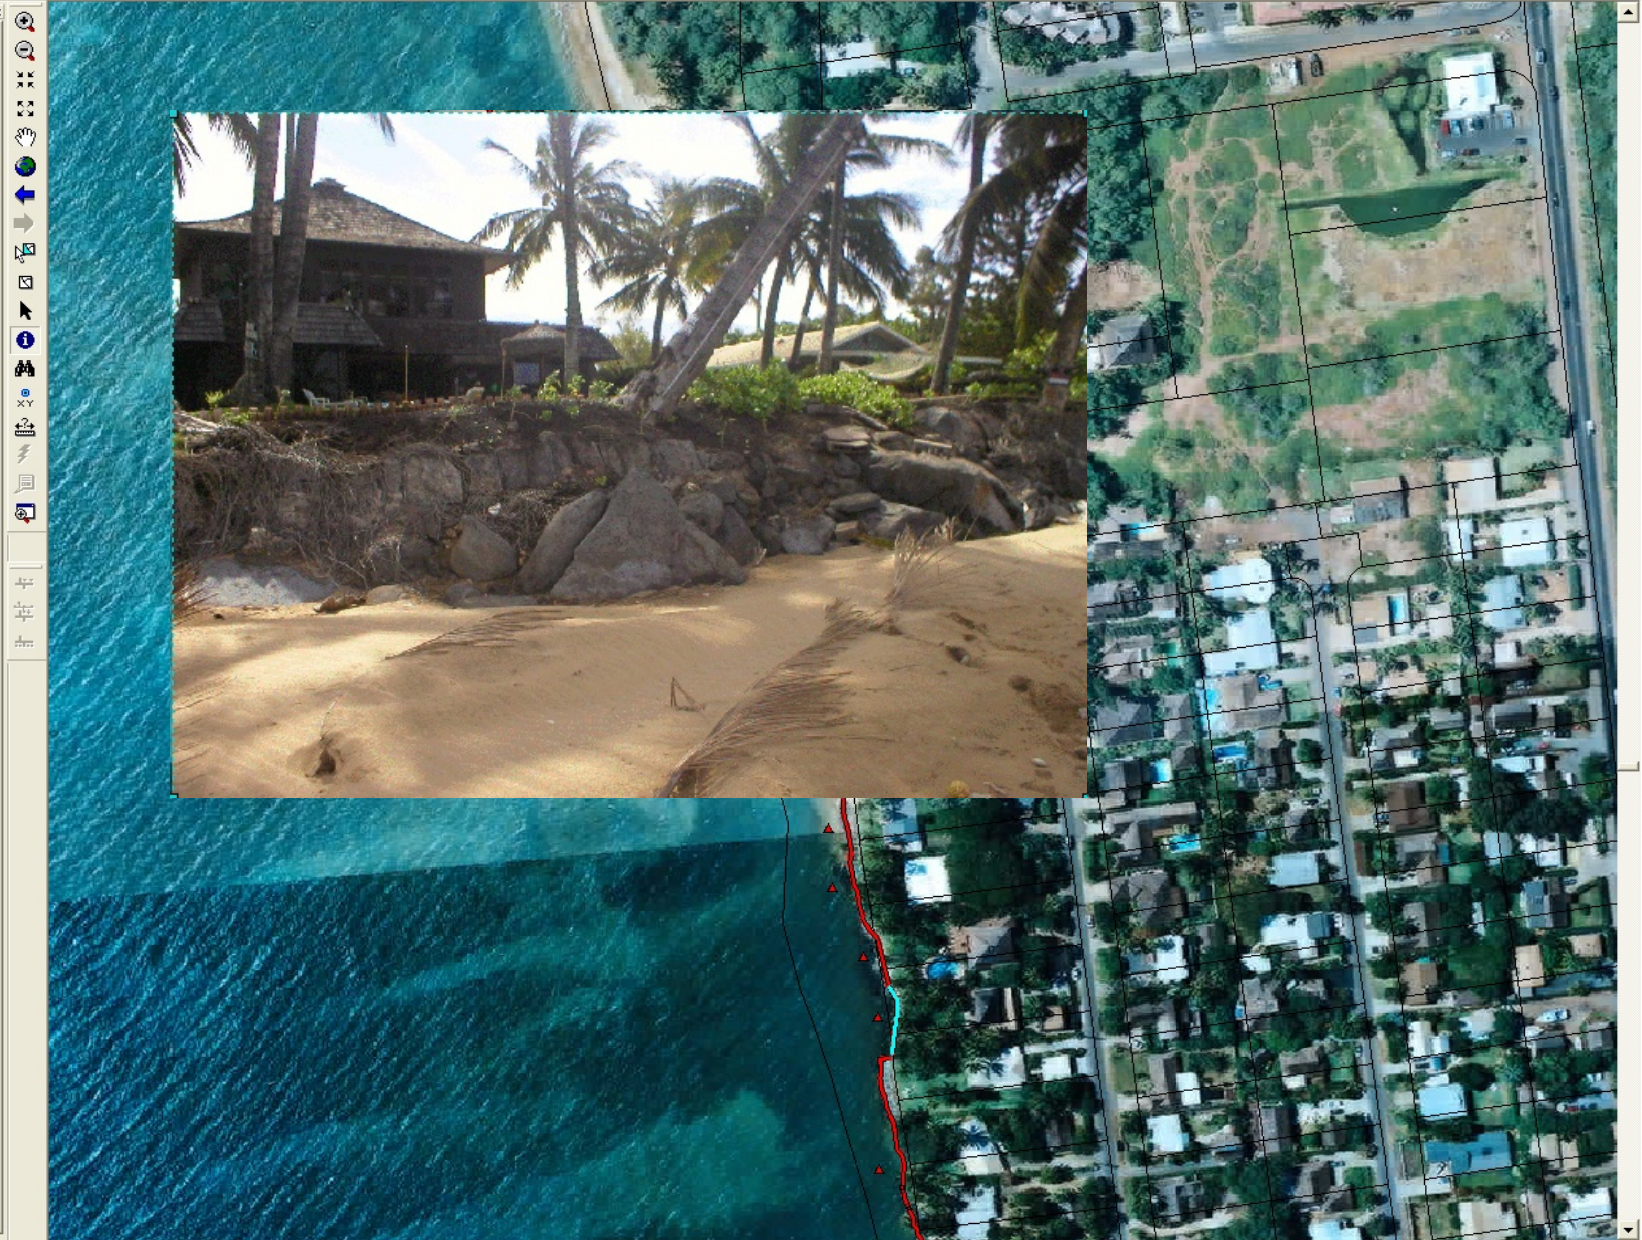
**View1**

Hardening structures.shp

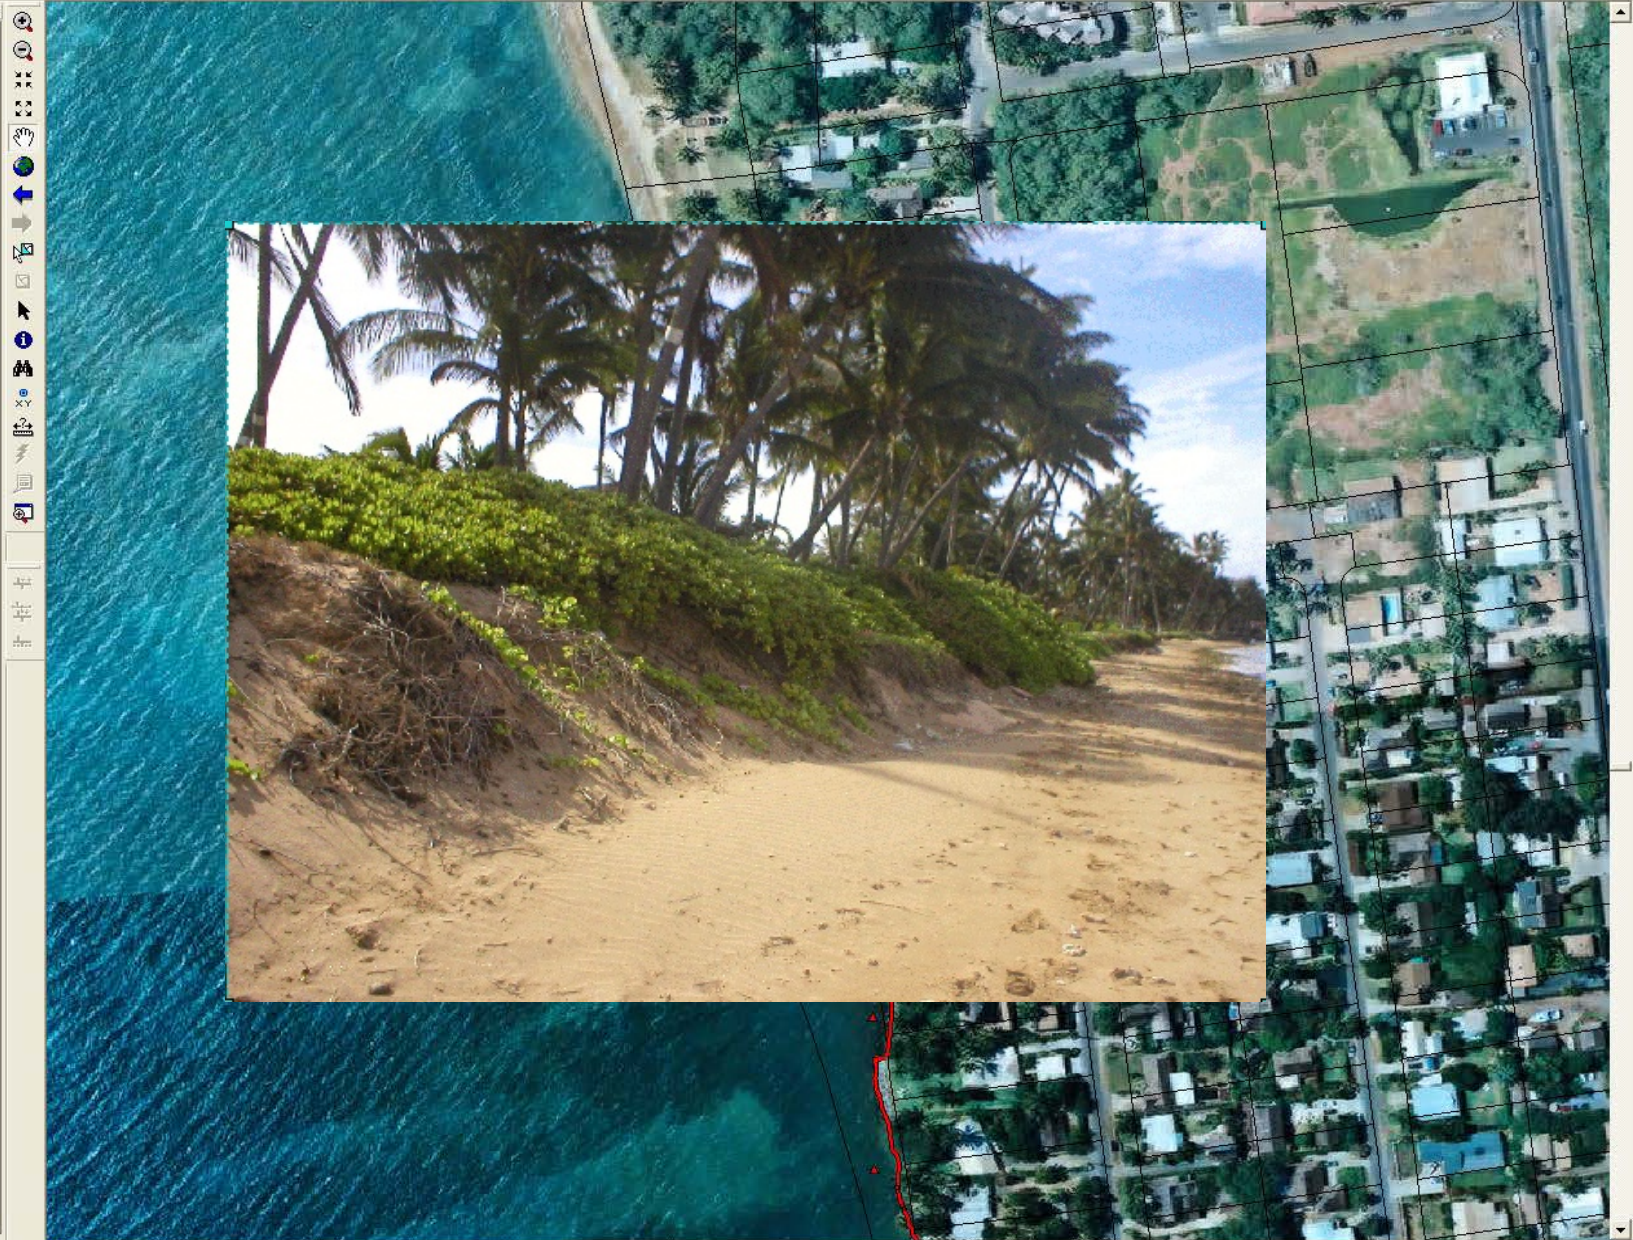
**View1**

Hardening structures.shp

Location: 764,795.247 2,295,730.384 Meters

Field	Value
FID	277
Shape	Polyline
PERMITTED	
DISTANCE_T	50 FT
NEWER_SECT	No
WAVES_TOUC	At high tide
BEACH	Yes - sand
SUBAERIAL_	Partial
COMP_BEAC	Narrower
EROSION_AT	Both sides
ACCRETION_	N/A
ACCESS_AL2	Yes
ACCESS_AL0	No
VISUAL_AC3	N/A
VISUAL_AC2	Partial
VISUAL_ACC	Yes
NEG_IMPAC	Yes
PHOTO__S	
LENGTH	110.9
TIME	09:38:41am
DATE	7/24/2003
TYPE	Sandbags
