Commission on Water Resource Management
Kalanimoku Building, Oahu
December 17, 2008

Staff Briefing on the
Implementation of East Maui
Interim Instream Flow Standards

Honopou (6034), Hanehoi (6037), Piinaau (6053),
Waiokamilo (6055), and Wailuanui (6056), Maui

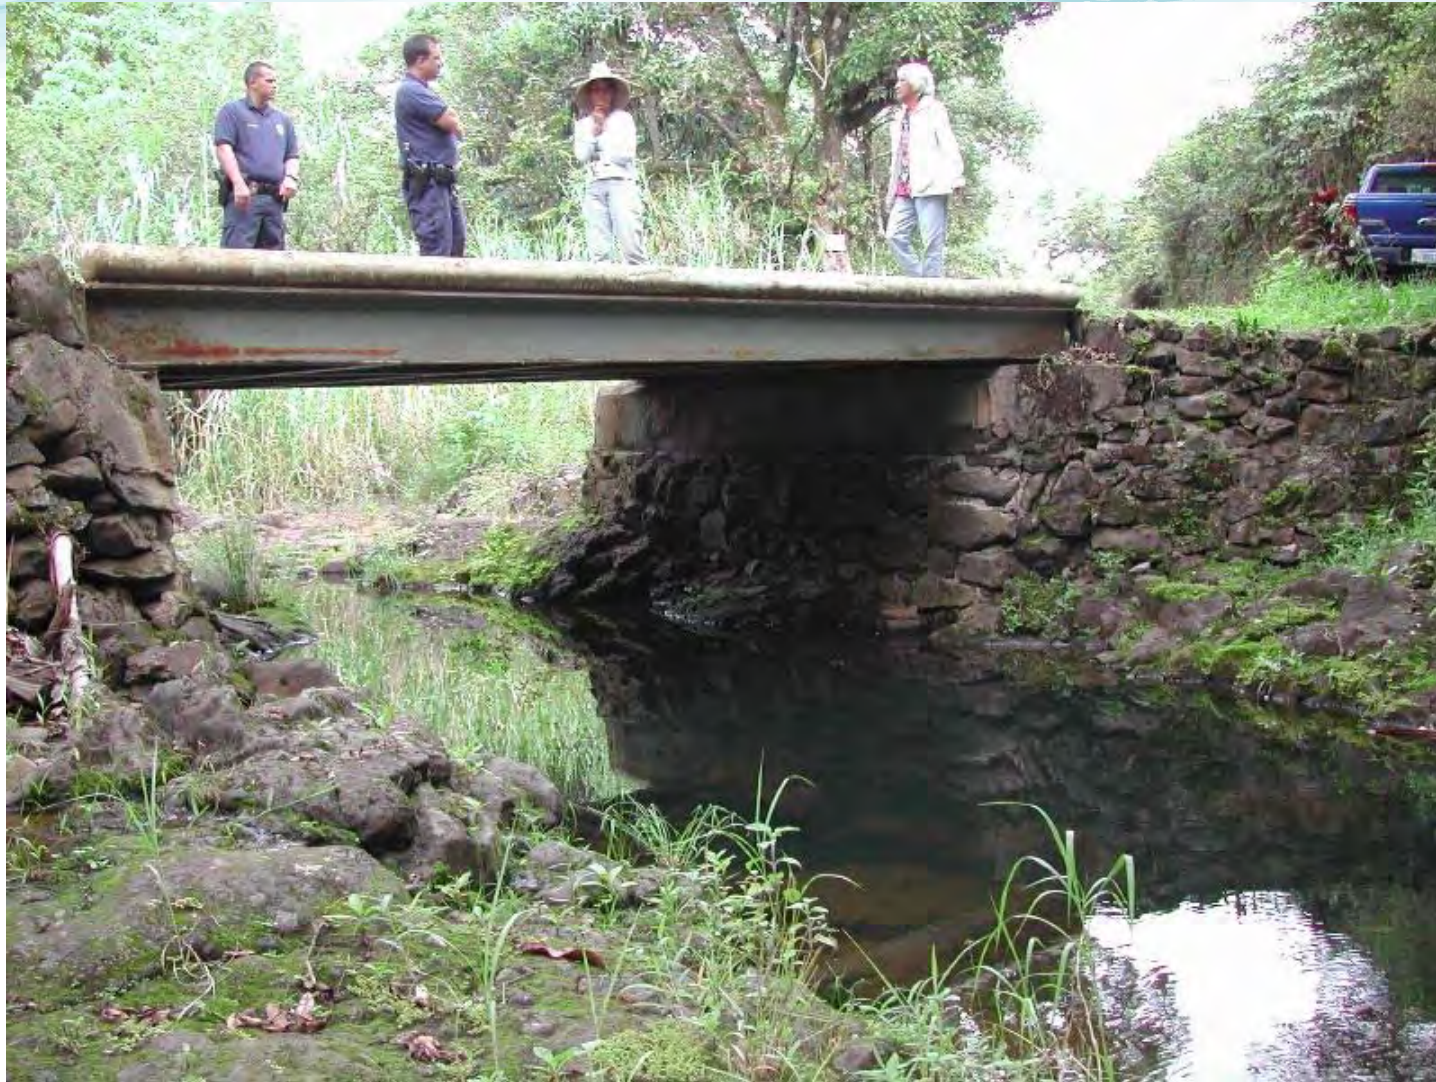
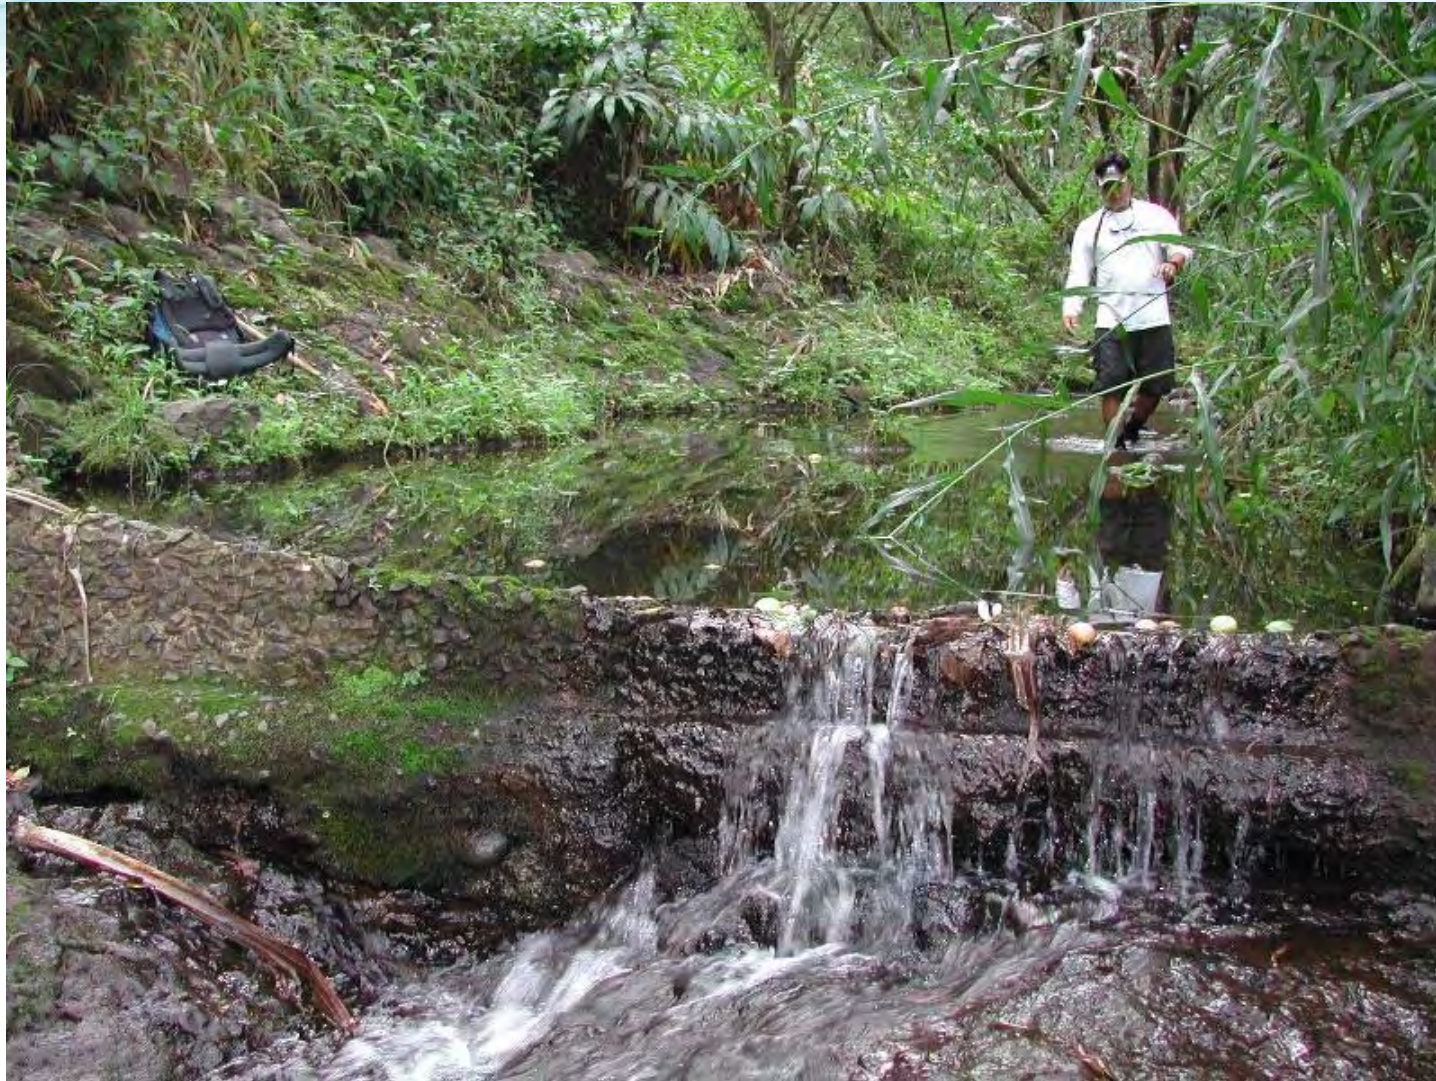
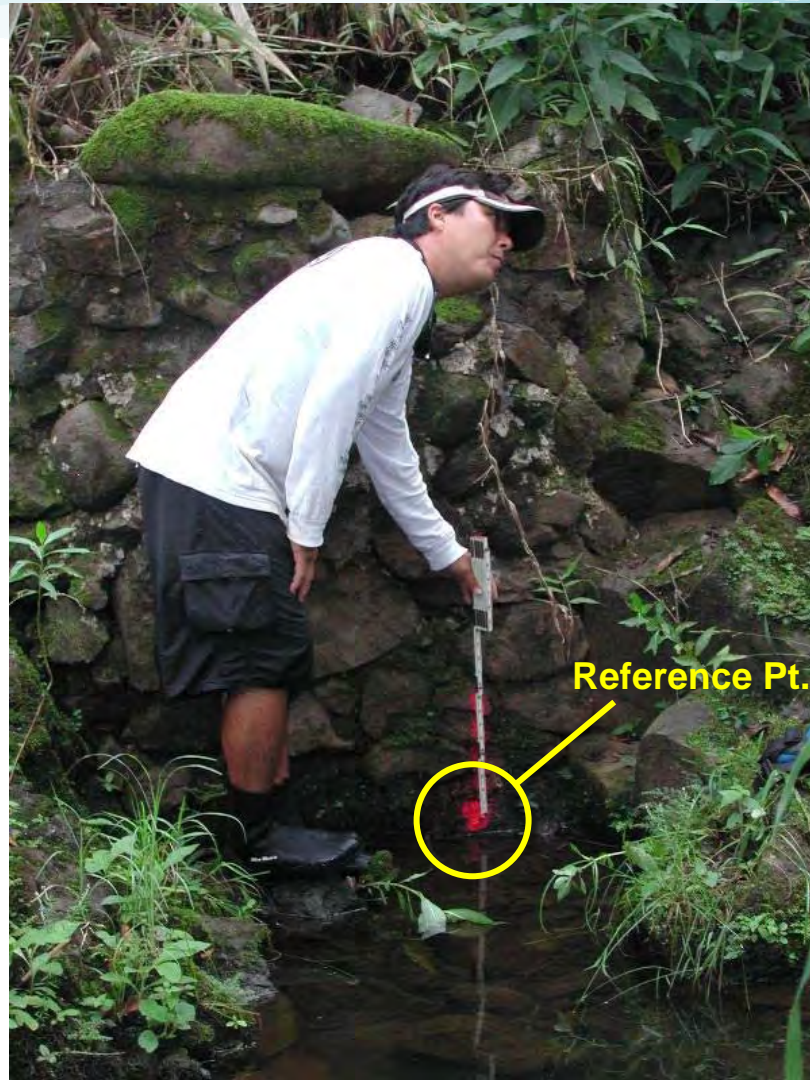
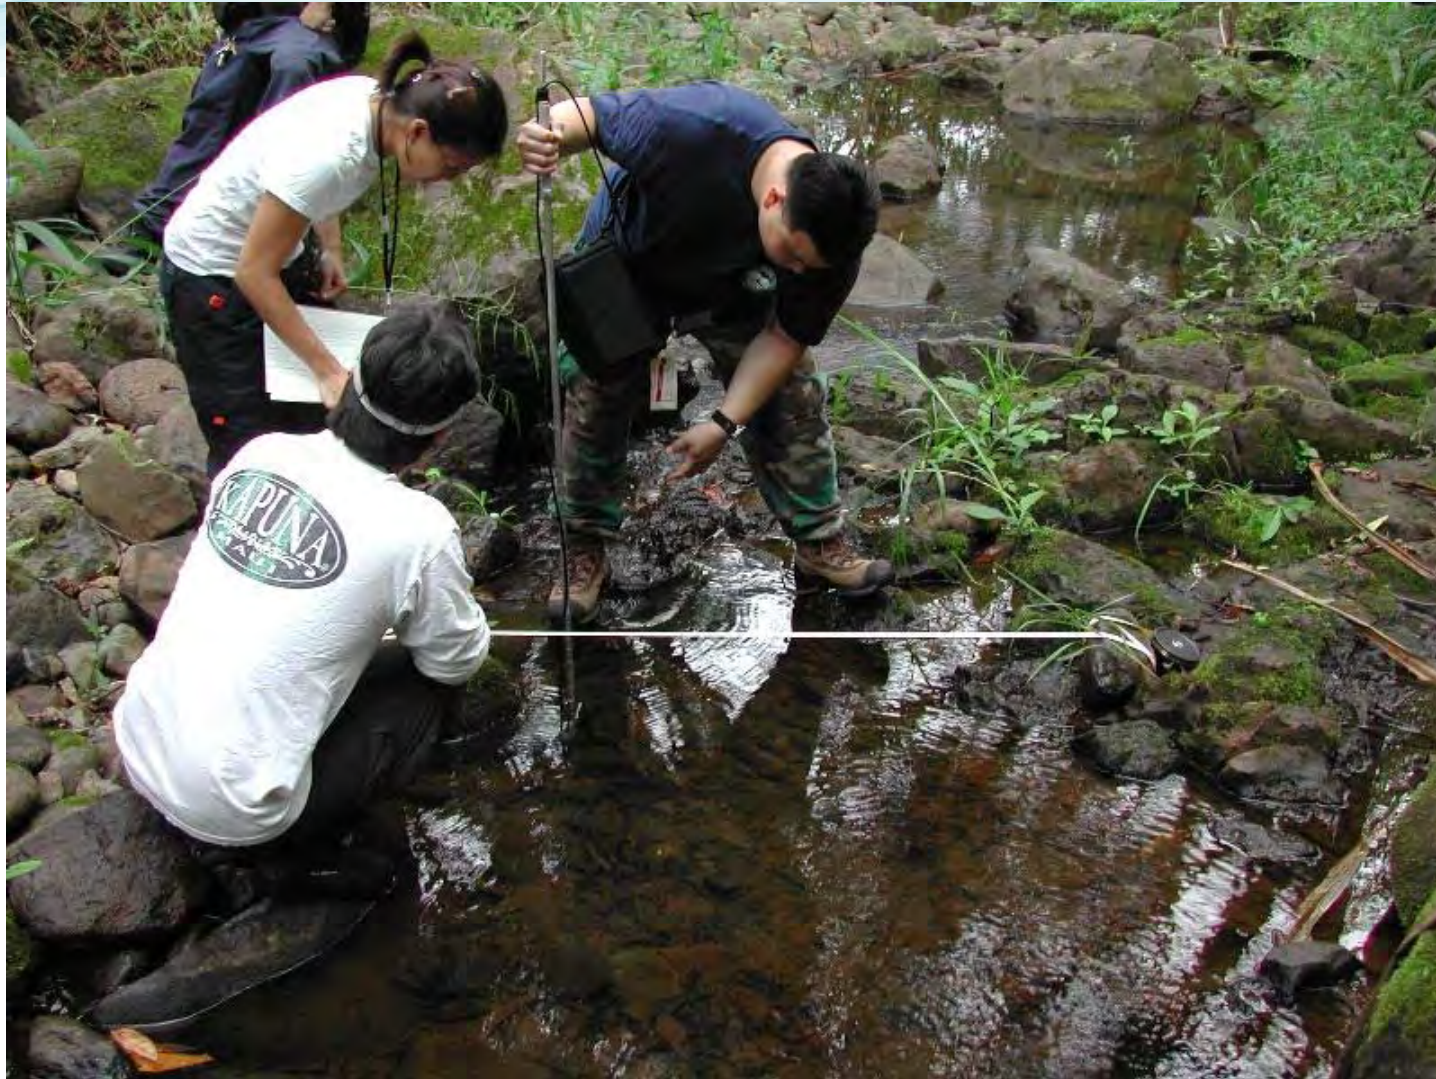
Measurements at IFS Site A

Date	Time	Discharge
10/23/2008	0830 hr	0.229 cfs (meter)
10/27/2008	0911 hr	0.242 cfs (meter)
10/28/2008	0825 hr	0.060 cfs (meter)
10/29/2008	1045 hr	0.093 cfs (bucket)
10/29/2008	1730 hr	0.085 cfs (bucket)
IIFS		2.000 cfs

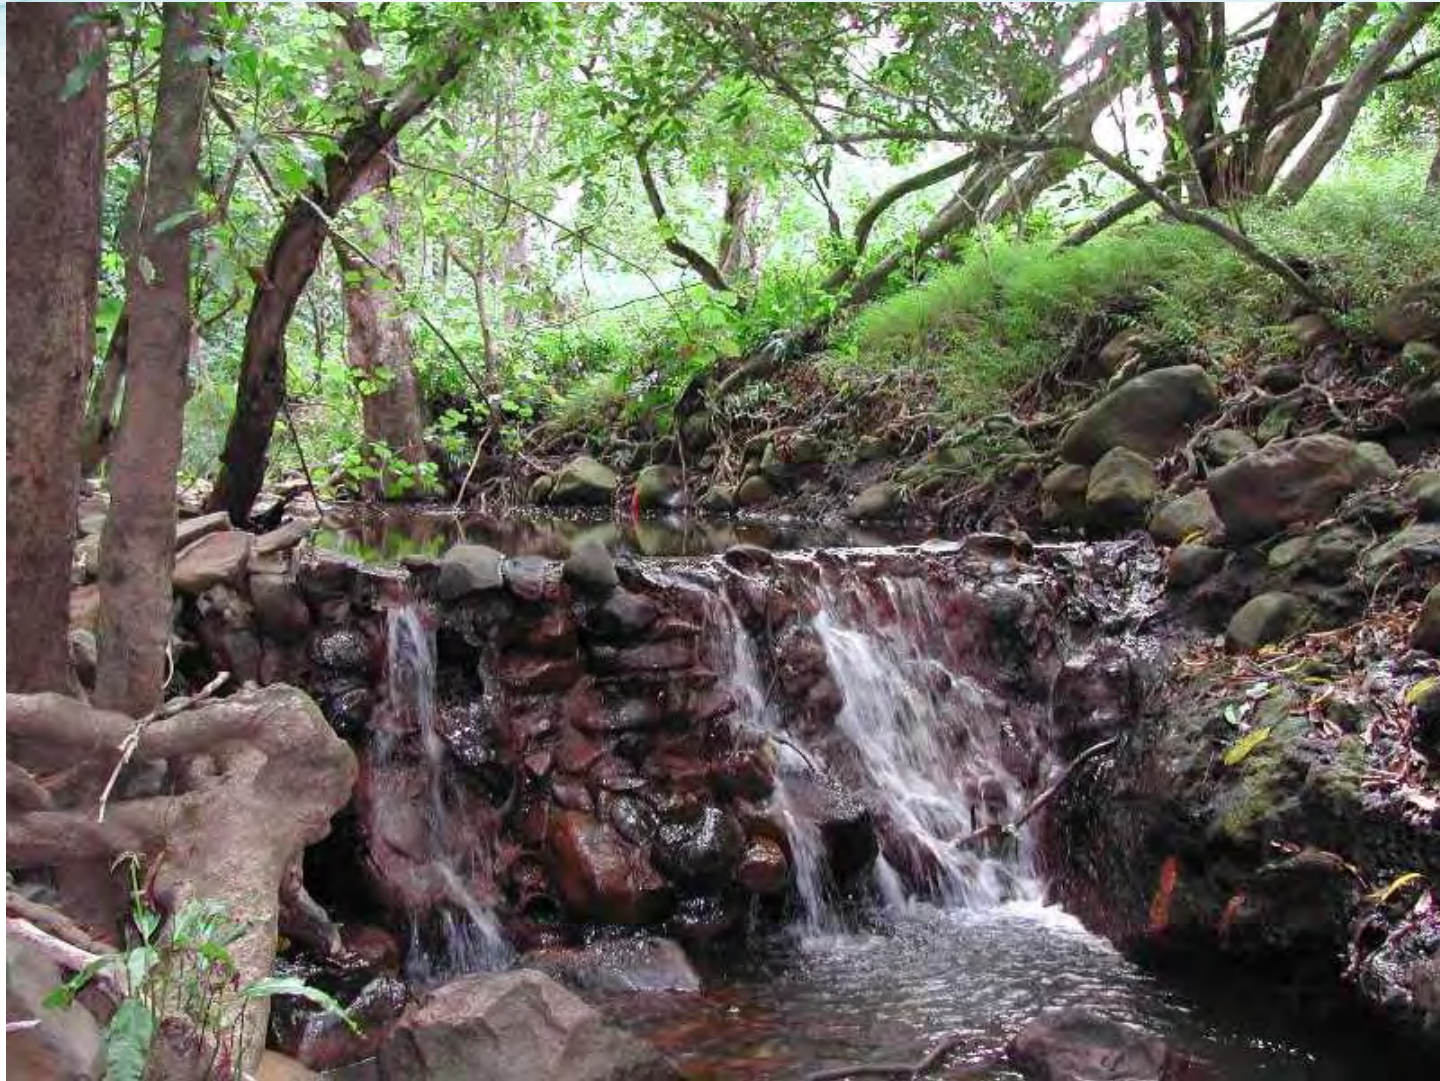
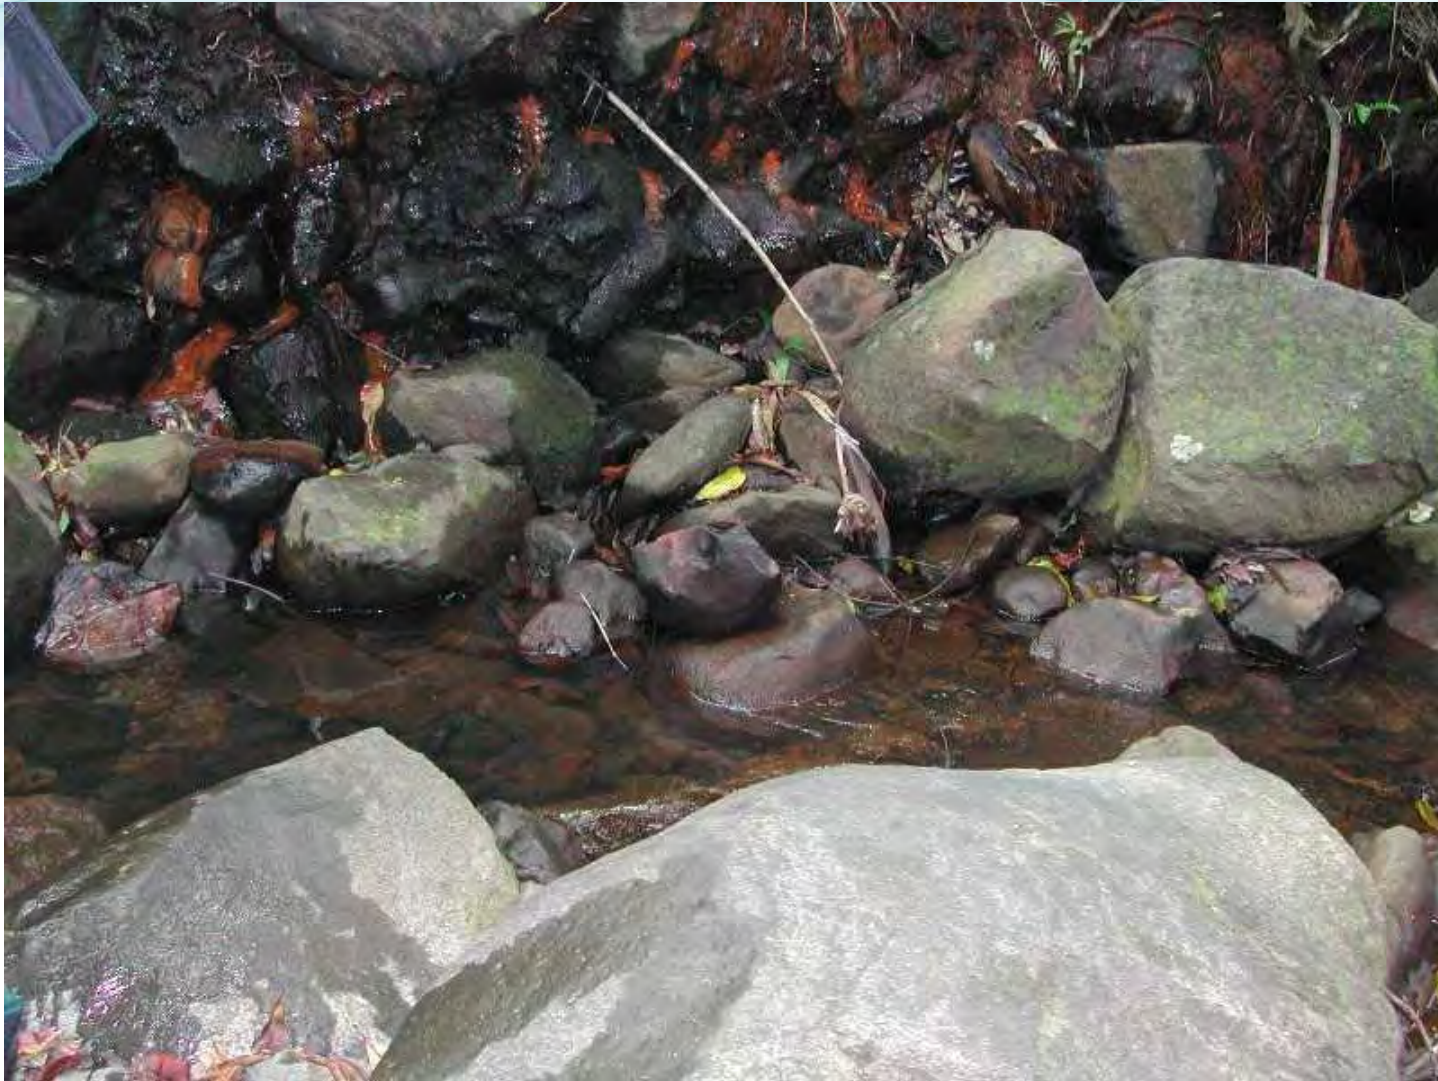
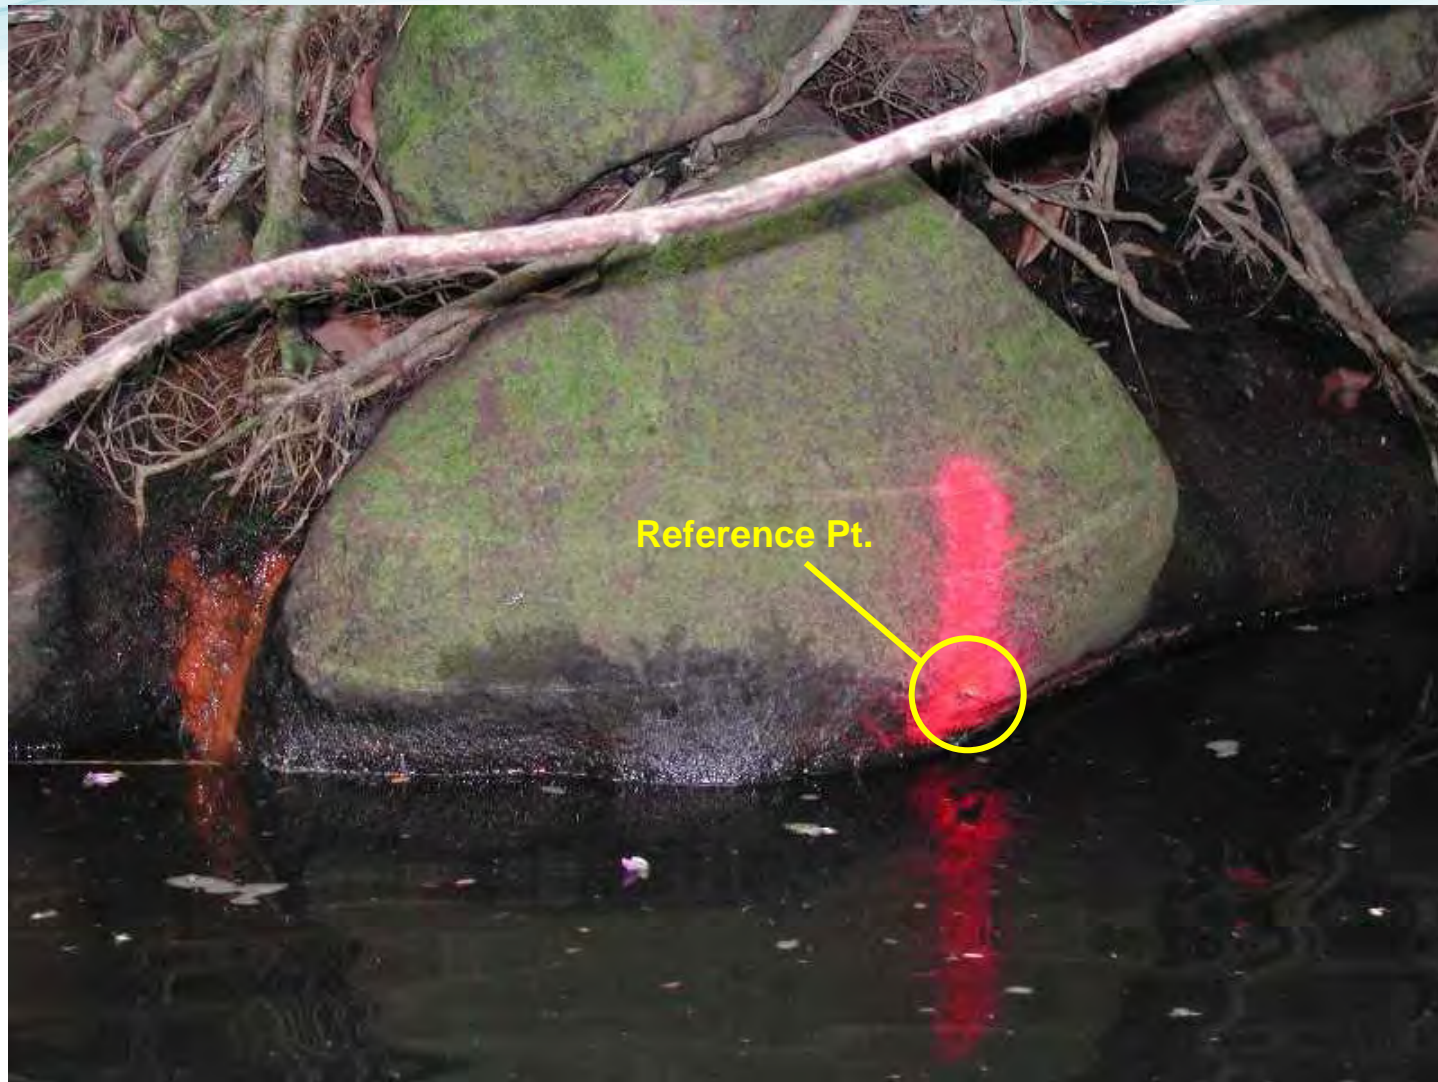
Measurements at IFS Site B

Date	Time	Discharge
10/23/2008	1109 hr	0.189 cfs (meter)
10/27/2008	1038 hr	0.139 cfs (meter)
10/28/2008	1000 hr	0.151 cfs (meter)
IIFS		0.72 cfs

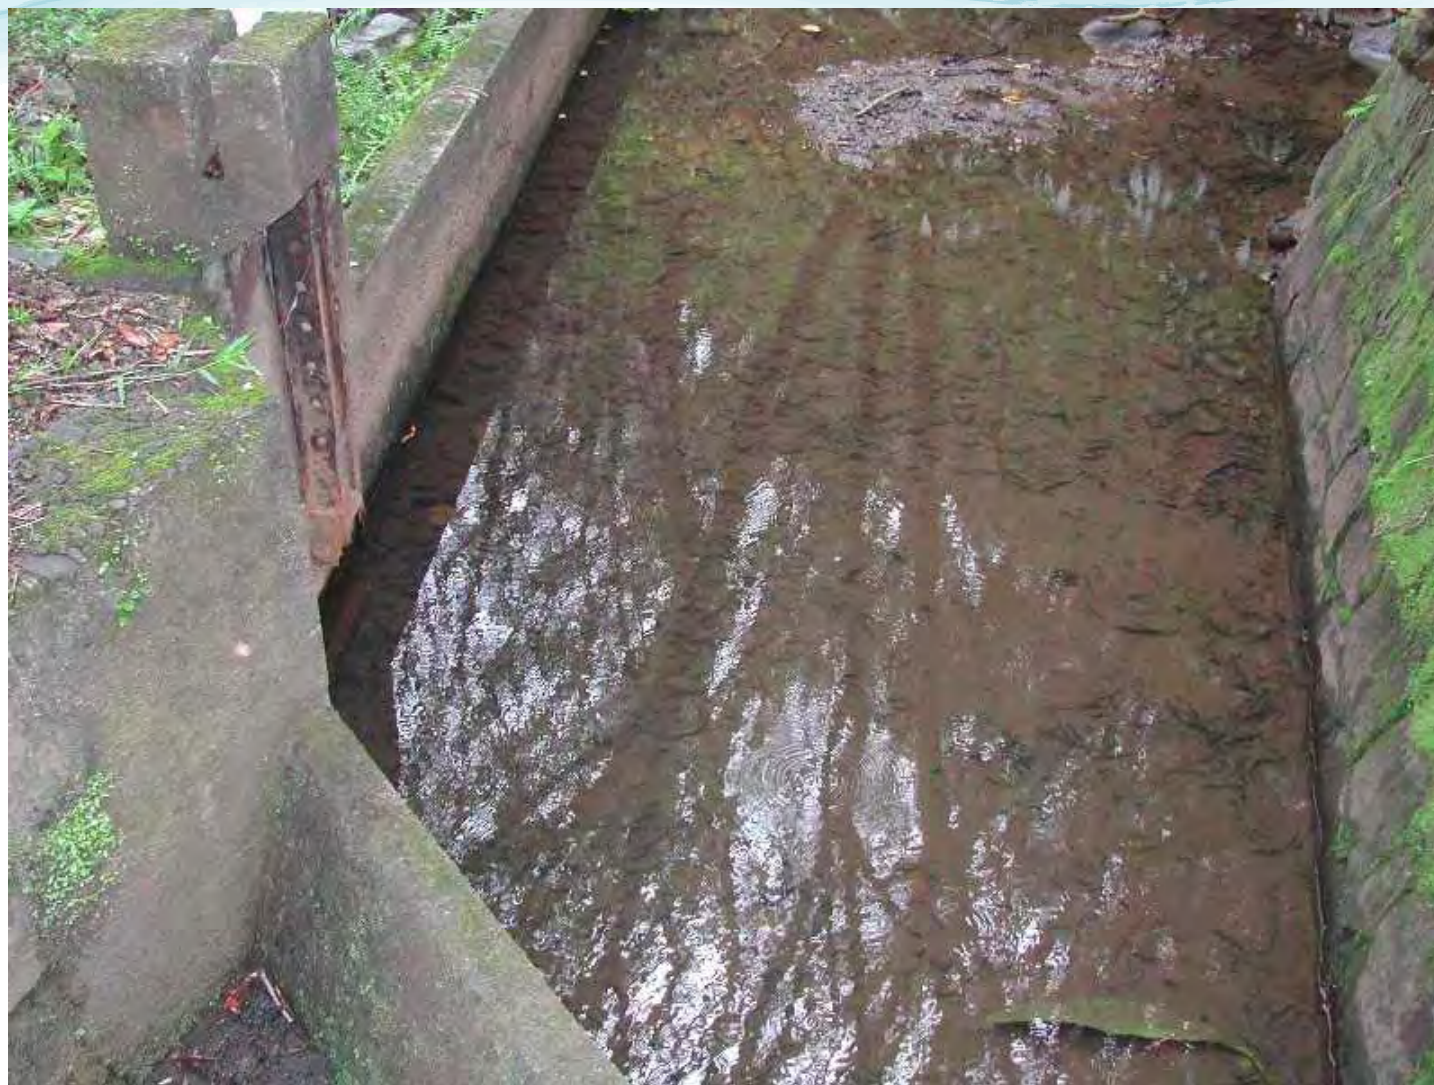
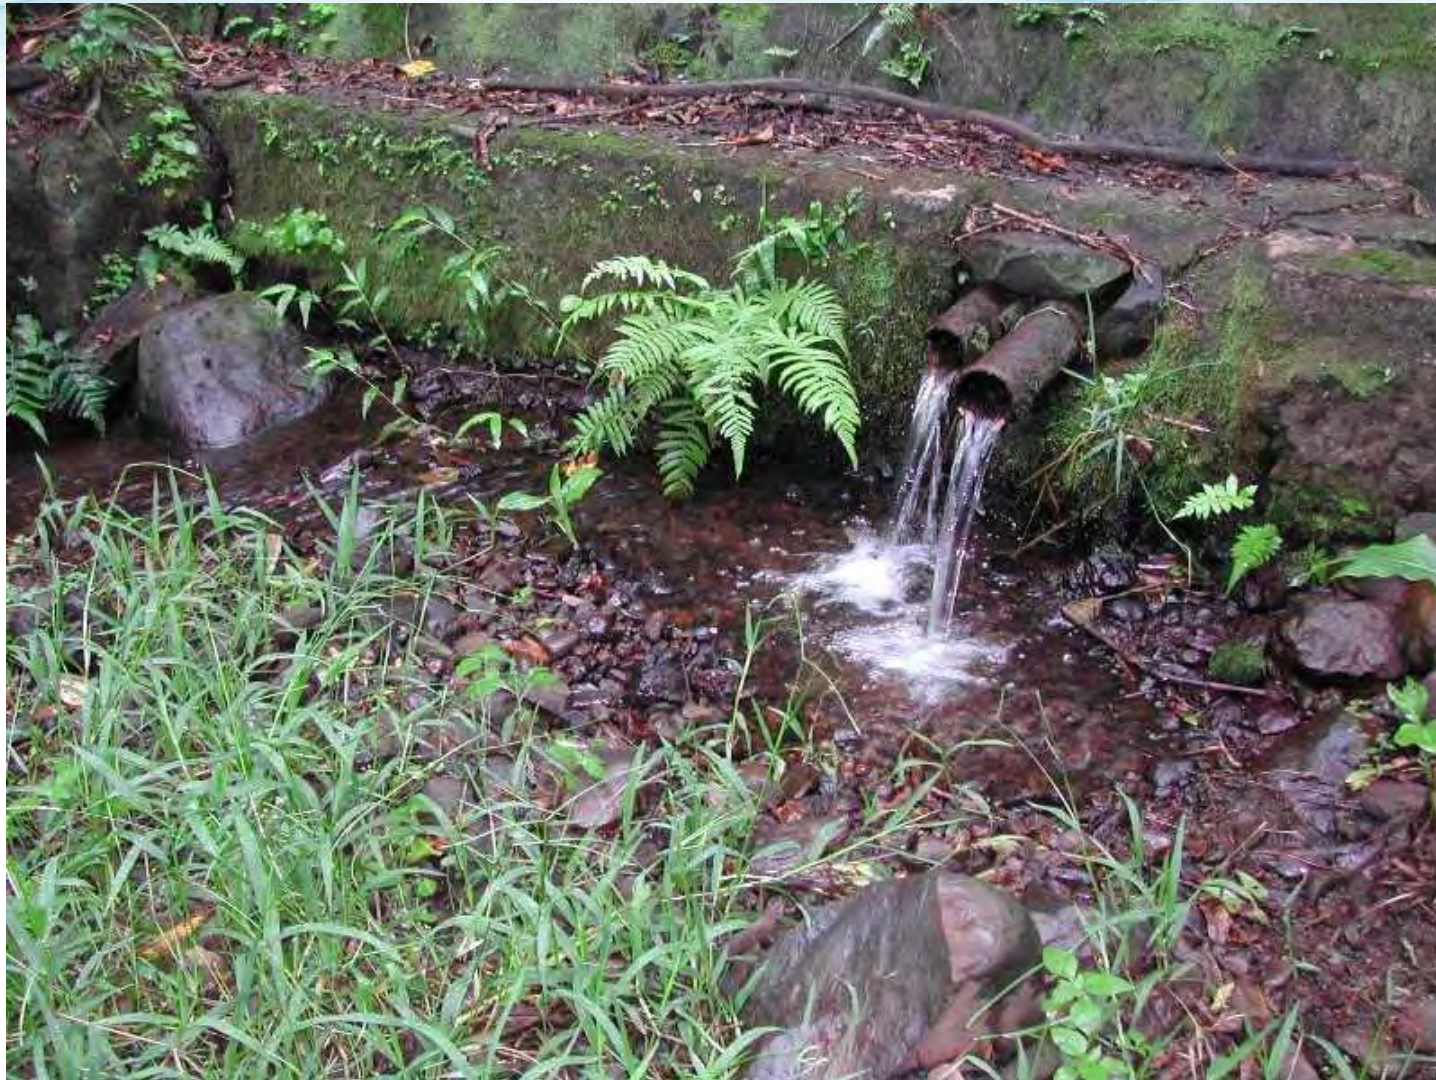
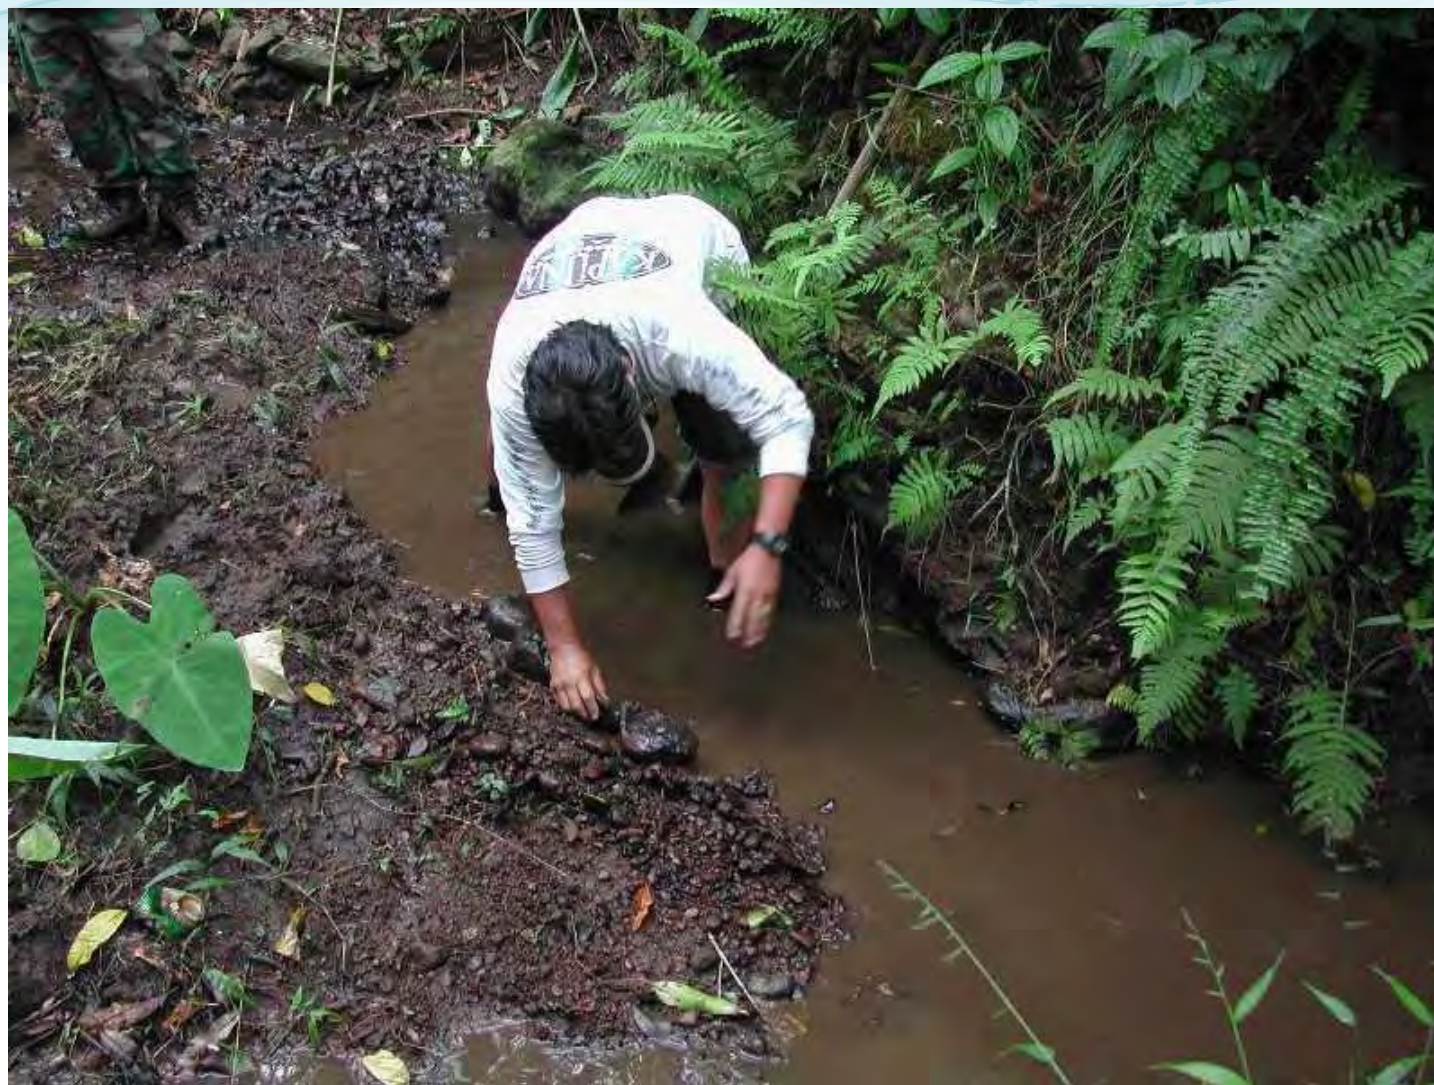
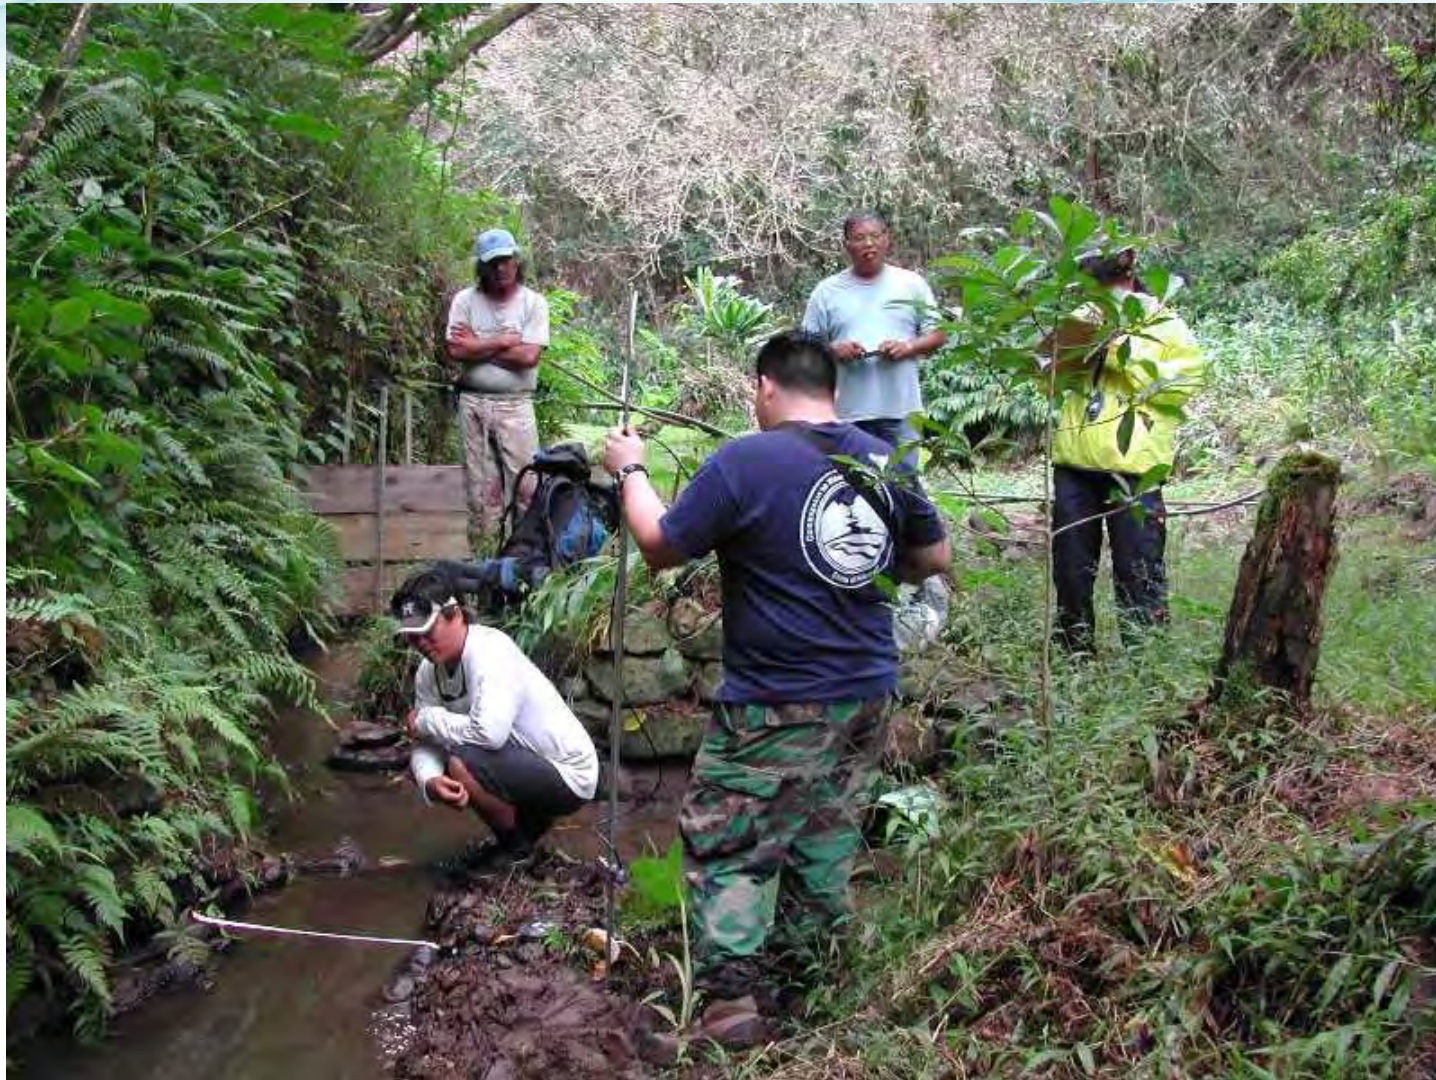
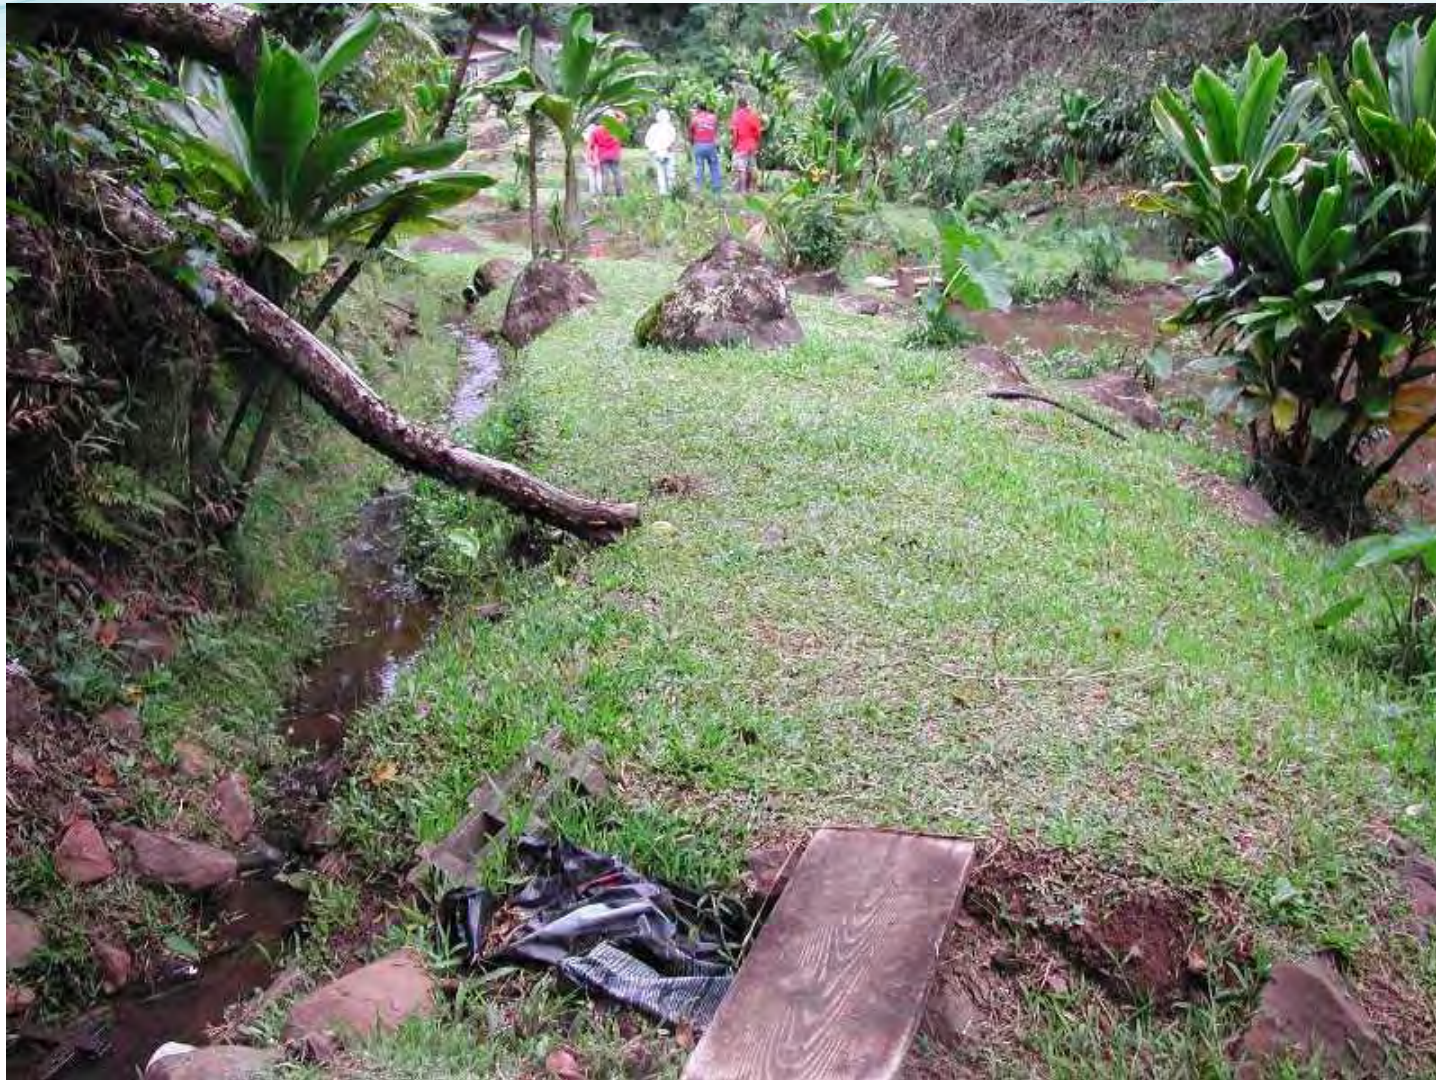
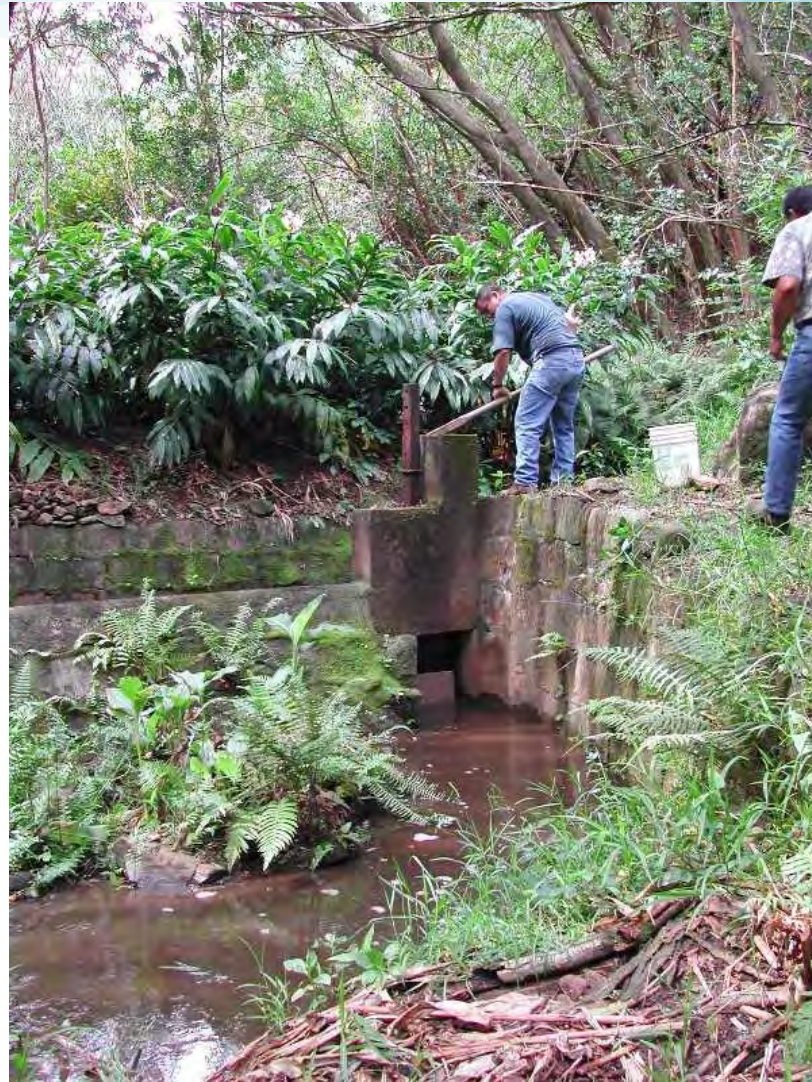
Measurements at IFS Site A

Date	Time	Discharge
10/23/2008	1404 hr	0.052 cfs (meter)
10/27/2008	1403 hr	0.047 cfs (meter)
10/27/2008	1430 hr	0.063 cfs (bucket)
10/28/2008	1130 hr	0.062 cfs (bucket)
10/28/2008	1312 hr	0.055 cfs (meter)
11/19/2008	1340 hr	0.244 cfs (meter)
IIFS		0.890 cfs
