Commission on Water Resource Management
Kalanimoku Building, Oahu
December 17, 2008

Staff Briefing on the
Implementation of East Maui
Interim Instream Flow Standards

Honopou (6034), Hanehoi (6037), Piinaau (6053),
Waiokamilo (6055), and Wailuanui (6056), Maui

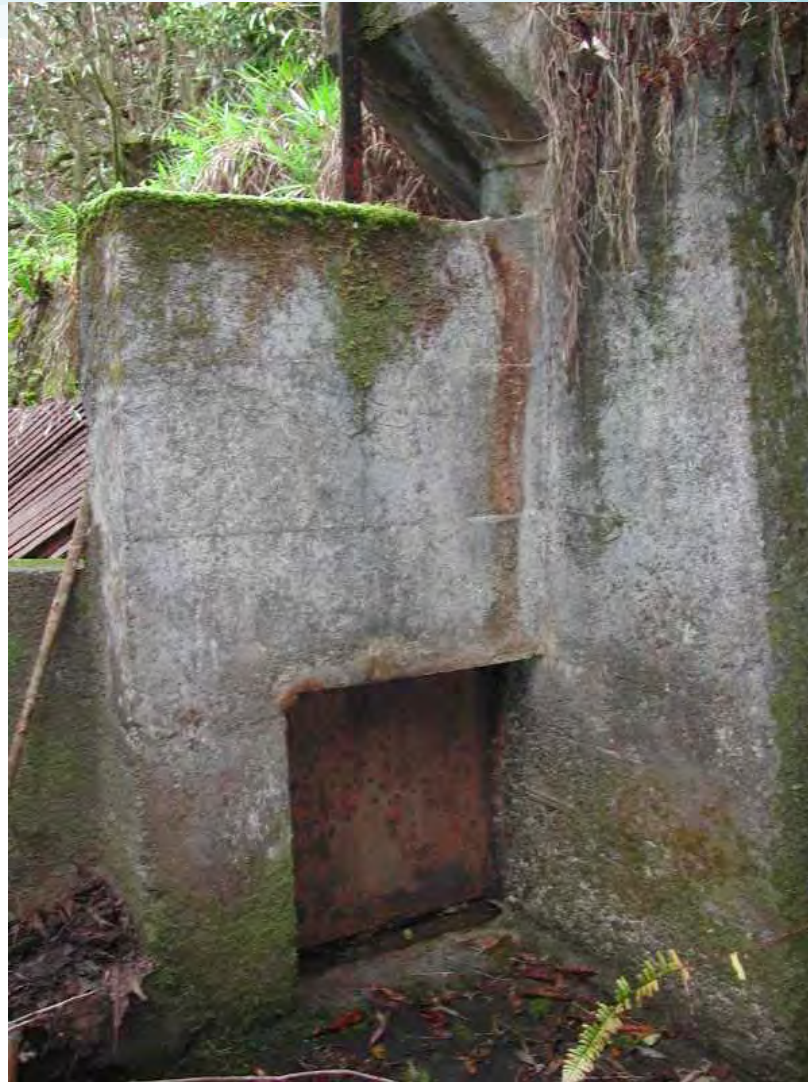
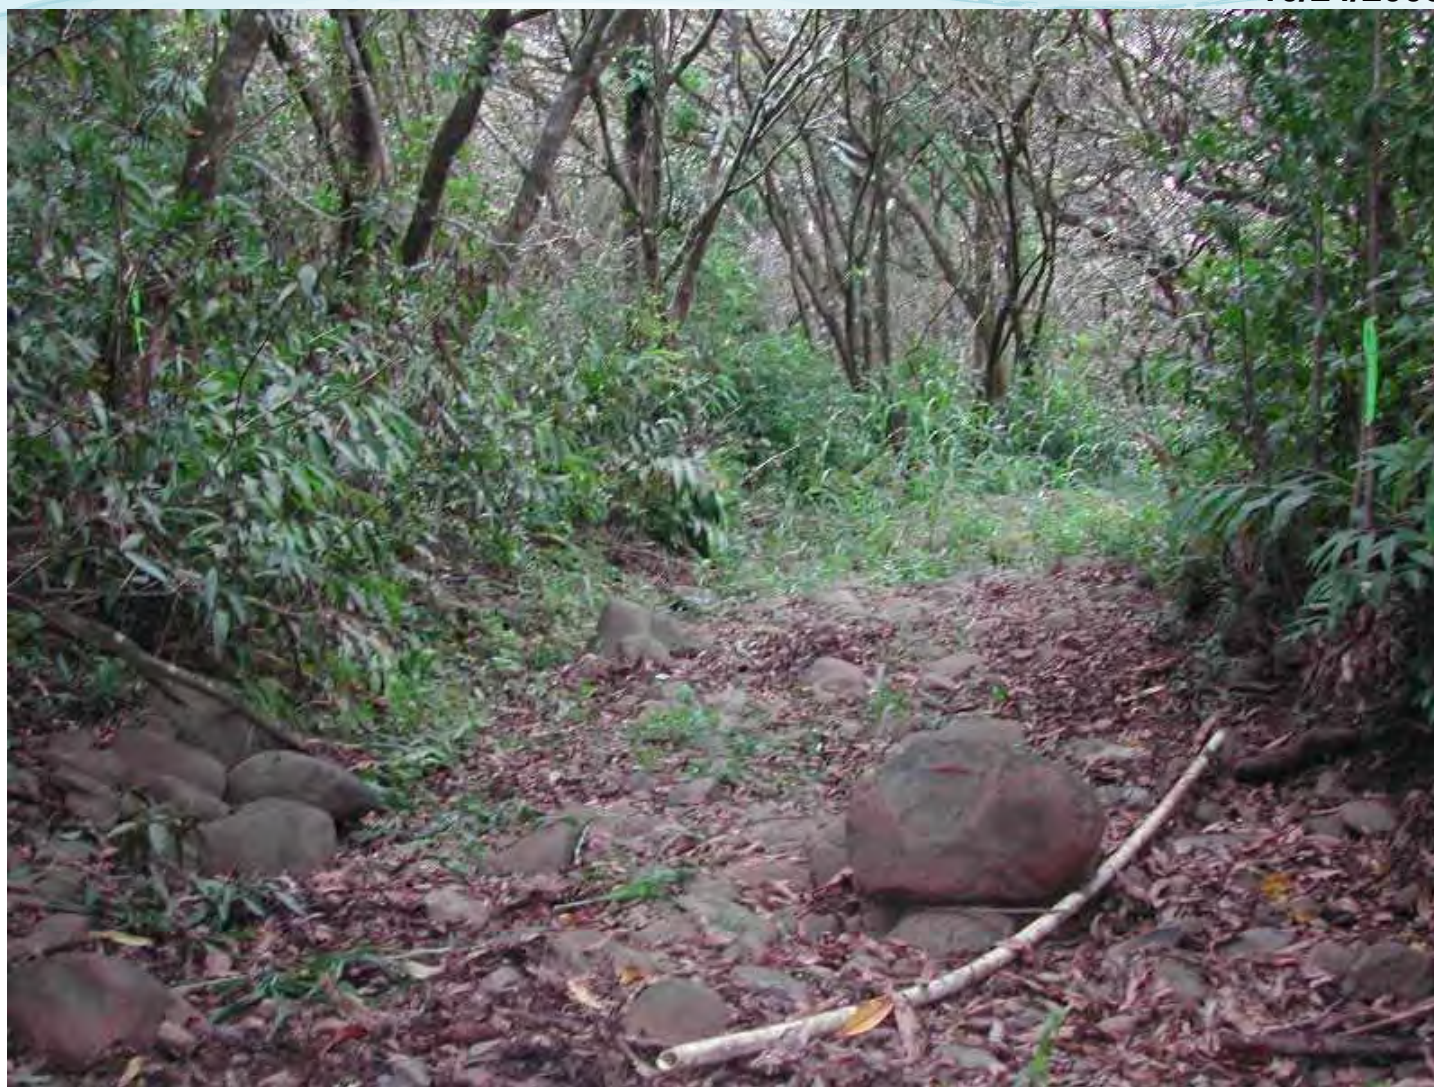
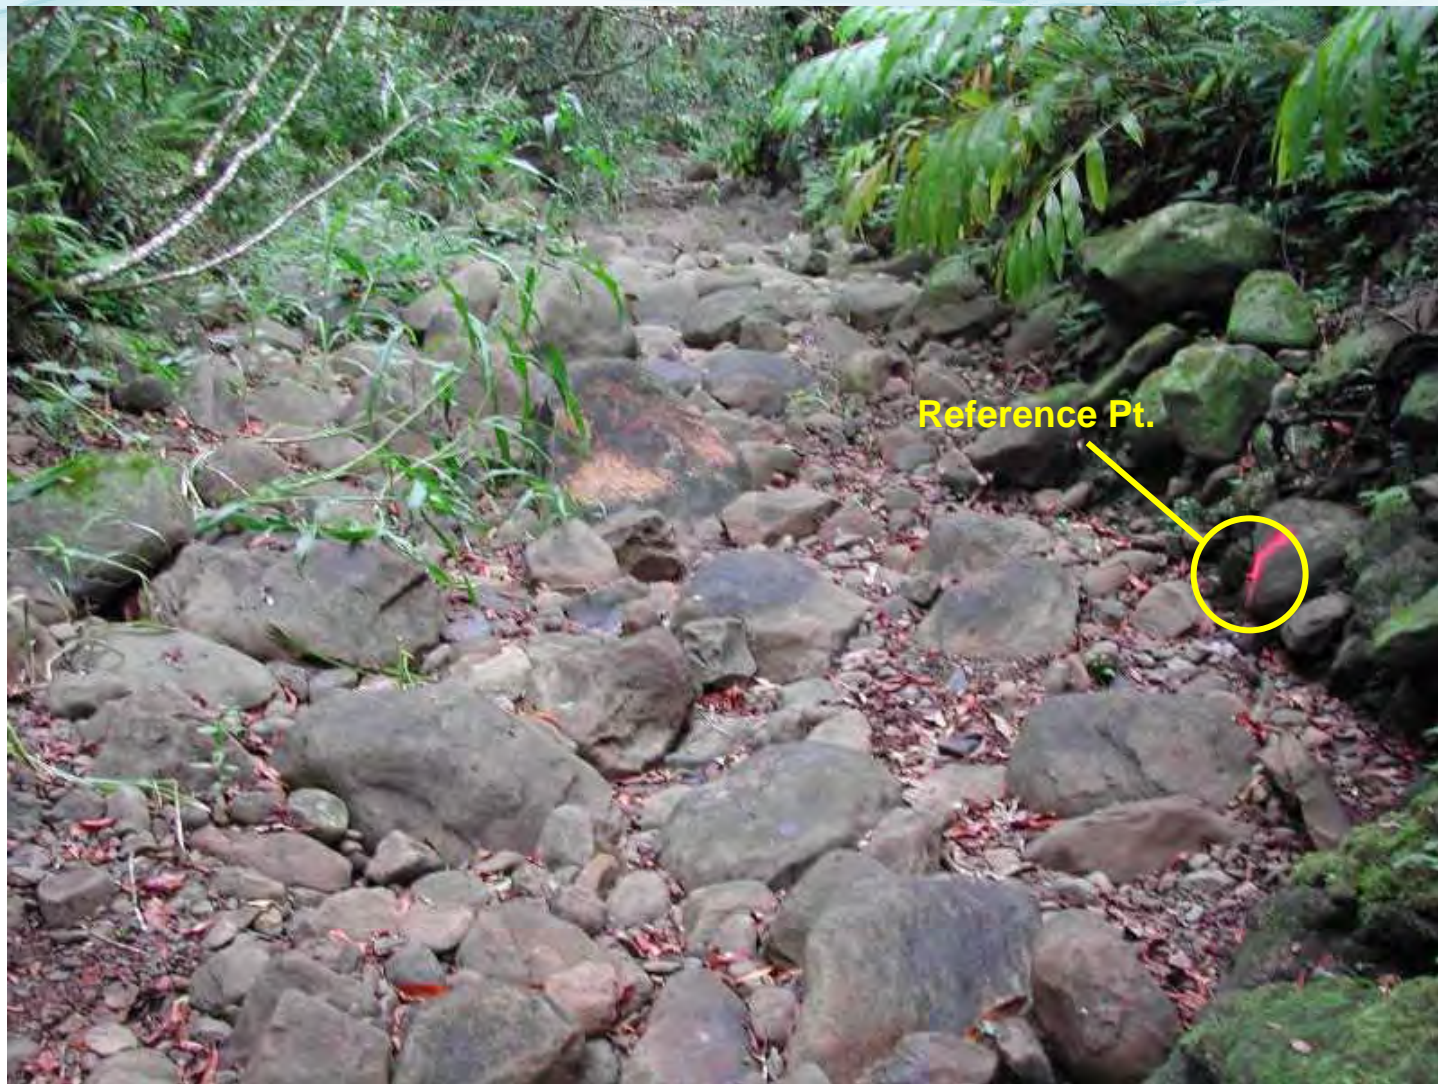
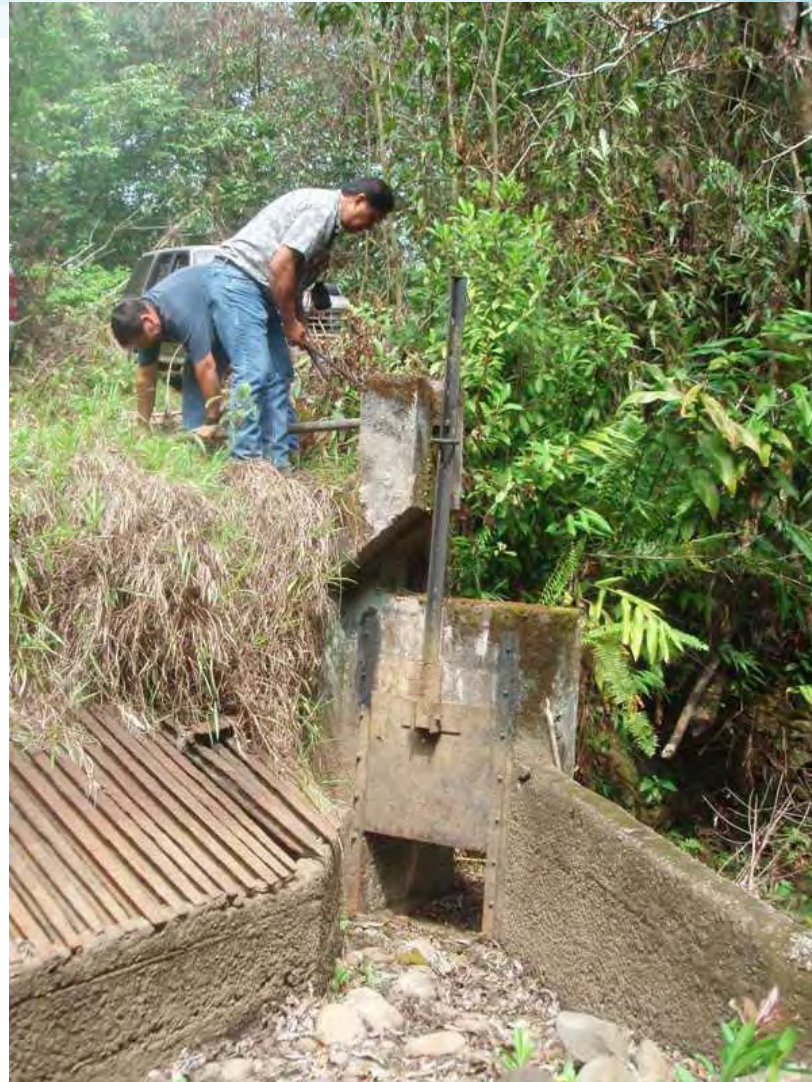
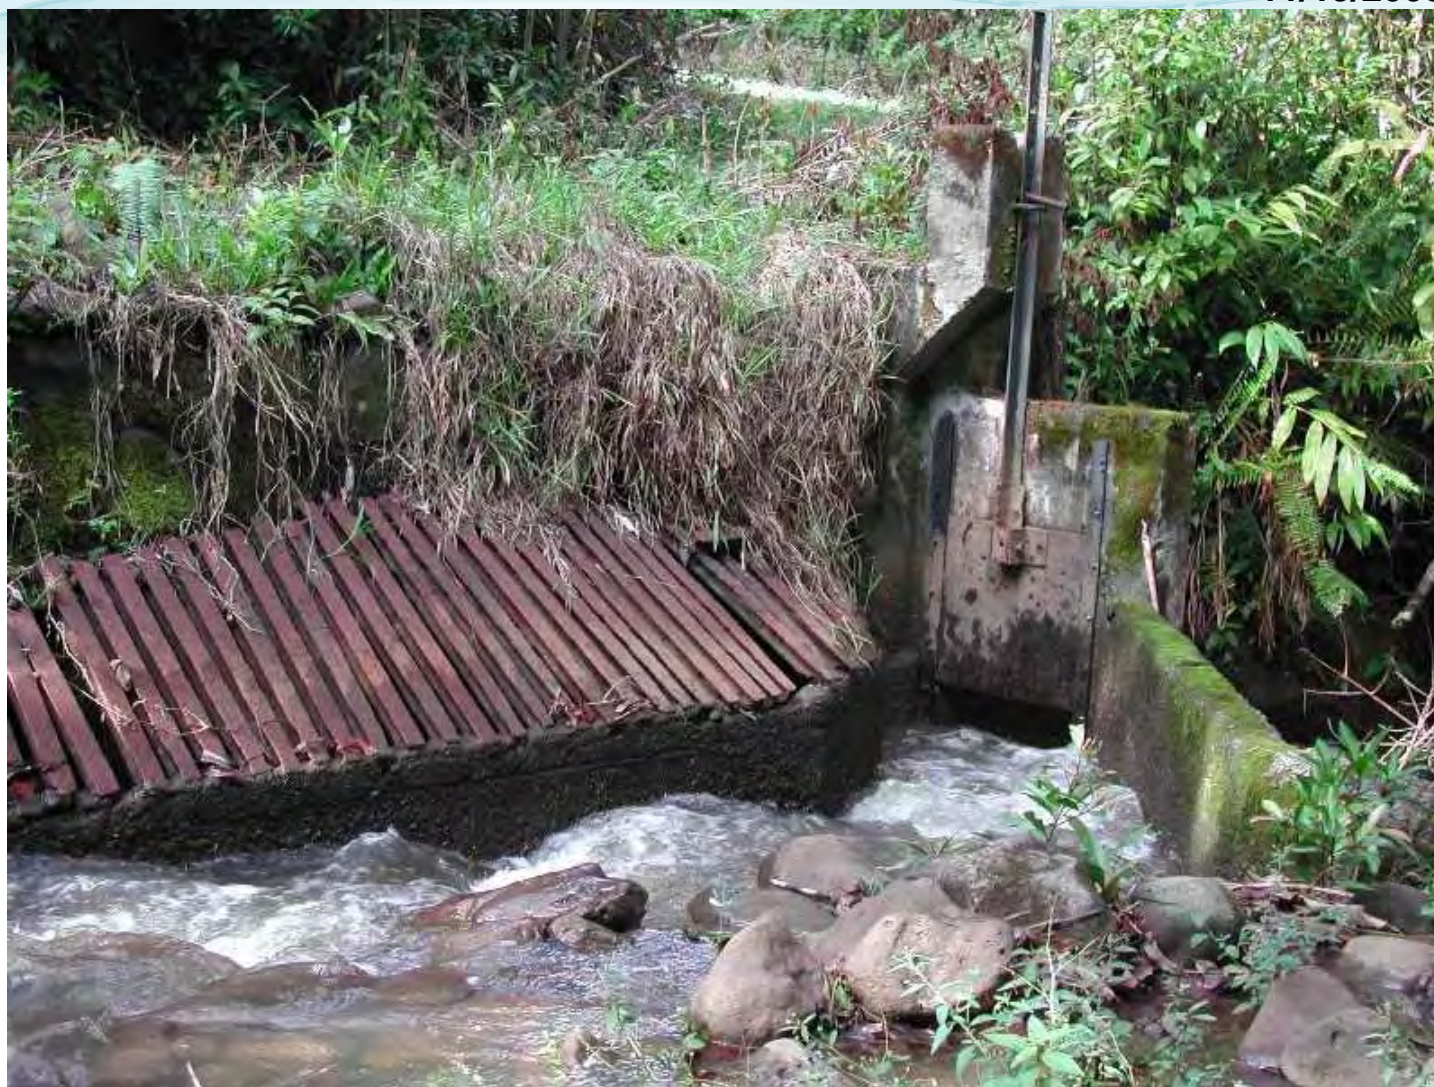
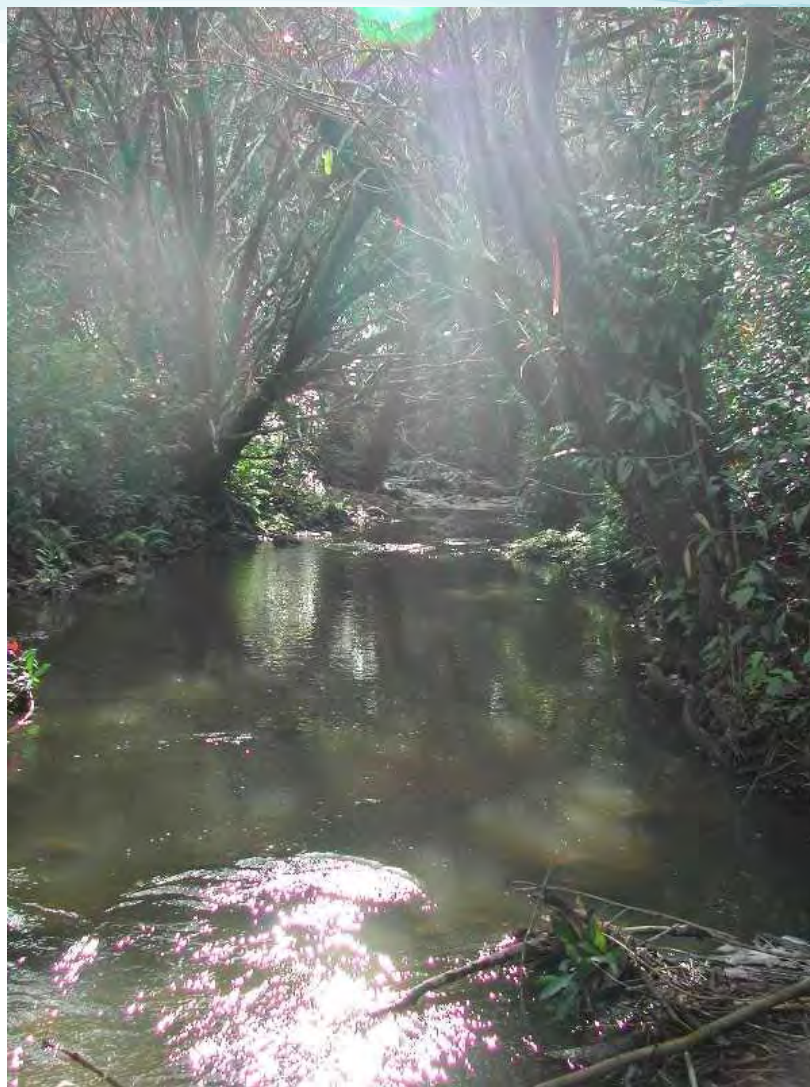
Measurements at IFS Site B

Date	Time	Discharge
10/24/2008	0800 hr	Dry
11/19/2008	1544 hr	4.711 cfs (meter)
IIFS		0.630 cfs

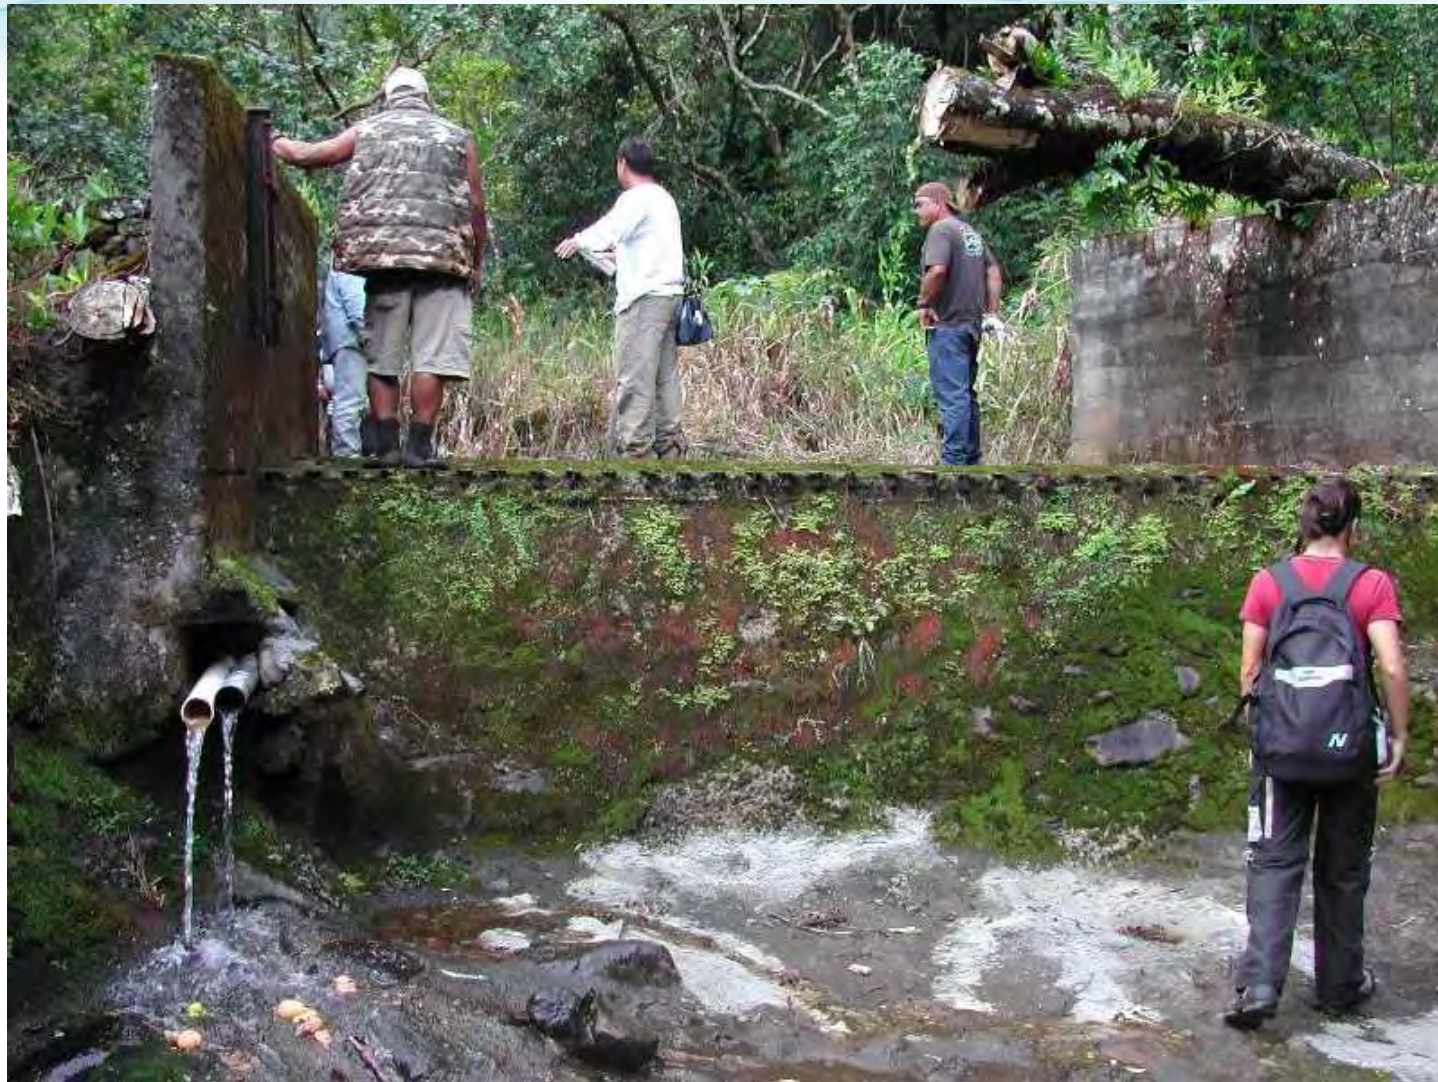
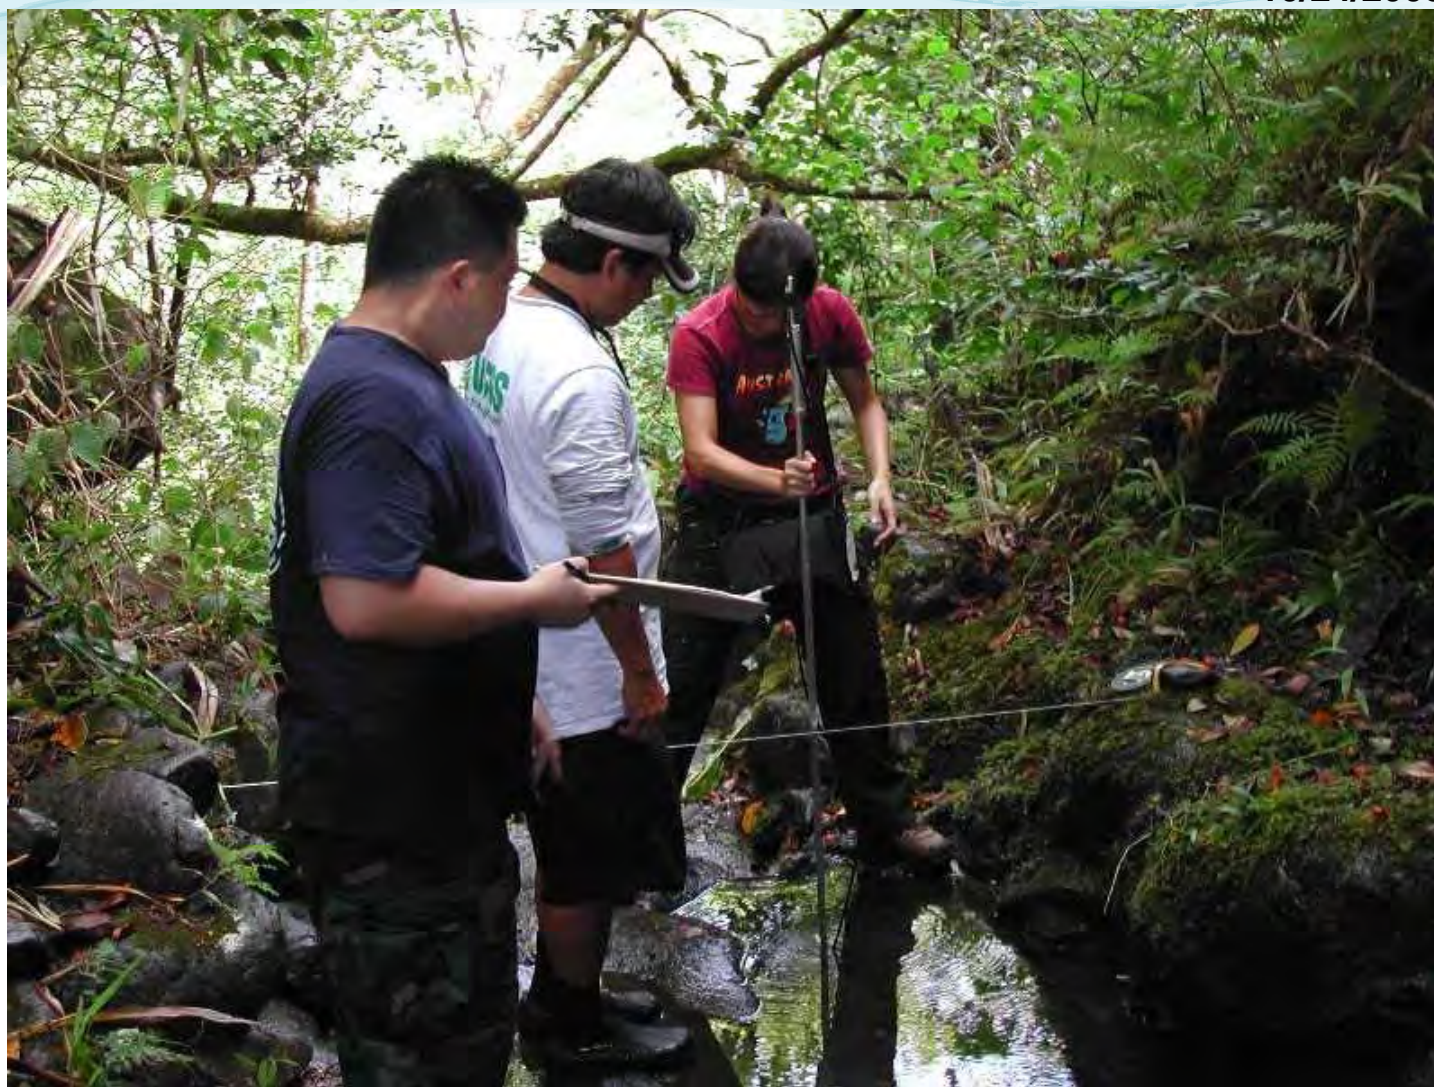
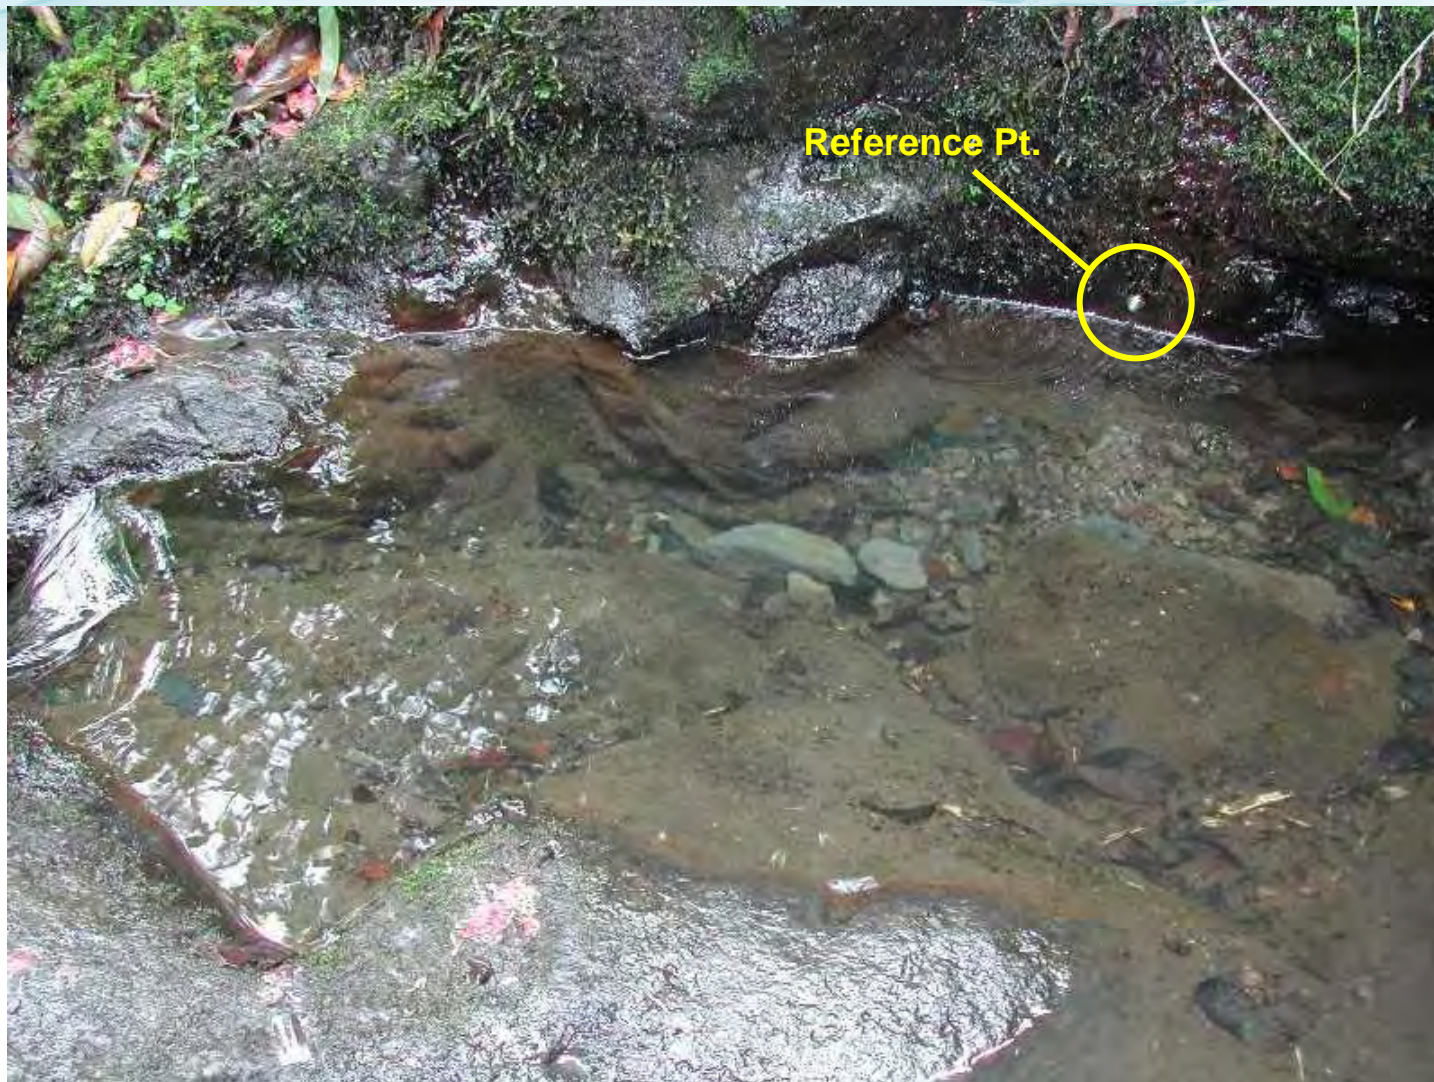
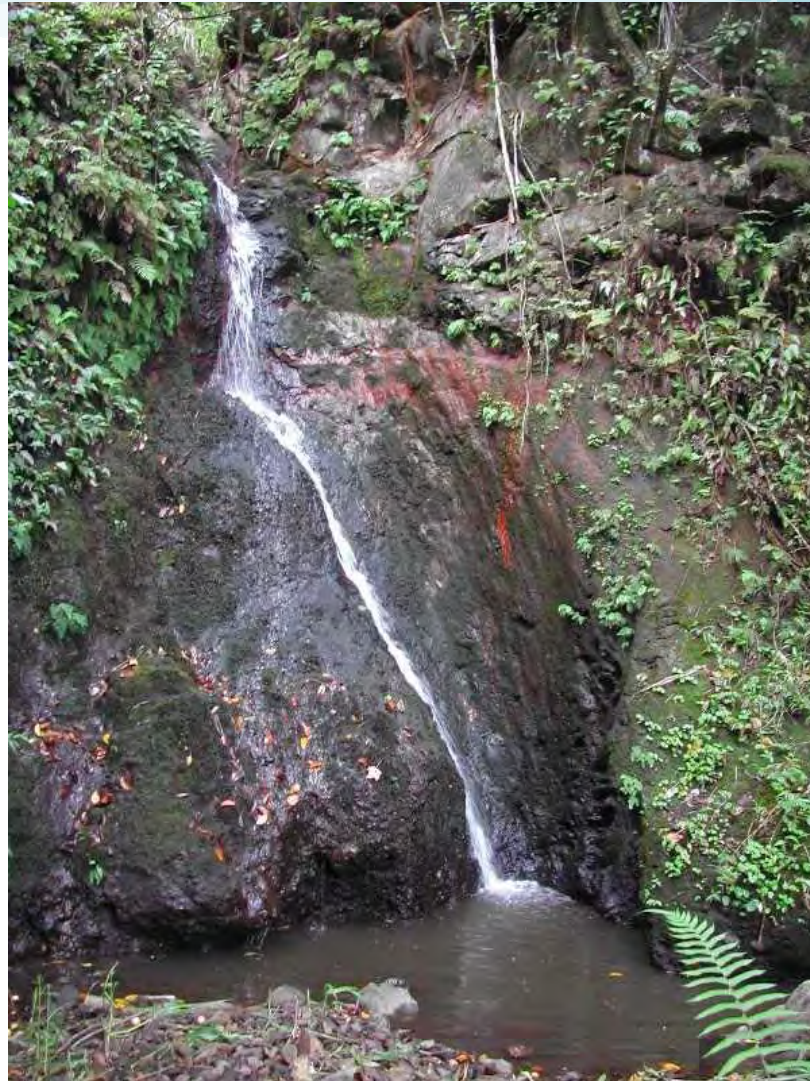
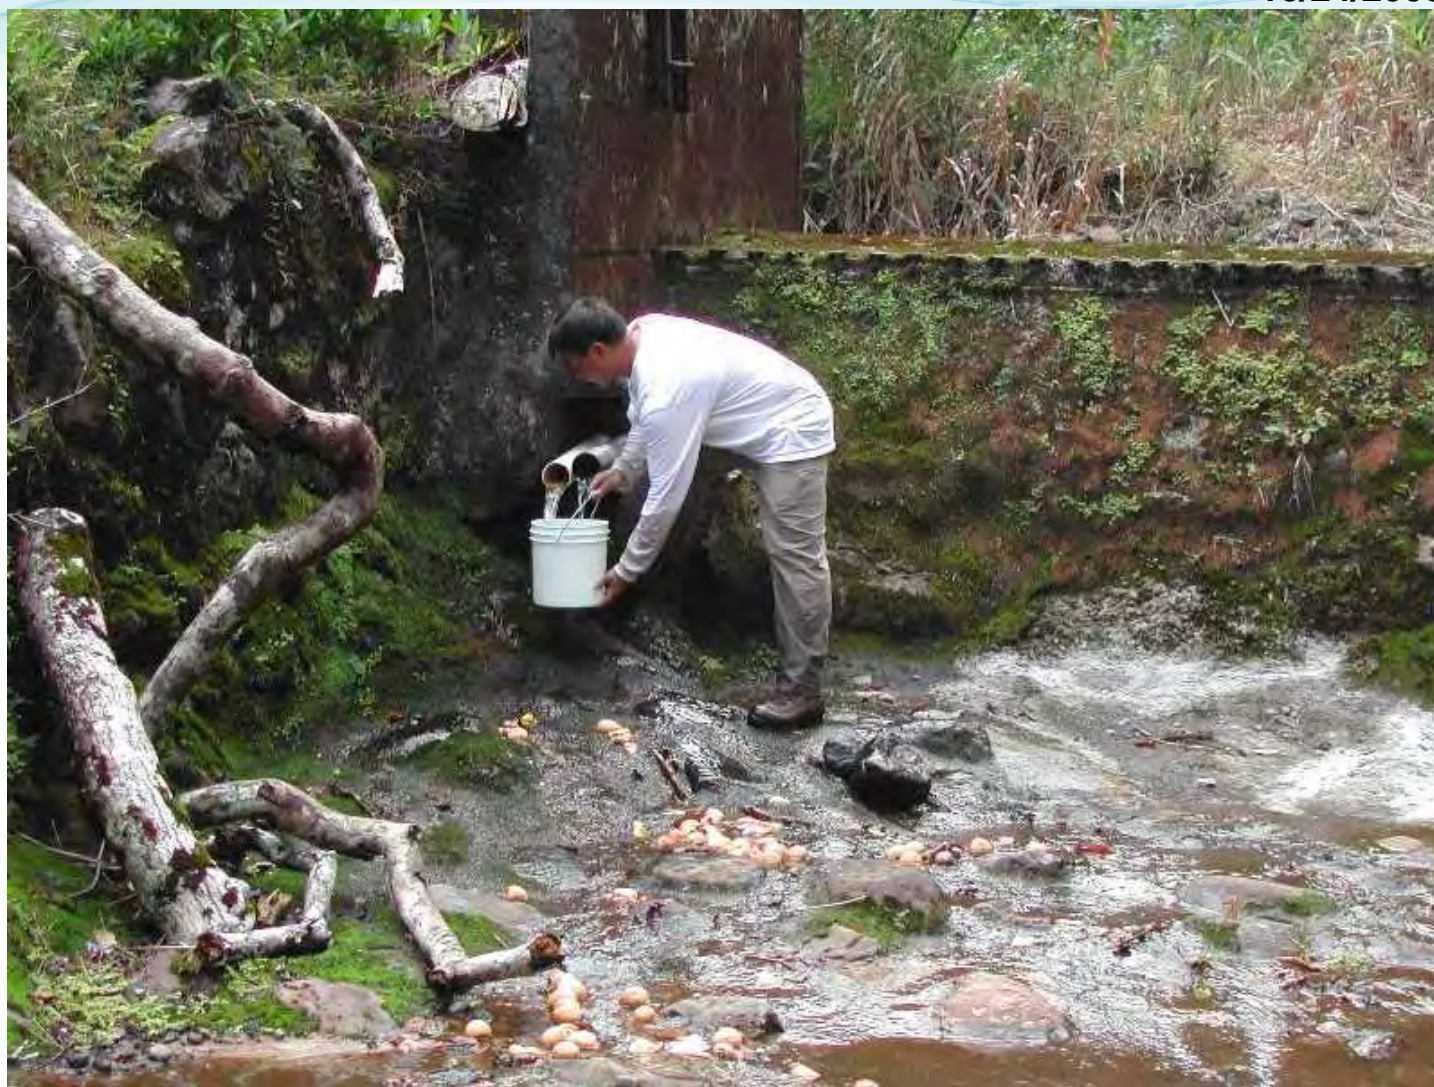
Measurements at IFS Site C

Date	Time	Discharge
10/24/2008	1043 hr	0.065 cfs (meter)
IIFS		1.150 cfs

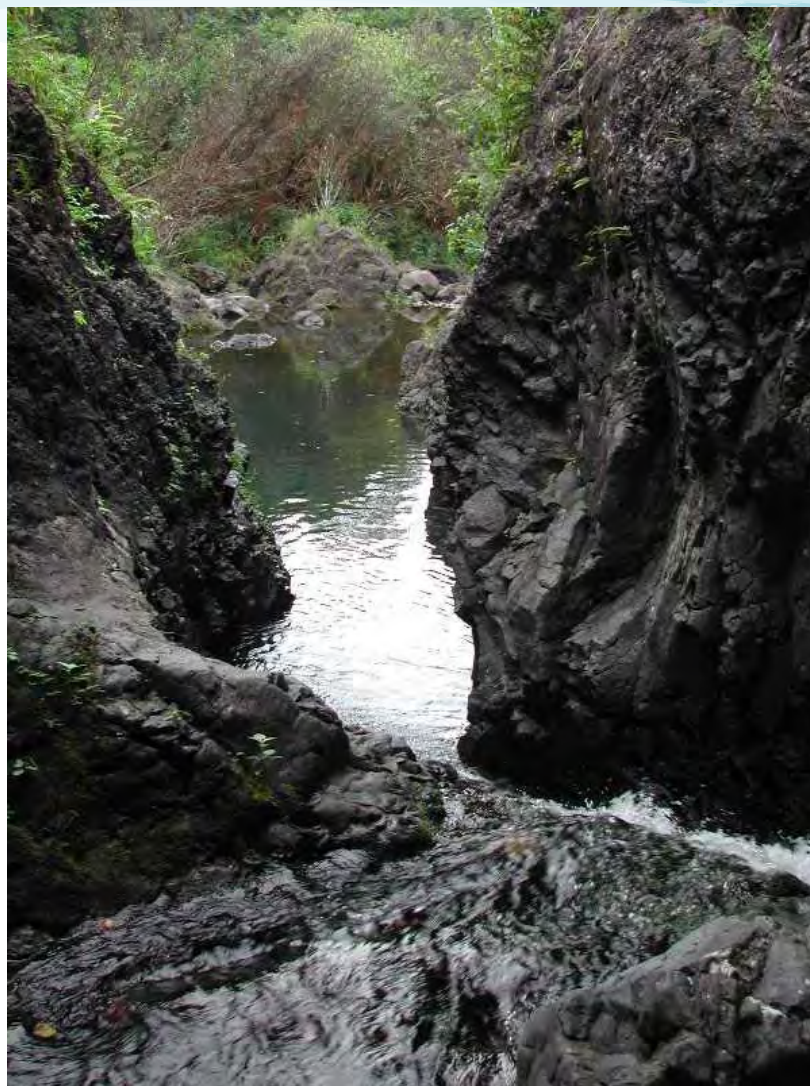
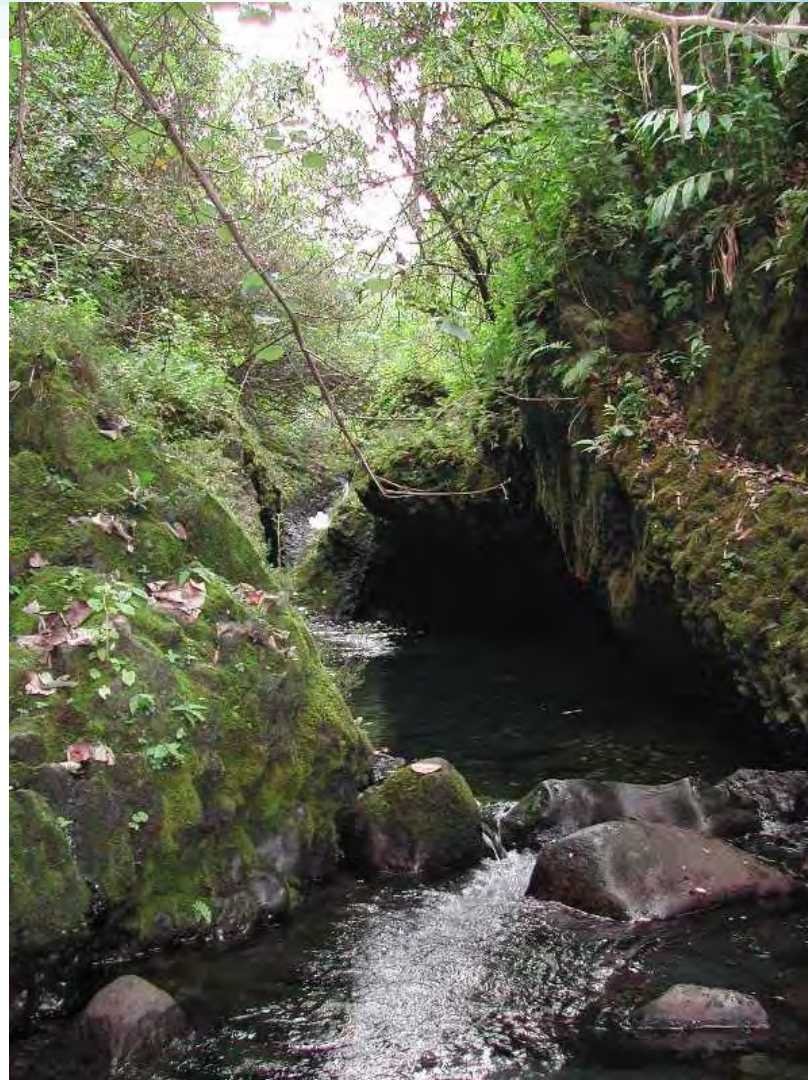
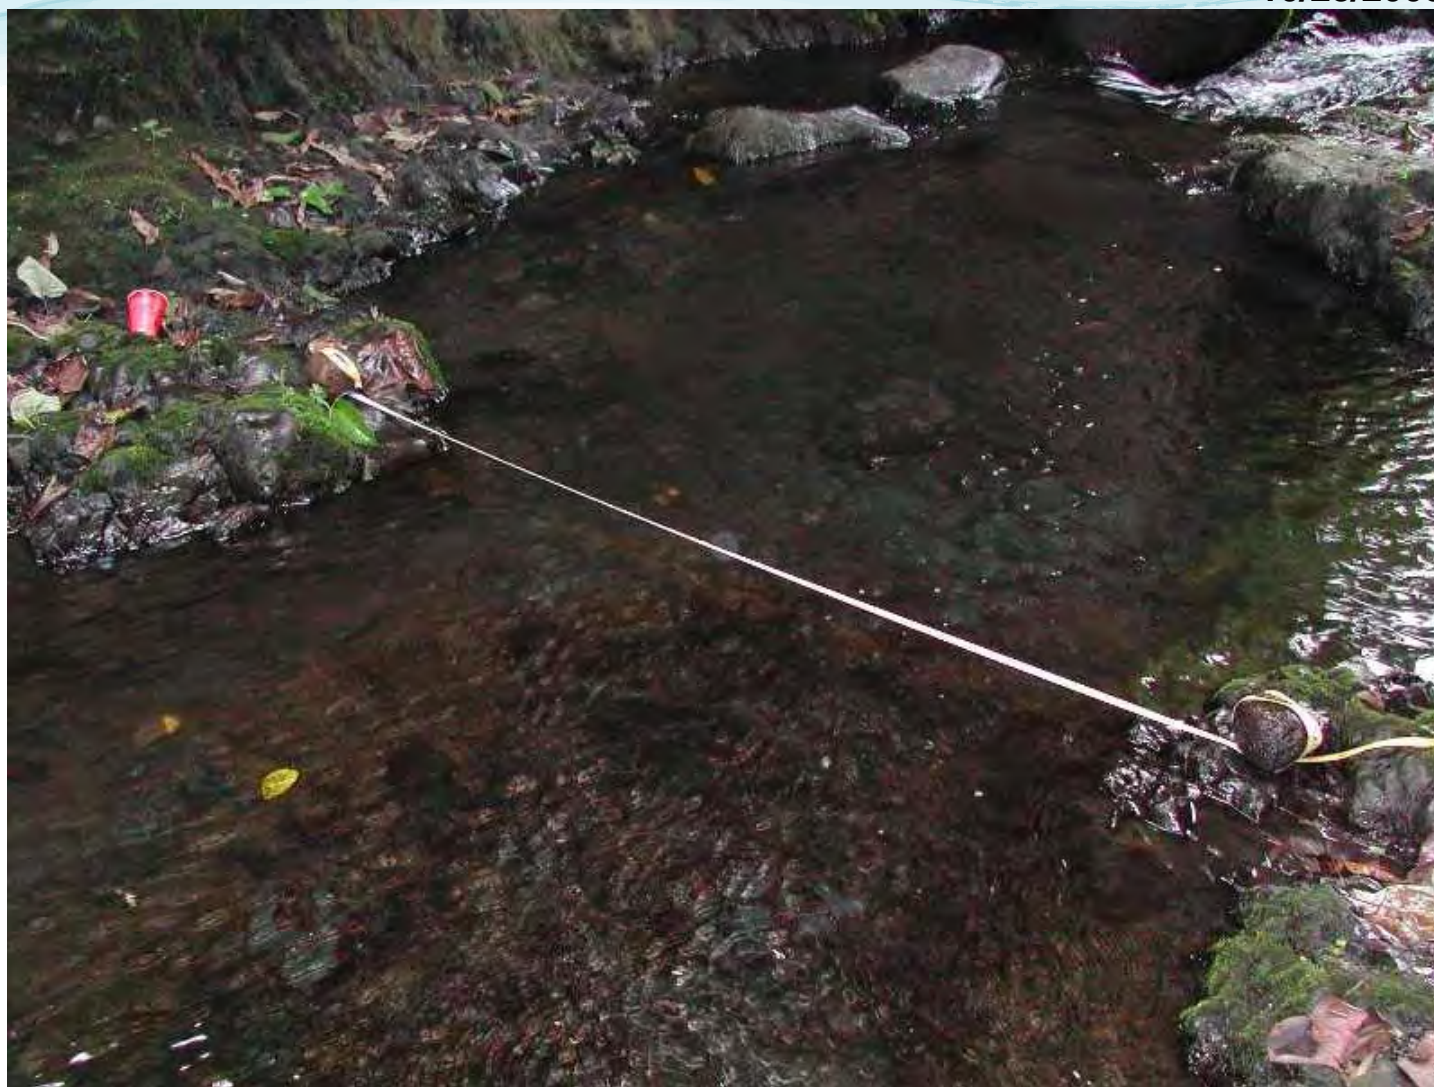
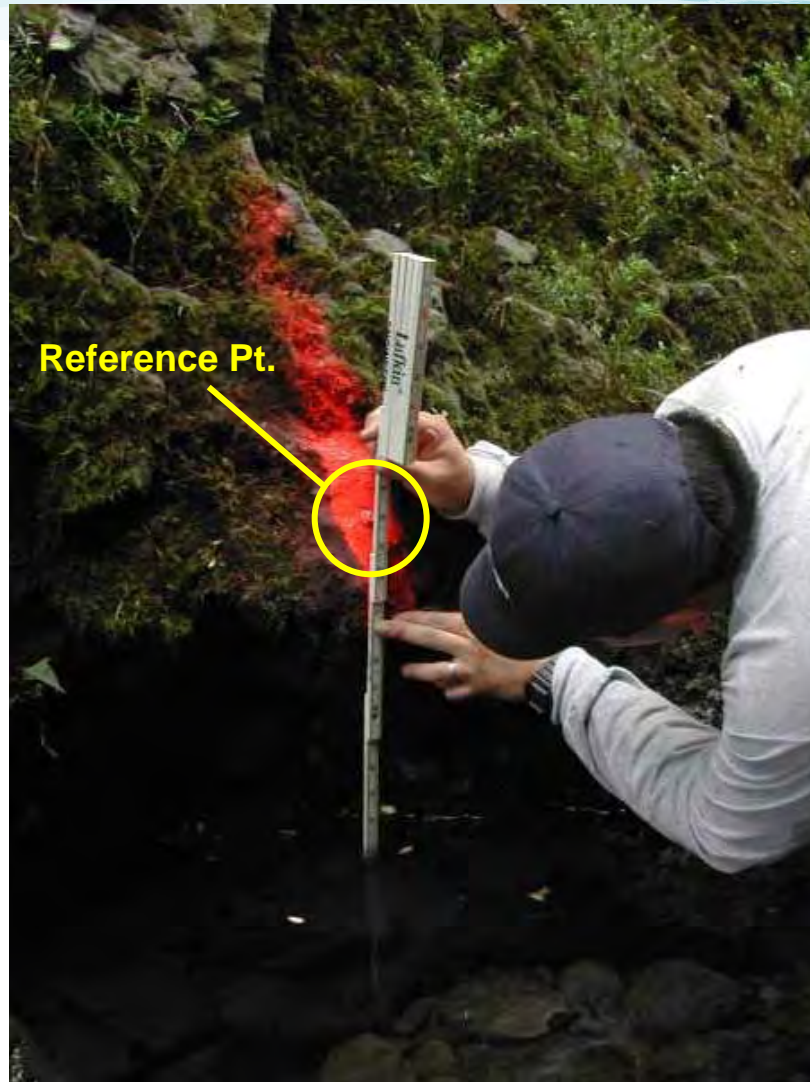
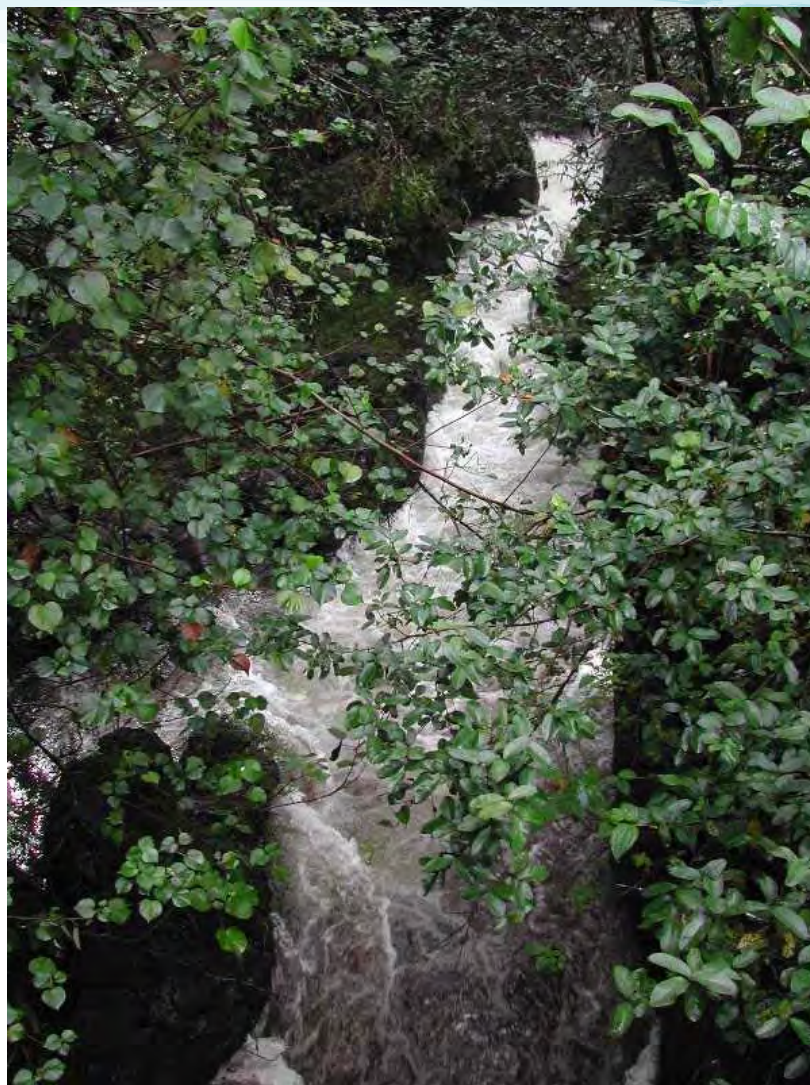
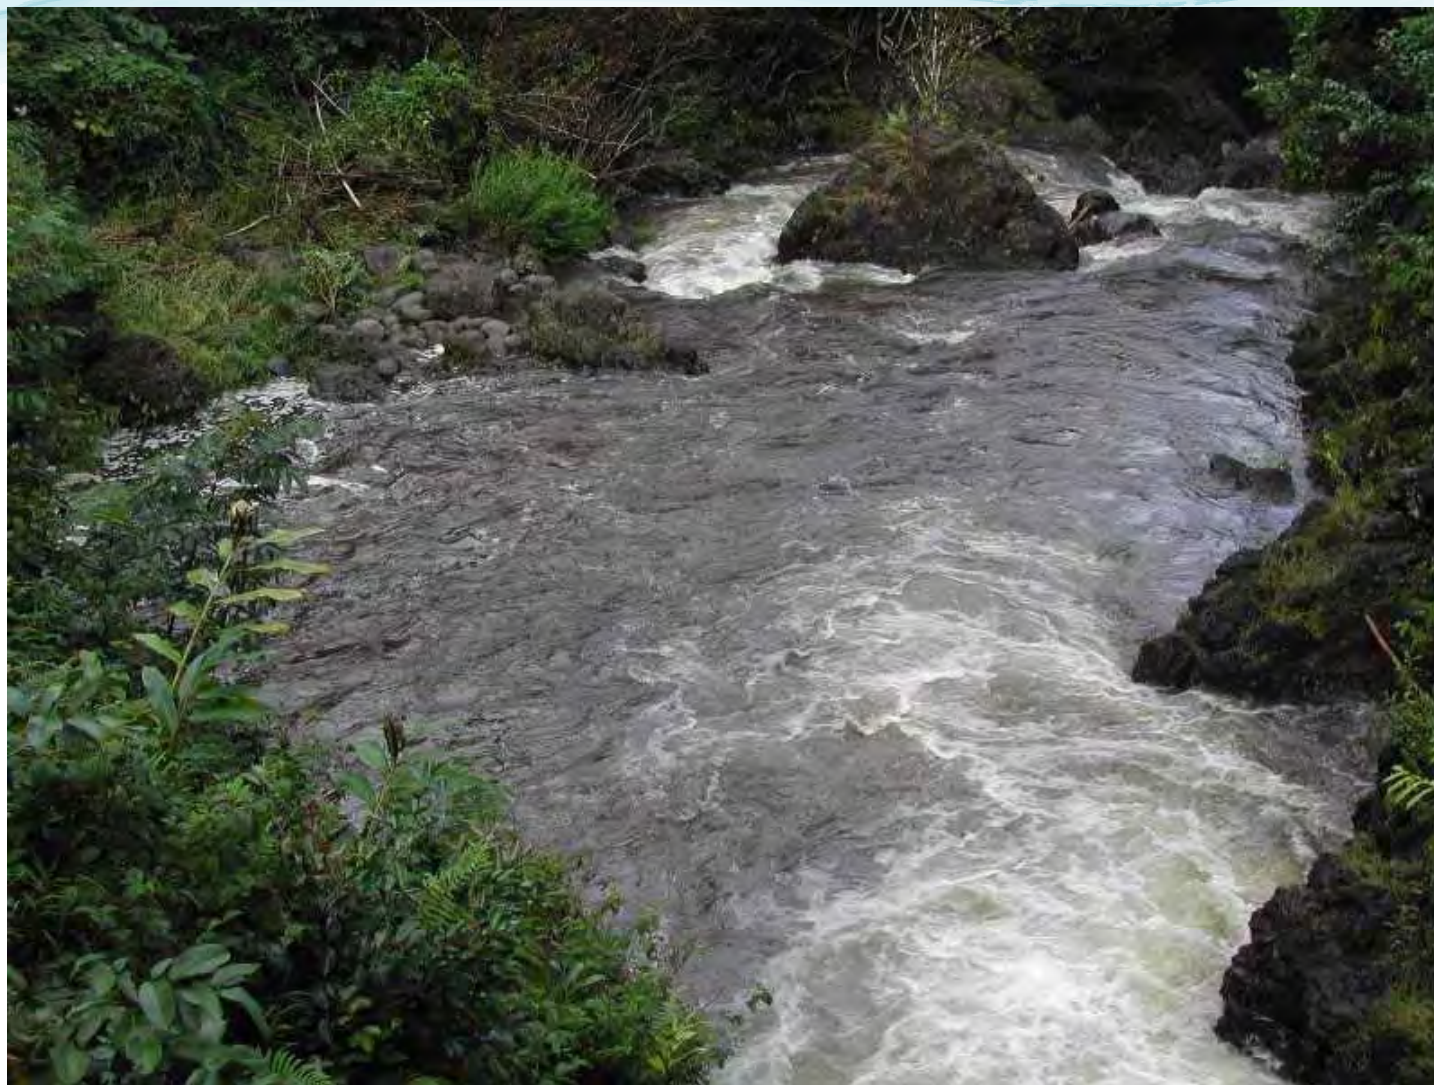
Measurements at IFS Site B

Date	Time	Discharge
10/28/2008	1555 hr	1.951 cfs (meter)
11/17/2008	0921 hr	2.133 cfs (meter)
11/18/2008		High flow
11/19/2008		High flow
IIFS		5.500 cfs

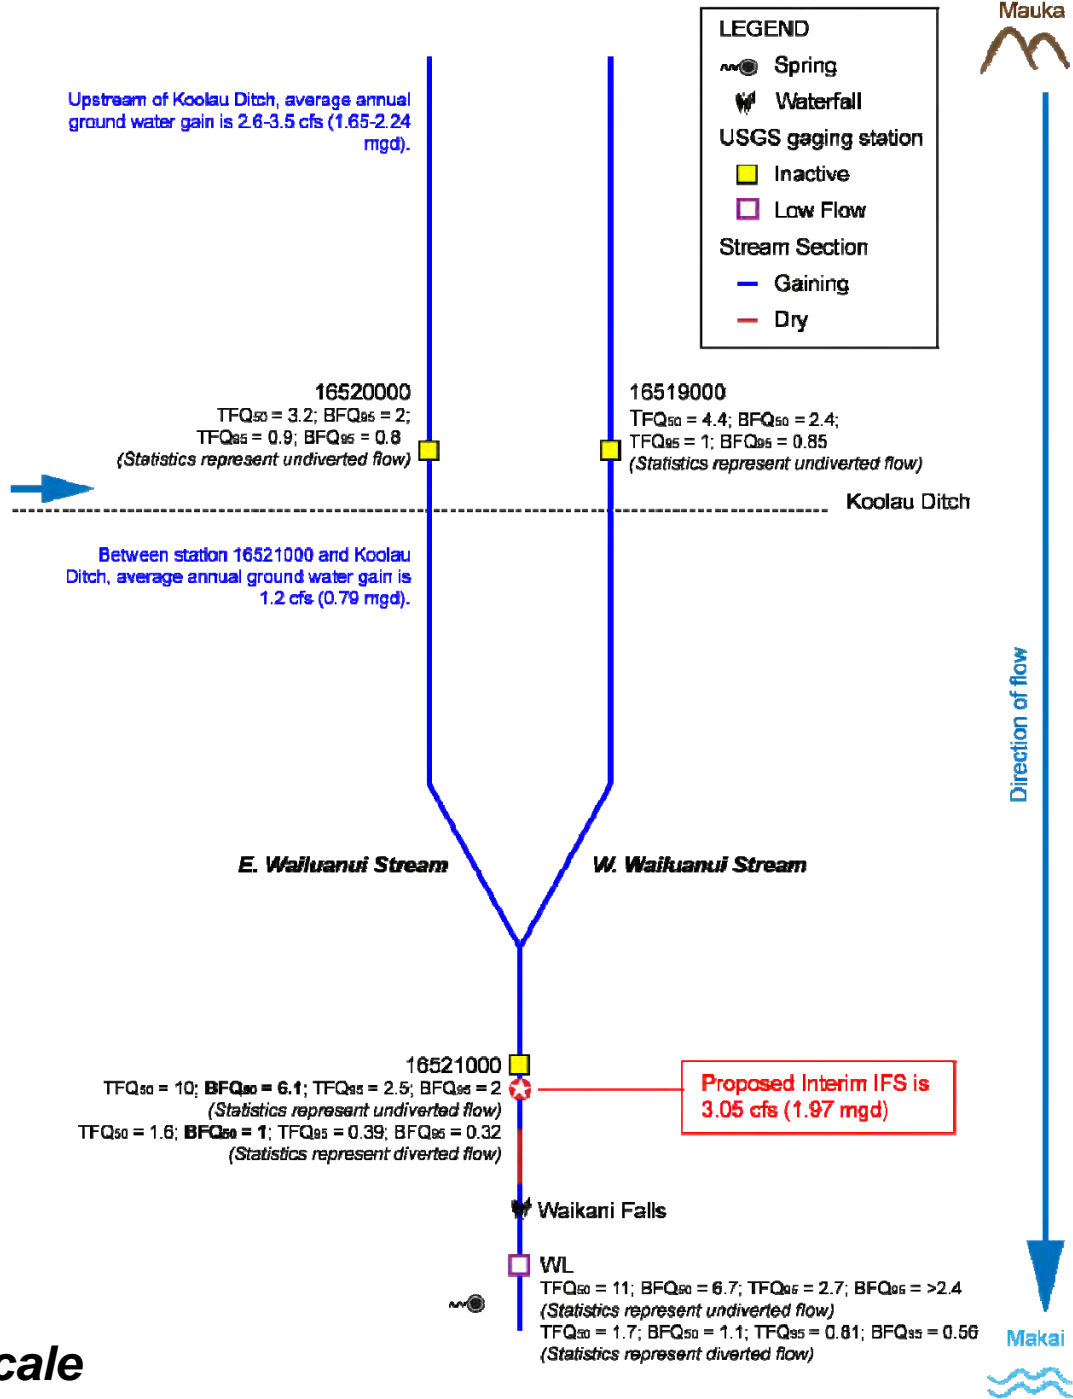
Diagram not to scale

Interim Instream Flow Standards

- **IFS:** Below East/West Wailuani confluence
3.05 cfs (1.97 mgd)
