Commission on Water Resource Management
Kalanimoku Building, Oahu
December 17, 2008

Staff Briefing on the
Implementation of East Maui
Interim Instream Flow Standards

Honopou (6034), Hanehoi (6037), Piinaau (6053),
Waiokamilo (6055), and Wailuanui (6056), Maui

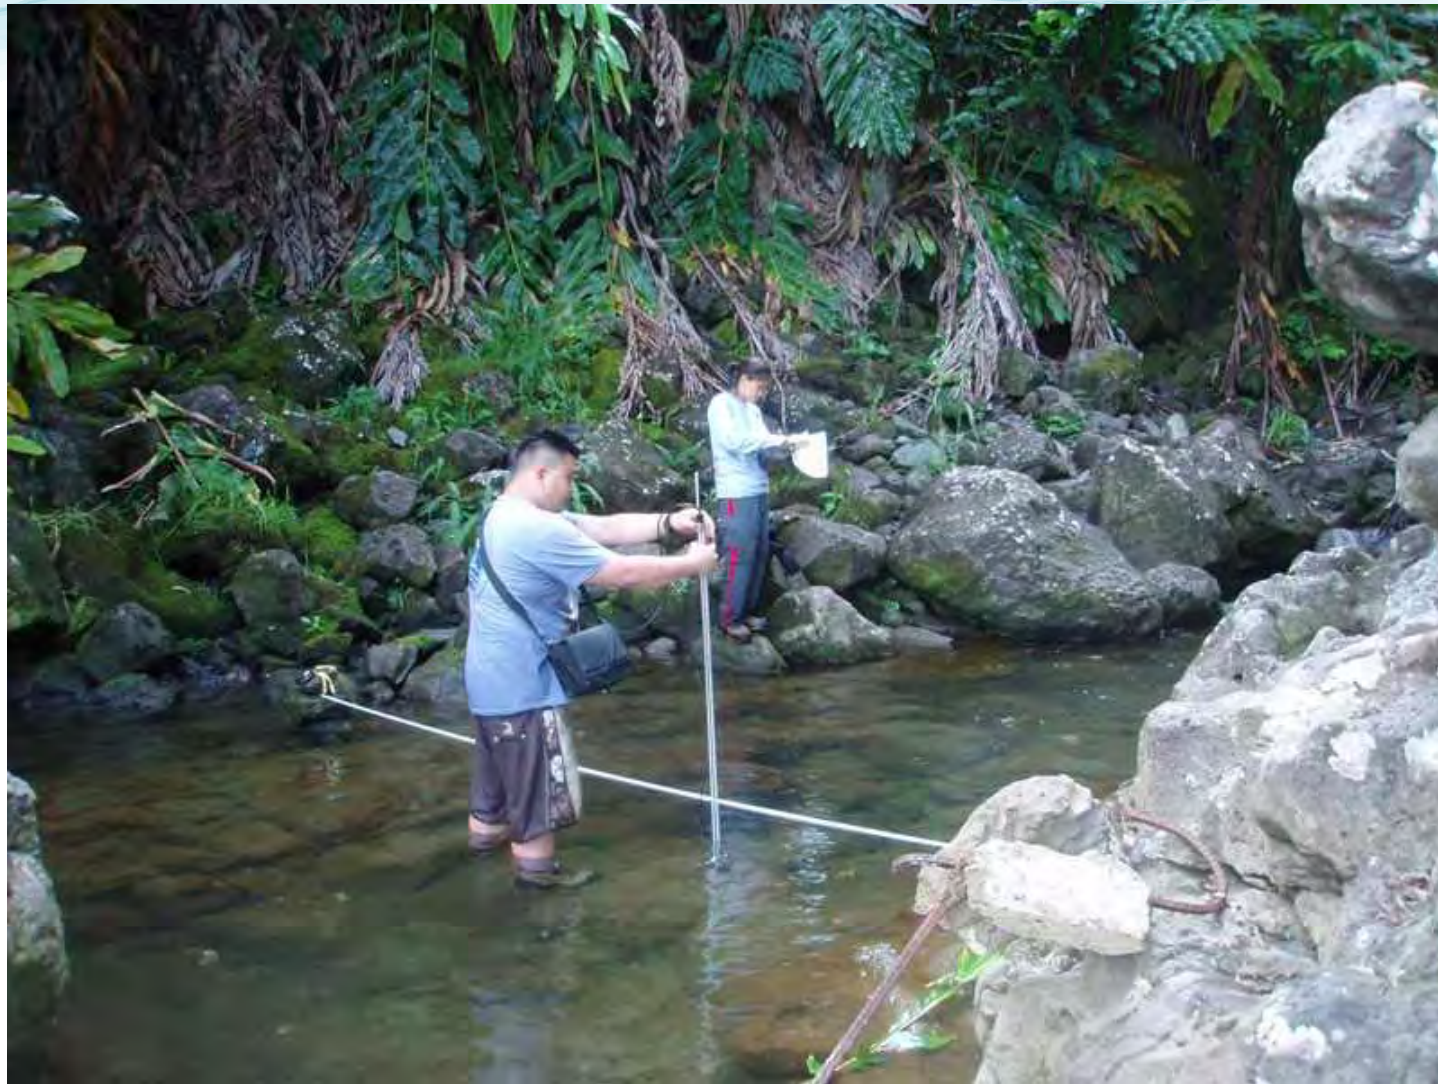
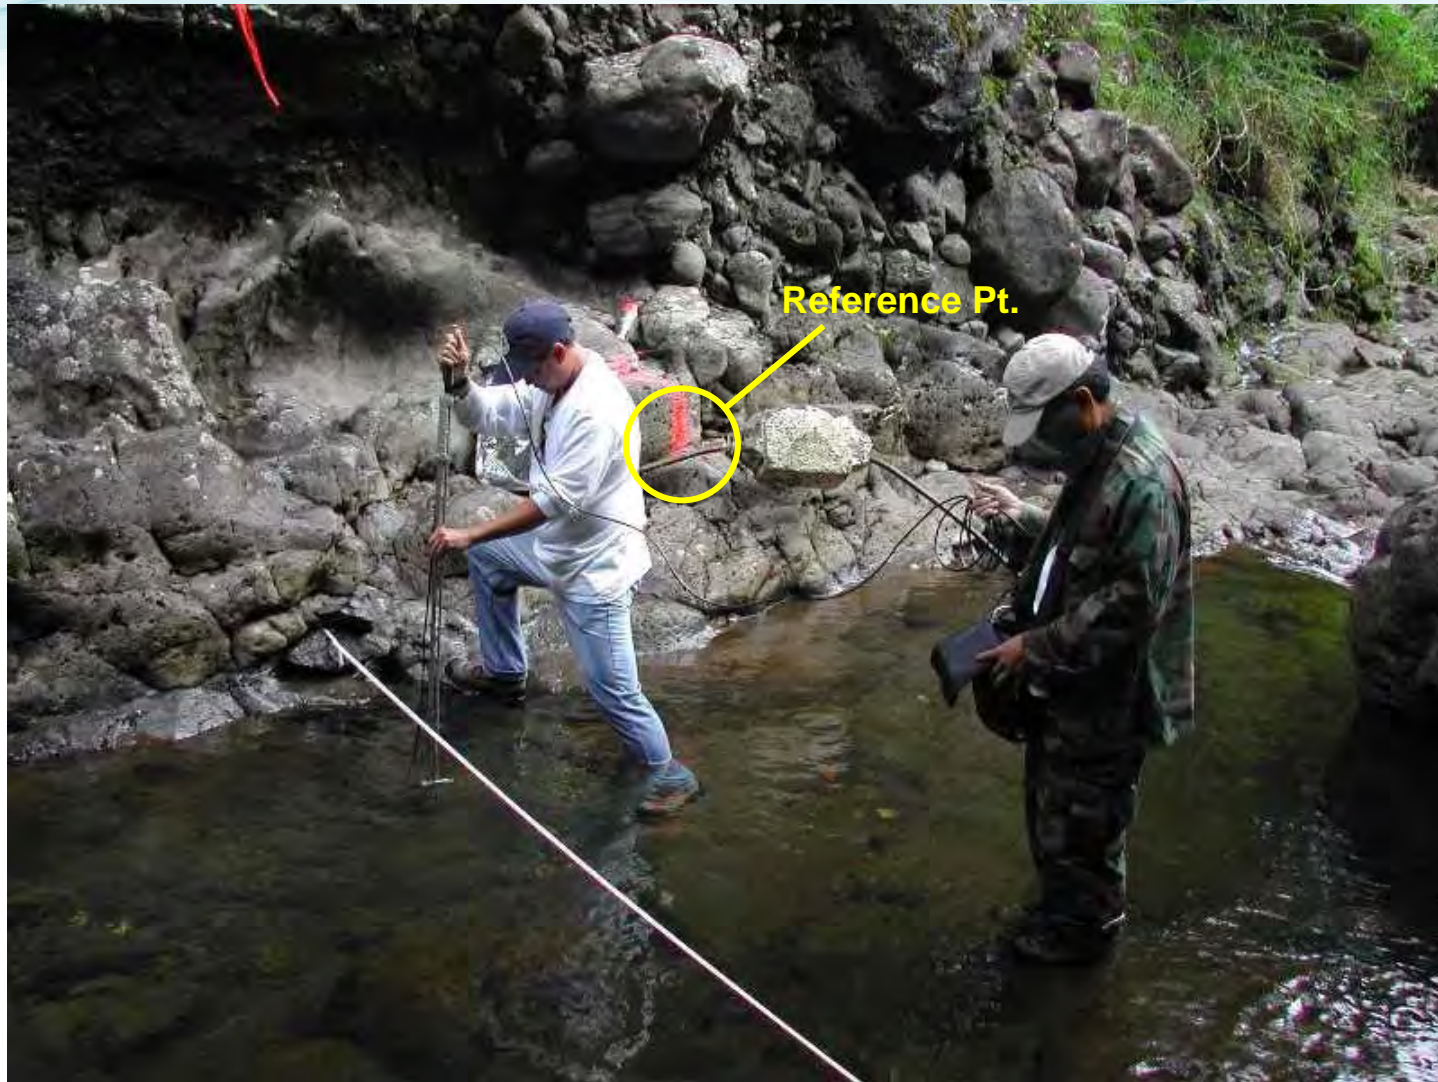
Measurements at IFS Site B

Date	Time	Discharge
10/29/2008	1437 hr	2.293 cfs (meter)
12/08/2008	1502 hr	2.803 cfs (meter)*
12/09/2008	1037 hr	2.392 cfs (meter)*
12/10/2008	0920 hr	2.076 cfs (meter)*
IIFS		5.500 cfs
