STATE OF HAWAII
DEPARTMENT OF LAND AND NATURAL RESOURCES
COMMISSION ON WATER RESOURCE MANAGEMENT
Stream Protection and Management Branch

FIELD INVESTIGATION REPORT

FI2008102302 (East Maui, Honopou IIFS Site B)

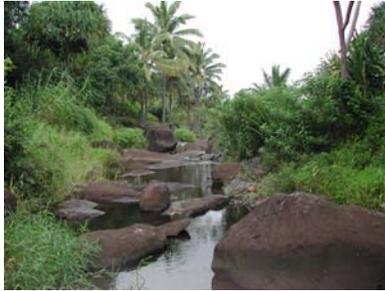
20081023040.JPG

File Name:	Brief Description:
20081023040	Confluence of Honopou Stream and tributary Puniawa Stream, facing makai.
20081023041	Above the confluence of Honopou Stream and tributary Puniawa Stream, facing mauka.
20081023045	PVC pipe on the gage pool side of Honopou stream.
20081023047	PVC pipe on the gage pool side of Honopou stream.
20081023048	Staff crew setting up the site for flow measurement on Honopou Stream.
20081023050	CWRM staff conducting flow measurement on Honopou Stream.
20081023051	CWRM staff, Dean Uyeno and Chui Ling Cheng, conducting flow measurement on Honopou Stream.
20081023053	Flow measurement site on Honopou Stream.
20081023054	Gage pool and concrete wall on Honopou Stream.
20081023055	Flow measurement site on Honopou Stream.
20081023056	Honopou Stream downstream from the gage pool.

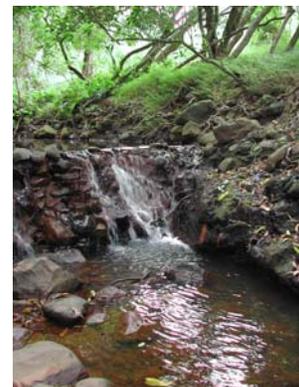
20081023057.JPG

20081023057	Gage pool and concrete wall on Honopou Stream.
20081023059	Gage pool on Honopou Stream.
20081023060	Reference point at the gage pool on Honopou Stream.
20081023063	PVC pipe extending from the gage pool to the other side of the concrete wall on Honopou Stream.
