STATE OF HAWAII
DEPARTMENT OF LAND AND NATURAL RESOURCES
COMMISSION ON WATER RESOURCE MANAGEMENT
 Stream Protection and Management Branch

FIELD INVESTIGATION REPORT
FI2008102303 (East Maui, Huelo IIFS Site A)

Date of Field Investigation:	October 23, 2008	Time (24-hour):	1300 - 1600
CWRM Staff:	Dean Uyeno, Ken Kawahara, Chui Ling Cheng		
Individuals Present:	Agency staff - Matt Wong (USGS-Maui field technician), Skippy Hau (DAR staff); Honopou community - Lynn Scott, Beatrice Kekahuna, Sanford Kekahuna, Boni Kekahuna, and Wanda Vierra; Huelo community - Ernie Schupp and Moke Kahiamoe		
Hydrologic Unit:	Hanehoi (6037)		
Stream Name:	Puolua (Huelo) Stream		
Findings:	<p>At approximately 1300 hours, the staff crew (CWRM staff, Skippy Hau and Matt Wong) and members from the Honopou community met with Ernie Schupp and Moke Kahiamoe at the parking lot of the Door of Faith Church on Huelo Road. From the church, everyone walked to Ernie's property via a dirt road. After arriving at the Haiku Ditch diversion on Puolua (Huelo) Stream, staff crew walked along the stream to the auwai intake where Ernie diverts water from the Puolua (Huelo) Stream for his taro loi. Matt Wong evaluated that len

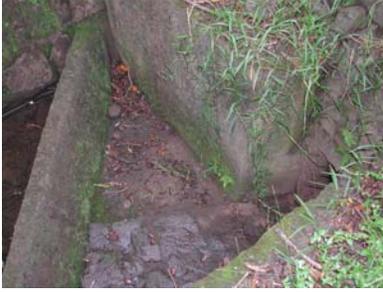
20081023066.JPG

Image Listing:	(Attach PDF of image contact sheet)		
File Name:	Brief Description:		
20081023066	Haiku Ditch diversion structure on Puolua (Huelo) Stream.		
20081023068	Haiku Ditch diversion structure on Puolua (Huelo) Stream.		
20081023069	Haiku Ditch diversion structure on Puolua (Huelo) Stream.		
20081023070	Haiku Ditch diversion structure (intake gate) on Puolua (Huelo) Stream.		
20081023071	2 pipes on the concrete wall of the Haiku Ditch diversion structure on Puolua (Huelo) Stream.		
20081023072	2 pipes on the concrete wall of the Haiku Ditch diversion structure on Puolua (Huelo) Stream.		
20081023073	2 pipes on the concrete wall of the Haiku Ditch diversion structure on Puolua (Huelo) Stream.		
20081023074	Puolua (Huelo) Stream downstream from Haiku Ditch.		
20081023075	Auwai intake on Puolua (Huelo) Stream.		
20081023080	Matt Wong setting up flow measurement site on Puolua (Huelo) Stream.		
20081023081	Matt Wong setting up flow measurement site on Puolua (Huelo) Stream.

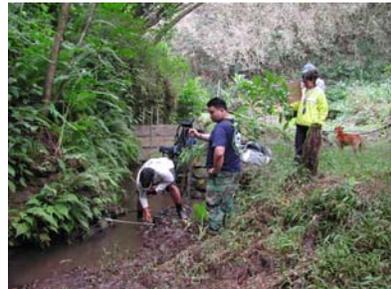
20081023083.JPG

20081023083	Matt Wong setting up flow measurement site on Puolua (Huelo) Stream.		
20081023086	Dean Uyeno conducting flow measurement on Puolua (Huelo) Stream.		
20081023092	CWRM staff (Dean Uyeno and Chui Ling Cheng) conducting flow measurement on Puolua (Huelo) Stream.		
20081023103	CWRM staff (Dean Uyeno and Chui Ling Cheng) conducting flow measurement on Puolua (Huelo) Stream.		
GPS Listing:			
Shapefiles:	(List file names of all shapefiles created and a brief description of each)		
File Name:	Brief Description:		
East_Maui_POI.shp	Points of interest (POI) recorded with the GPS unit during the field visit. The file includes POI recorded from all the East Maui field investigations.
