STATE OF HAWAII
DEPARTMENT OF LAND AND NATURAL RESOURCES
COMMISSION ON WATER RESOURCE MANAGEMENT
 Stream Protection and Management Branch

FIELD INVESTIGATION REPORT
FI2008102801 (East Maui, Honopou IIFS Site A)

| Stream Name: | Honopou Stream | | |

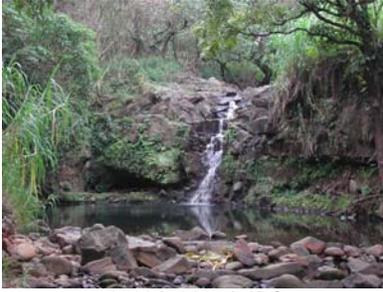
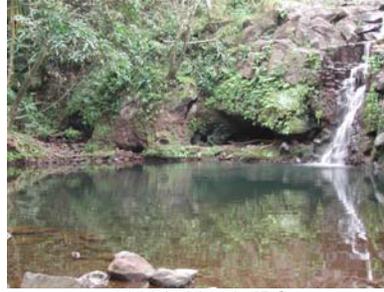
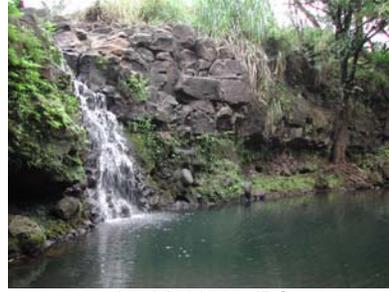
20081028001.JPG

CWRM staff then walked to a large pond downstream from Haiku Ditch on Honopou Stream.

| File Name: | Brief Description: |
|---|--|
| 20081028001 | Pond downstream of Haiku Ditch on Honopou Stream. |
| 20081028002 | Pond downstream of Haiku Ditch on Honopou Stream. |
| 20081028005 | Pond downstream of Haiku Ditch on Honopou Stream. |

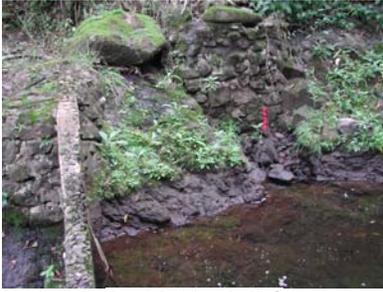
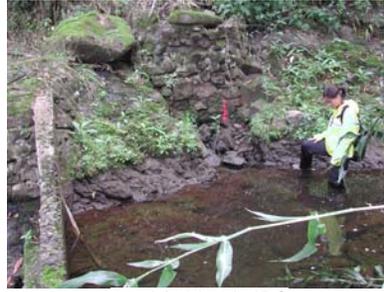
20081028006.JPG

| File Name: | Brief Description: |
|---|--|
| 20081028006 | Gage pool and reference point on Honopou Stream IIFS Site A. |
| 20081028009 | Gage pool and reference point on Honopou Stream IIFS Site A. |

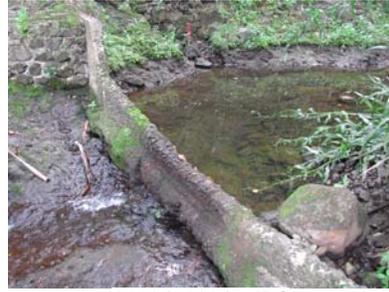
20081028010.JPG

Staff then drove to the bridge that crosses Honopou Stream further downstream to measure flow at IIFS Site A. Staff met with Garret Hew, Henry Robello, and members of the Honopou community at the bridge. CWRM staff prepared IIFS Site A on Honopou Stream for flow measurement. CWRM staff checked the downstream gage pool for debris and there was none. Staff noticed that the water level in the gage pool was considerable lower than the water level observed in previous field visits, during which the water overtopped the concrete-reinforced masonry (CRM) wall of the gage pool. Since the water level in the gage pool was low, and that water was not spilling over the CRM wall, Garret Hew noticed leakage at the center of the wall footing that was not apparent in previous field visits when the water overtopped the wall. When CWRM staff returned to the Honolulu Office, Matt Wong of the USGS-Maui Office contacted Chui Ling Cheng regarding the leakage. He mentioned that a gage pool with multiple leakages may not be stable enough for gage height readings. CWRM staff plans to return to this site in November to investigate this issue further.

| File Name: | Brief Description: |
|---|--|
| 20081028010 | Gage pool and reference point on Honopou Stream IIFS Site A. Water level was below the CRM wall. |
