**STATE OF HAWAII**  
**DEPARTMENT OF LAND AND NATURAL RESOURCES**  
**COMMISSION ON WATER RESOURCE MANAGEMENT**  
 Stream Protection and Management Branch

**FIELD INVESTIGATION REPORT**  
**FI2008102803 (East Maui, Huelo Haiku Ditch, restore)**

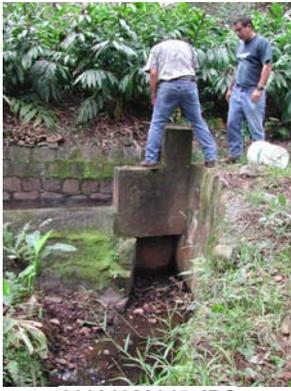
**20081028015.JPG**

| <b>File Name:</b> | <b>Brief Description:</b> |
|---|---|
| 20081028015 | Garret Hew and Henry Robello inspecting the Haiku Ditch sluice gate on Puolua (Huelo) Stream. |

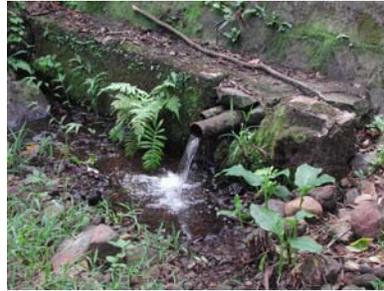
**20081028016.JPG**

| <b>File Name:</b> | <b>Brief Description:</b> |
|---|---|
| 20081028016 | The two PVC pipes that bypasses Haiku Ditch on Puolua (Huelo) Stream. |

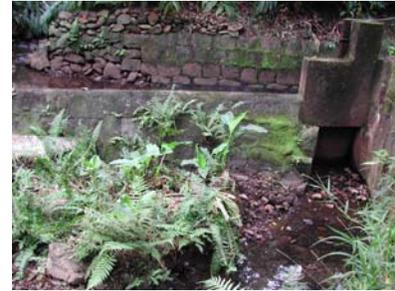
**20081028017.JPG**

| <b>File Name:</b> | <b>Brief Description:</b> |
|---|---|
| 20081028017 | Haiku Ditch on Puolua (Huelo) Stream. |

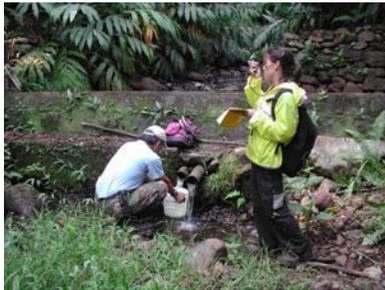
**20081028019.JPG**

At approximately 1130 hours, CWRM staff, Garret Hew and Henry Robello, arrived at the Haiku Ditch diversion on Puolua (Huelo) Stream. CWRM staff took a volumetric measurement of the water flowing through the two 5.4-inch (O.D.) PVC pipes that bypasses Haiku Ditch on Puolua (Huelo) Stream. With a stopwatch, staff recorded the number of seconds each of the pipes took to fill a 2 gallon bucket. This process was repeated 5 times, making a total of 5 measurements per pipe. As computed back in the Honolulu Office, the flow from the pipes was 0.062 cubic feet per second (0.040 million gallons per day).

| <b>File Name:</b> | <b>Brief Description:</b> |
|---|---|
| 20081028019 | CWRM staff conducting volumetric measurement of the water flowing through the two PVC pipes that bypasses Haiku Ditch on Puolua (Huelo) Stream. |

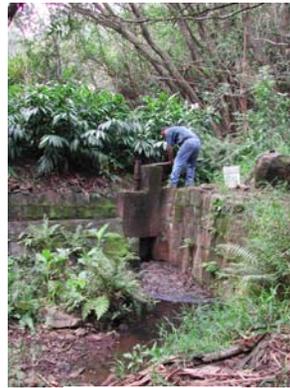
**20081028022.JPG**

The purpose of the field visit was to document the flow release at the ditch. Henry Robello proceeded to lift up the Haiku Ditch sluice gate with a metal bar. Once the gate was opened, water from the upstream side of the sluice gate flowed through the gate opening. Water slowly stopped flowing from the two pipes that bypasses Haiku Ditch on Puolua (Huelo) Stream.

| <b>File Name:</b> | <b>Brief Description:</b> |
|---|---|
| 20081028022 | Henry Robello opening the Haiku Ditch sluice gate on Puolua (Huelo) Stream. |

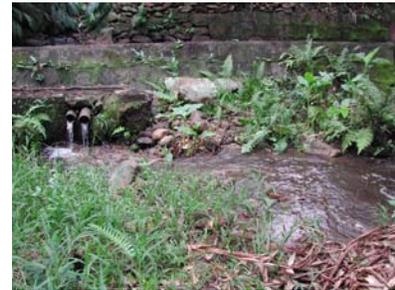
**20081028023.JPG**

| <b>File Name:</b> | <b>Brief Description:</b> |
|---|---|
| 20081028023 | Haiku Ditch on Puolua (Huelo) Stream. Haiku Ditch sluice gate opened. |

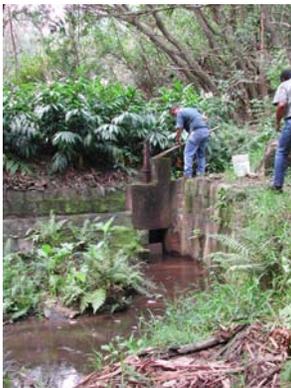
**20081028025.JPG**

| <b>File Name:</b> | <b>Brief Description:</b> |
|---|---|
| 20081028025 | Henry Robello opening the Haiku Ditch sluice gate on Puolua (Huelo) Stream. |

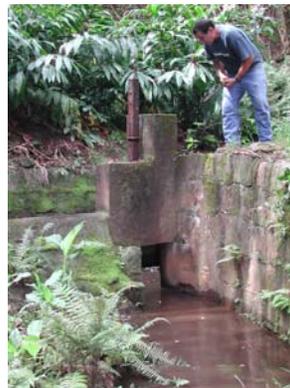
**20081028026.JPG**

| <b>File Name:</b> | <b>Brief Description:</b> |
|---|---|
| 20081028026 | Haiku Ditch sluice gate on Puolua (Huelo) Stream opened. |

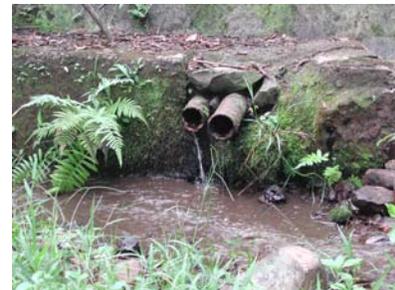
**20081028027.JPG**

| <b>File Name:</b> | <b>Brief Description:</b> |
|---|---|
| 20081028027 | The two PVC pipes that bypasses Haiku Ditch on Puolua (Huelo) Stream, after the sluice gate was opened. |

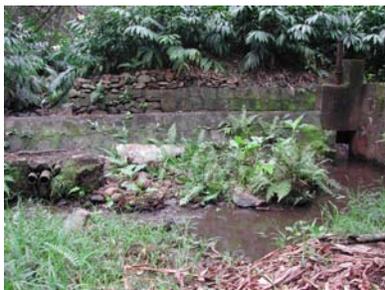
**20081028028.JPG**

| <b>File Name:</b> | <b>Brief Description:</b> |
|---|---|
| 20081028028 | Haiku Ditch on Puolua (Huelo) Stream after the sluice gate was opened.. |
