STATE OF HAWAII
DEPARTMENT OF LAND AND NATURAL RESOURCES
COMMISSION ON WATER RESOURCE MANAGEMENT
 Stream Protection and Management Branch

FIELD INVESTIGATION REPORT
FI2008102902 (East Maui, Wailuanui IIFS Site)

| Hydrologic Unit: | Wailuanui (6056) | | |
| Stream Name: | Wailuanui Stream | | |

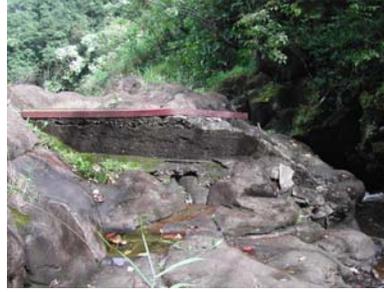
20081029010.JPG

| File Name: | Brief Description: |
|---|---|
| 20081029010 | Concrete structure near the top of Waikani Fall that may have been remnants of a previous gaging station or weir. |

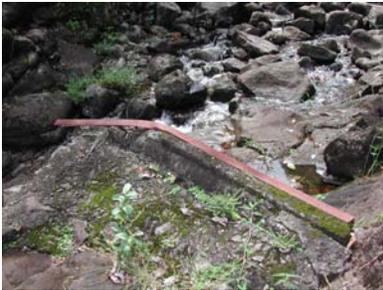
20081029016.JPG

| File Name: | Brief Description: |
|---|---|
| 20081029016 | Concrete structure near the top of Waikani Fall that may have been remnants of a previous gaging station or weir. |

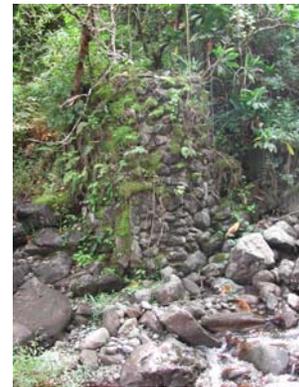
20081029022.JPG

| File Name: | Brief Description: |
|---|---|
| 20081029022 | CRM wall on the right bank of Wailuanui Stream near the top of Waikani Falls. |

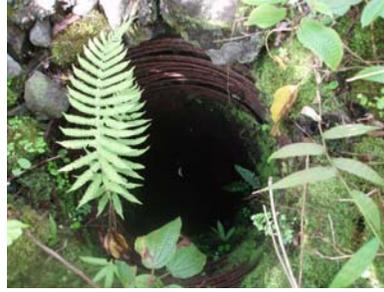
20081029041.JPG

| File Name: | Brief Description: |
|---|---|
| 20081029041 | Old stilling well on the right bank of Wailuanui Stream near the top of Waikani Falls. |

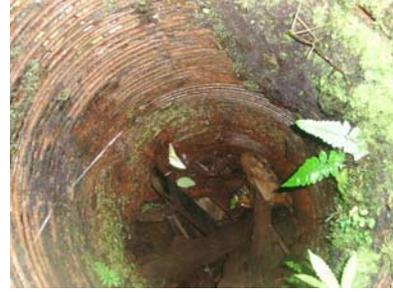
20081029046.JPG

| File Name: | Brief Description: |
|---|---|
| 20081029046 | Old stilling well on the right bank of Wailuanui Stream near the top of Waikani Falls. |

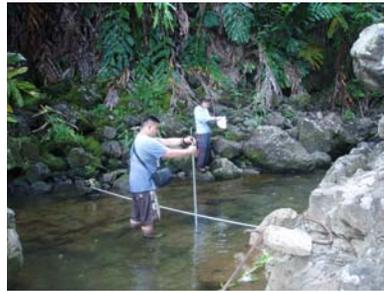
20081029053.JPG

CWRM staff prepared the site for flow measurement. The site was flagged with yellow tape, labeled with the stream name, IIFS site, and the date. Staff completed the entire flow measurement in 40 minutes. In addition to flow measurement, staff crew also recorded wind velocity, air temperature, water temperature and weather conditions. As computed back in the Honolulu Office, the flow at IIFS Site was 2.293 cubic feet per second (1.482 million gallons per day), with no gage height readings.

| File Name: | Brief Description: |
|---|---|
| 20081029053 | CWRM staff conducting flow measurement at IIFS Site on Wailuanui Stream. |
