**STATE OF HAWAII**  
**DEPARTMENT OF LAND AND NATURAL RESOURCES**  
**COMMISSION ON WATER RESOURCE MANAGEMENT**  
 Stream Protection and Management Branch

**FIELD INVESTIGATION REPORT**  
**FI2008111805 (East Maui, Palauhulu, high flow)**

<b>Date of Field Investigation:</b>	November 18, 2008	<b>Time (24-hour):</b>	1540-1600
<b>CWRM Staff:</b>	Ed Sakoda, Dean Uyeno, and Chui Ling Cheng		
<b>Individuals Present:</b>	Skippy Hau (DAR)		
<b>Hydrologic Unit:</b>	Piinaau (6053)		
<b>Stream Name:</b>	Palauhulu Stream

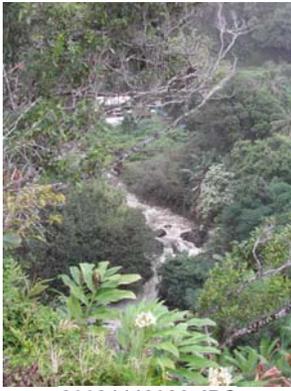
**20081118086.JPG**

At 1540 hours, CWRM staff and Skippy arrived at the Keanae Valley Lookout. From the lookout, staff could view Keanae Flume, Palauhulu Stream, and the large pond before flowing out to the ocean. During the field visit on Oct. 24, 2008 (refer to FI2008102403), Palauhulu Stream downstream from Keanae Flume was completely dry. No water was flowing into the large pond further downstream. At this field visit, the water level in Palauhulu Stream was at least 5 feet high based on the concrete base of the flume. Water was flowing into the large pond. Due to the heavy rain\*, the high flows flushed debris and other contaminants out to the ocean, creating a large plume.

<u>File Name:</u>	<u>Brief Description:</u>
20081118086	Palauhulu Stream and Keanae Flume from the Keanae Valley Lookout.
20081118088	Mouth of Piinaau Stream.
20081118091	Keanae Valley taro patches.
20081118093	Palauhulu Stream upstream from Hana Highway.
20081118094	IIFS Site B on Palauhulu Stream upstream from Hana Highway.
20081118095	Palauhulu Stream downstream from Hana Highway.
20081118096	Palauhulu Stream downstream from Hana Highway.

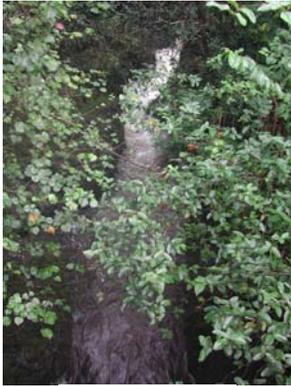
**20081118093.JPG**

CWRM staff and Skippy then drove to the Hana Highway bridge that crosses Palauhulu Stream. Staff observed Palauhulu Stream from the bridge and determined the flow velocities in the stream to be too high for taking measurements.
