STATE OF HAWAII
DEPARTMENT OF LAND AND NATURAL RESOURCES
COMMISSION ON WATER RESOURCE MANAGEMENT
 Stream Protection and Management Branch

FIELD INVESTIGATION REPORT
FI2008111807 (East Maui, Honopou IIFS Site A)

Date of Field Investigation:	November 18, 2008	Time (24-hour):	1730 - 1800
CWRM Staff:	Ed Sakoda, Dean Uyeno, and Chui Ling Cheng		
Individuals Present:	Skippy Hau (DAR)		
Hydrologic Unit:	Honopou (6034)		
Stream Name:	Honopou Stream

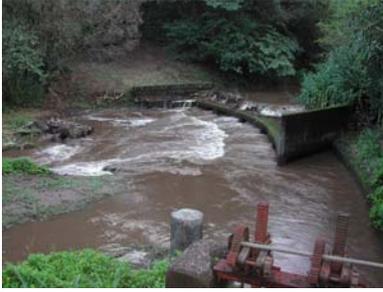
20081118126.JPG

At 1730 hours, CWRM staff and Skippy arrived at the Haiku Ditch diversion intake on Honopou Stream. Due to the high flows from the heavy rain*, debris had collected on the upstream side of the berm that EMI constructed on Oct. 27, 2008 (refer to FI2008102703 for more information). The berm did not wash downstream. Water was flowing over the berm and Haiku Ditch. The water level at the ditch was higher than the opening of the control gate at the right bank of the stream. Backflow of water from the control gate was apparent.

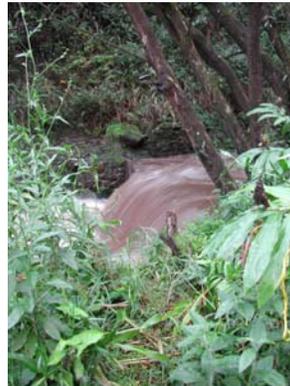
20081118139.JPG

CWRM staff drove down Honopou Road to IIFS Site A on Honopou stream. Flow velocities in Honopou Stream were too high for taking flow measurements. Water flowed pass the CRM wall of the gage pool. The reference point was no longer visible.
