**STATE OF HAWAII**  
**DEPARTMENT OF LAND AND NATURAL RESOURCES**  
**COMMISSION ON WATER RESOURCE MANAGEMENT**  
 Stream Protection and Management Branch

**FIELD INVESTIGATION REPORT**  
**FI2008111905 (East Maui, Hanehoi IIFS Site B)**

<b>Date of Field Investigation:</b>	November 19, 2008	<b>Time (24-hour):</b>	1420 - 1610
<b>CWRM Staff:</b>	Ed Sakoda, Dean Uyeno, Chui Ling Cheng		
<b>Individuals Present:</b>	Skippy Hau (DAR staff)		
<b>Hydrologic Unit:</b>	Hanehoi (6037)		
<b>Stream Name:</b>	Hanehoi Stream

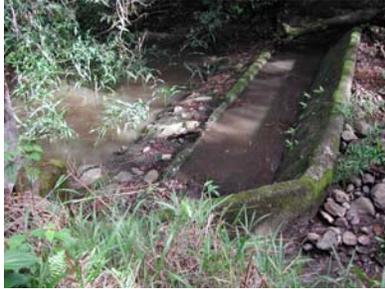
**20081119064.JPG**

<b>File Name:</b>	<b>Brief Description:</b>
20081119064	Haiku Ditch on Hanehoi Stream.
20081119065	Hanehoi Stream upstream of Haiku Ditch.
20081119066	Hanehoi Stream upstream of Haiku Ditch.
20081119067	Haiku Ditch diversion intake on Hanehoi Stream.
20081119068	Haiku Ditch on Hanehoi Stream.
