STATE OF HAWAII
DEPARTMENT OF LAND AND NATURAL RESOURCES
COMMISSION ON WATER RESOURCE MANAGEMENT
 Stream Protection and Management Branch

FIELD INVESTIGATION REPORT
FI2008111906 (East Maui, Honopou Haiku Ditch)

Date of Field Investigation:	November 19, 2008	Time (24-hour):	1620 - 1700
CWRM Staff:	Ed Sakoda, Dean Uyeno, and Chui Ling Cheng		
Individuals Present:	Skippy Hau (DAR); Lynn Scott (Honopou resident)		
Hydrologic Unit:	Honopou (6034)		
Stream Name:	Honopou Stream

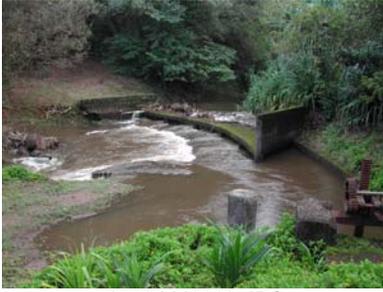
20081119069.JPG

<u>File Name:</u>	<u>Brief Description:</u>
20081118169	Haiku Ditch diversion intake on Honopou Stream.
20081118170	Haiku Ditch diversion intake on Honopou Stream.
20081118171	Haiku Ditch diversion intake on Honopou Stream.
