**STATE OF HAWAII**  
**DEPARTMENT OF LAND AND NATURAL RESOURCES**  
**COMMISSION ON WATER RESOURCE MANAGEMENT**  
 Stream Protection and Management Branch

**FIELD INVESTIGATION REPORT**  
**FI2008121003 (East Maui, West Wailuanui Koolau Ditch)**

<b>Date of Field Investigation:</b>	December 10, 2008	<b>Time (24-hour):</b>	1220 - 1340
<b>CWRM Staff:</b>	Ken Kawahara, Ed Sakoda, Dean Uyeno, and Chui Ling Cheng		
<b>Individuals Present:</b>	Amanda Martin (President of Na Moku); EMI - Garret Hew (Water Resources Manager), Mark Vaught (Operations Manager), Henry Robello (Field Superintendent); DOCARE officers		
<b>Hydrologic Unit:</b>	Wailuanui (6056)		
<b>Stream Name:</b>	West Wailuanui Tributary

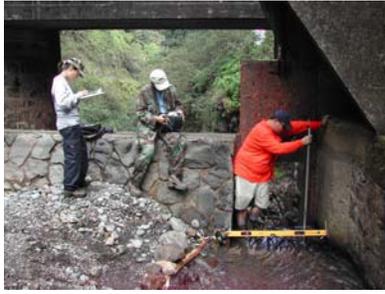
20081210022.JPG

<b>File Name:</b>	<b>Brief Description:</b>
20081210022	CWRM staff conducting flow measurement at the Koolau Ditch bypass sluice gate on West Wailuanui Stream.
20081210024	CWRM staff conducting flow measurement at the Koolau Ditch bypass sluice gate on West Wailuanui Stream.
20081210025	CWRM staff conducting flow measurement at the Koolau Ditch bypass sluice gate on West Wailuanui Stream.
20081210026	Koolau Ditch bypass sluice gate on West Wailuanui Stream before gate adjustment.
20081210029	Koolau Ditch bypass sluice gate on West Wailuanui Stream before gate adjustment.
20081210030	EMI staff adjusting the Koolau Ditch bypass sluice gate on West Wailuanui Stream.
20081210033	CWRM staff measuring the height of the Koolau Ditch bypass sluice gate on West Wailuanui Stream after the adjustment.
20081210034	CWRM staff measuring the height of the Koolau Ditch bypass sluice gate on West Wailuanui Stream after the adjustment.

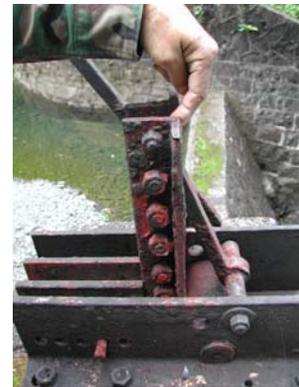
20081210039.JPG

20081210039	Notches of the Koolau Ditch bypass sluice gate on West Wailuanui Stream after adjustment.
20081210040	Notches of the Koolau Ditch bypass sluice gate on West Wailuanui Stream after adjustment.
20081210041	Notches of the Koolau Ditch bypass sluice gate on West Wailuanui Stream after adjustment.
20081210046	Dean Uyeno, Dexter Tom, Amanda Martin, Ken Kawahara, and Garret Hew at the Koolau Ditch bypass sluice gate on West Wailuanui Stream.
20081210048	Amanda Martin, Ken Kawahara, and Garret Hew at the Koolau Ditch bypass sluice gate on West Wailuanui Stream.
20081210051	CWRM staff flagging the height of the Koolau Ditch bypass sluice gate opening after adjustment.
20081210052	Notches of the Koolau Ditch bypass sluice gate on West Wailuanui Stream after adjustment.
20081210053	Notches of the Koolau Ditch bypass sluice gate on West Wailuanui Stream after adjustment.
20081210054	Amanda Martin, Ken Kawahara, and Garret Hew at the Koolau Ditch bypass sluice gate on West Wailuanui Stream.

The final height of the sluice gate opening after adjustment was 0.35 feet. CWRM staff used fluorescent yellow flagging tape to mark the height of the sluice gate opening.

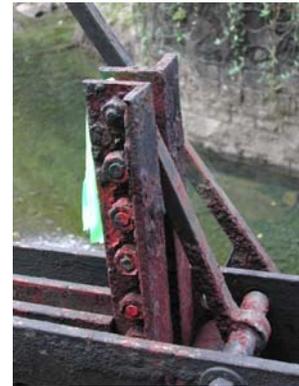
20081210055.JPG

20081210055	Notches of the Koolau Ditch bypass sluice gate on West Wailuanui Stream after adjustment.
20081210057	Koolau Ditch (#8) minor diversion intake on Wailuanui Stream.
20081210059	Koolau Ditch (#7) diversion intake on Wailuanui Stream.
