STATE OF HAWAII
DEPARTMENT OF LAND AND NATURAL RESOURCES
COMMISSION ON WATER RESOURCE MANAGEMENT
 Stream Protection and Management Branch

FIELD INVESTIGATION REPORT
FI2009020901 (East Maui, Wailua Valley Taro)

Date of Field Investigation:	February 9, 2009	Time (24-hour):	1000 - 1730
CWRM Staff:	Ed Sakoda, Dean Uyeno, and Chui Ling Cheng		
Individuals Present:	Alan Murakami, Ed Wendt, Amanda Martin, Kimo Day, Steven Hookano		
Hydrologic Unit:	Wailuanui (6056)		
Stream Name:

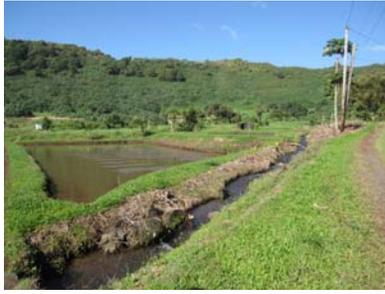
20090209001.jpg

File Name:	Brief Description:
20090209001	Wailua Valley taro patches fed by Waikani Falls / Pond.
20090209002	Wailua Valley taro patches fed by Lakini.
20090209008	Auwai dividing the patches that are fed by Waikani Falls / Pond (left) and those fed by Lakini (right).
20090209012	Lower patches fed by Lakini.
20090209016	Pipe outflow from taro patch to auwai.
20090209024	Taro patches belonging to Kimo Day. These patches were fed by Waikani Falls / Pond.
20090209026	Taro patches belonging to Kimo Day. These patches were fed by Waikani Falls / Pond.
20090209031	Taro patches belonging to Kimo Day, and a 6-inch pipe that took water from Waikani Falls / Pond to the taro patches.
20090209032	General area fed by Waikani Falls / Pond.

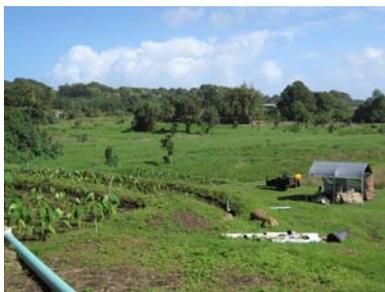
20090209033.jpg

20090209033	General area fed by Lakini.
20090209035	A 6-inch pipe with water from Waikani Falls / Pond to the taro patches.
20090209048	Intake pipe (6-inch) at the beginning of the auwai taking water from Waikani Falls / Pond.
20090209049	Where water from Waikani Falls / Pond splits into two pipes.
20090209051	Where water from Waikani Falls / Pond outflows into the auwai.
20090209057	Waikani Falls.
20090209058	Wailuanui Stream downstream of Waikani Falls.
20090209065	Alan Murakami clearing the intake at Waikani Pond.
20090209069	Where water from Waikani Falls / Pond outflows into the auwai after clearing of the intake at Waikani Pond.
20090209070	Location where water from Waikani Falls / Pond outflows into the auwai after clearing of the intake at Waikani Pond.
20090209077	Where water from Waikani Falls / Pond outflows into the auwai after clearing of the intake at Waikani Pond.
20090209080	Auwai full with water from Waikani Falls / Pond after clearing of the intake at Waikani Pond.

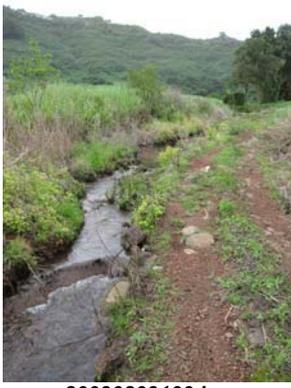
20090209100.jpg

20090209100	Lower ditch in Wailua Valley.
20090209114	Pumpkin patch along the lower ditch in Wailua Valley.
20090209118	Overlooking the center of Wailua Valley at the lower ditch.
20090209120	Taro patches belonging to Nakanelua and Young families. These patches were fed by the middle ditch.
20090209134	Middle ditch in Wailua Valley.
20090209139	Young's family taro patches in the center of Wailua Valley.
20090209148	Steven Hookano's taro patches in Wailua Valley.
20090209149	Middle ditch in Wailua Valley.
